National Transportation Safety Board
Office of Research and Engineering
Washington, D.C. 20594

Performance Study

Location: Spokane, Washington
Date: May 7, 2015
Time: 1604 PDT
Airplane: Piper PA 46-350P, N962DA
NTSB Number: WPR15FA158

Radar Study
WPR15FA158, Piper PA 46-350P, N962DA

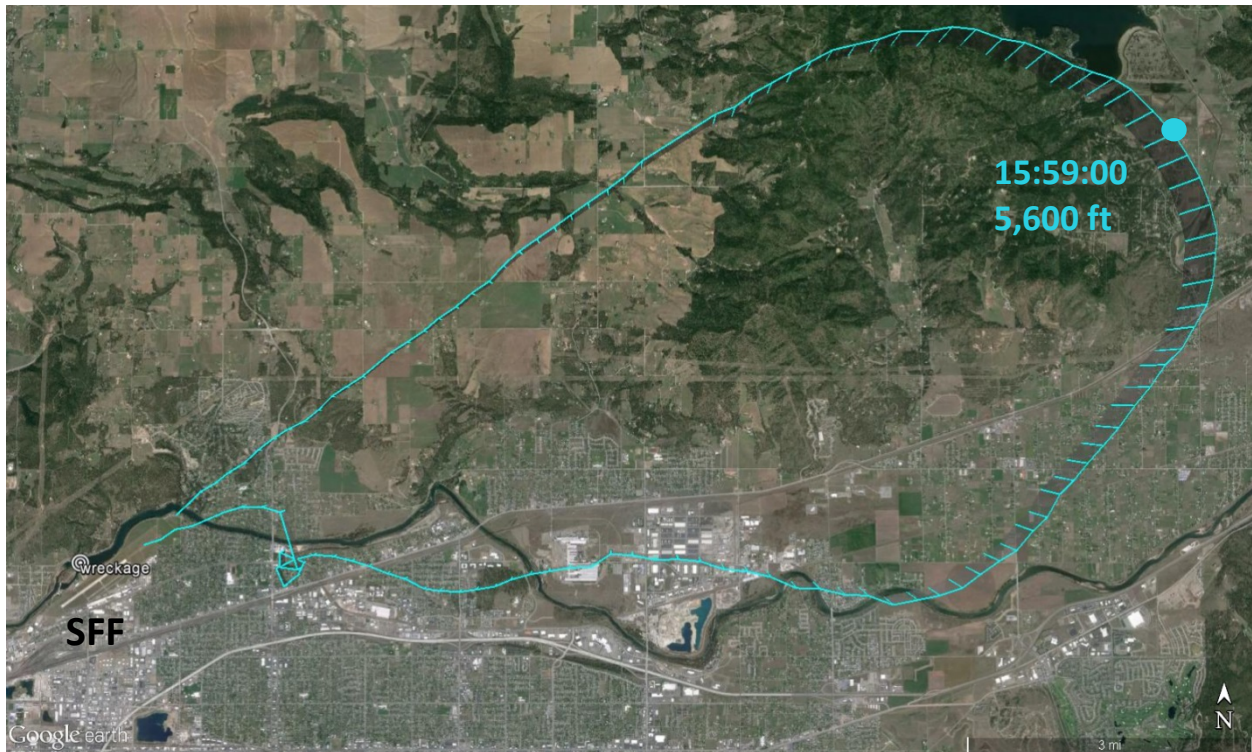
The radar track for the flight is shown in Figure 1. The aircraft took off from SFF at 1553, climbed and turned to the right before experiencing a sudden, tight right turn, and loss of altitude, shown in Figure 2. After regaining altitude, the aircraft continued flying to the west before completing a left turn to align with runway 22R for landing. The radar data ended 0.6 NM before the runway threshold. The aircraft collided with the river 1,300 ft to the right of the runway (Figure 3). The final mile of flight was not recorded by radar and was therefore not studied for this report.

Figure 1. Aircraft flight path from GEG radar and wreckage location. Flight path is counter-clockwise and SFF is in the lower left corner. Marked point is point of maximum altitude.

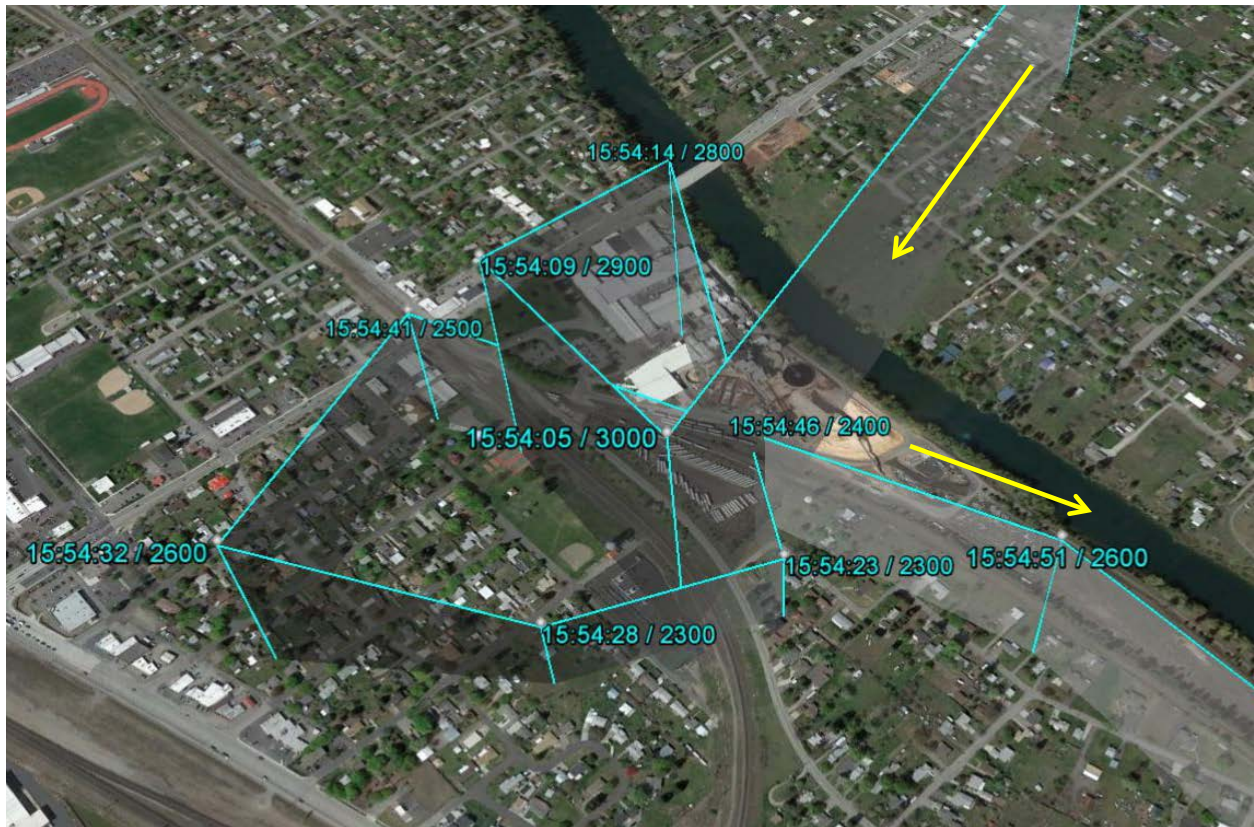
Figure 2. Aircraft flight path from GEG radar focusing on the sudden right turn after take-off. Yellow arrows indicate flight path.

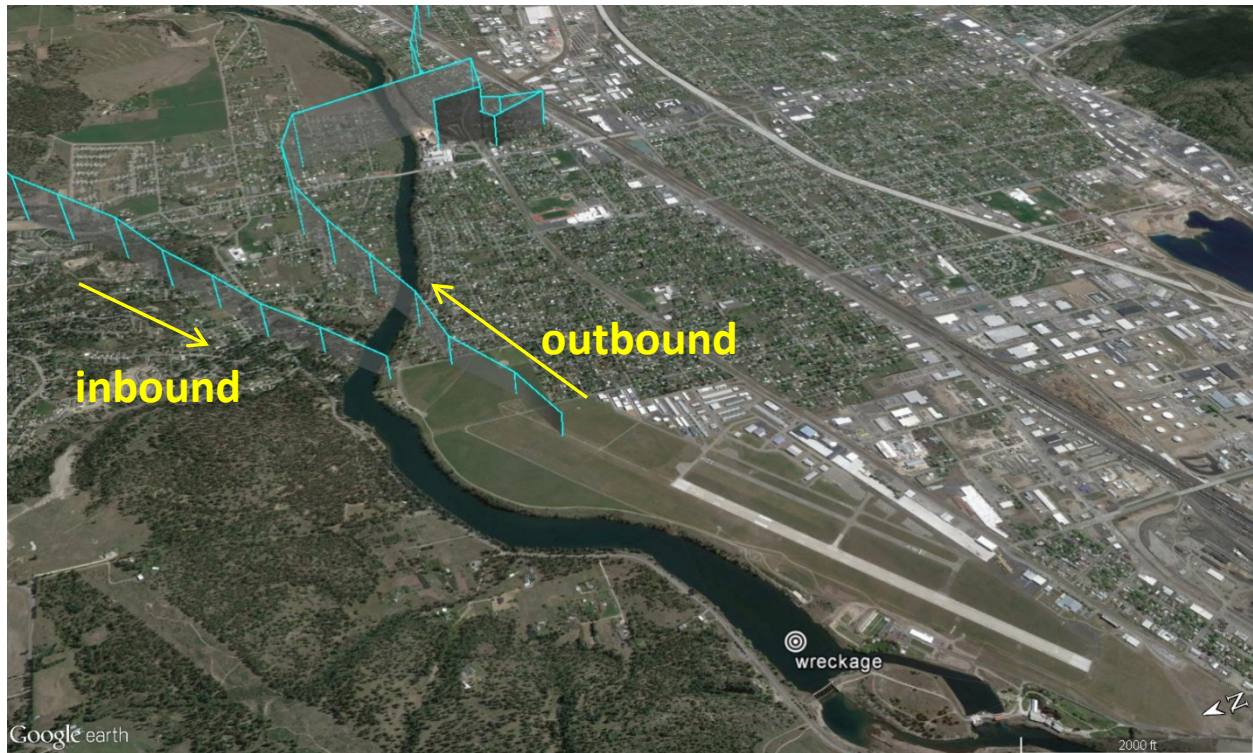
Figure 3. Aircraft flight path from GEG radar and wreckage location. Flight path direction shown by yellow arrows.

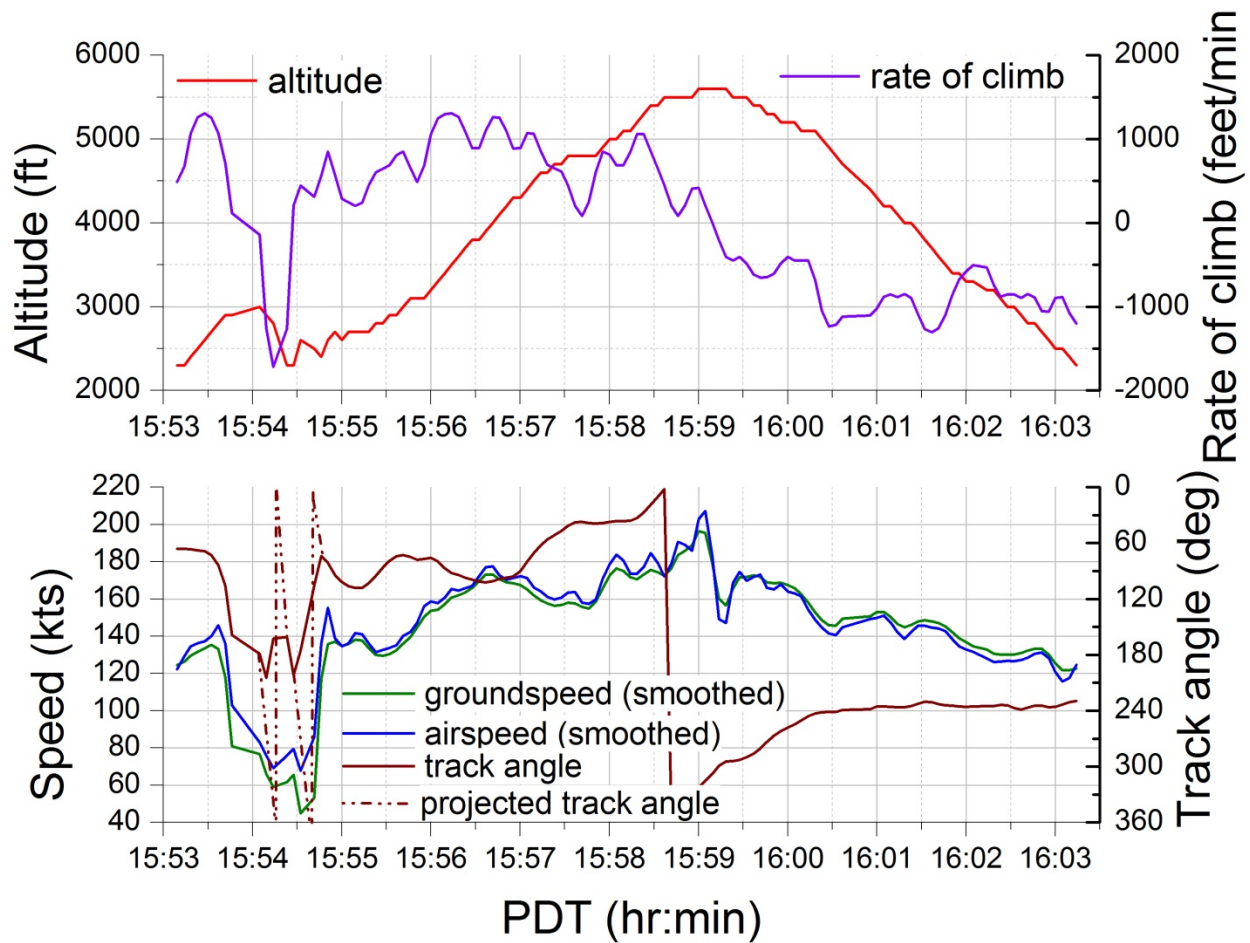
The aircraft's rate of climb and speeds were calculated using the radar data and are shown in Figure 4. The aircraft had reached an altitude of 3,000 ft and an airspeed of about 140 kts before the early hard right turn. During the event, the aircraft lost 700 ft of altitude and the airspeed dropped to just below 80 kts. After the aircraft recovered, it resumed climbing, reaching a maximum altitude of 5,600 ft and a speed of approximately 190 kts at 15:59. The aircraft's reported stall speed is 58 kts and cruise speed is 196 kts.

Figure 4. Aircraft’s altitude from radar with its calculated rate of climb, groundspeed, airspeed, and track angle. Due to the radar sample rate the track angle does not accurately show the two full turns the aircraft completed early in the flight. The dotted projected track angle has been added to the plot to better illustrate this event.

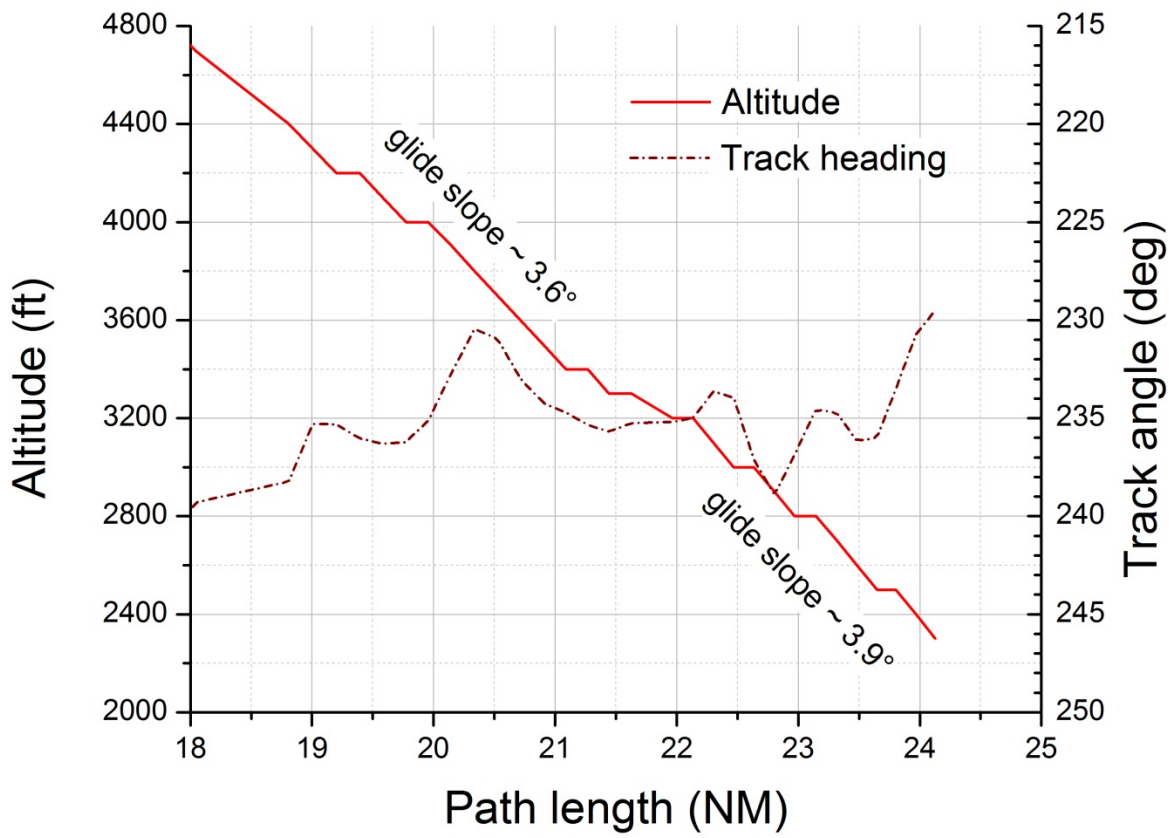
After 15:59, the aircraft completed its turn onto final for runway 22R while descending and reducing speed. For the final six nautical miles of recorded flight, the aircraft’s track angle was steady on about 235° (runway 22R’s true heading is 234°) and was descending at a rate of 1000 ft/min. The final calculated speed was about 120 kts. The aircraft’s glide slope is shown in Figure 5. The glide path for runway 22R is 3.5°, so the aircraft’s glide slope was steeper than recommended.

Figure 5. Aircraft's altitude and track angle versus path length. Calculated glide slopes shown.

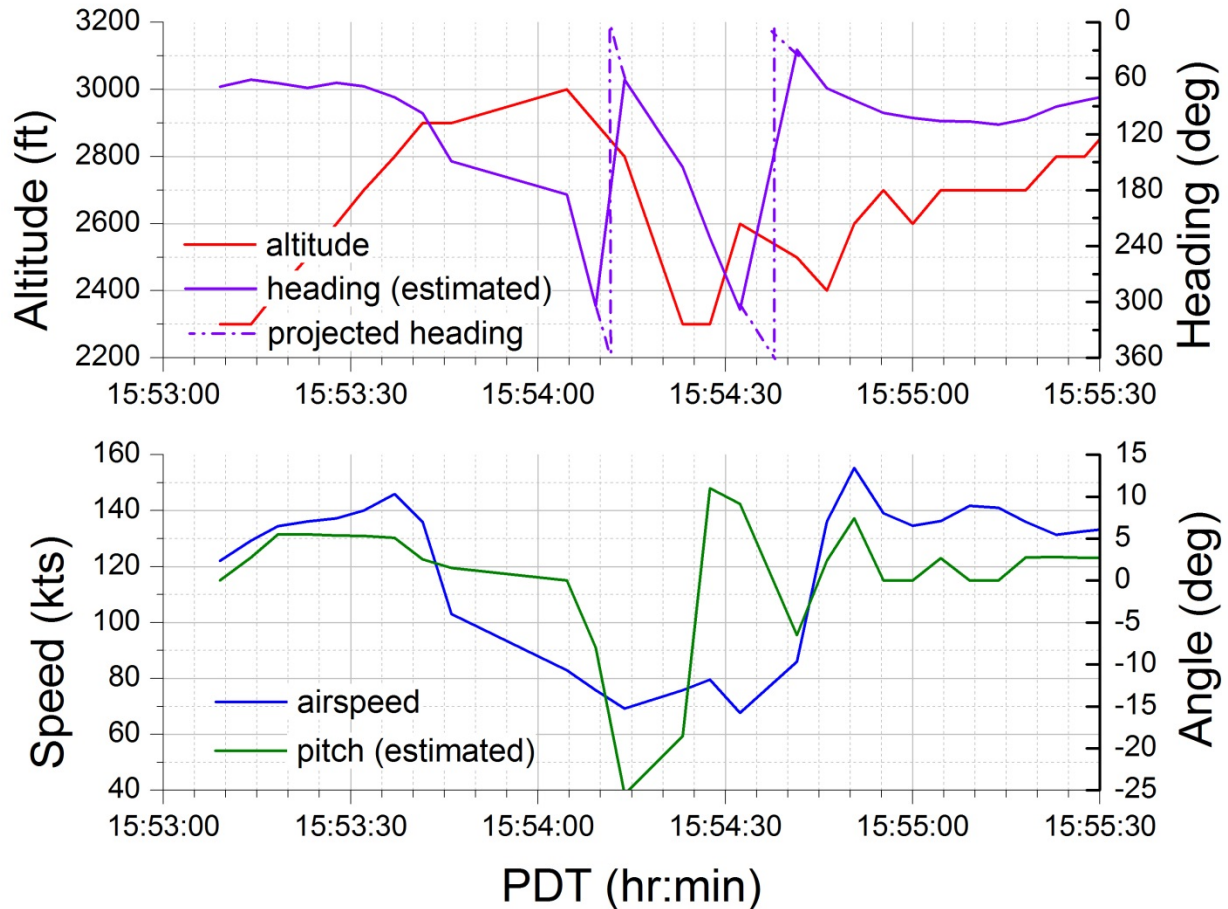
A simple aerodynamic model of a PA-46 was constructed to estimate likely heading and pitch attitudes of the aircraft during the early flight hard right turn. Figure 6 shows that during the initial climb and early turn, the aircraft's pitch remained below 10°. By 15:55:30 the aircraft had begun to regain altitude and speed.

Figure 6. Estimated aircraft heading, altitude, speed, and pitch during early flight turn.
