SITE (ID); Jennings/Kreilow, LA-5136

TOWER TYPE / HT: Guyed Tower / ~480 ft.

Jennings/Kreilow LA-5136

Guyed Tower Inspection Report

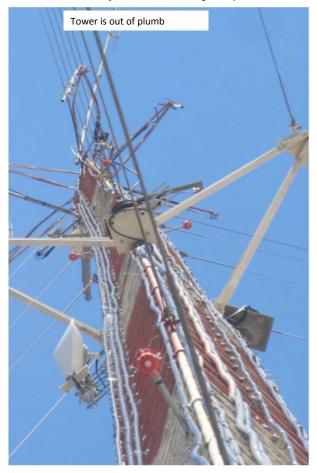
Damage at guy wires A7 and A8. There is no visible damage above the grips but it is likely

Antennas at the top have been damaged. This is likely due to tower movement

-Replace all guy wires at the 7th and 8th level. The two on side A show visible damage and side C shows some possible stretching or kinking.

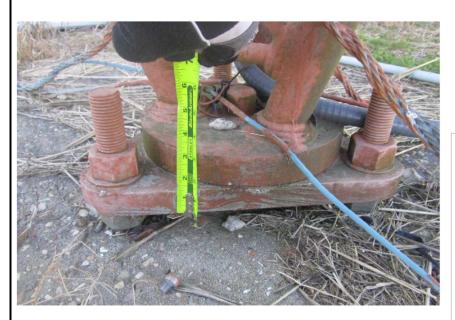
TOWER BASE SKETCH

6" c-c bottom FW, 2" SR legs

1" pin

9" dia. x 1.5" thick plate

(3) 1.25" dia. anchor rods

14" x 1.25" thick triangle plate

1.5" gap

6' x 6' base at grade level, 2" ave exposed above grade
