**National Transportation Safety Board**  
Office of Railroad, Pipeline and Hazardous Materials Investigations  
Human Performance and Survival Factors Division  
Washington, D.C. 20594

**Railcar Crashworthiness Group Chairman's Factual Report**  
**August 19, 2015**

Railroad: Metro-North Railroad  
Train: Passenger Train 659  
Location: Valhalla, New York  
Date: February 3, 2015  
Time: 6:26 pm EST<sup>1</sup>  
Number: DCA15MR006

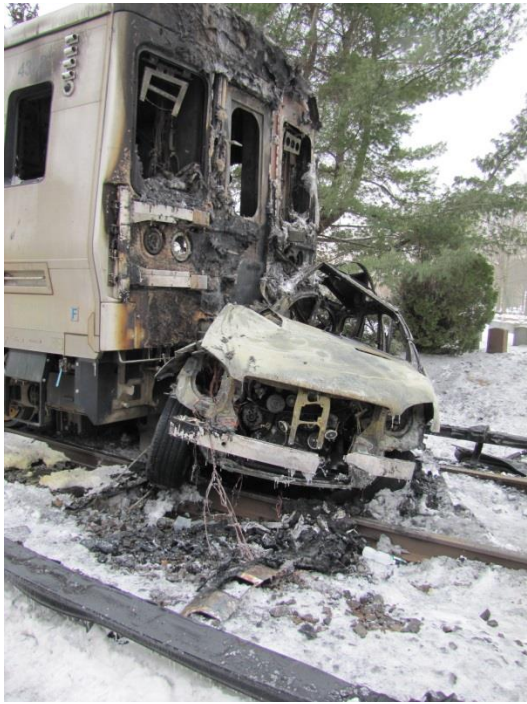
After the train struck the SUV on the grade crossing, the train and SUV continued to travel north along the track and came to a stop about 665 feet north of the grade crossing. North of the crossing, the third rail runs along the east side of the track. Where a curve in the track begins, the third rail ends on the east side of the track, and it begins on the west side of the track. At this point, there is a downward slope from the track to the ground.<sup>2</sup> The third rail on the west side of the track penetrated through the SUV and into the first car of the train. (See figures 1 and 2.)

Figure 1- A view of the train and SUV looking west

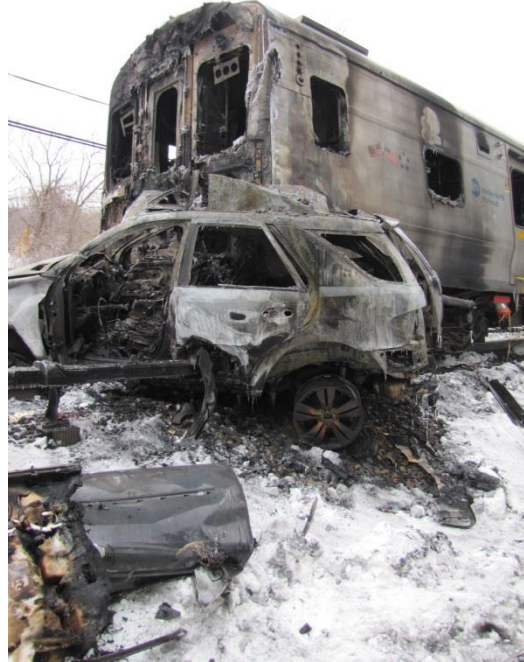
Figure 2- A view of the train and SUV looking southeast

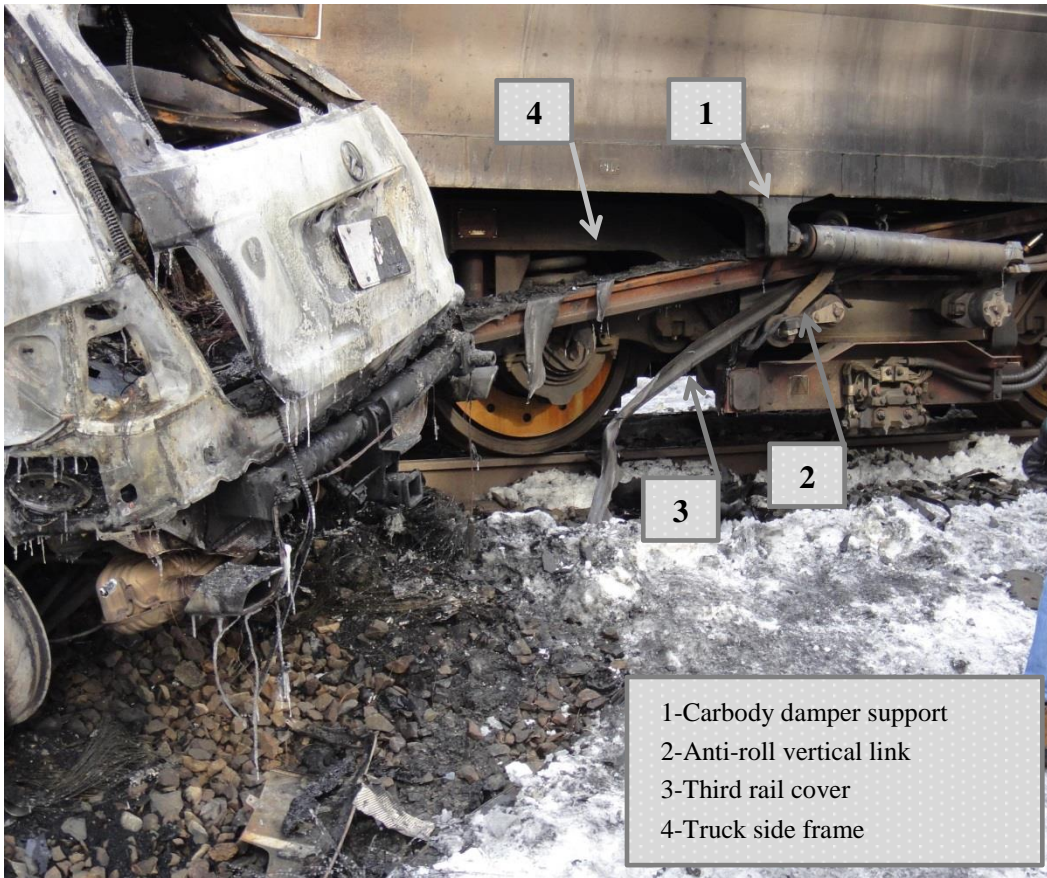
At the front left side of car 4333, a portion of the loop steps was missing, and the third rail was restrained behind the damaged loop step assembly.<sup>3</sup> The rail was trapped between the anti-roll vertical link and the truck assembly. (See figure 3.) The vertical link was twisted, and there was an impact mark on its longitudinal surface. There were scrape marks on the truck side frame top plate. Segments of damaged third rail protection cover were found on top of the truck and the third rail. The vertical link was flame cut to access the third rail to separate SUV from car 4333. After the SUV was removed from the train, a hole was observed in the front right door of the SUV.<sup>4</sup>

Figure 3- The front left side of car 4333

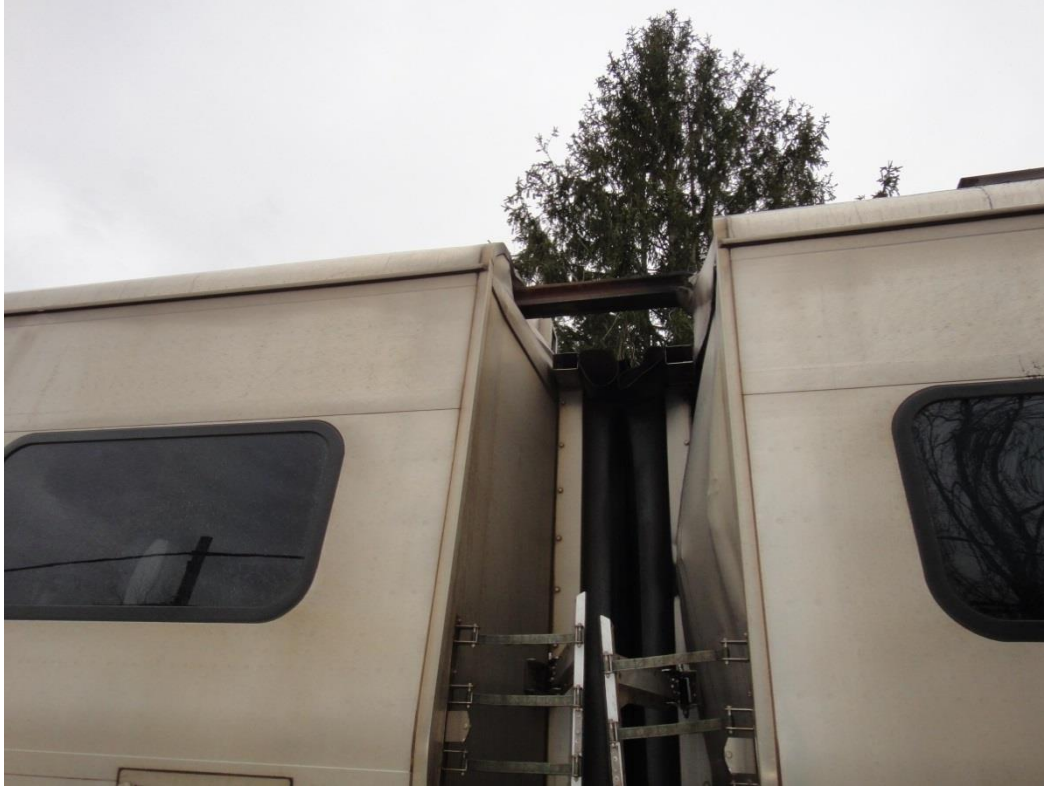
At the rear of the railcar, there were outward bulges at the end of the car on the right side. (See figure 4.) One segment of the third rail punctured and exited through the top right rear of car 4333 and penetrated into the top right front of car 4332. Inside of car 4332, the third rail was lodged between the exterior carbody shell and the interior ceiling panels.

Figure 4- The third rail between the rear of car 4333 (on the right) and front end of car 4332

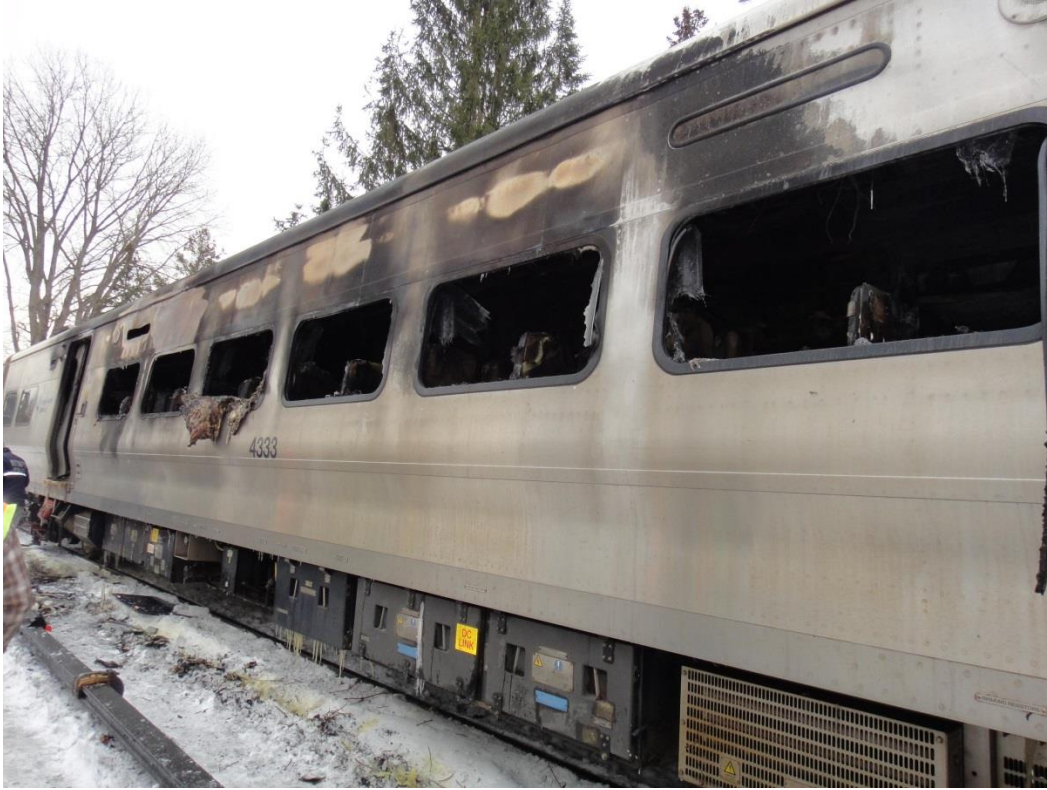
On the right side of railcar 4333, a partially melted window was found outside of the car on the ground next to the emergency window near the front of the train. (See figure 5.) An emergency window and a portion of its zip strip with one handle were on the ground outside near the emergency window in the center section of the car.<sup>5</sup> The other center section windows were melted or missing. The rear, right side windows were in place. Pieces of rear emergency door release cover were on the ground near the door. Both side passenger doors passenger side doors were open. There was thick soot on the carbody near window openings.

Figure 5- The right side of car 4333

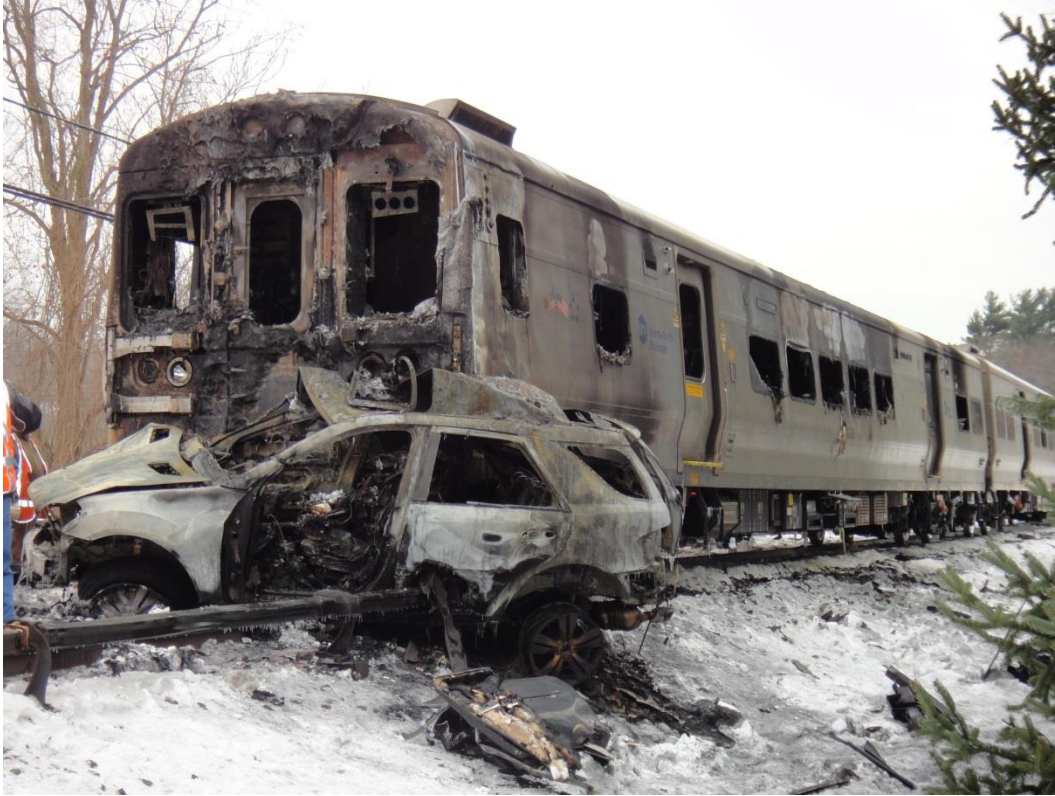
On the left side of railcar 4333, the rear emergency window was on the ground. The zip strip and window gasket were found inside of the car. The second window in the rear section of the car was in place. The remaining windows on the left side of the car were melted or missing. (See figure 6.) The emergency access window from the front side passenger door was outside of the car on the ground. The exterior zip strip was in place in the door. The left side passenger doors could not be opened. There was thick soot on the carbody near window openings.

Figure 6- The left side of car 4333

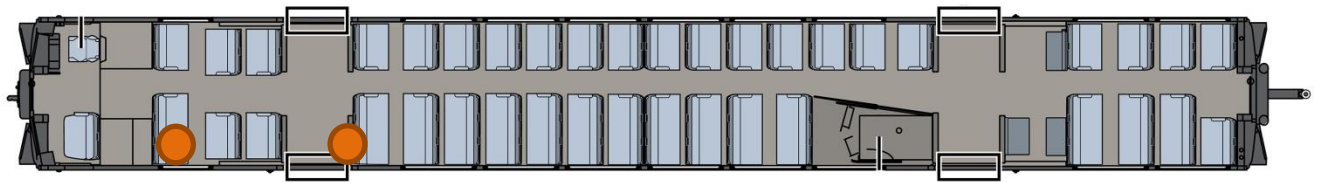
In car 4333, the third rail punctured a hole into the exterior subfloor of the car about 8 feet from the front left corner of the car. (See figure 7.) This hole extended into the floor and interior of the car. In the interior of the car, the hole was located under the first row of passenger seats behind the left side electrical locker. At this location, the nose piece of the third rail (a segment about 6 feet long) came to rest between the center hand hold of the second seat row. There was a second puncture in the exterior subfloor of the car located about 18 feet from the front left corner of the car. This hole extended into the floor below the front left vestibule and into the interior of the car under the first row of passenger seats behind the vestibule. Third rail connecting plates and power bonds were found at this entry location.

Figure 7- A plan view of car 4333 with the front of the car at the left. The two circles show the locations where the third rail entered the car.

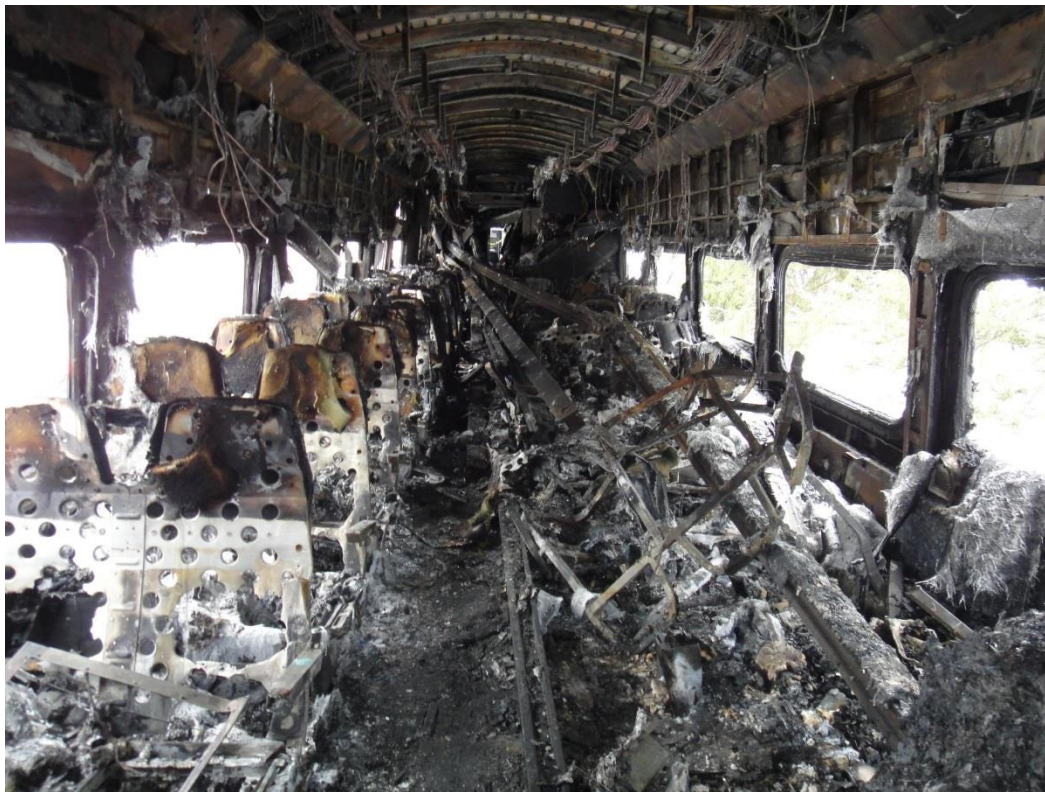
There were 11 sections of third rail inside of the car.<sup>6</sup> (See figures 8 and 9.) Throughout the car, there was extensive fire damage.<sup>7</sup> In the center section of the car, the left side center section seat frames and backs were bent toward the rear of the car. (See Attachment 1 for further information.) The right side seat frames were generally secure in position. There was no baggage racks mounted on the side walls in the center section of the car. Sections of broken baggage rack were found throughout the car. At the rear of the car, one section of the third rail was on the floor about one foot from the rear door.

Figure 8- A view toward the rear of the interior of car 4333

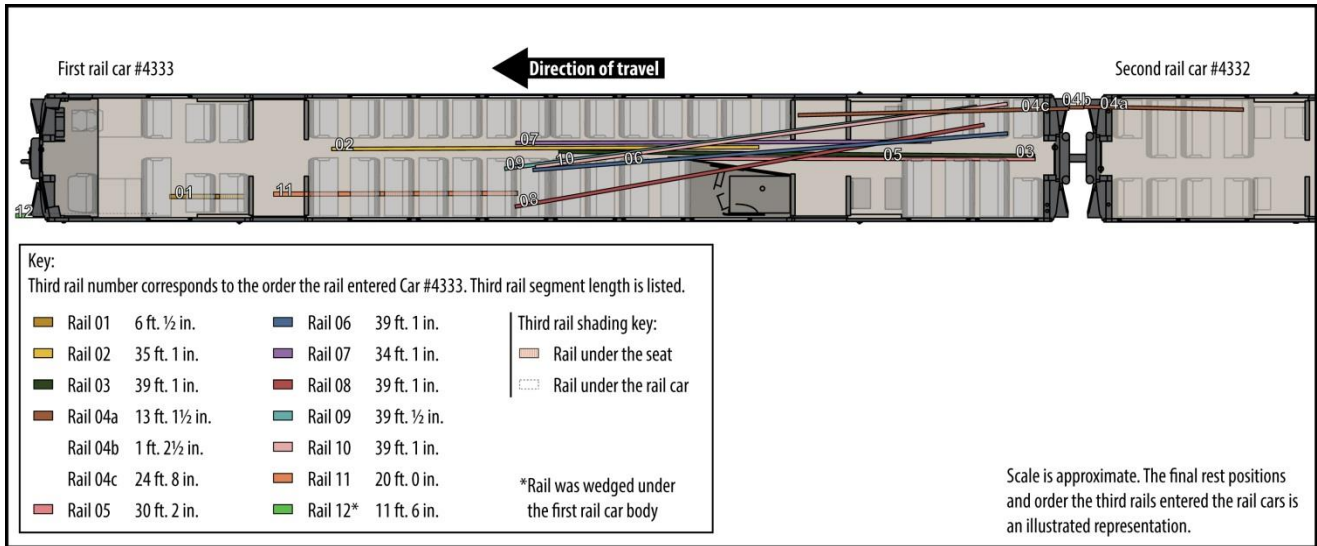
Figure 9-The approximate positions of the third rail located inside of car 4333

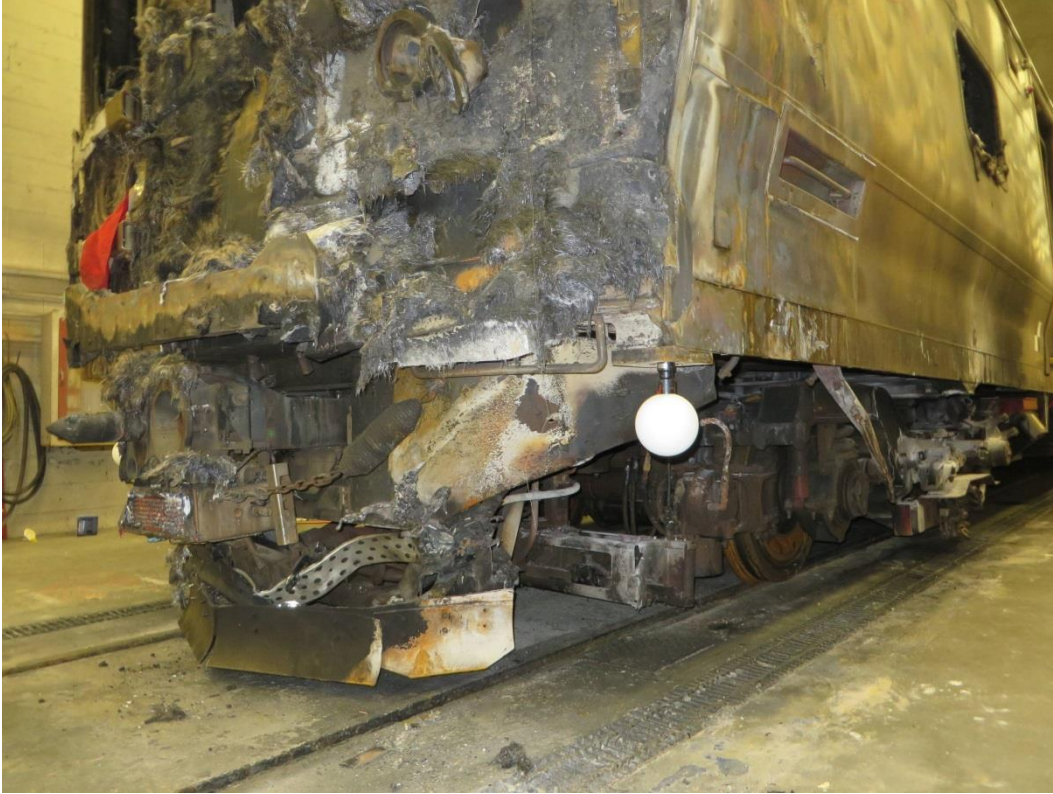
At the front left side corner of the car, the carbon steel underframe structure and pneumatic piping were discolored, the stainless steel skin was discolored and warped, and the horn was separated from its mounting plate. (See figure 10.)

Figure 10- The front left corner of car 4333<sup>8</sup>

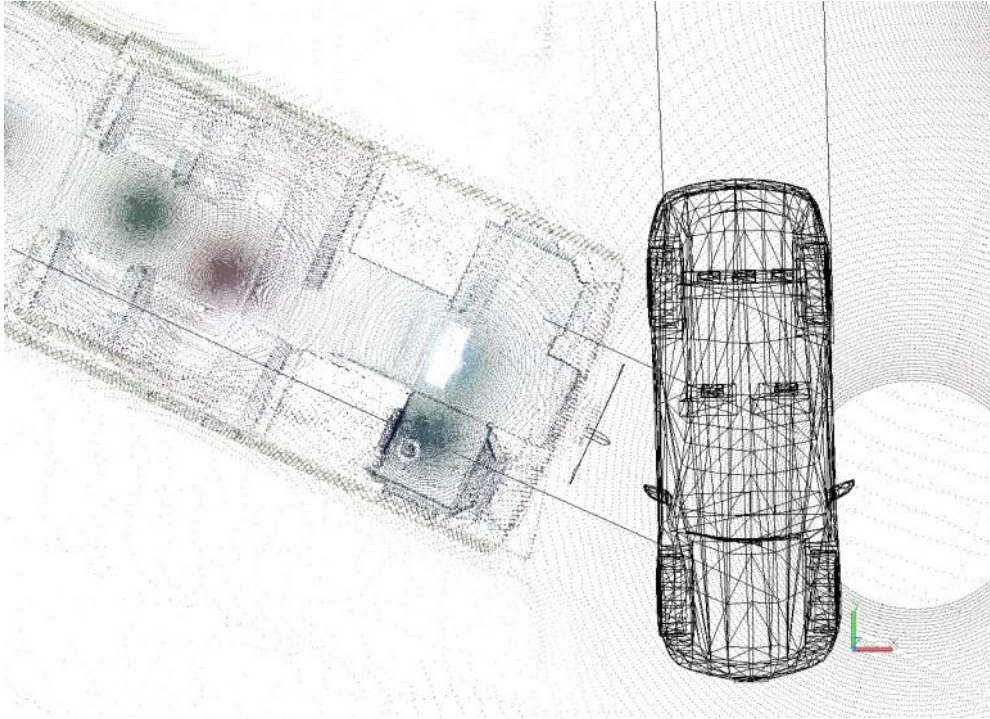
Figure 13- The estimated pre-impact position of the SUV relative to car 4333 based on the coupler alignment pin on the railcar and the hole in the SUV's door

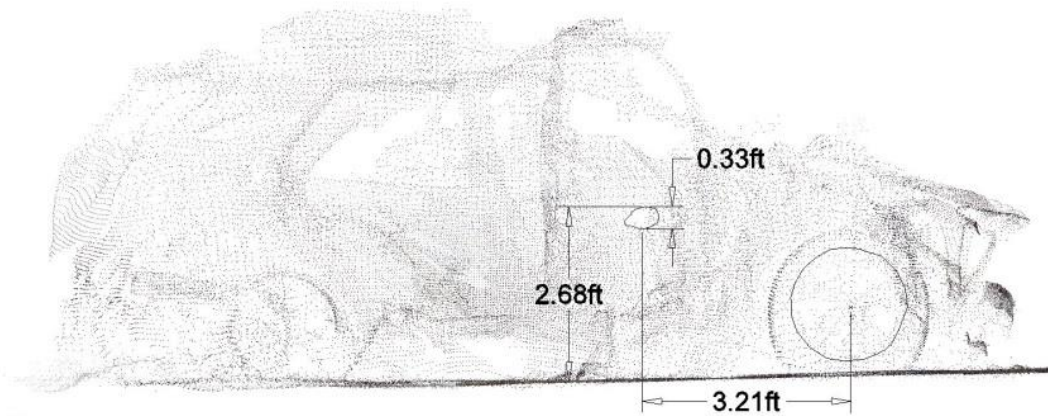
Figure 16- A side view showing the size and position of the puncture hole on the front, passenger door of the crash-involved SUV based on the 3D laser scan
