National Transportation Safety Board
Office of Railroad, Pipeline and Hazardous Materials Investigations
Washington, D.C.

Railroad Operations Group Factual Report
Amtrak
Highway-Rail Grade Crossing Accident
Crozet, Virginia
Lanetown Road
January 31, 2018

NTSB Accident Number HWY18MH005

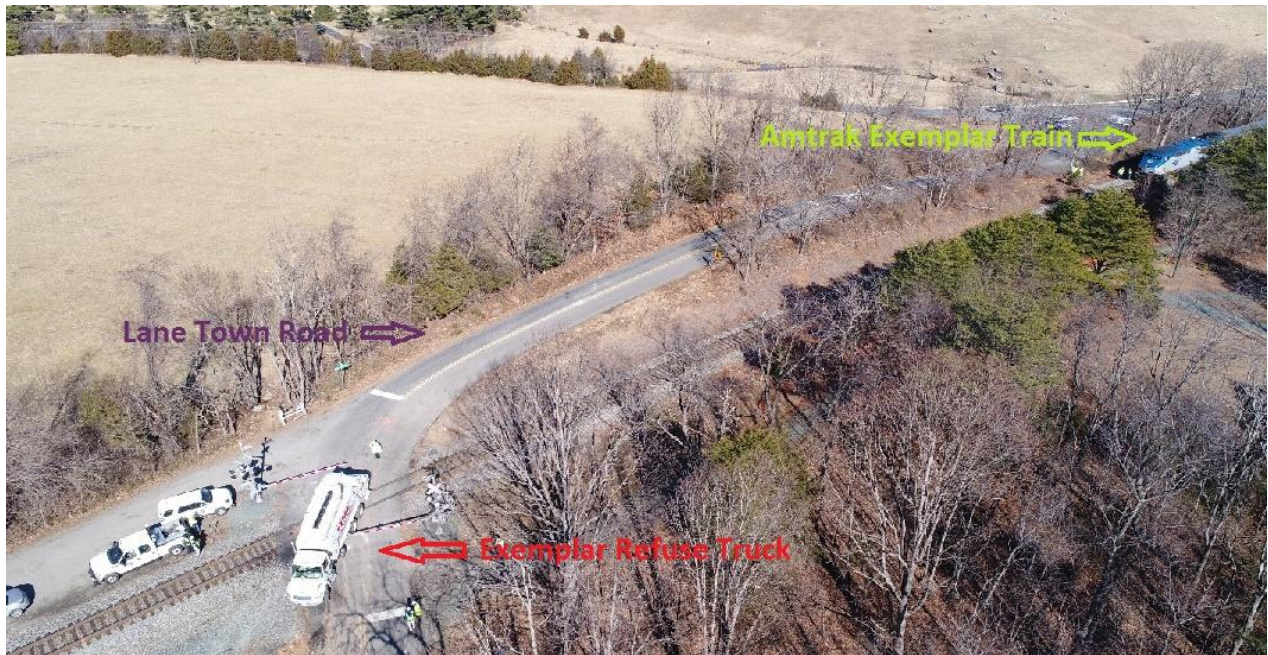
REFERENCE NUMBER	REFERENCE DESCRIPTION	DISTANCE EAST OF HIGHWAY-RAIL GRAD CROSSING
R1	Exemplar engineer first saw the refuse truck travelling south on Lanetown road with the warning devices activated	1148 ft.
R2	Road Foreman of Engines first saw the refuse truck travelling south on Lanetown road with the warning devices activated	1082 ft.
R3	Point at which the Road Foreman of Engines reporting seeing the refuse truck drive around the crossing gate	896 ft.
R4	Distance from the highway-rail grade crossing of the emergency brake application	410 ft.

2 Figure 2. Observation of Exemplar Train and Refuse Truck. (Photo NTSB)
