**RAILROAD SIGNAL & TRAIN CONTROL GROUP  
FACTUAL REPORT OF INVESTIGATION**

**Highway-Rail Collision  
Amtrak P09806 Silver Meteor  
25<sup>TH</sup> St. West Palm Beach Fl.**

**July 6, 2016**

**DCA16FR009**

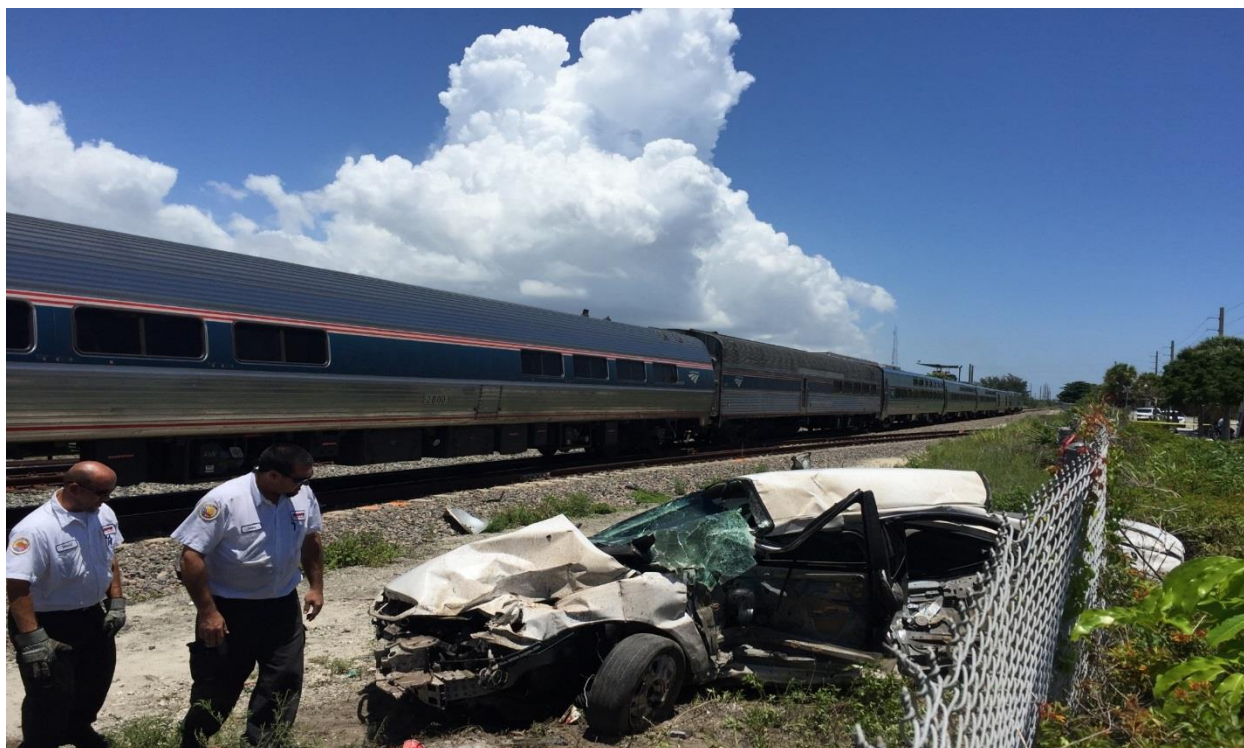
Figure-1 depicts vehicle that was struck by Amtrak 98 Silver Meteor in Northeast quadrant of 25<sup>th</sup> Street Highway Grade Crossing, West Palm Beach Florida, July 6, 2016, 9:59 am.

There were \$16,305.00 damages to the Amtrak locomotive. No other damage was done to the SFRTA signal system or track because of this Highway-Rail collision.

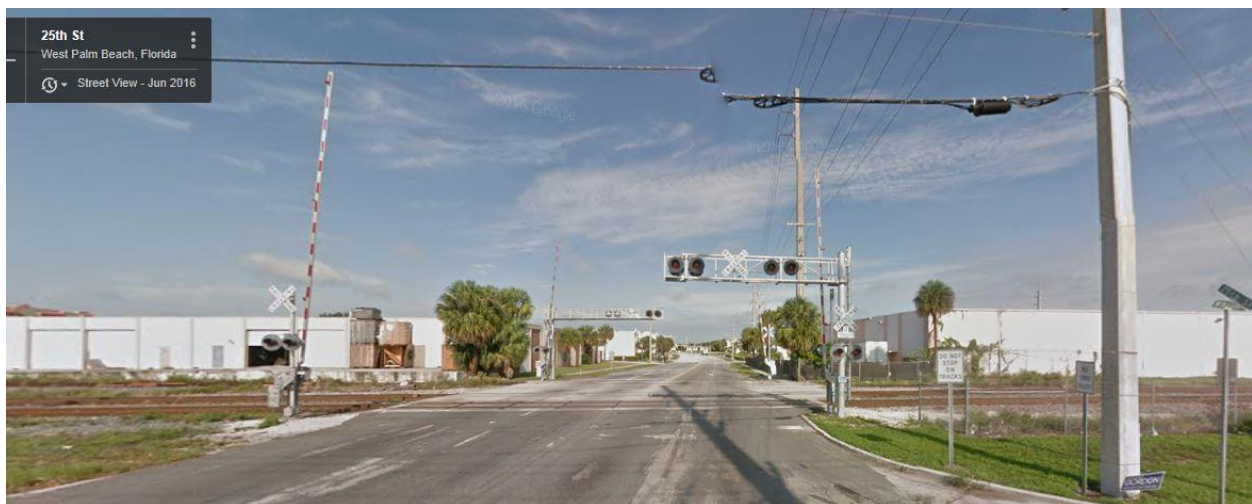
advance warning signs. There are stop bars painted on the road along with “do not stop on track” signs. The construction of the road is standard asphalt. The Highway Grade Crossing Warning System is equipped with four quadrant gates, lights, bells and two cantilever structures for over lane lighting. There are four quadrant gates at the location because this portion of track is an approved quiet zone. All flashing light units at this highway rail-grade crossing are twelve-inch lights equipped with Light Emitting Diodes (LEDs). Exit gates are located at the southeast and northwest quadrants. The signal bungalow is located at the southeast quadrant. It is an 8X8 steel house. A Safetran Grade Crossing Predictor GCP-3000 D2 unit was utilized as the primary warning control for both main tracks and was programmed to a frequency of 156 HZ. This unit was in the primary mode upon entering the crossing. The standby unit was fully functional. There was no internal recorder module in the unit, but an external North American Signal (NAS) recorder was on-site. Upon inspection, it was observed that the NAS external recorder was in the off position, in maintenance mode, and the CPU circuit board was missing.

Figure-2 depicts view traveling west on 25<sup>th</sup> street, same as driver was traveling.

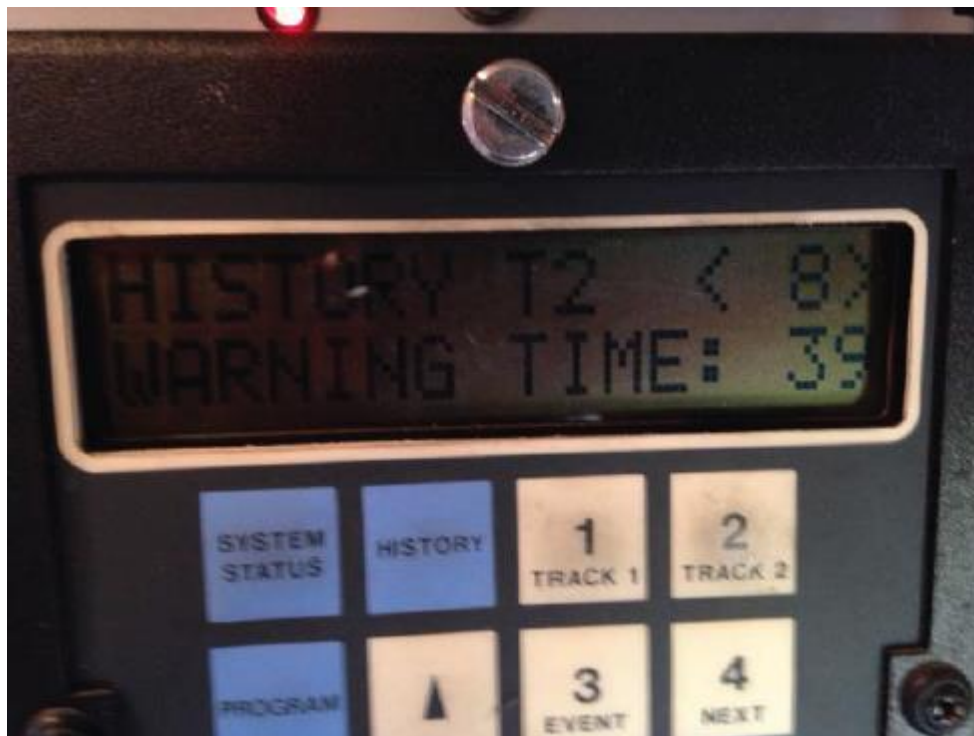
Upon arrival, a stop and flag protection order was placed on both main lines and the crossing signal bungalow was sealed. Post-Inspection began with obtaining the information contained within the GCP-3000 display panel. The warning time of the last ten trains that included the accident train were recorded and photographed. The warning time of the GCP that was recorded in the display module for the accident train was 39 seconds {F-3 pg-9}. The NAS recorder indicated actual warning time of the control relay to be only one second {table 1 pg-8}. Post-accident testing continued with shunt tests on both main tracks and recording the results of each test. The termination shunts were removed to ensure proper operation and approach distance. Battery and ground tests were performed on the highway rail-grade crossing. Trains were observed in both directions on both tracks at track speed to verify warning times. All applicable tests were

performed referenced by Code of Federal Regulation Title 49 Part 234 Subpart D Maintenance, Inspection, and Testing. There were no exceptions noted during the Post-Accident Inspection of the Grade Crossing Warning Device or signal appurtenances associated with the Highway Grade Crossing Warning System. Additionally, the NAS event recorder was tested at the manufacturer's test facility in Gainesville FL. on August 23, 2016 by NTSB, FRA and National American Signal technicians with no exception taken.

Figure-3 depicts warning time of the Grade Crossing Predictor to be 39 seconds
