**RAILROAD SIGNAL & TRAIN CONTROL GROUP
FACTUAL REPORT OF INVESTIGATION**

**Side Collision between Westbound UP
Train AMNML-07 and Northbound
UP Train ALDAS-06
at Texarkana Interlocking in
Texarkana, Texas on
September 8, 2015**

DCA-15-FR-014

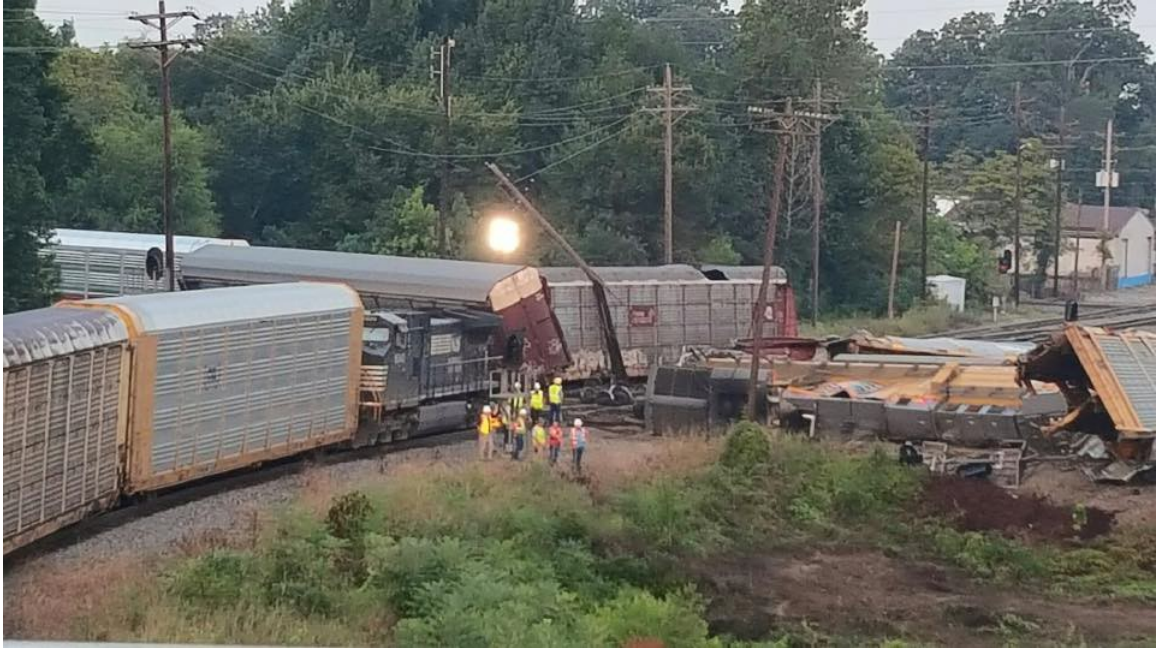
On September 8, 2015 about 12:34 am central daylight time, a Union Pacific Railroad (UP) train AMNML-07 (train #1) collided into the side of UP train ALDAS-06 (train #2) in Texarkana, Texas. The collision occurred at an interlocking near the Texarkana rail yard at Control Point (CP) CB418. At CP CB418 the Little Rock Subdivision and the Pine Bluff Subdivision intersect at grade. Engineer and conductor of UP AMNML-07 sustained minor injuries as a result of the collision. Event recorder data showed train #1 traveling at 19 mph before the train was placed into emergency brake application by the engineer. The recorder data also showed an impact speed of 6 mph.

Figure 1: Aerial view of accident scene. [Photo courtesy of News Radio KEEL Shreveport La.]

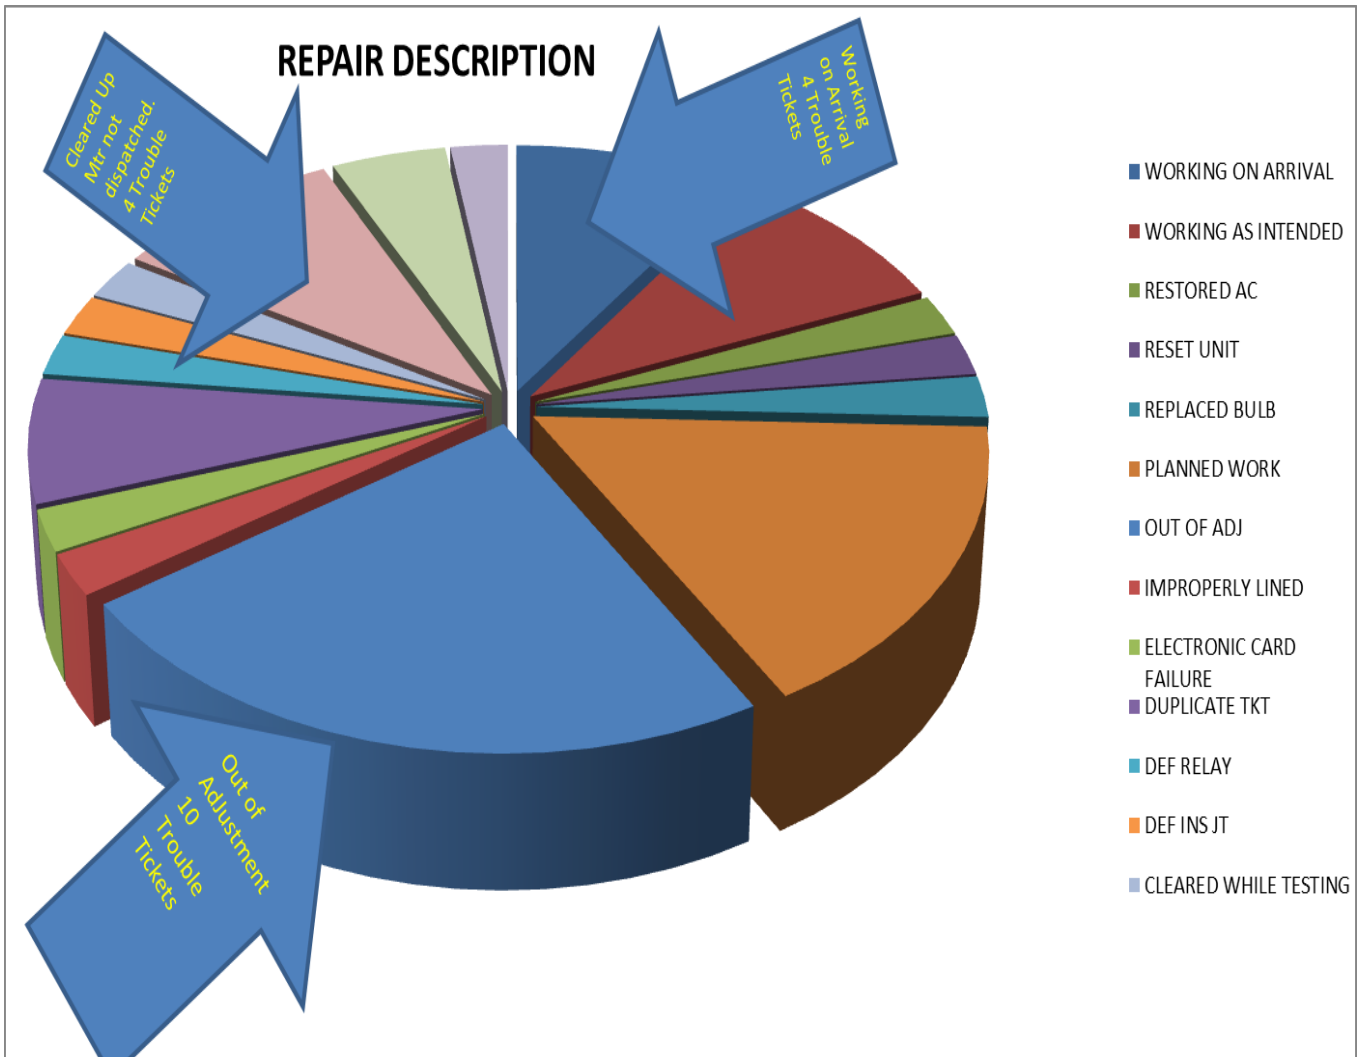
Chart 1 Trouble/Remedy Tickets

Signal system trouble/remedy tickets logged by the Signal Operations Center for CP R001 and CP CB418 were reviewed for the 9-month period preceding the date of the accident. Investigators were provided with trouble ticket reports that were generated during this period for review. A total of 43 trouble/ remedy tickets were generated in a 9 month period pertaining to and associated with signal trouble at the Interlocking at CP R001 and CP CB 418. A review of the trouble/remedy tickets reflected that 18 of those tickets could be attributed to one of the following categories:

- A. Signal trouble cleared up, maintainer not dispatched,
- B. Working on arrival,
- C. Out of adjustment,

Chart 1 summarizes the data from the Trouble/Remedy Tickets.
