National Transportation Safety Board

Pipeline and Operations Factual Report

Description: Explosion and fire at private residence
Product: Natural Gas
Location: 10708 Paiute Way, Rancho Cordova, California
Date/Time: December 24, 2008, 1:35 p.m. PST
NTSB No.: DCA09FP003

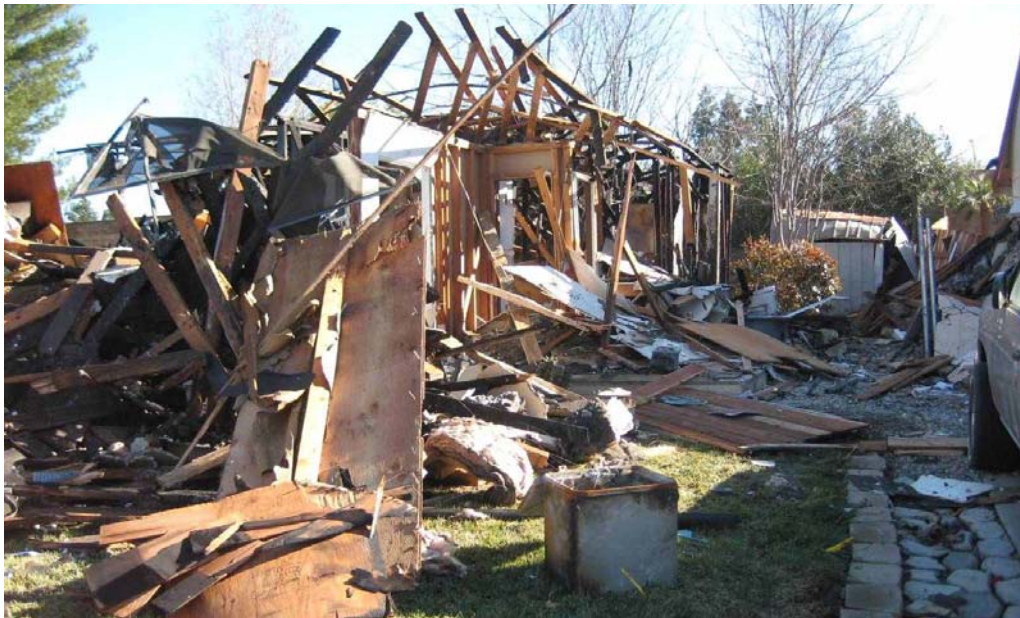
At approximately 1:35 p.m. (PST) on December 24, 2008, an explosion and fire caused by a natural gas leak destroyed a residence at 10708 Paiute Way in Rancho Cordova, CA. One elderly person suffered fatal injuries and five other people, including one utility employee and one firefighter were hospitalized as a result of the explosion. Two adjacent homes, one on either side, had severe damage and several homes suffered minor damage. The property damage figure according to the Pacific Gas and Electric Company is \$ 267,000.

FIGURE 1 – DAMAGE CAUSED BY THE EXPLOSION

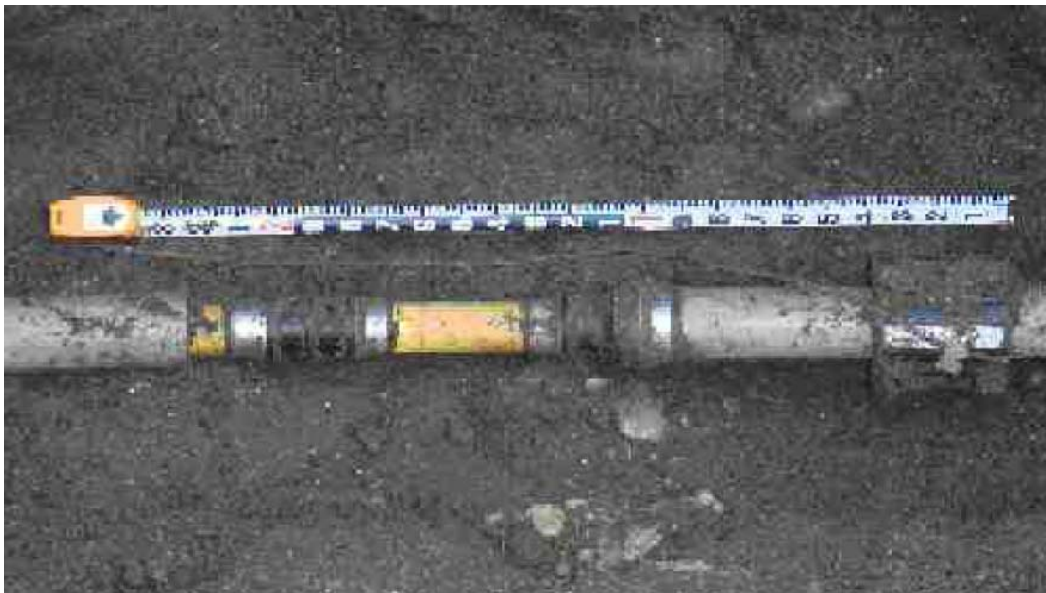
Post-accident excavation revealed that the source of the natural gas leak occurred where a spool piece of pipe had partially pulled out of a 1¼-inch coupling. The figure #2 pictured below shows a close-up view of the excavated section of pipeline where the failure occurred. The photograph is oriented from east to west. Moving from left to right the photograph shows a portion of the original 2-inch Aldyl-A plastic main pipe, followed by a small portion of the 21-foot section of 1¼-inch yellow polyethylene pipe, a 1¼-inch coupling, a 6-inch section of 1¼-inch unmarked yellow polyethylene pipe, a 1¼-inch-by-2-inch transition fitting, and another portion of the original 2-inch Aldyl-A plastic main pipe.

FIGURE 2 –LEAK AS DISCOVERED IN THE FIELD. THE “SPOOL PIECE” IS IN THE CENTER OF THE PHOTOGRAPH AND THE LEAK IS ON THE RIGHT SIDE OF THE 1¼-INCH COUPLING.

The pipeline failure occurred at the 1¼-inch coupling. The 6-inch section of 1¼-inch yellow polyethylene pipe, which had been used to complete a repair, pulled out of the coupling on the west side. The short section of yellow pipe was unmarked.

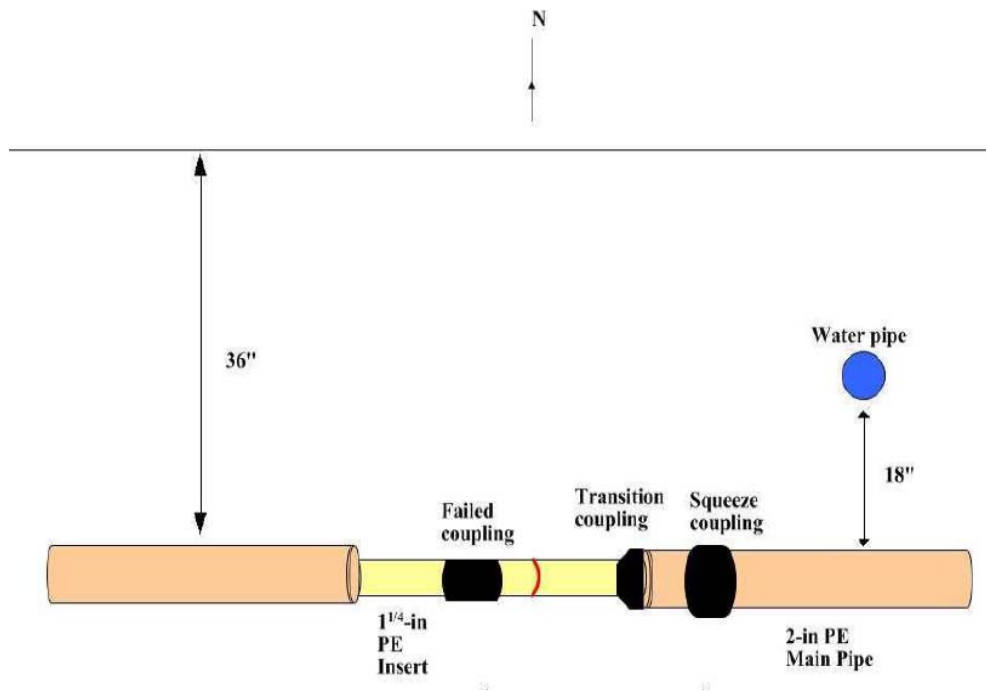
Aldyl-A plastic pipe gas main located on the owner’s property (off the south side of the street). The gas main, which was originally installed in 1977, was then cut at two locations about 20 feet apart. The leak was repaired by inserting 20 feet of 1¼-inch polyethylene pipe inside the older 2-inch diameter Aldyl-A plastic pipe. The insertion was made across the leak. The main was then reconnected by installing a 2-inch to 1¼-inch Metfit reducing coupling to join one end of the severed 2-inch main to one end of the 1¼-inch polyethylene insert. The other end of the 1¼-inch insert was then joined by a 1¼-inch Metfit straight coupling to an approximately 6-inch long piece of 1¼ inch polyethylene pipe. This short pipe section or “spool piece” was then joined to the other severed end of the 2-inch main by a Metfit 1¼-inch to 2-inch reducing coupling. This leak repair on the gas main was completed on September 21, 2006. The pipe installed was US Poly 1¼-inch iron pipe size (IPS) polyethylene pipe installed at a working pressure of approximately 55-psig and a maximum allowable operating pressure of 60-psig.

FIGURE 3 – GRAPHIC DIAGRAM OF REPAIR
