**RECONSTRUCTION GROUP CHAIRMAN'S FACTUAL
REPORT OF INVESTIGATION**

A. ACCIDENT: DCA-96-MA-070

Location: East Moriches, New York
Date: July 17, 1996
Time: 2031 Eastern Daylight Time
Airplane: Boeing 747-131, N93119

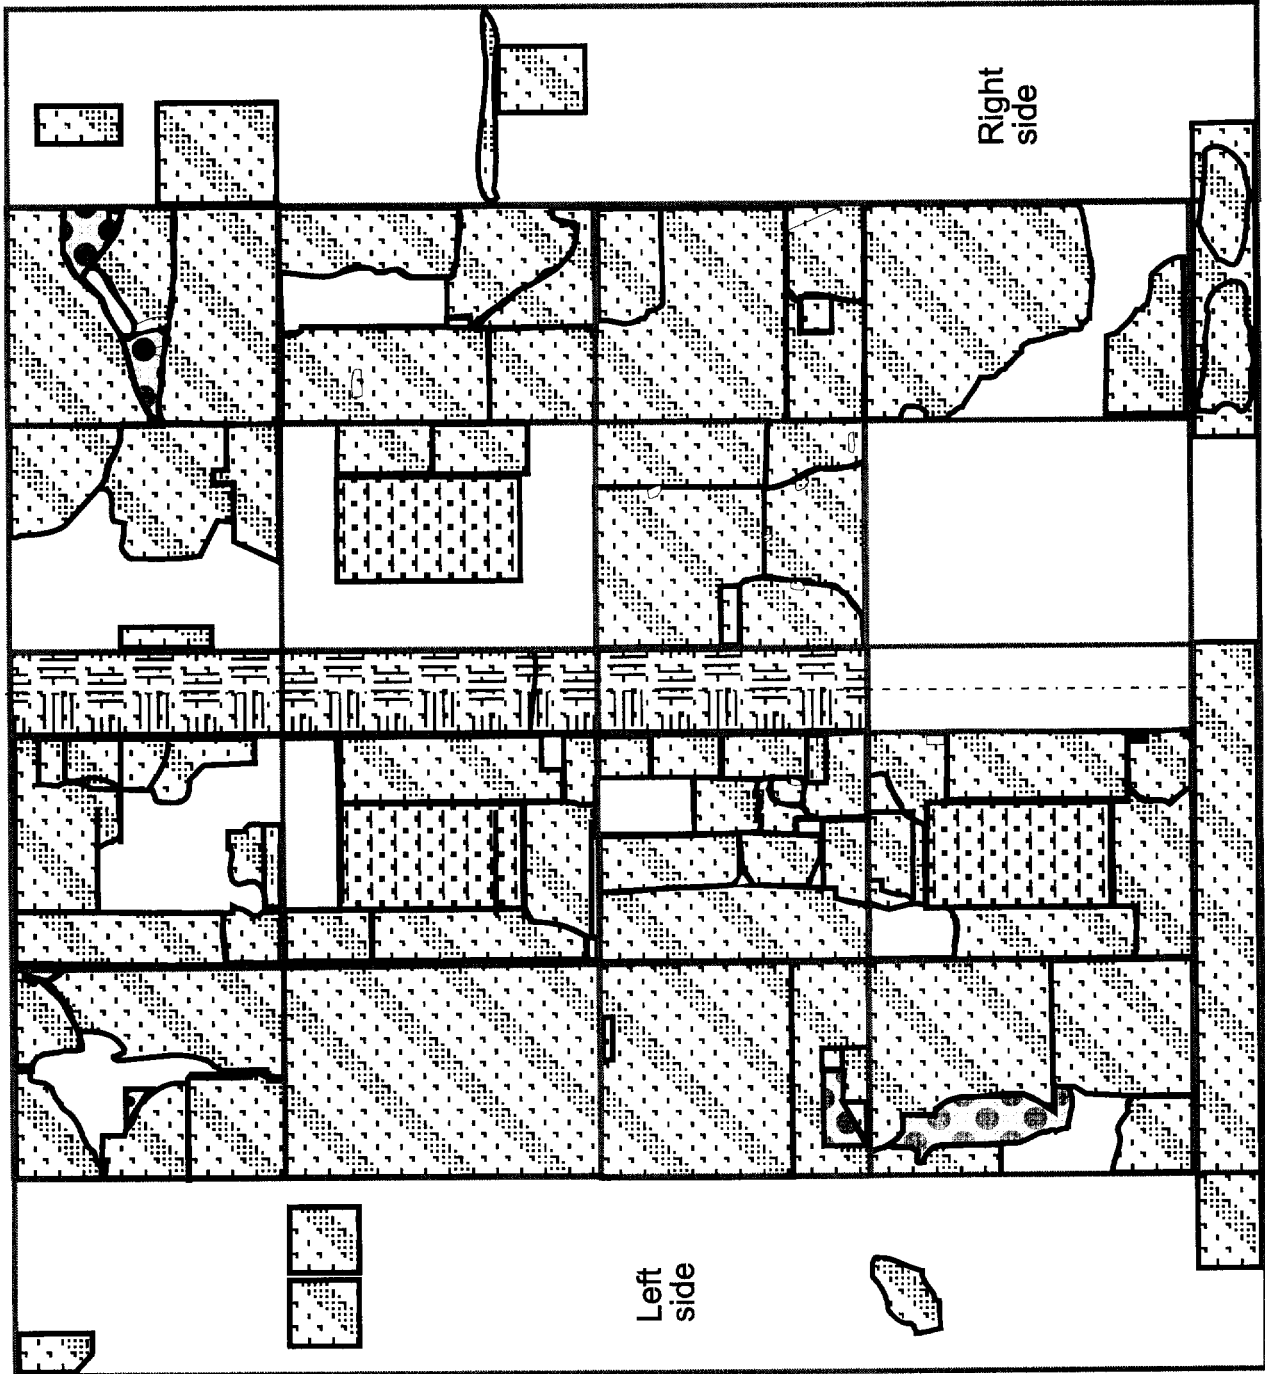
Figure 3 - Fairings under the center fuel tank

Under the center wing fuel tank, 75.6 percent of the fairings were placed between the 104-inch body line on each side of the centerline. The area that attached under the wing from 104 to 146 inches was thinner and had frequently spaced frames. Very few pieces were identified in this area. When the area under the wing is included into the calculation, along with 15-inch wide band that forms the vapor barrier to the rear of the tank, the percentage of fairings identified and placed under the center wing tank was reduced to 56.3 percent. See figure 3 and spreadsheet 1.

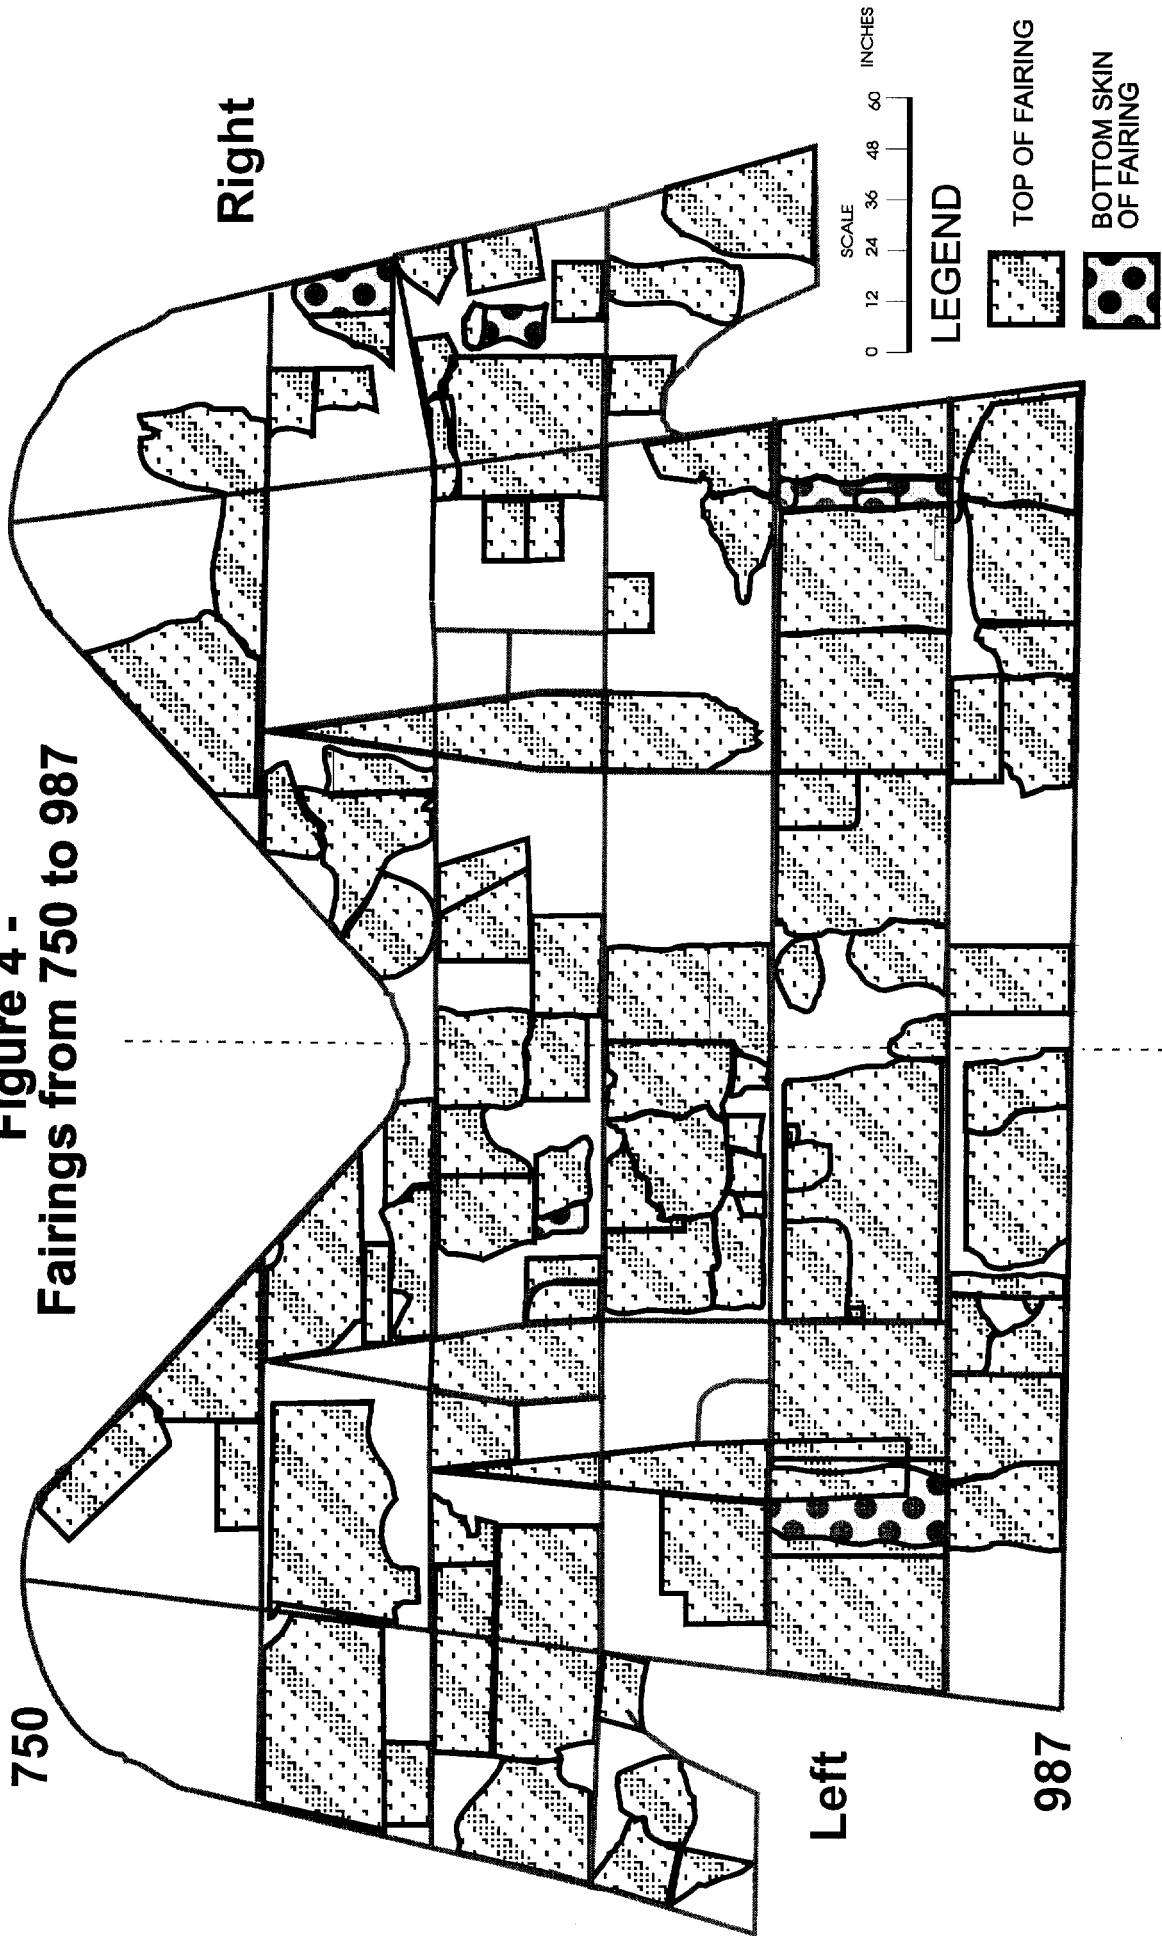
**Figure 4 -
Fairings from 750 to 987**

The fairings forward of the center wing fuel tank between 700 and 987 were placed and documented as shown in figure 4. About 64 percent of these fairings were identified and placed as indicated in spreadsheet 2.

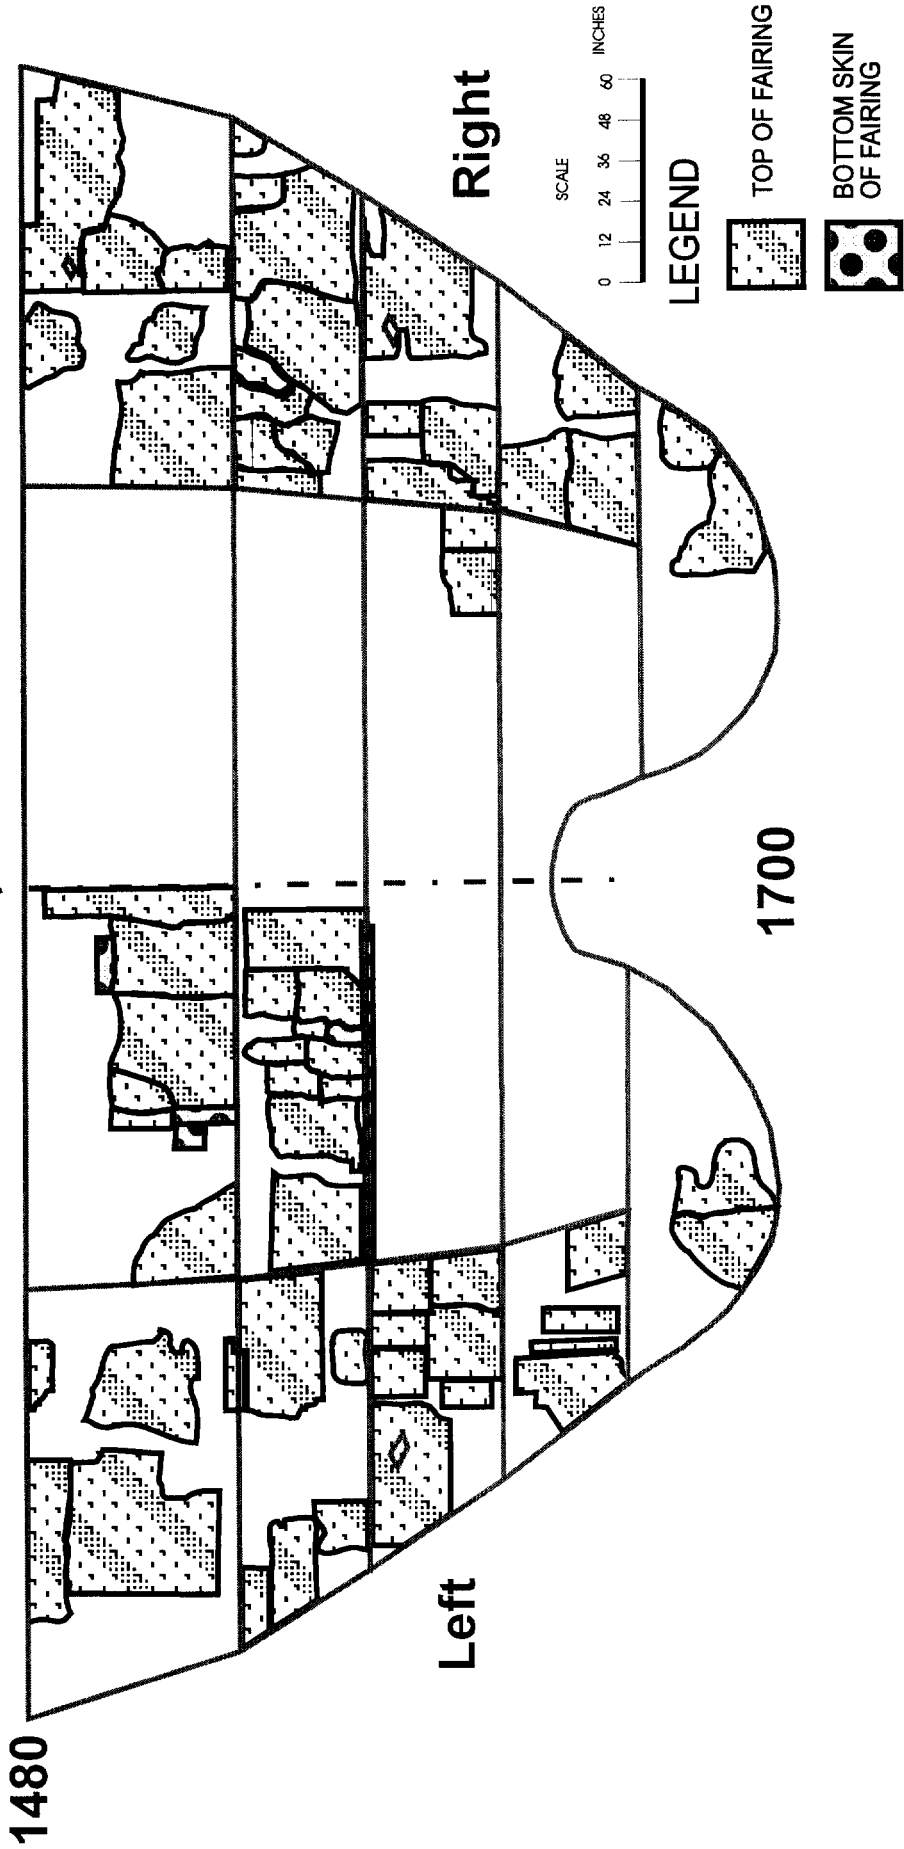
Figure 5 - Fairings from 1480 to 1700

The fairings rearward of the landing gear doors between 1480 and 1700 were placed and documented as shown in figure 5. About 39 percent of these fairings were identified and placed as indicated in spreadsheet 3. The panels between 1480 and 1540 were thicker due to the greater distance

spanned (60 versus 40 inches). Many pieces could be tentatively located into this area, but could not be matched or positively placed as part of the panel. Similarly other thinner parts in the rear compartment areas could not be positively placed.
