RECORD OF EMAIL

Date: June 24, 2015
Person Contacted: Scott Boek (Federal Aviation Administration)
NTSB Accident Number: WPR15LA179

N44508
H/H MLG Collapse
© GEU

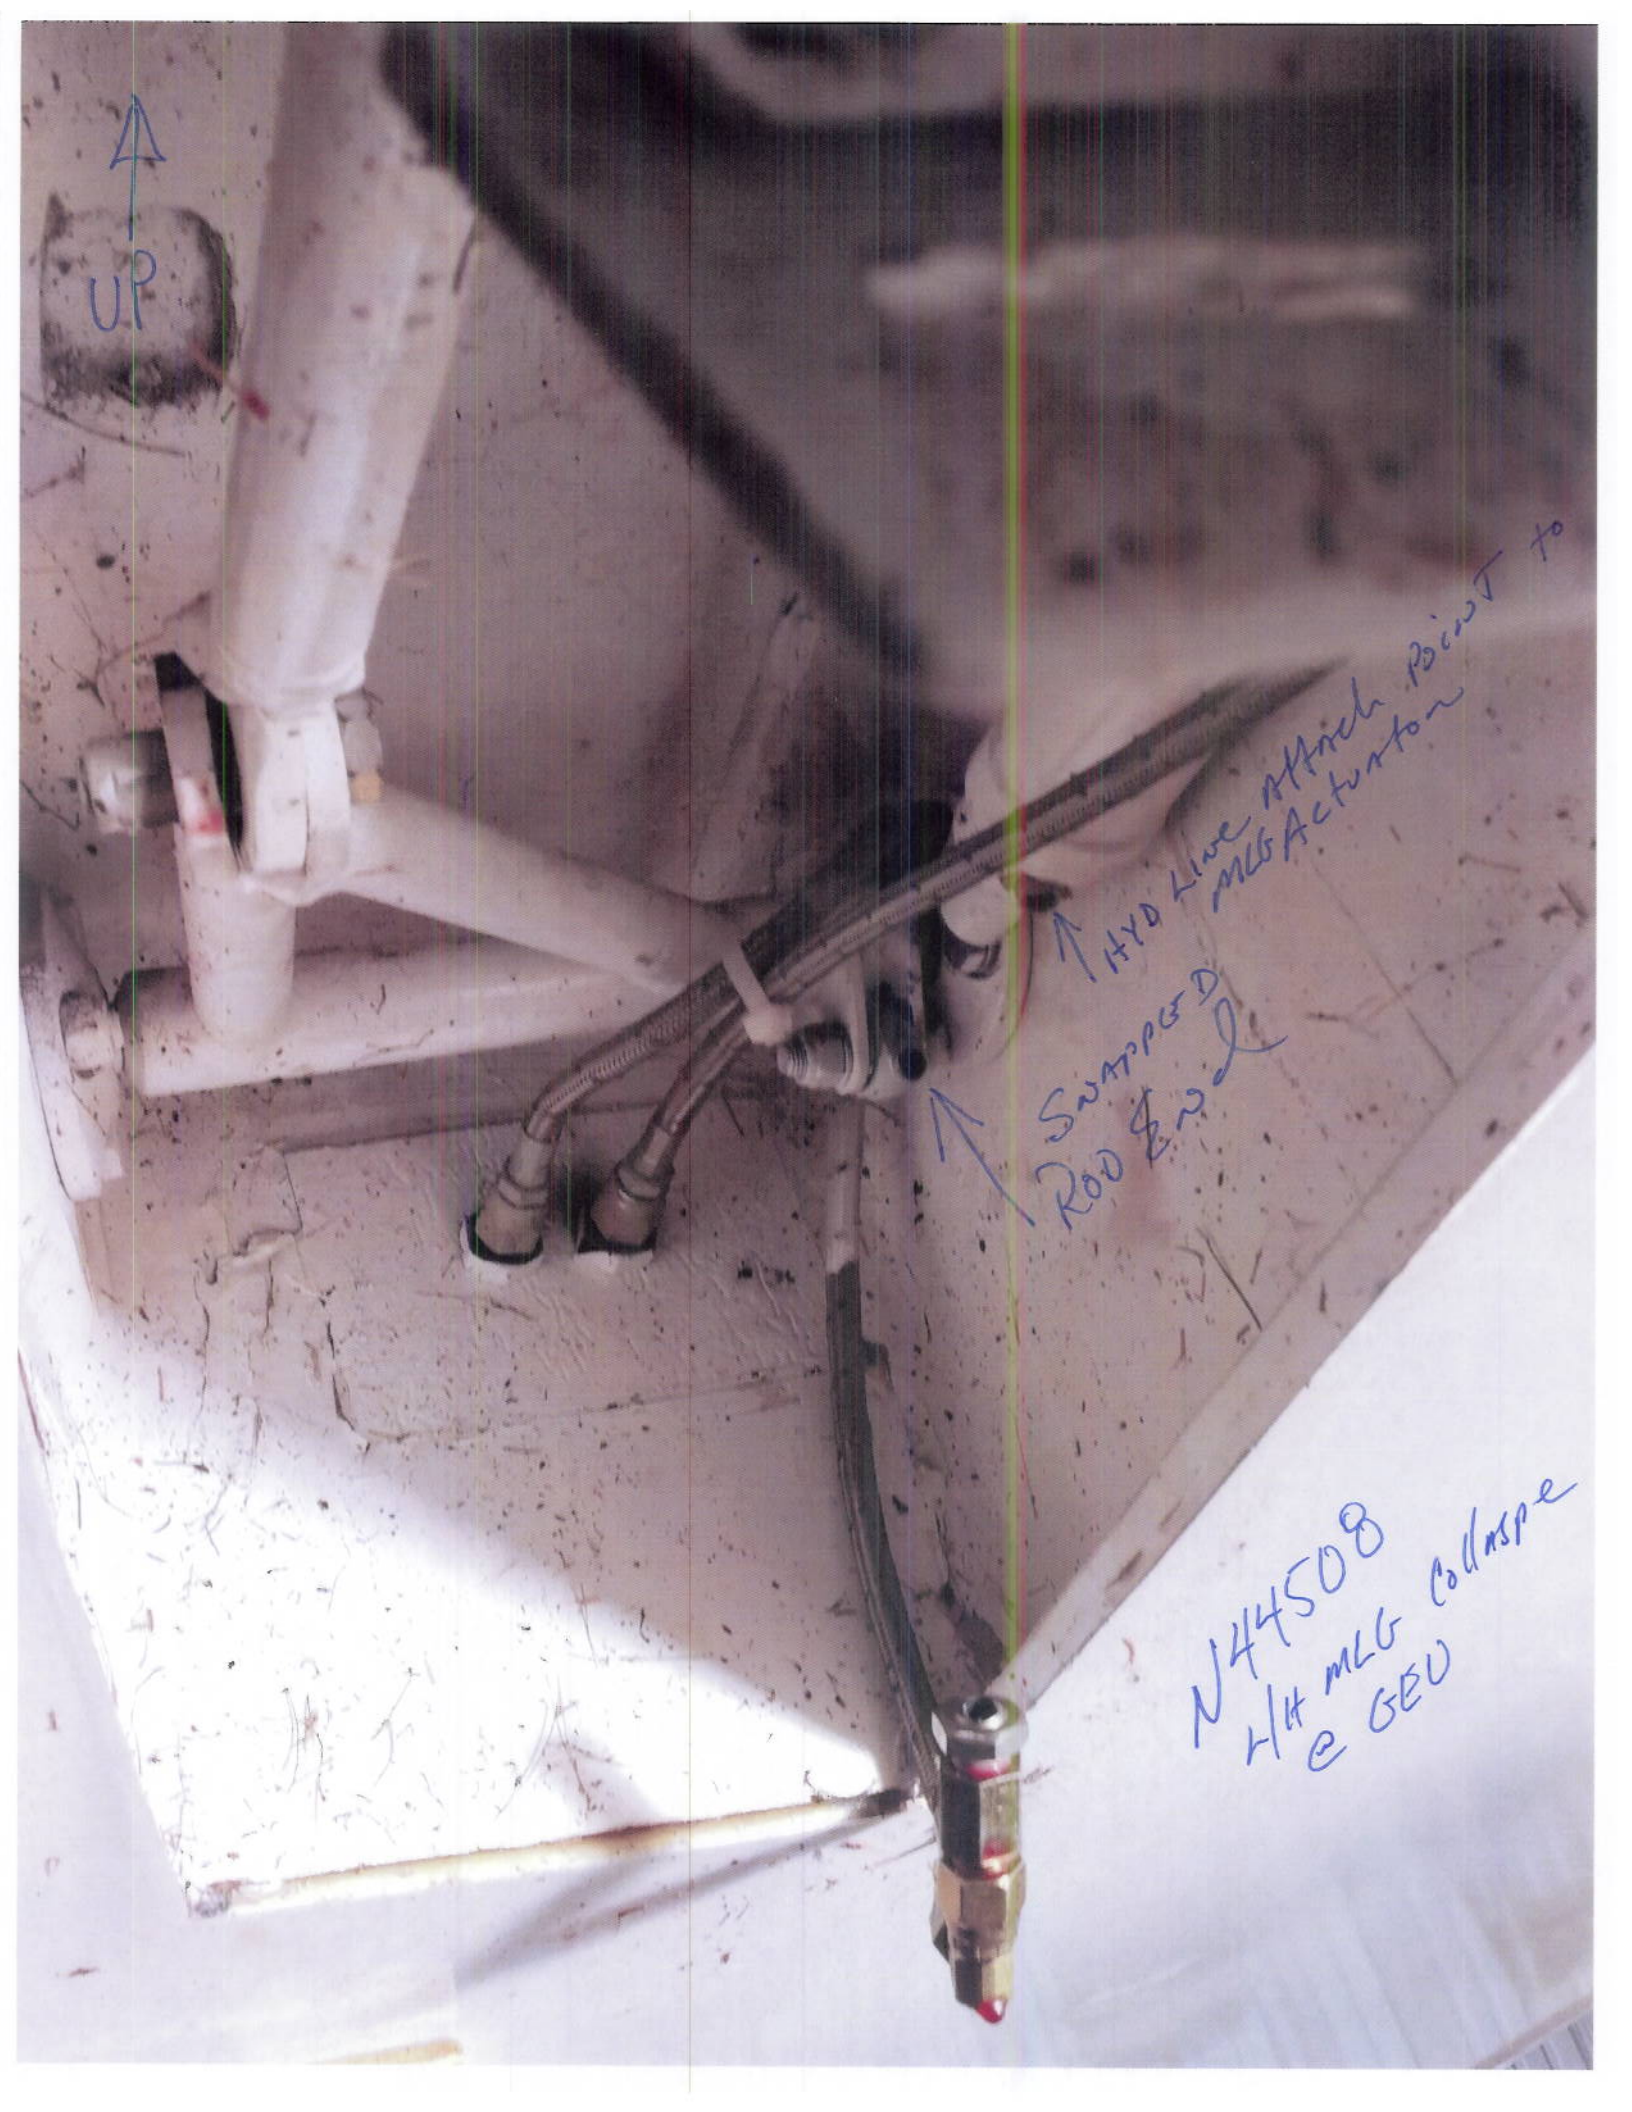
During an email conversation with Mr. Scott Boek from the Federal Aviation Administration, he reported that the main landing gear actuator heim rod end failed where the threads meet the rod end. When the gear collapsed, it ripped the hydraulic line to the gear actuator and the fluid leaked onto the gear leg. Given the angle and the positioning of the linkage, Mr. Boek was unable to observe the fracture surfaces. Mr. Boek provided the below photograph.

↑ HYD Line Attach Point to
MLG Actuator

↑ SWAPPED
ROD END
