RECORD OF CONVERSATION

Date: December 10, 2014
Person Contacted: Daryl McMillan
NTSB Accident Number: ERA15LA062

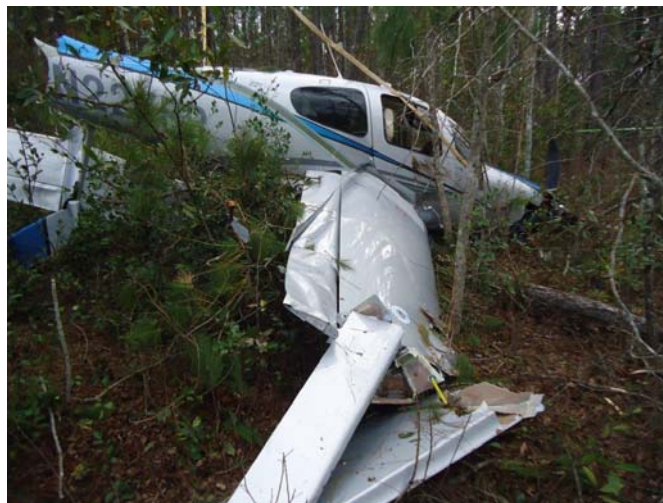
He stated that the main wreckage was located at 32 degrees 51 minutes 38 seconds North latitude and 081 degrees 3 minutes 42 seconds West longitude. The airplane heading was 249 degrees magnetic. There were no obvious issues with the engine, and no oil was observed inside the engine compartment. In the resting position of the airplane (slight nose low), a total of four quarts registered on the oil dipstick (actually called oil gage rod and cap assembly, part number (P/N 656616-2); it was tightly secured. The empennage was fractured slightly forward of the leading edge of the horizontal stabilizer, but remained connected by control cables. He did not see any evidence of oil streaking on the empennage, but he had not yet raised the airplane.

Figure 1: View showing the fractured empennage

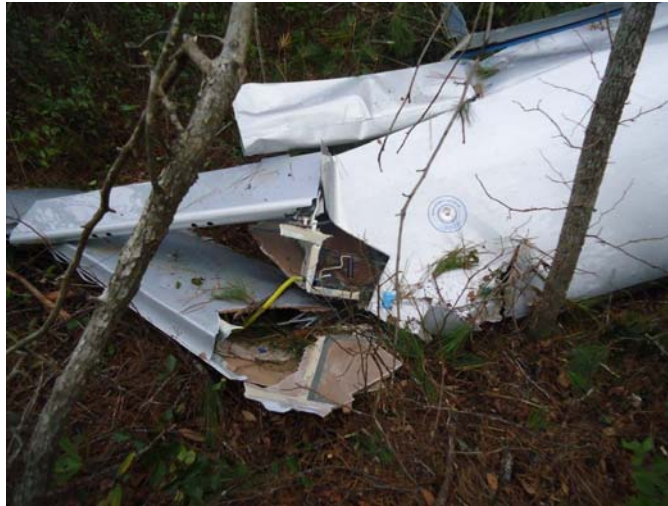
The right wing was broken about the location of the outboard end of the flap.

Figure 2: View of the Right Wing Fracture Location
