NATIONAL TRANSPORTATION SAFETY BOARD
Vehicle Recorder Division
Washington, DC 20594

Specialist's Factual Report By Christopher Babcock

Location: 430 Nautical Miles northwest of San Francisco, California
Date: August 13, 2015
Aircraft: Bartels Lancair Evolution
Registration: N427LE
NTSB Number: WPR15LA242

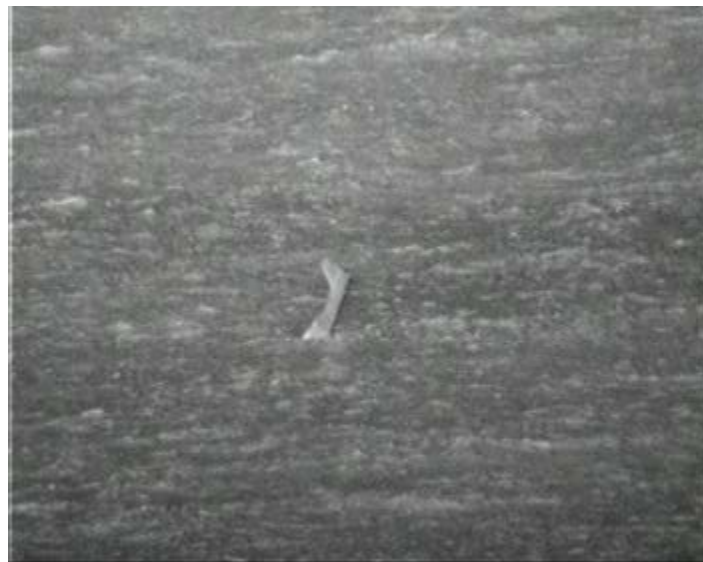
video showed the aircraft in a nose low attitude with the nose of the aircraft submerged beneath the surface (Figure 2). Figure 3 shows a still after the camera had zoomed in on the aircraft. Figure 4 shows a still frame of the empennage of the aircraft with the left wing, horizontal stabilizer, and vertical stabilizer visible about 20 minutes into the video. Figure 5 shows the last clear view of the aircraft in the video, showing the left wingtip and tail, at about 42 minutes into the video.

Figure 2. Still frame from about 19 minutes into the video showing nose low attitude.

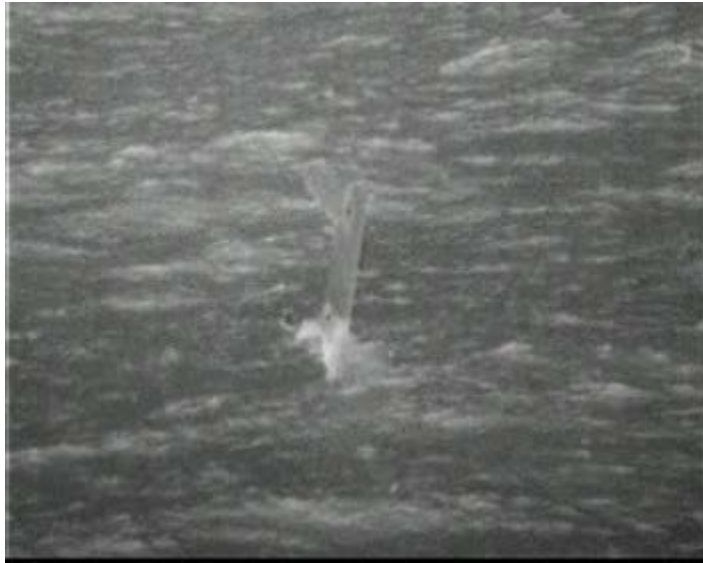
Figure 3. Still frame after camera had zoomed in.

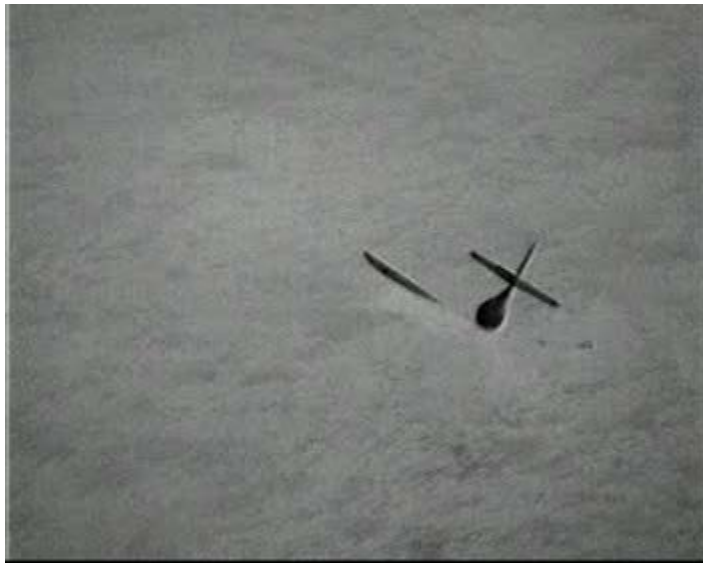
Figure 4. Still frame showing left wing, vertical stabilizer, and horizontal stabilizer visible.

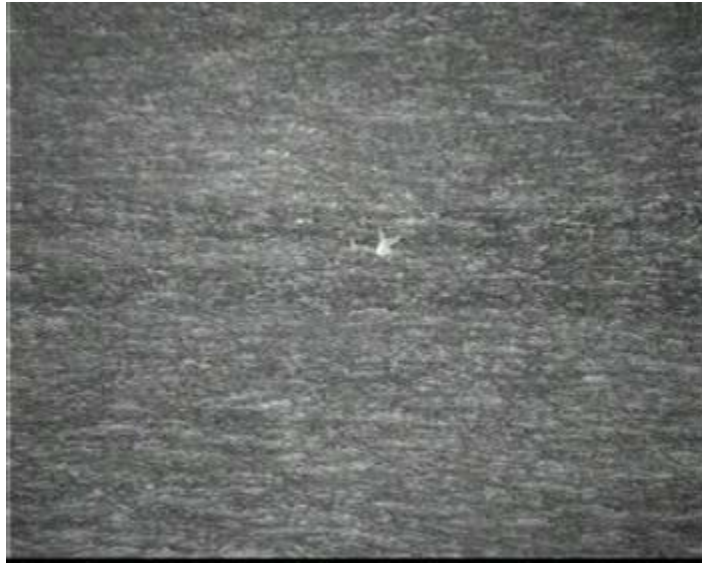
Figure 5. Last clear view of the aircraft in the video.
