## RECORDS

The airplane's maintenance records were obtained from the following sources: the pilot's fiancé, the wreckage, information from the FAA, and Performance One, a maintenance facility that regularly maintained the airplane.

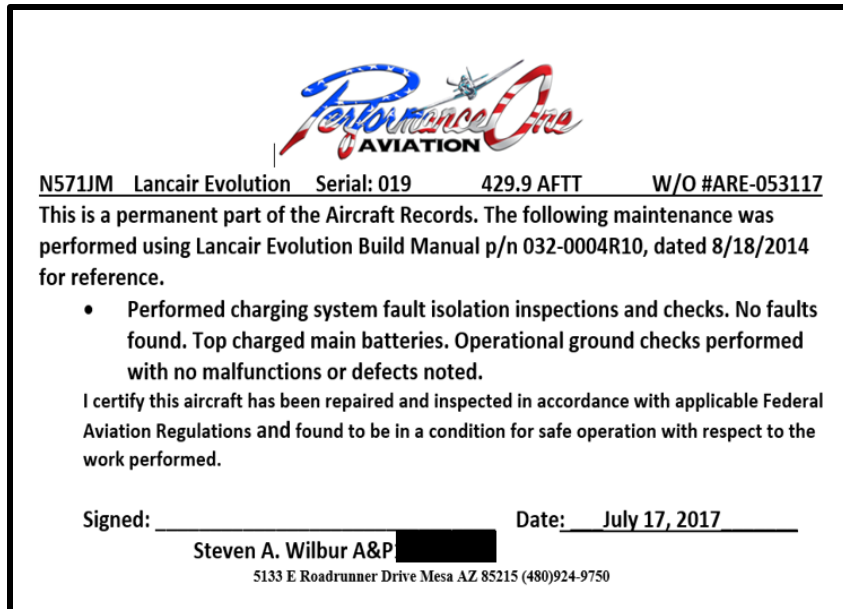
Picture 7: July 17<sup>th</sup> Record

The July 17 logbook entry provided by Performance One noted an AFTT of 429.9 hours and reference work order ARE-053117. The entry stated: Performed charging system fault isolation inspections and checks. No faults found. Top charged main batteries. Operational ground checks performed with no malfunctions or defects noted.

The entry was signed by the Performance One owner.

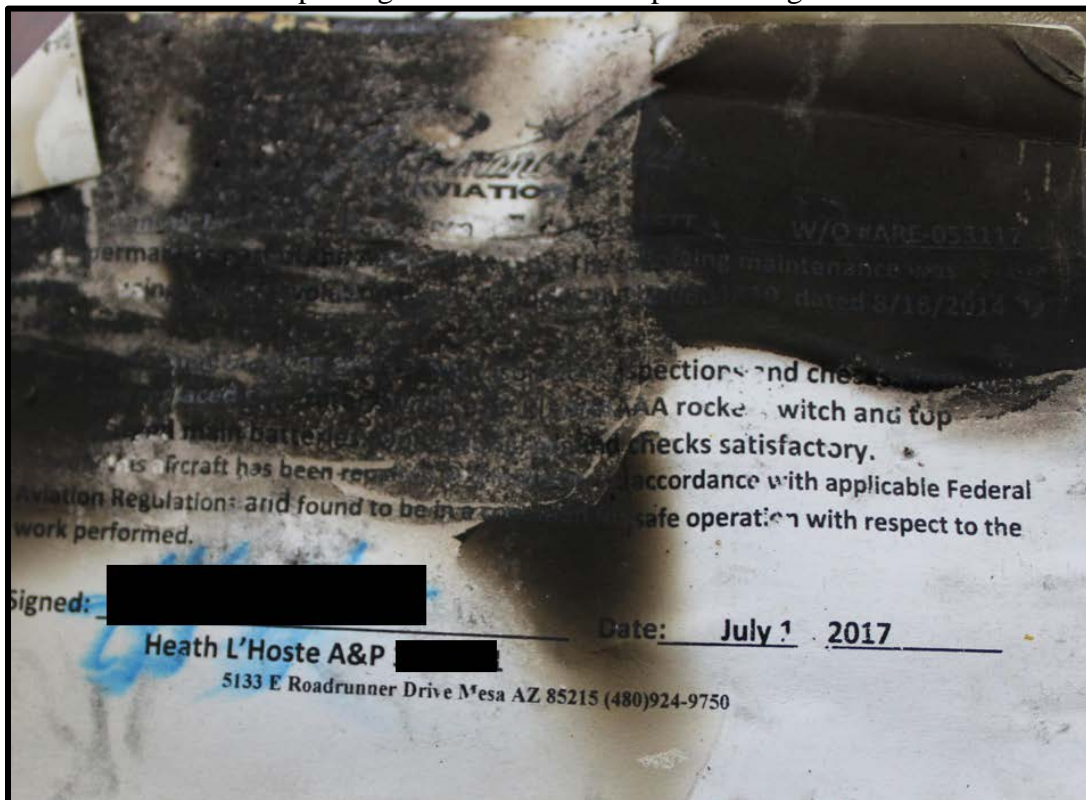
Picture 8: Burned Record in Wreckage

A logbook entry found in the wreckage but not provided by Performance One did not have a readable date aside from July 2017, but contained a AFTT of 429.9 hours under the same work order number ARE-053117. The entry stated:

Performed charging system fault isolation inspection and checks. Removed and replaced generator switch p/n K1ABAAAAA rocker switch and top charged main batteries. Operational ground checks satisfactory.
