RECORD OF COMMUNICATION

Date: May 30, 2013
Person Contacted: Mr. Jim Gill (Airborne Eyewitness)
NTSB Accident Number: WPR13FA244

WPR13FA244 Accident Locale

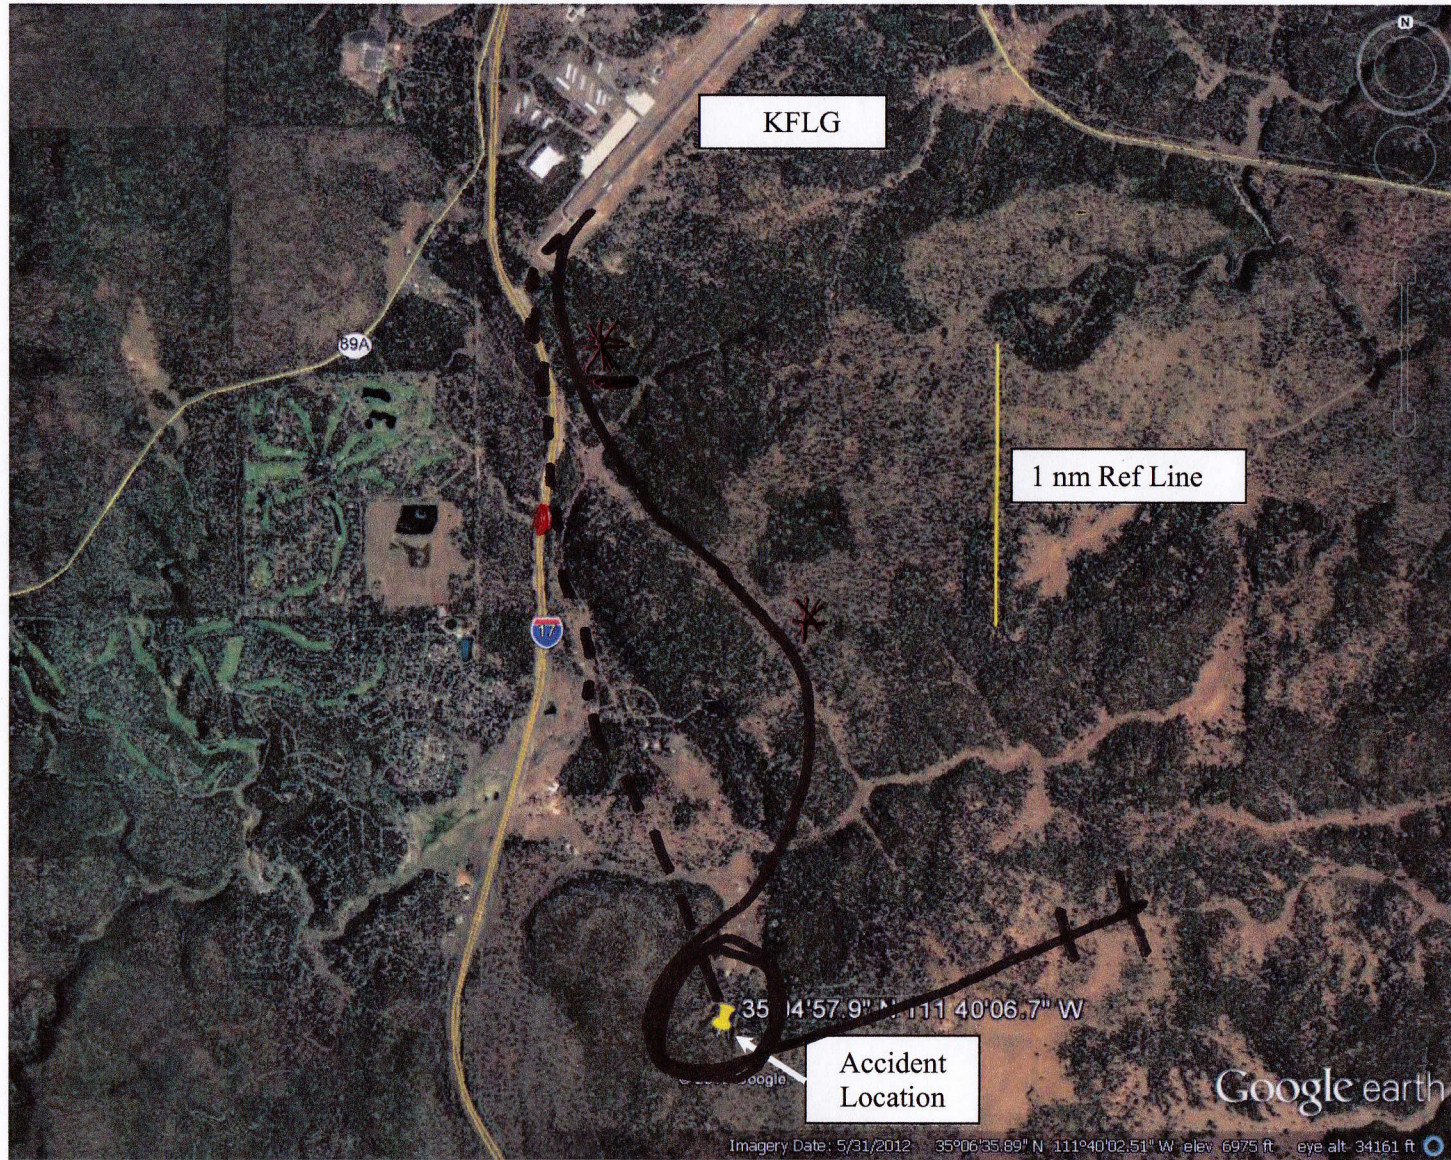
The Bonanza appeared as though it was (intentionally/deliberately) following the highway. (refer to hand-marked Google Map attached)

At that time the Bonanza's position was over the highway east of Golf Course. (see Google Map)

① - LOCATION OF BONANZA WHEN I MADE MY FIRST CALL TO TWR.
