DCA-11-FR-002
BNSF Coal Train – Work Train Collision
Red Oak, IA
April 17, 2011

DCA-11-FR-002

**REAR END COLLISION/DERAILMENT OF BNSF RAILWAY CBTMCNM0-26A
STRIKING BNSF RAILWAY WORK TRAIN UBRGCR15-15G**

SIGNAL GROUP FACTUAL REPORT

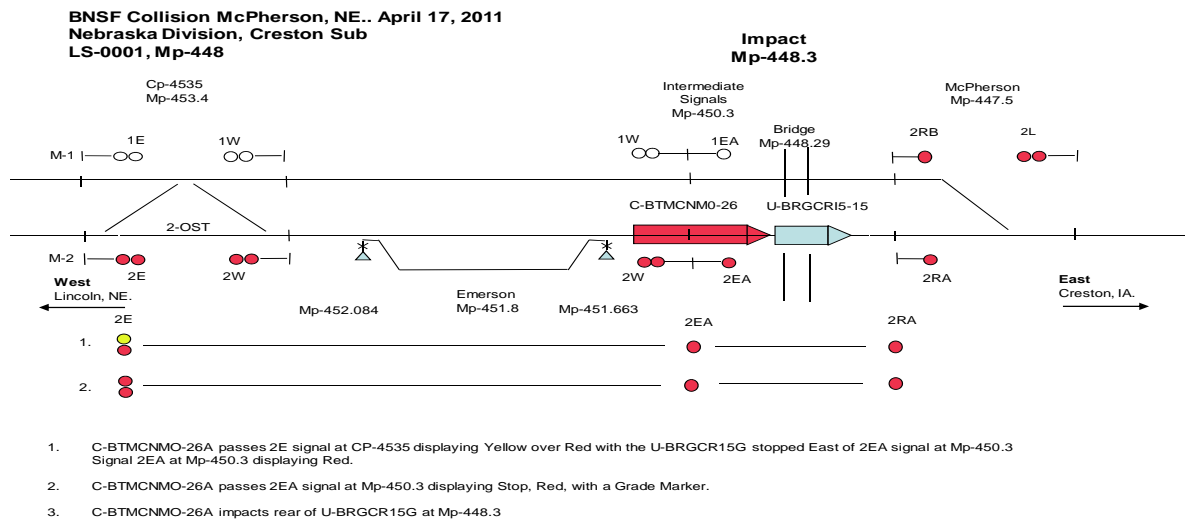
Figure 1. Signal System Layout with Derailment Location. (Not to Scale)

On April 17, 2011 at about 6:55 a.m. central daylight time, eastbound BNSF Railway coal train C-BTMCNM0 26A, BNSF Railway 9159 East, collided with the rear end of standing BNSF Railway maintenance of way equipment train U-BRGCR15 15G, BNSF Railway 9470 East, near Red Oak, Iowa. The accident occurred at milepost 448.3 on the number two track on the Creston subdivision of the BNSF Railway Nebraska Division². The coal train was travelling about 23 mph when it struck the standing train.

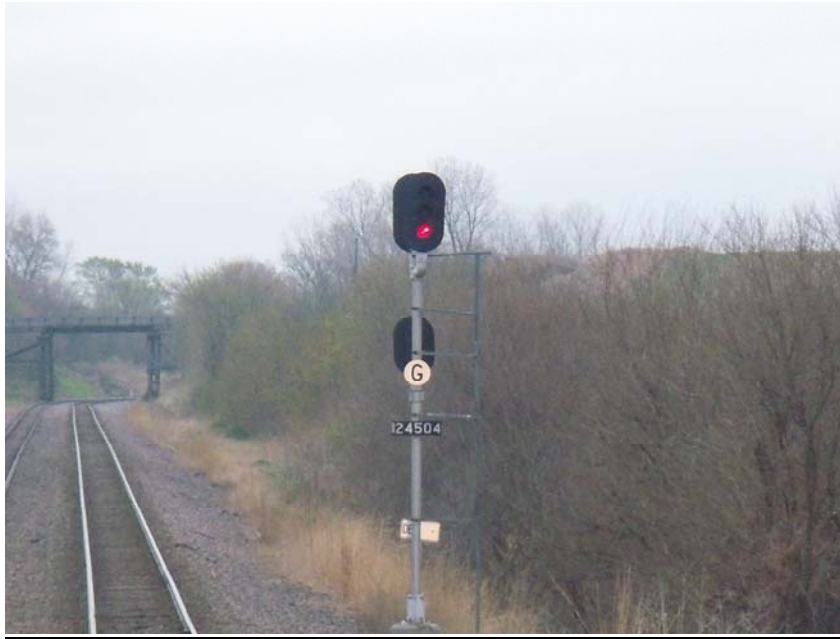
Figure 2. Intermediate Signal 24504 with Grade Marker.

Back-to-back intermediate signals are located on both main tracks at MP 450.3 between the two control points. The signal equipment at these intermediate signal consists of three position color-light type signals. The eastbound intermediate signals have a grade marker attached to the signal mast below the color-light signal heads. These grade markers are displayed at this location because the track grade is too severe for trains to stop and proceed. With this marker displayed a train is allowed to proceed at restricted speed by the intermediate signal without stopping when a red aspect is displayed. The indication for this signal is "Proceed at Restricted Speed."³ (See Figure 2.)
