**National Transportation Safety Board
Washington, D.C. 20594**

Regulatory Oversight Group Factual Report

Operator: Washington Gas
Accident Site: Flower Branch Apartments, 8701 Arliss Street, Silver Spring, MD
Date/Time: August 10, 2016, at 11:53 p.m.
NTSB No.: DCA-16-FP-003
Event type: Building Explosion and Fire

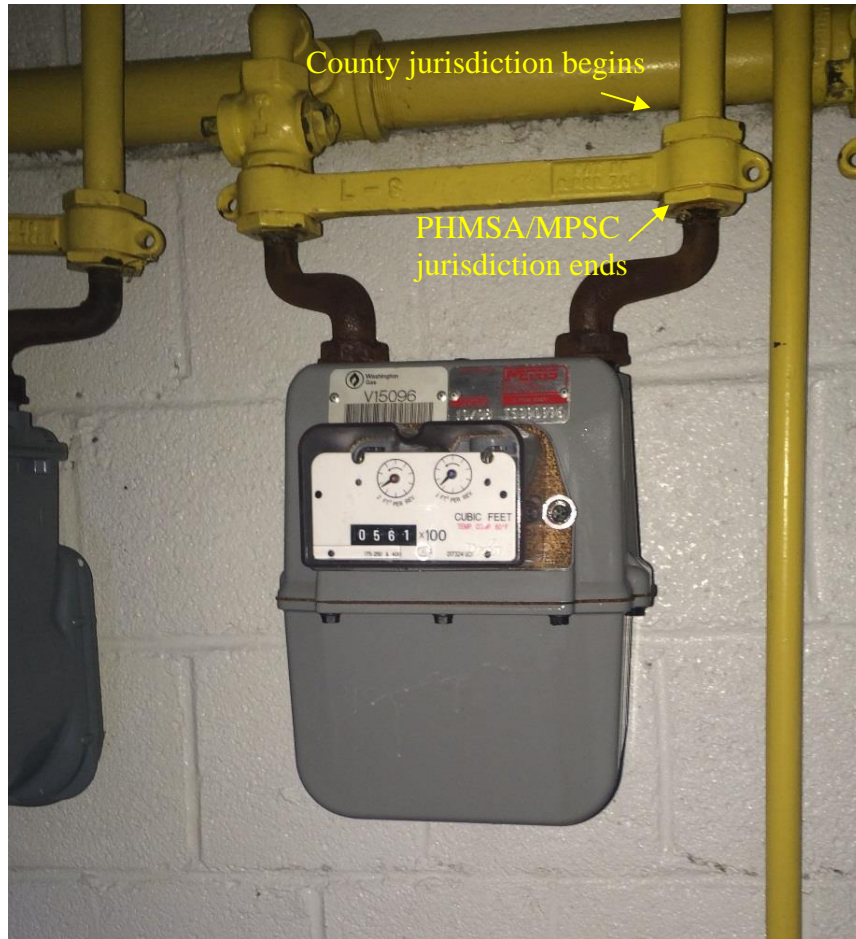
Figure 1: Exemplar Gas Meter in Flower Branch Apartment Complex

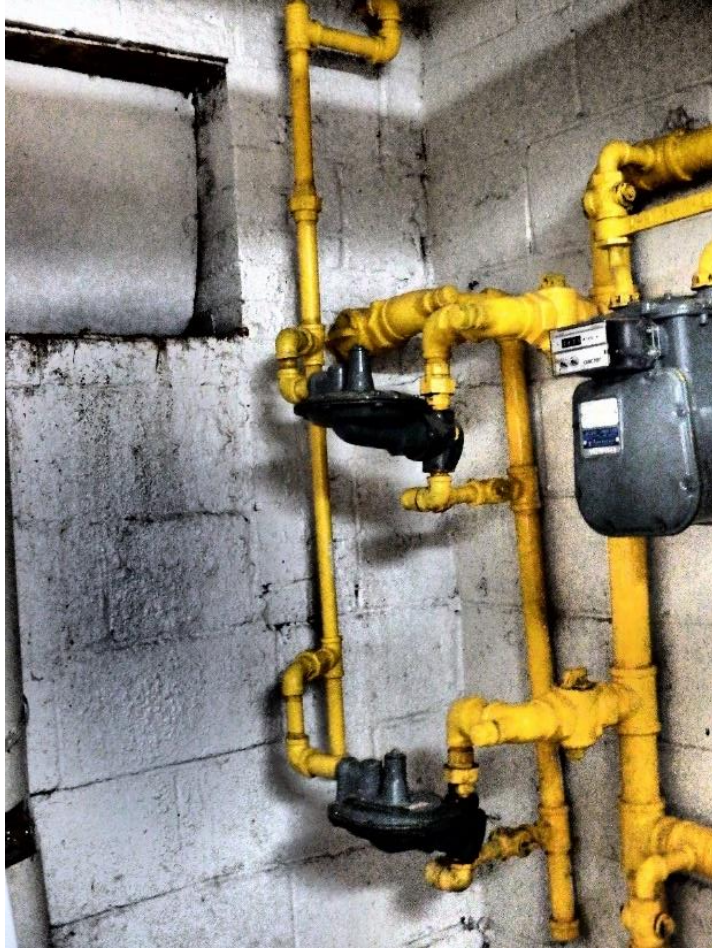
The gas meter rack in building 8701 included 15 gas meters and two mercury regulators. Figure 2 shows a typical installation of two regulators and piping assembly from a nearby Flower Branch apartment building, which is similar to the piping configuration that was in Building 8701. The mercury regulators involved in the accident from Building 8701 are further described in Material Laboratory Factual Report No. 16-097.

Figure 2: Exemplar Regulator Assembly in a nearby Flower Branch Apartment Building on Arliss Street

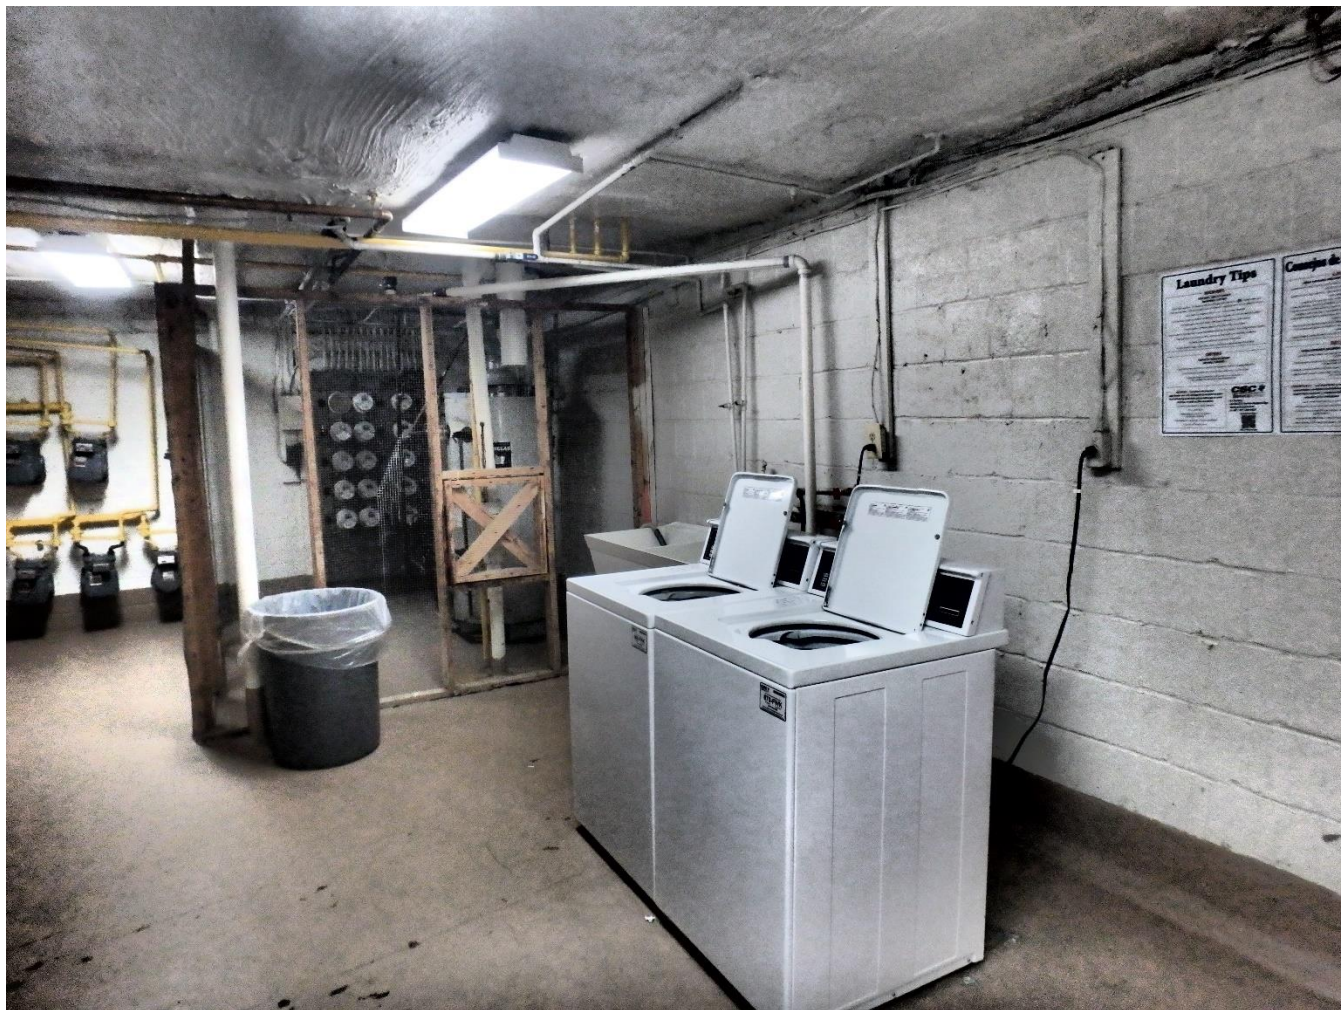
The meters at the 8701 Flower Branch Apartments were located in a locked basement room that had a water heater, which was activated by a pilot light during a heating cycle, which is further described in the Materials Laboratory Factual Report No. 16-100. In other Flower Branch apartment buildings, there was a similar spacing between the water heater and the meter assembly, as seen in Figure 3. However, other than the water heater, there were no other appliances in the basement of Building 8701

and the water heater in Building 8701 was not protected by a security cage, as seen in other Flower Branch Apartment buildings in Figure 3.¹¹ Also recovered from the accident is an electrical panel that was located in the basement of building 8701, similar to the one seen in Figure 3.

Figure 3: Exemplar Gas Meter room in the Flower Branch Apartment Complex
