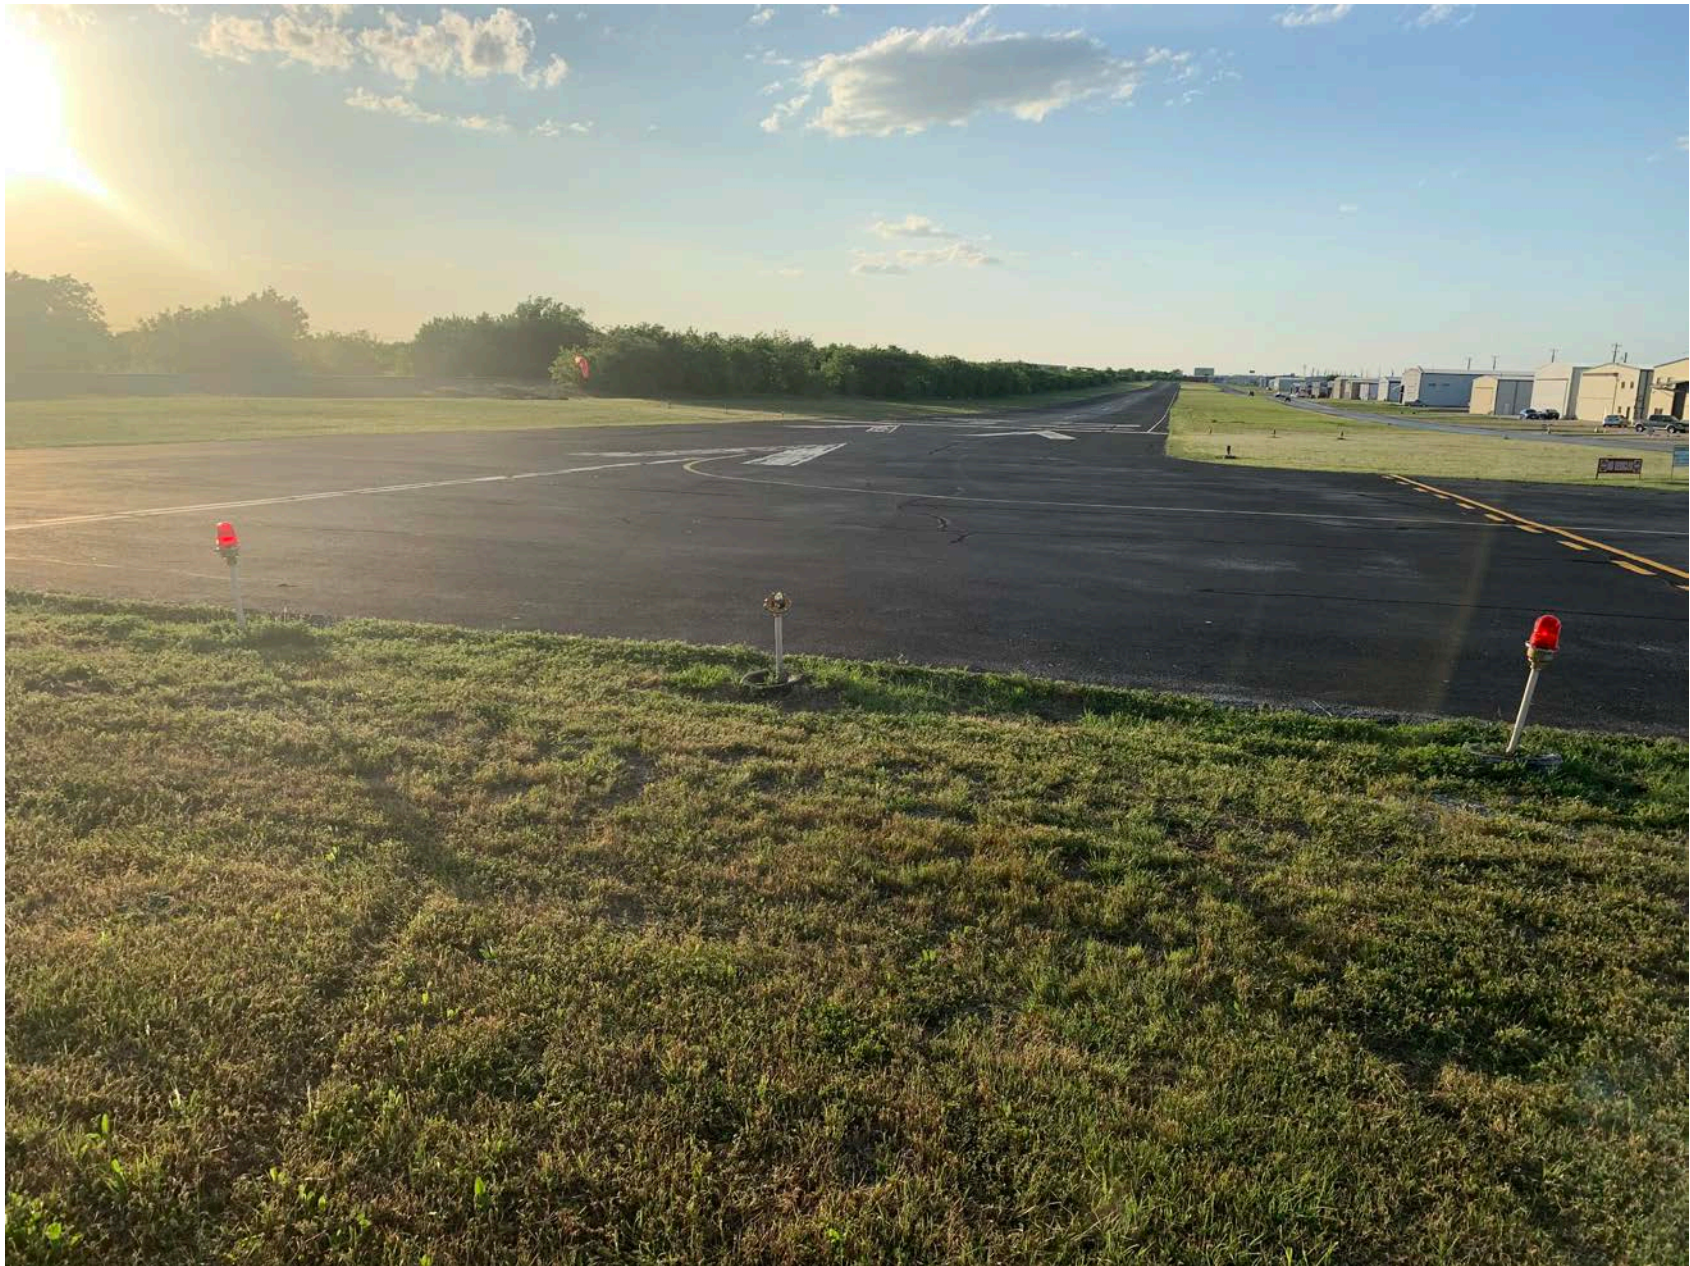
Photo 1 – View towards the departure end of runway 14. Note tire tracks and toppled airport lights (FAA photo)

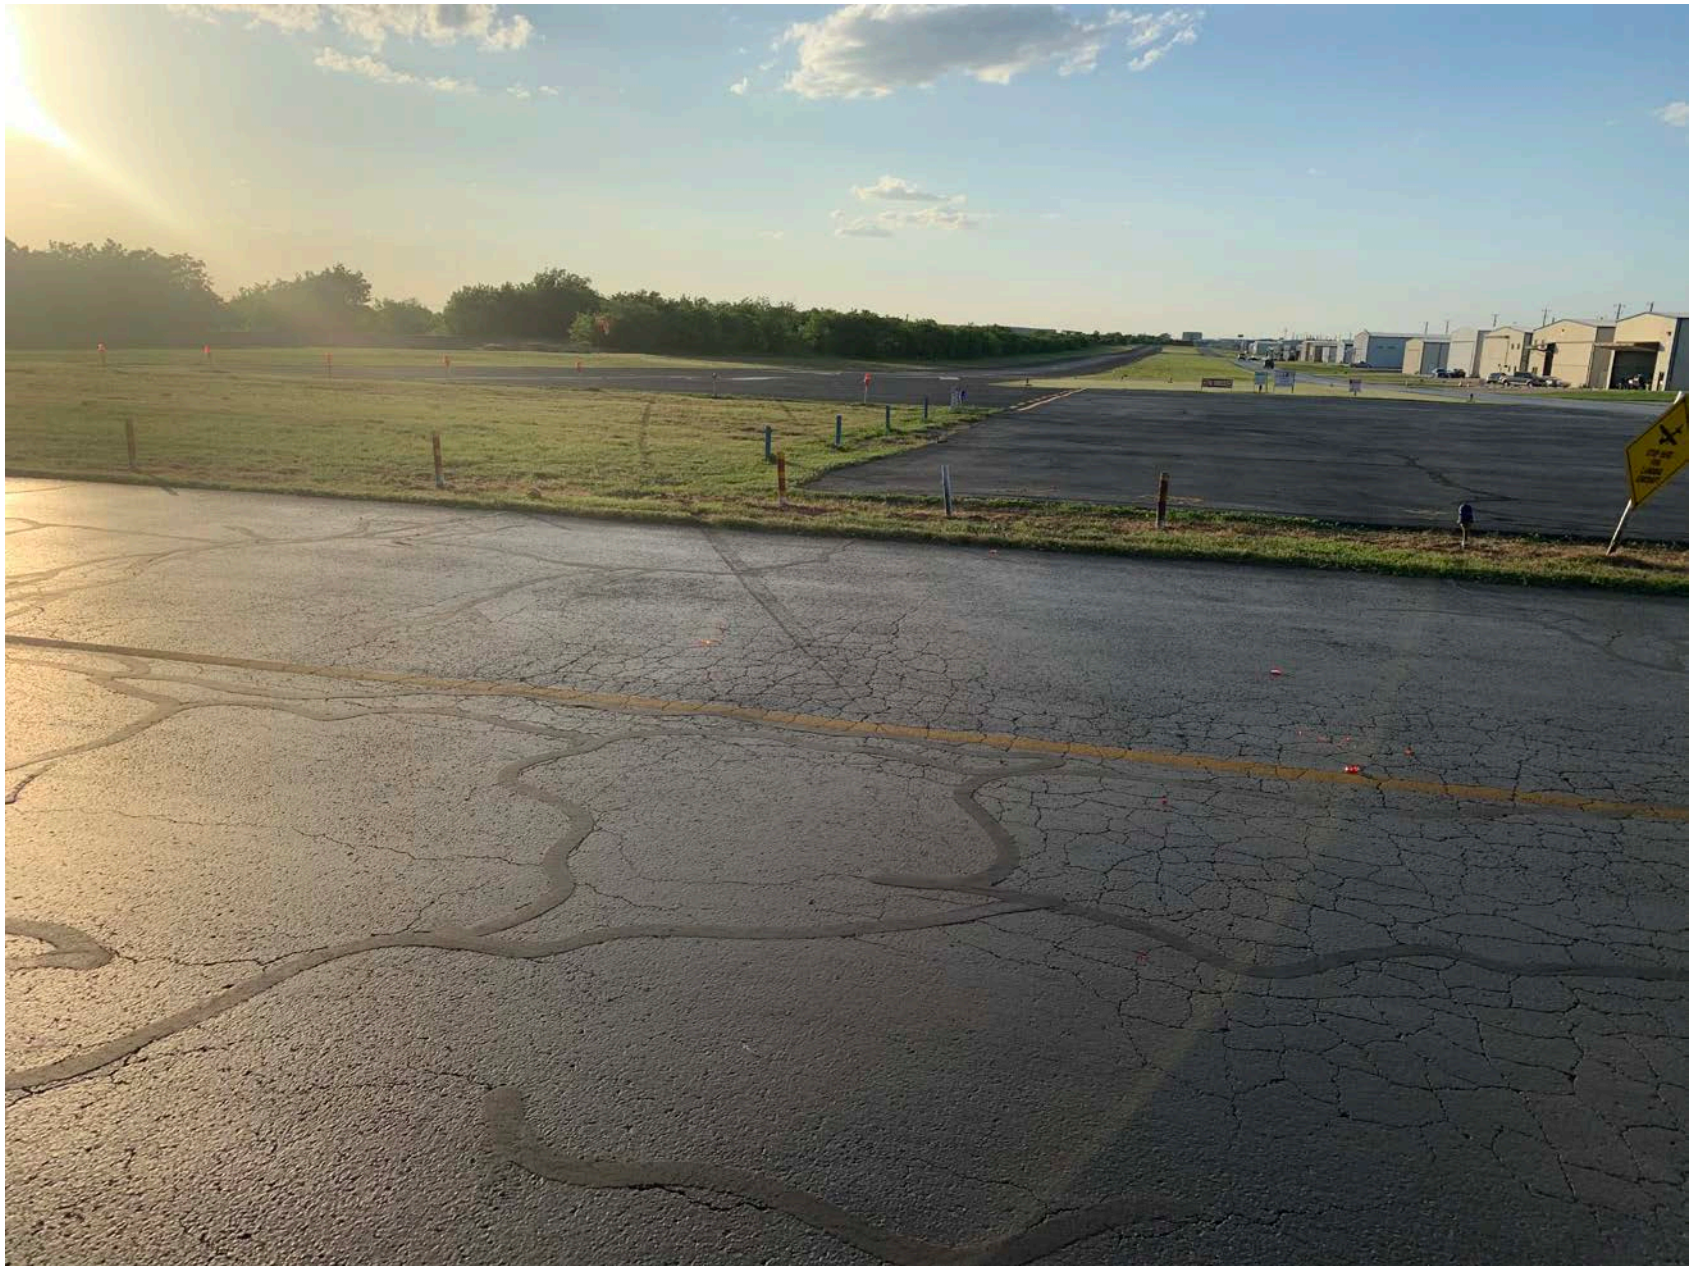
Photo 2 – Tire tracks cross perimeter road (FAA photo)

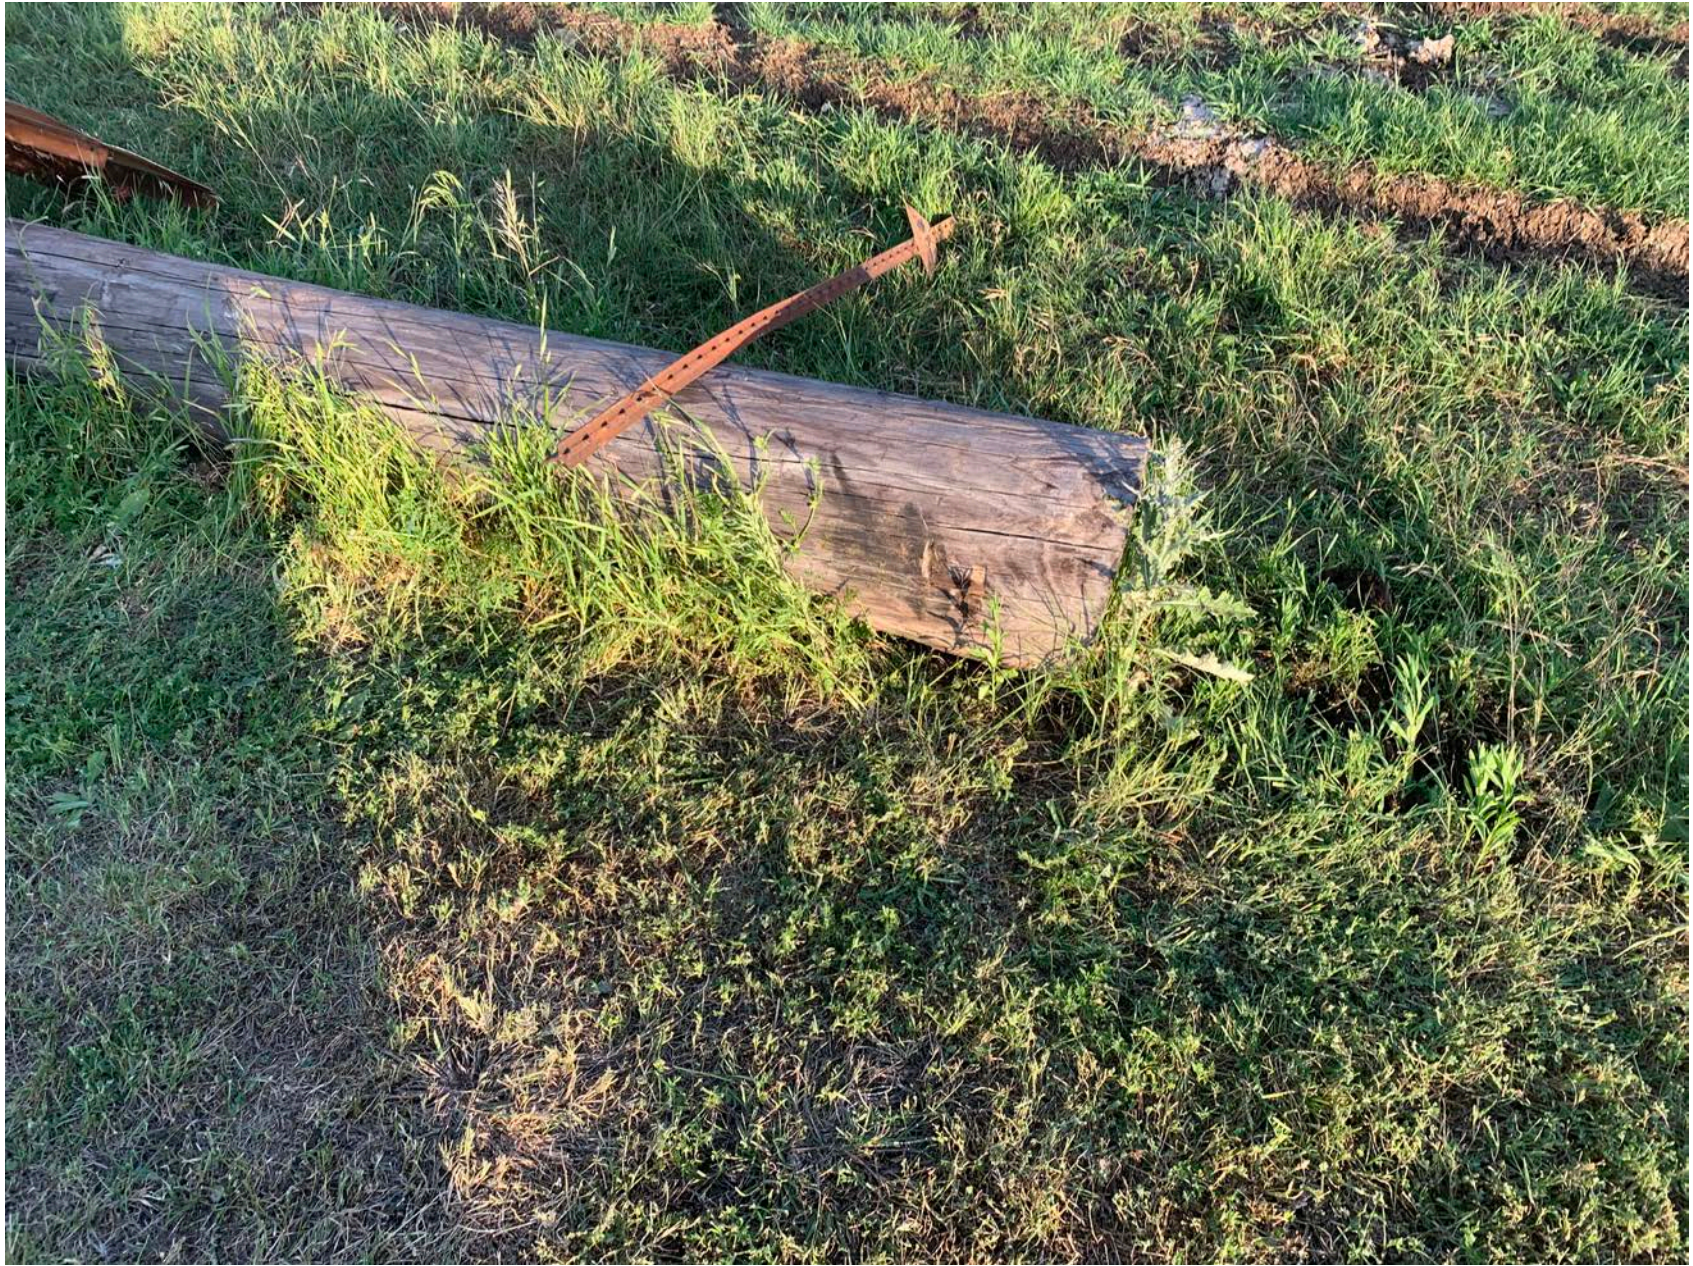
Photo 3 – Toppled fence posts (FAA photo)

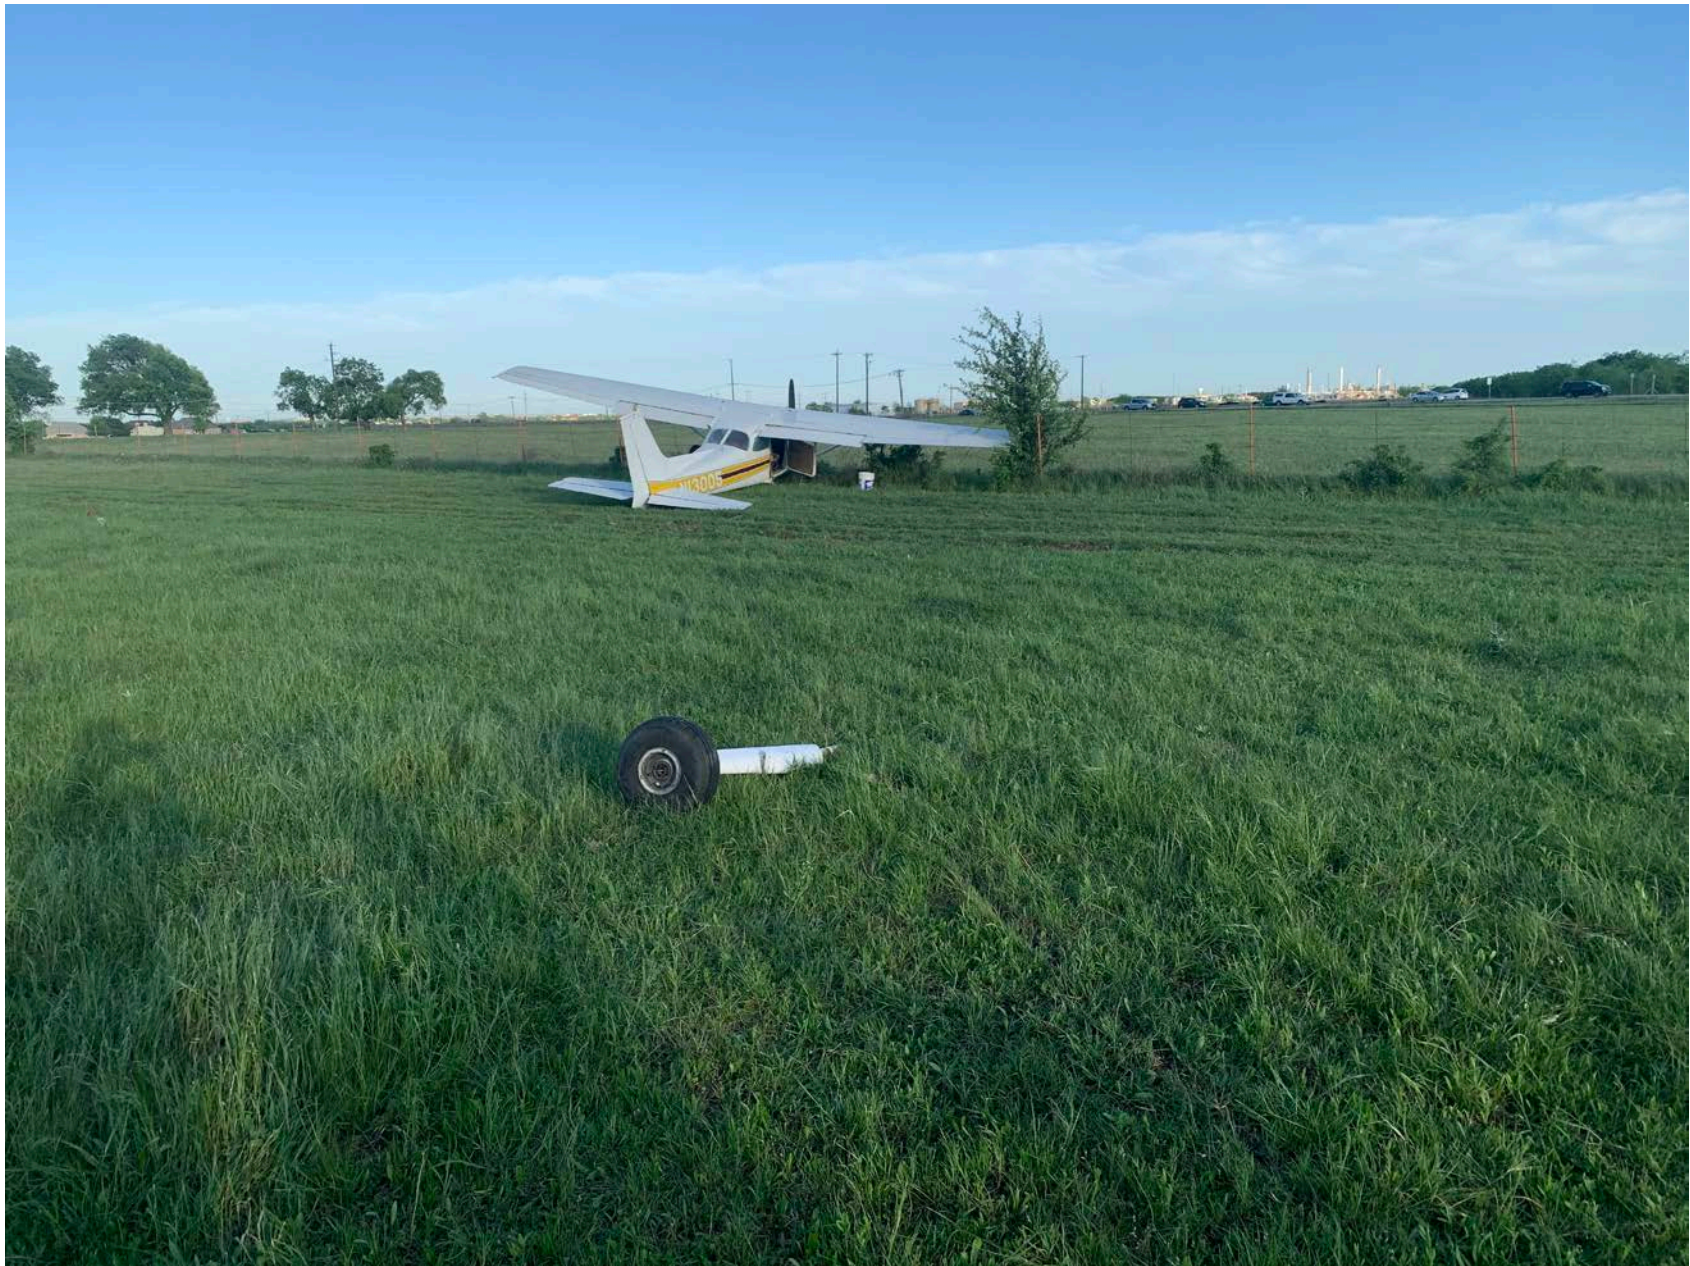
Photo 4 – N13005 sits against a second fence. Note severed right main landing gear in foreground (FAA photo)

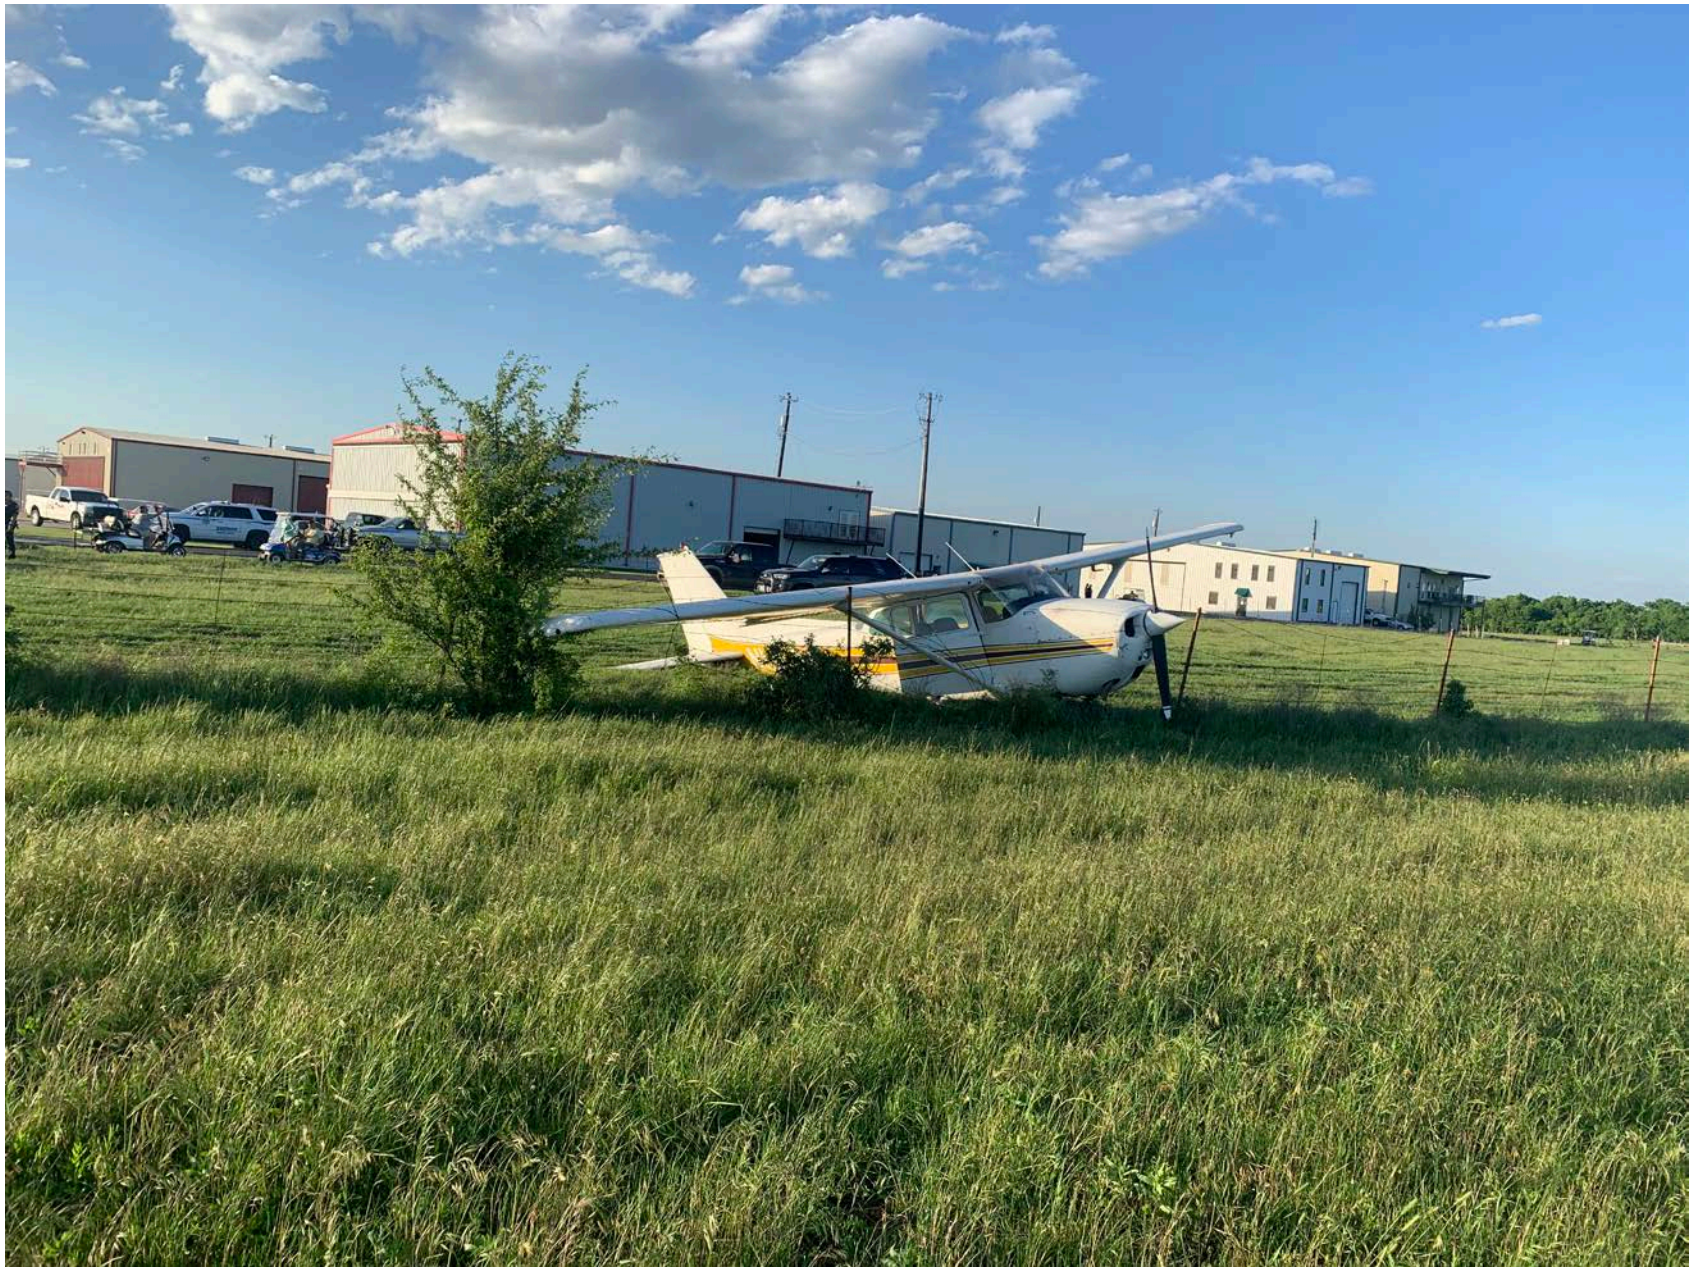
Photo 5 – N13005 at the accident site (FAA photo)

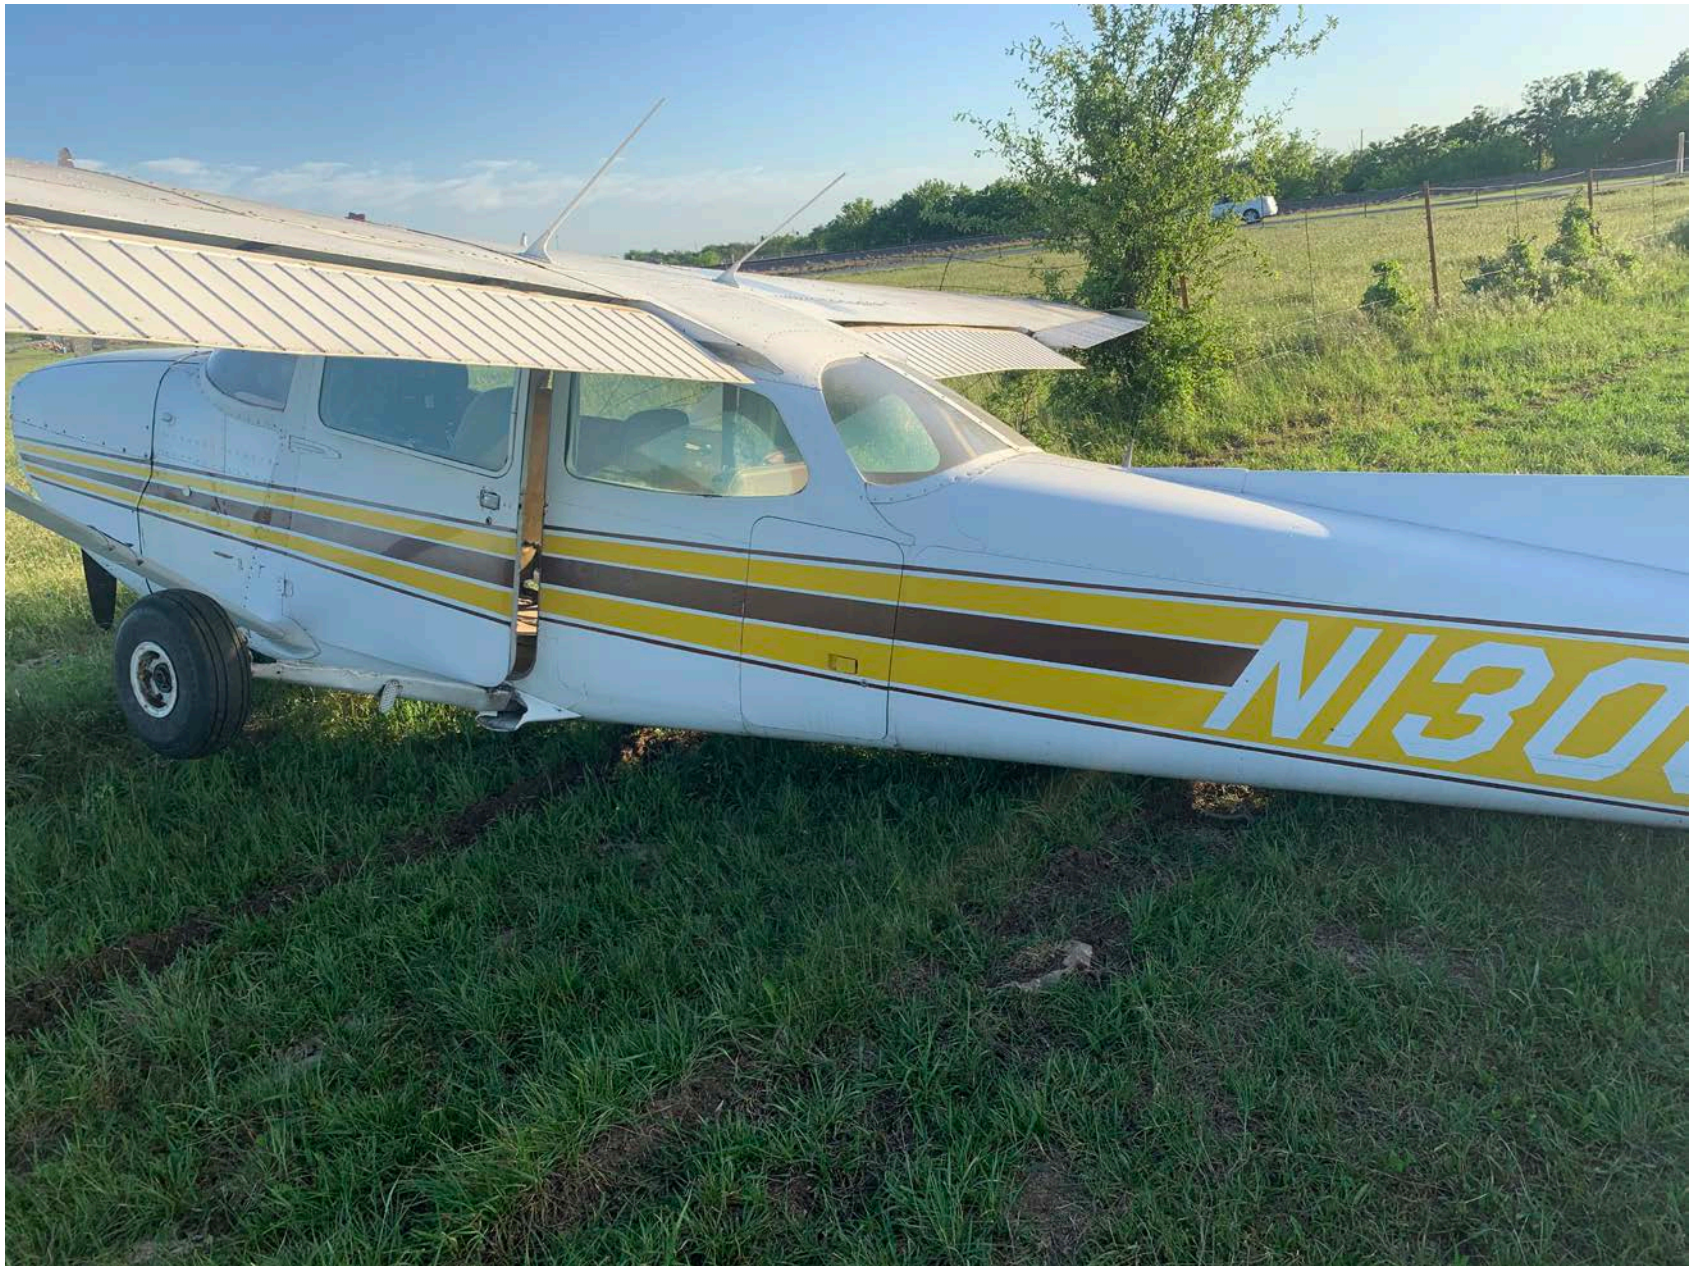
Photo 6 – Left main landing gear stayed attached but was bent forward (FAA photo)

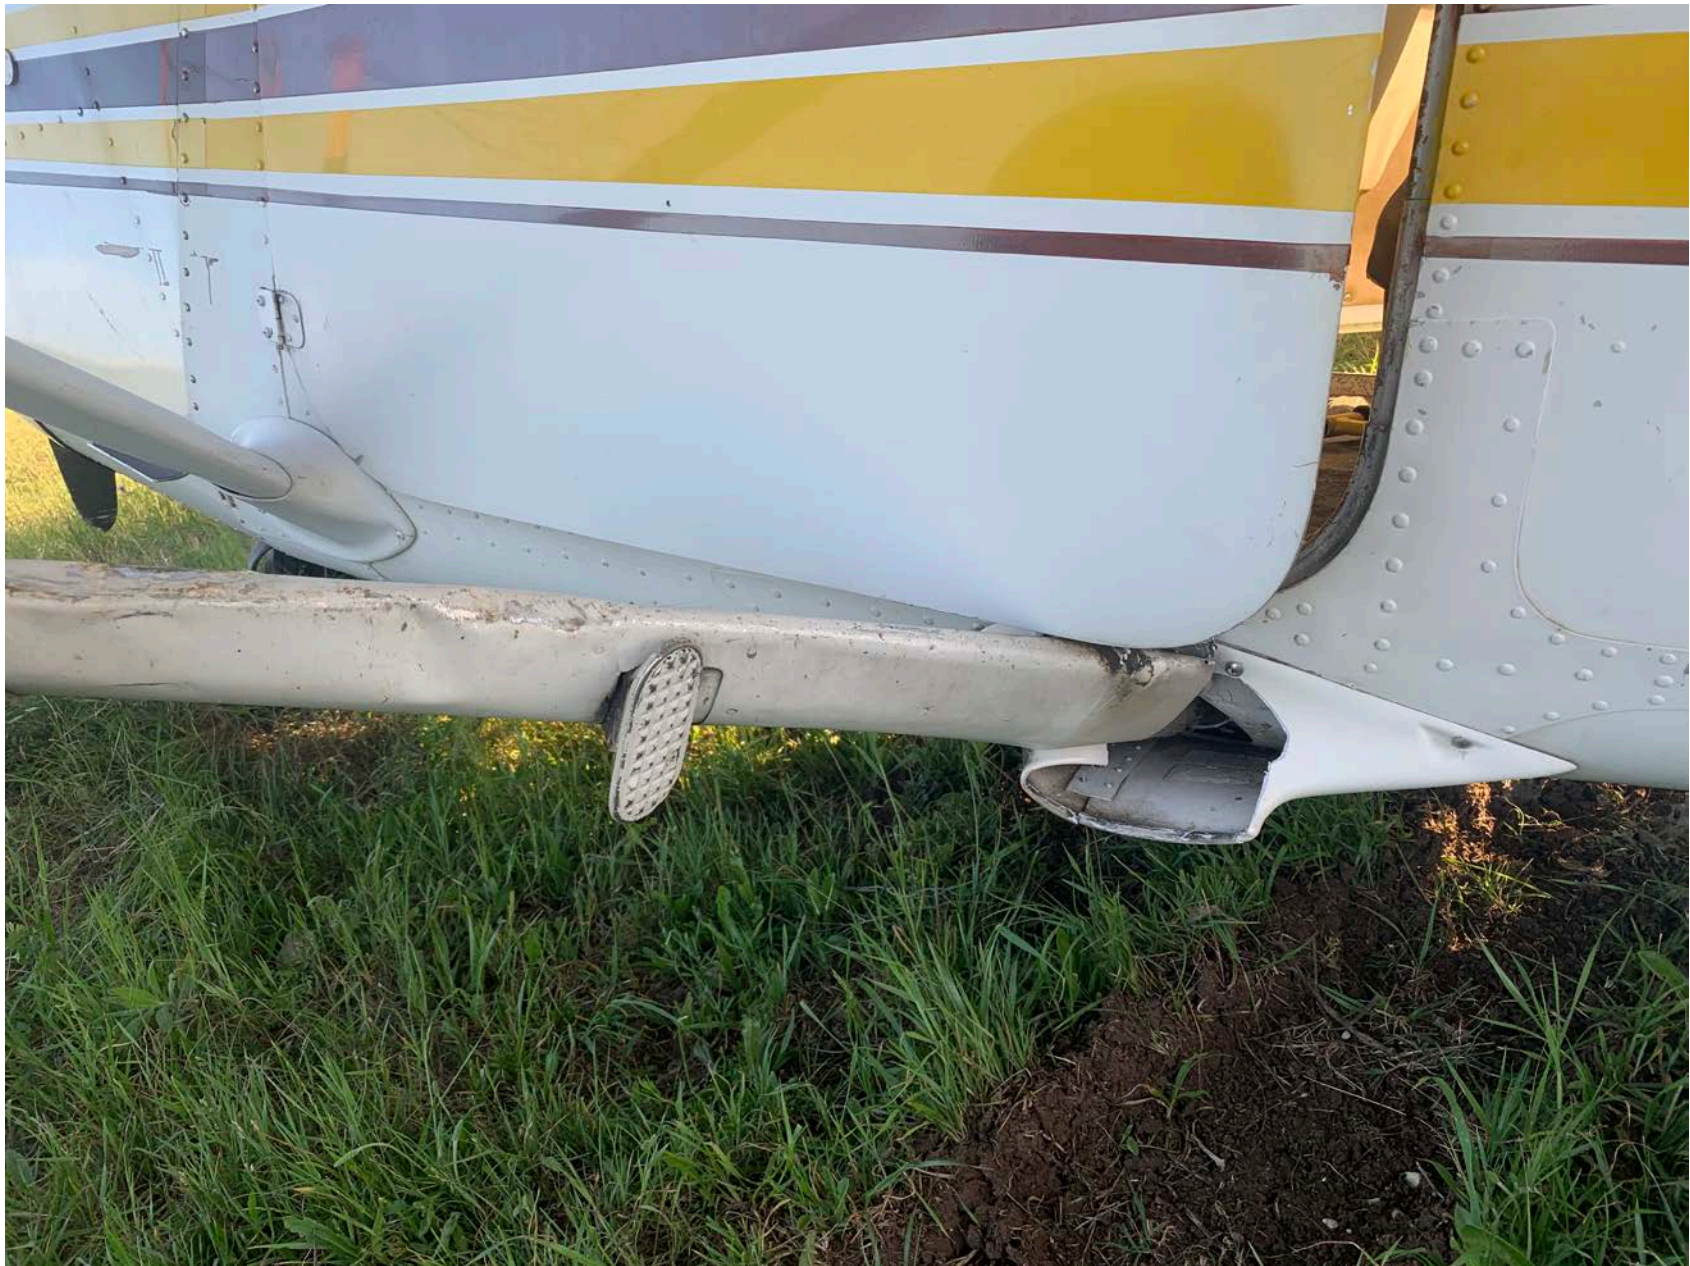
Photo 7 – Close-up view of left main landing gear (FAA photo)

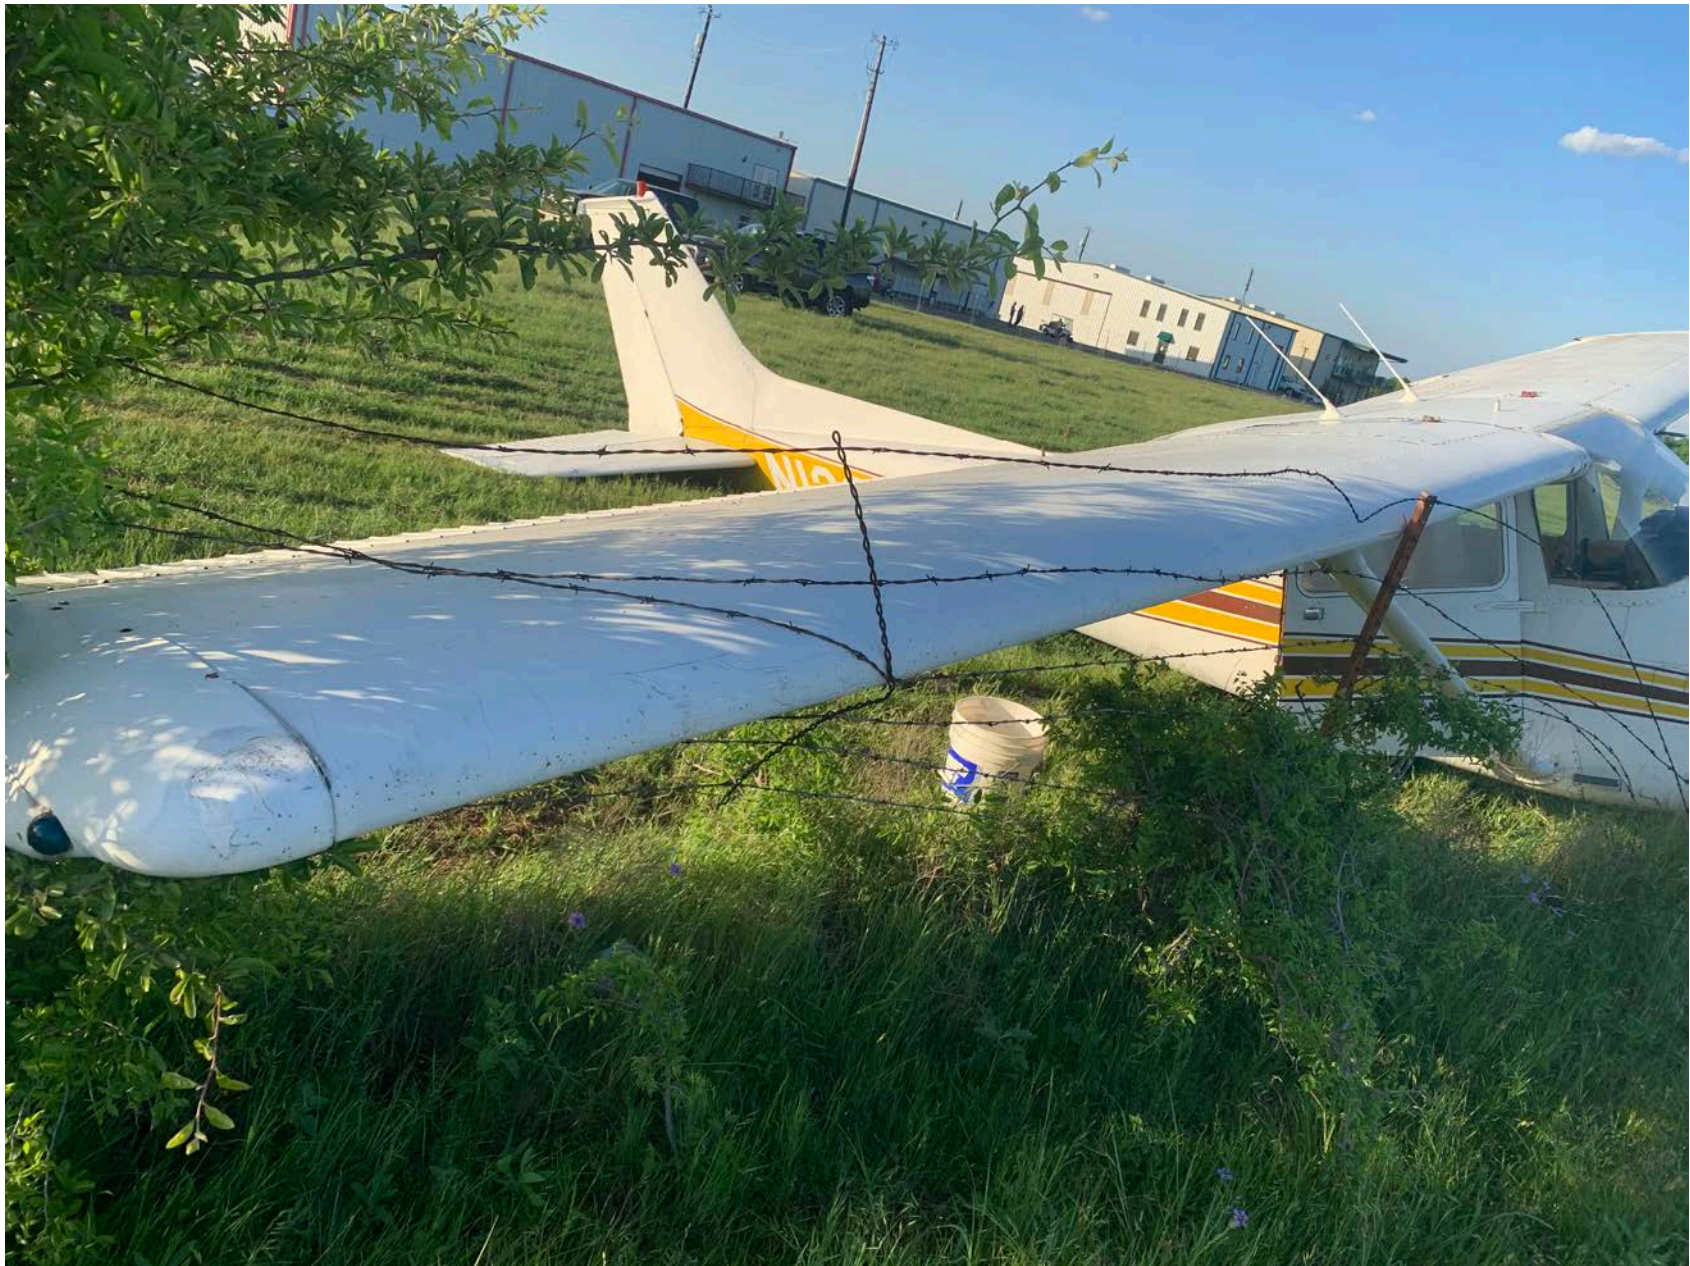
Photo 8 – Barbed wire fence around engine cowling and right wing (FAA photo)

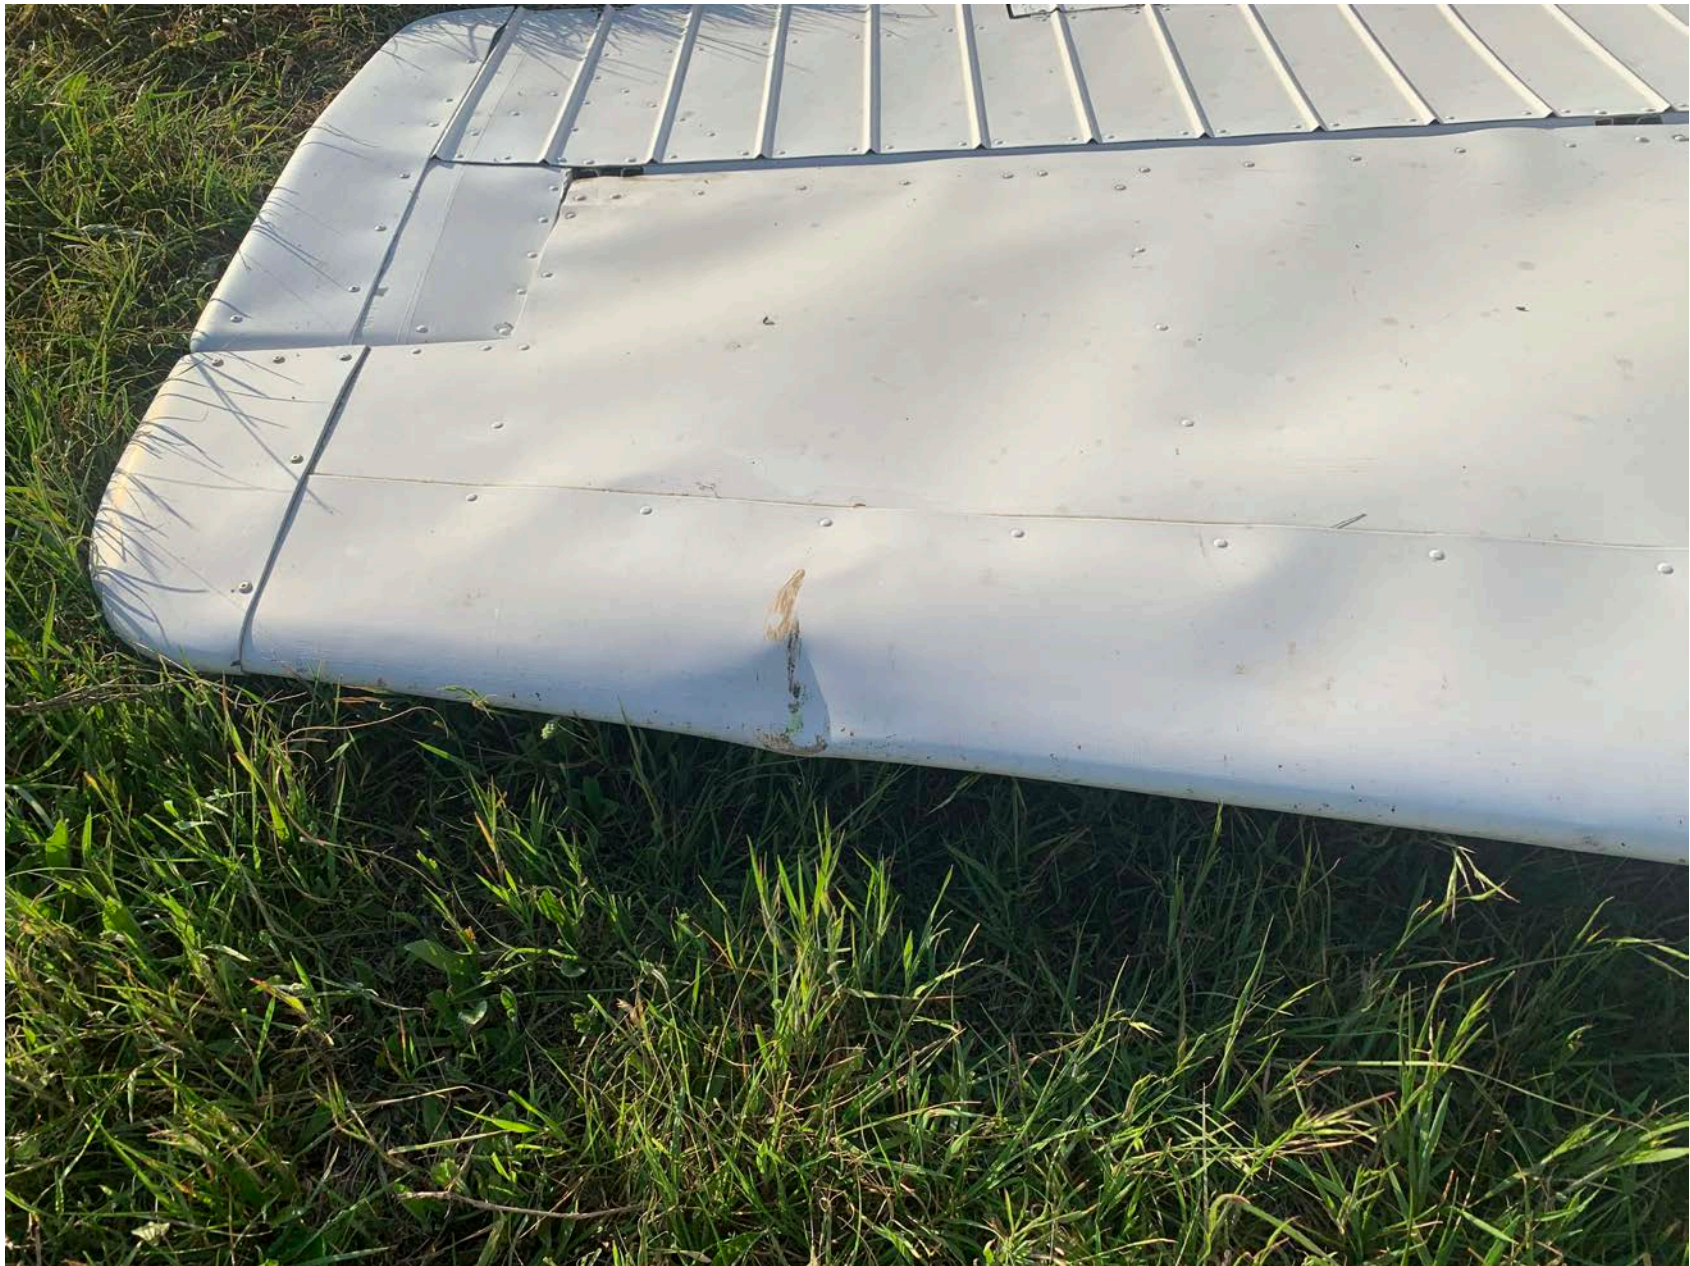
Photo 9 – Leading edge damage and skin wrinkles in right horizontal stabilizer (FAA photo)
