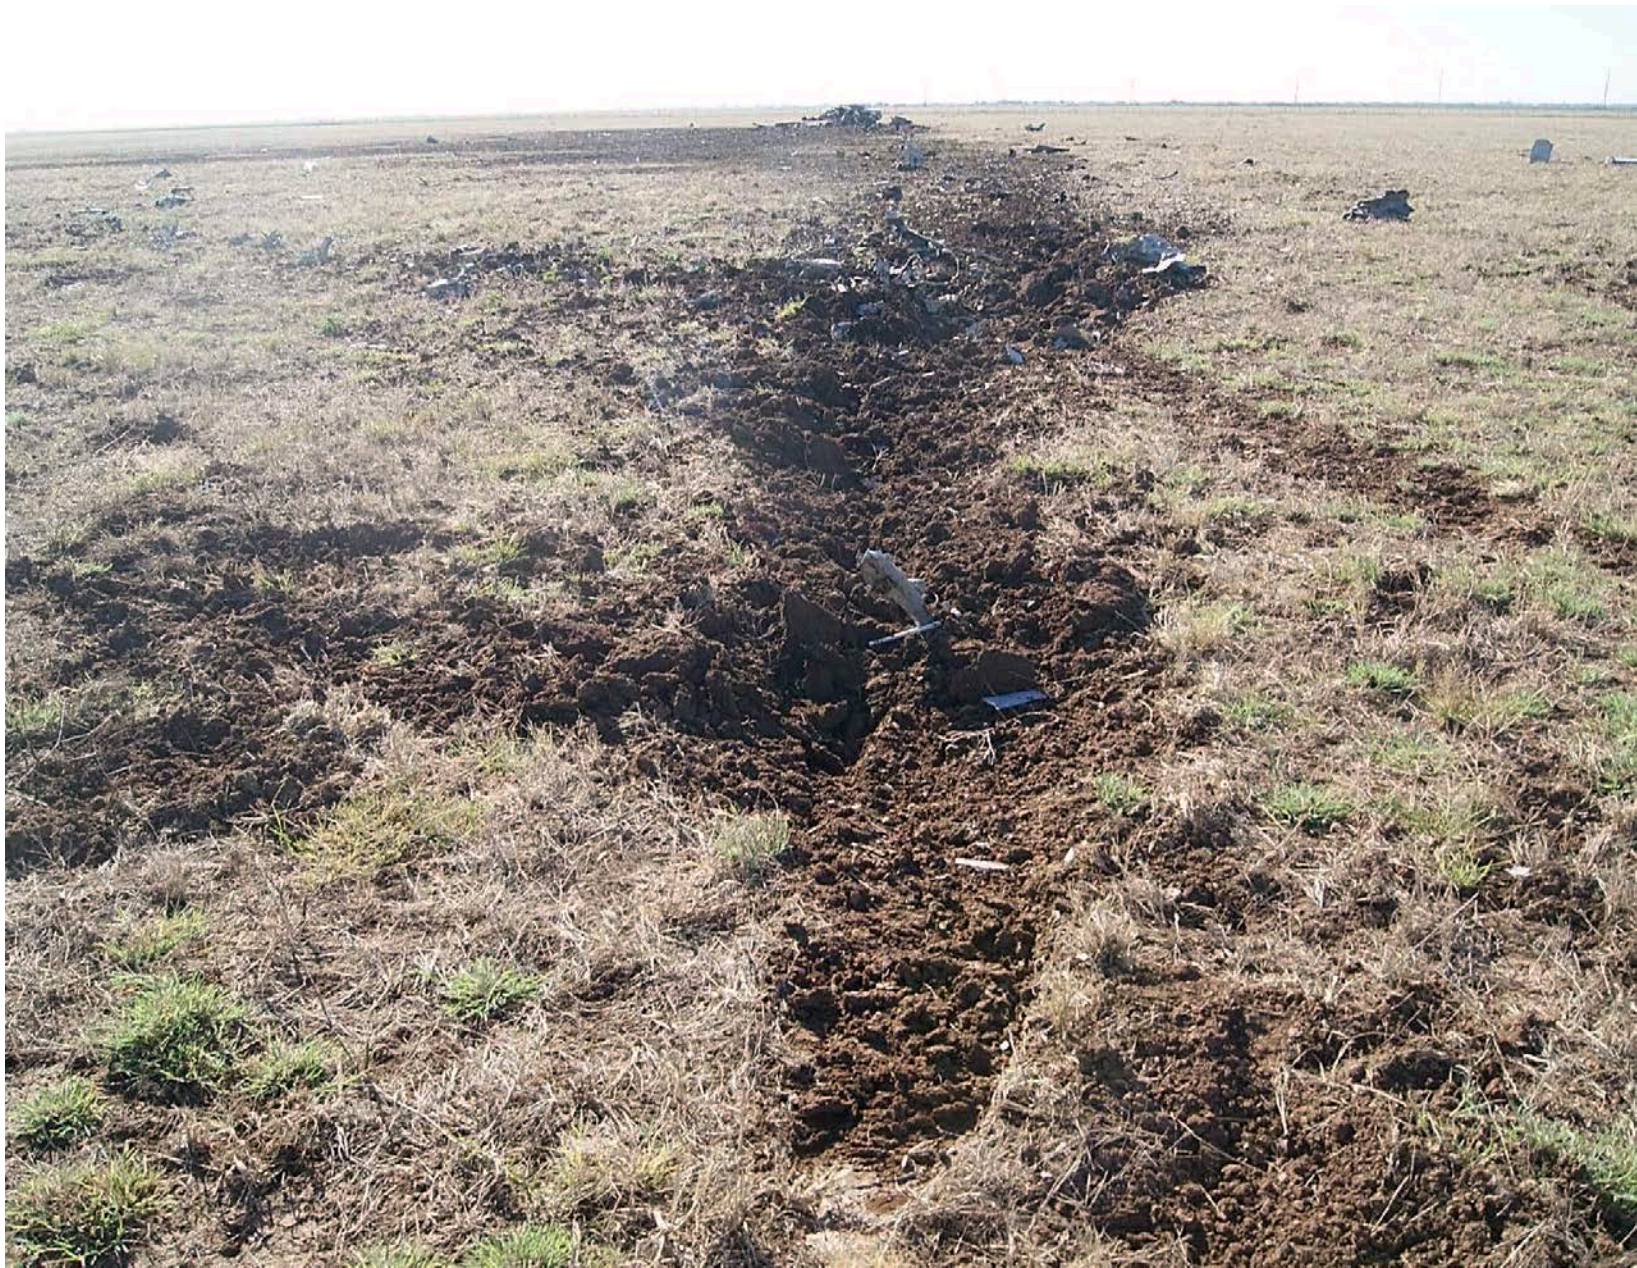
Photo 3 – The debris path was 580 feet long and aligned on a magnetic course about 170°. Remains of the left wing are to the left of the crater.

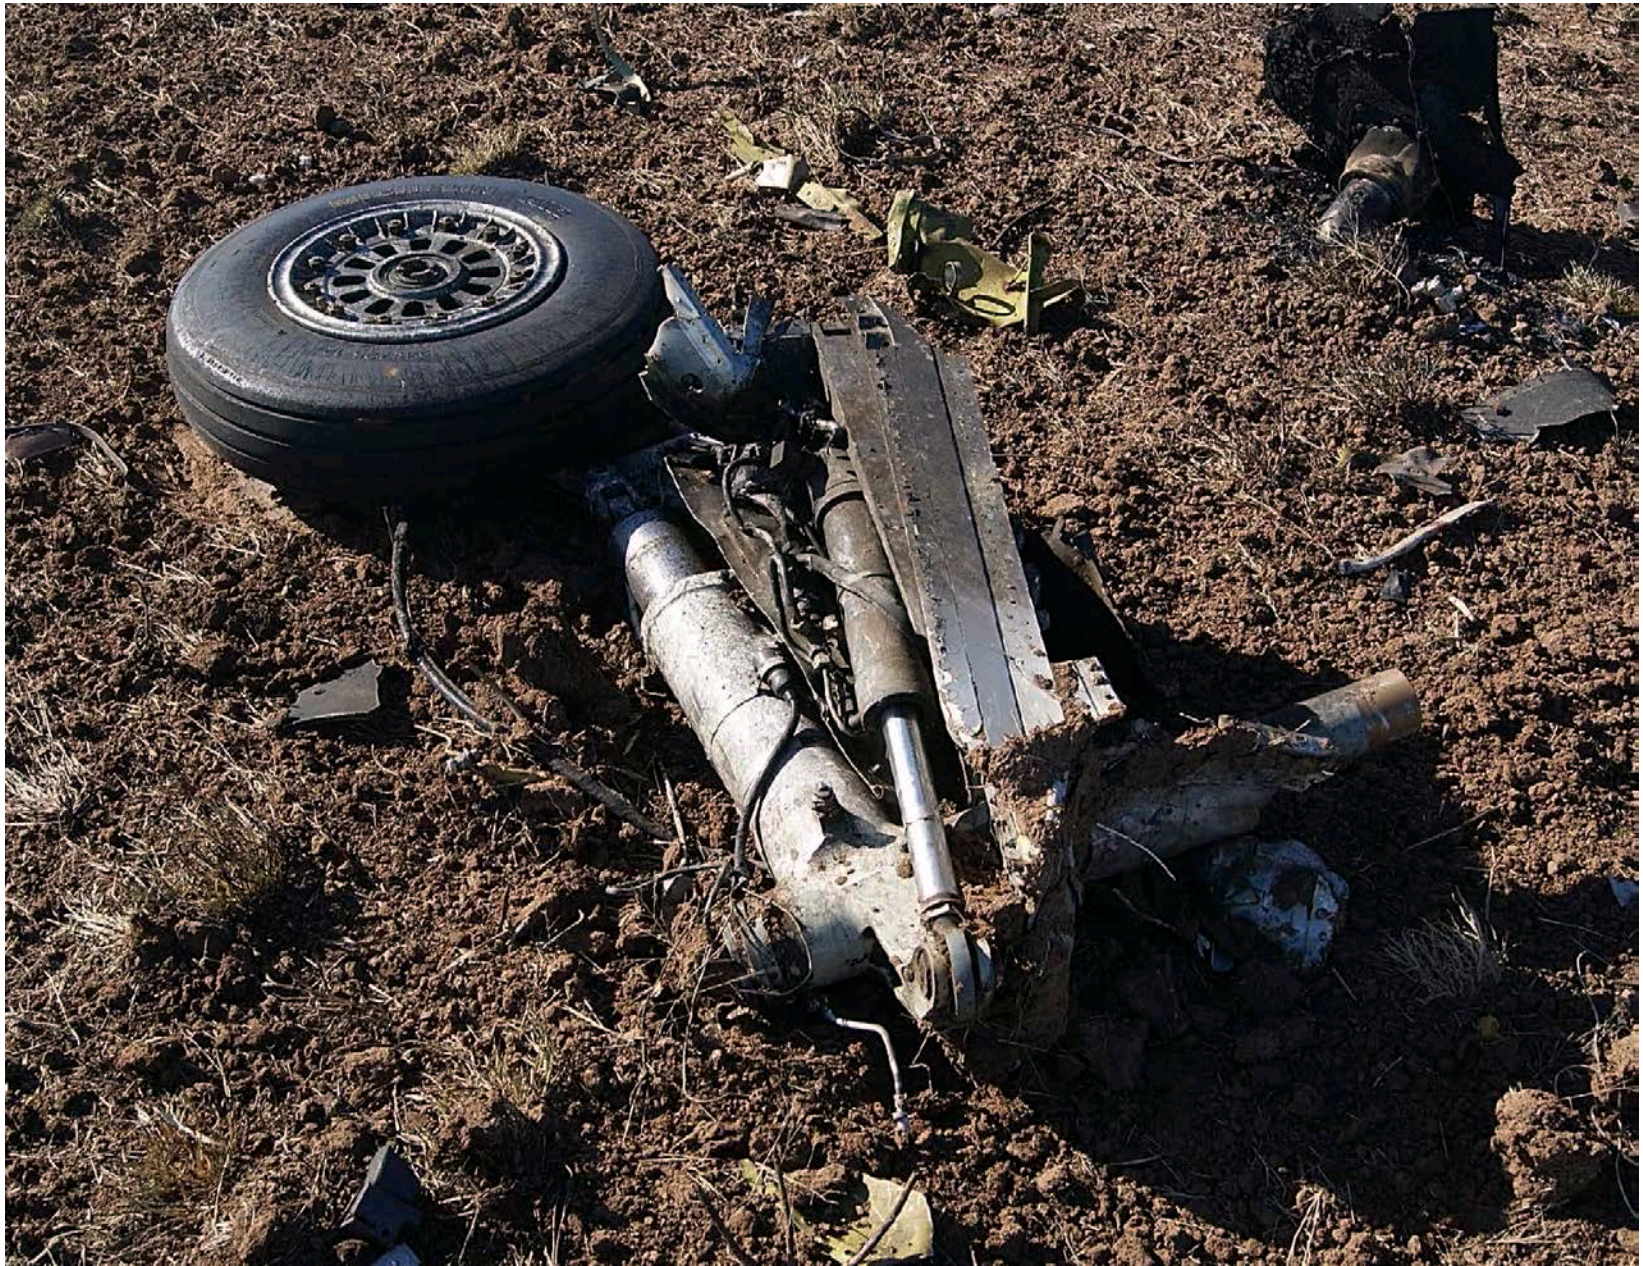
Photo 4 – Left main landing gear.

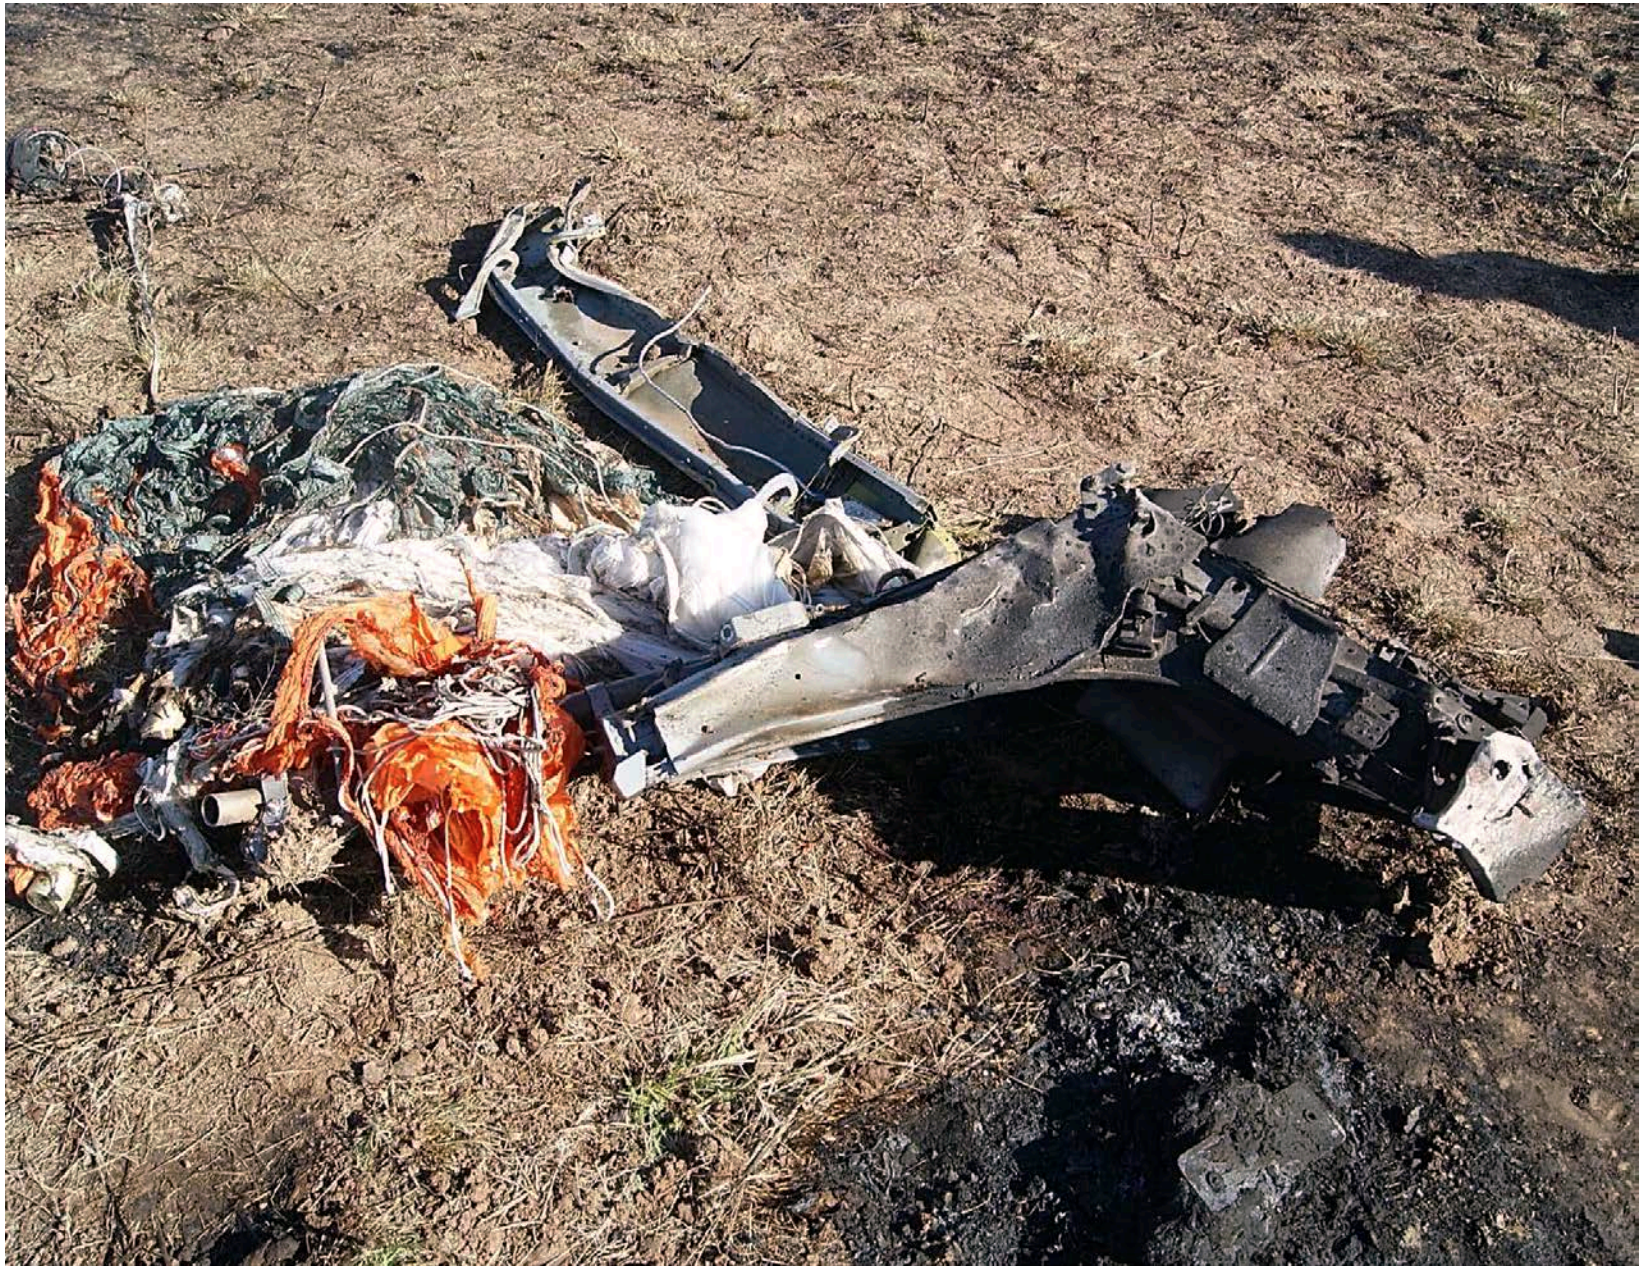
Photo 5 – Pilot's seat and parachute.

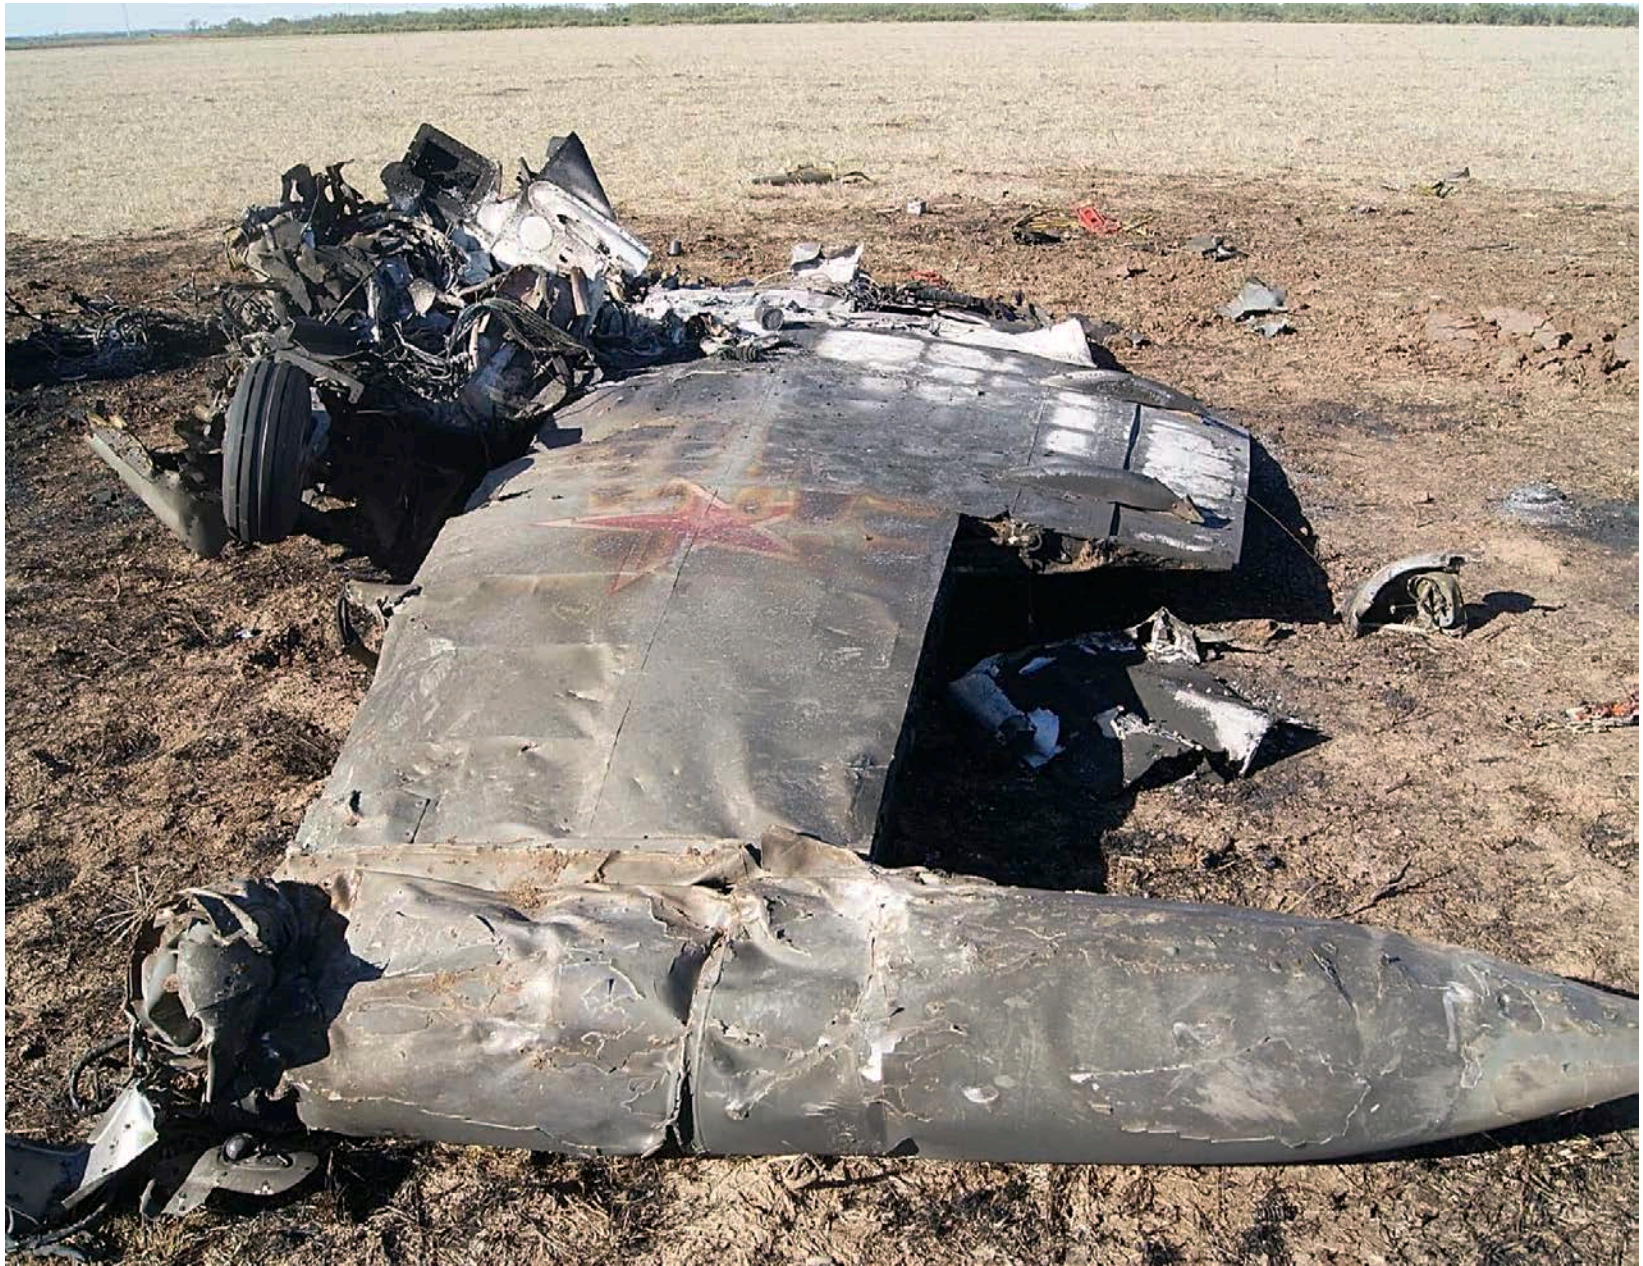
Photo 6 – Inverted right wing, remains of cockpit, and landing gear.

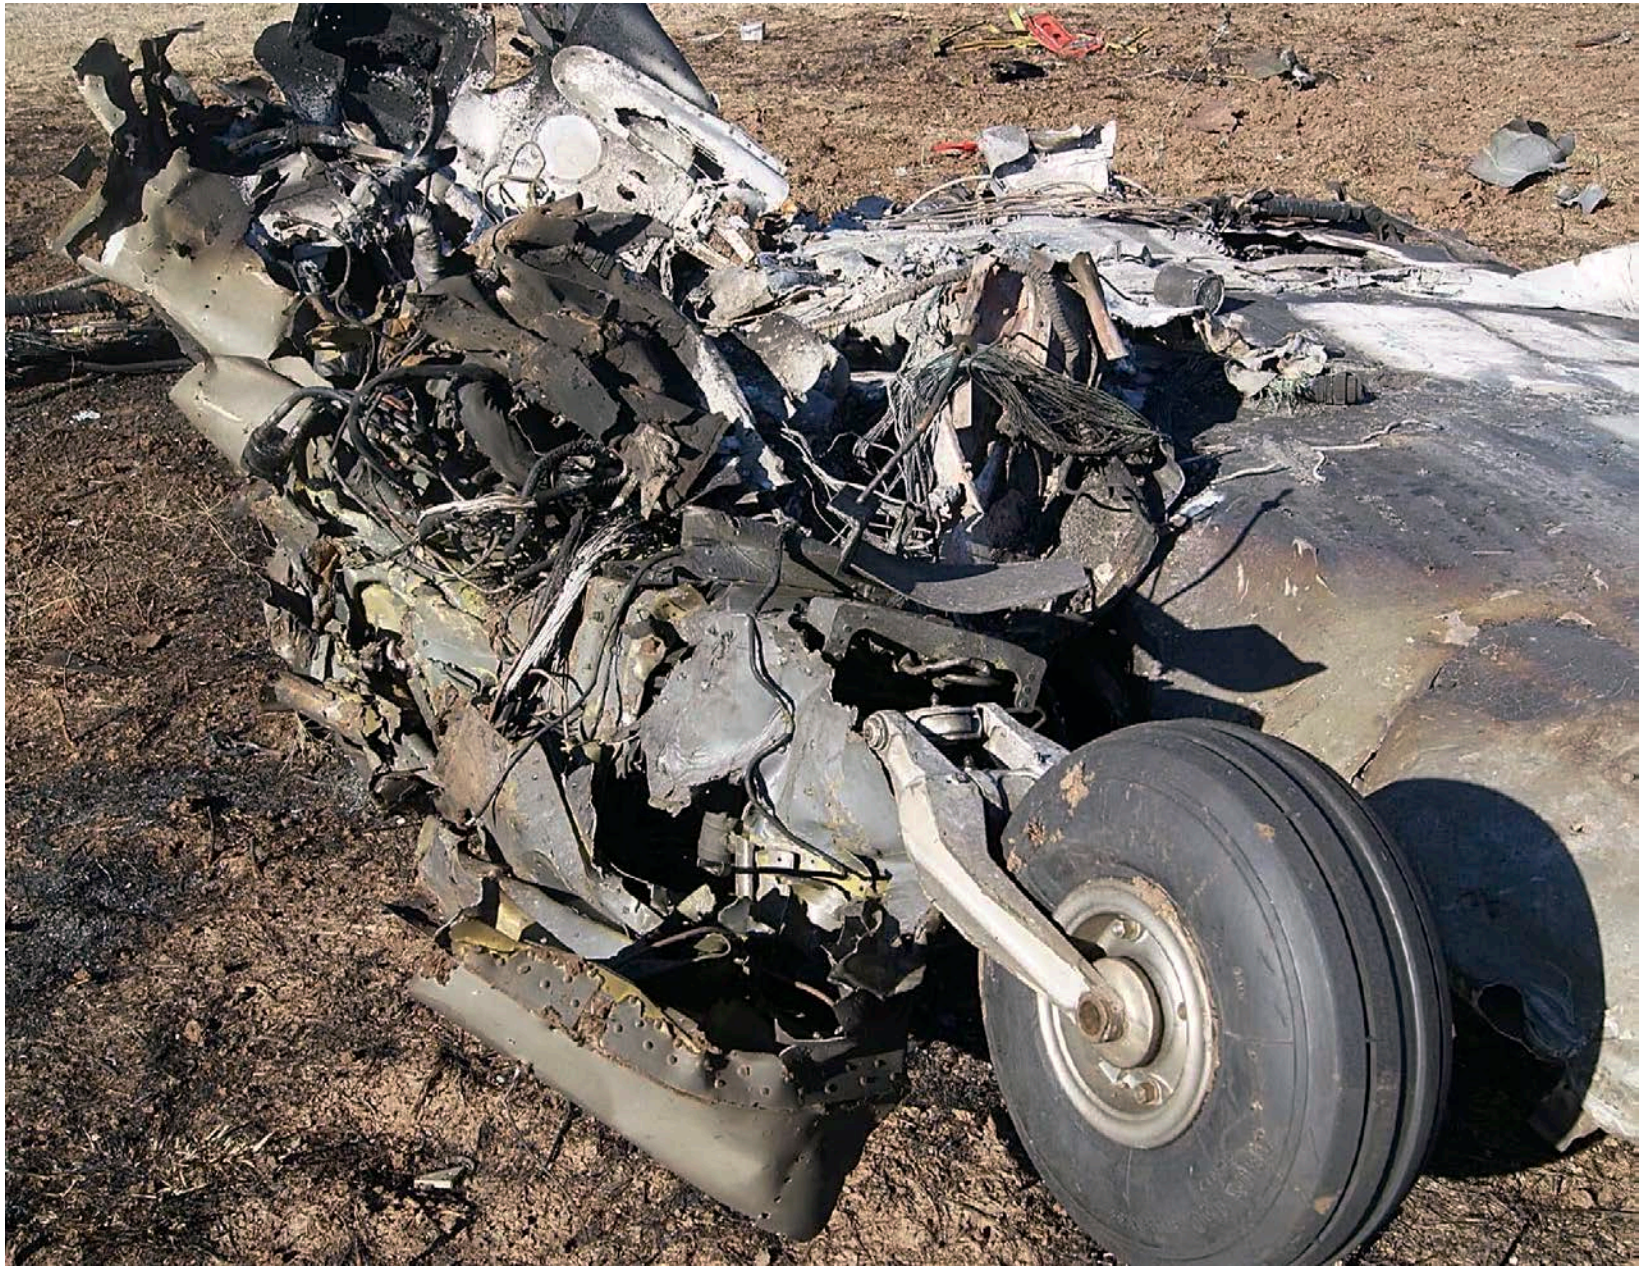
Photo 7 – Right main landing gear and portions of cockpit instruments.

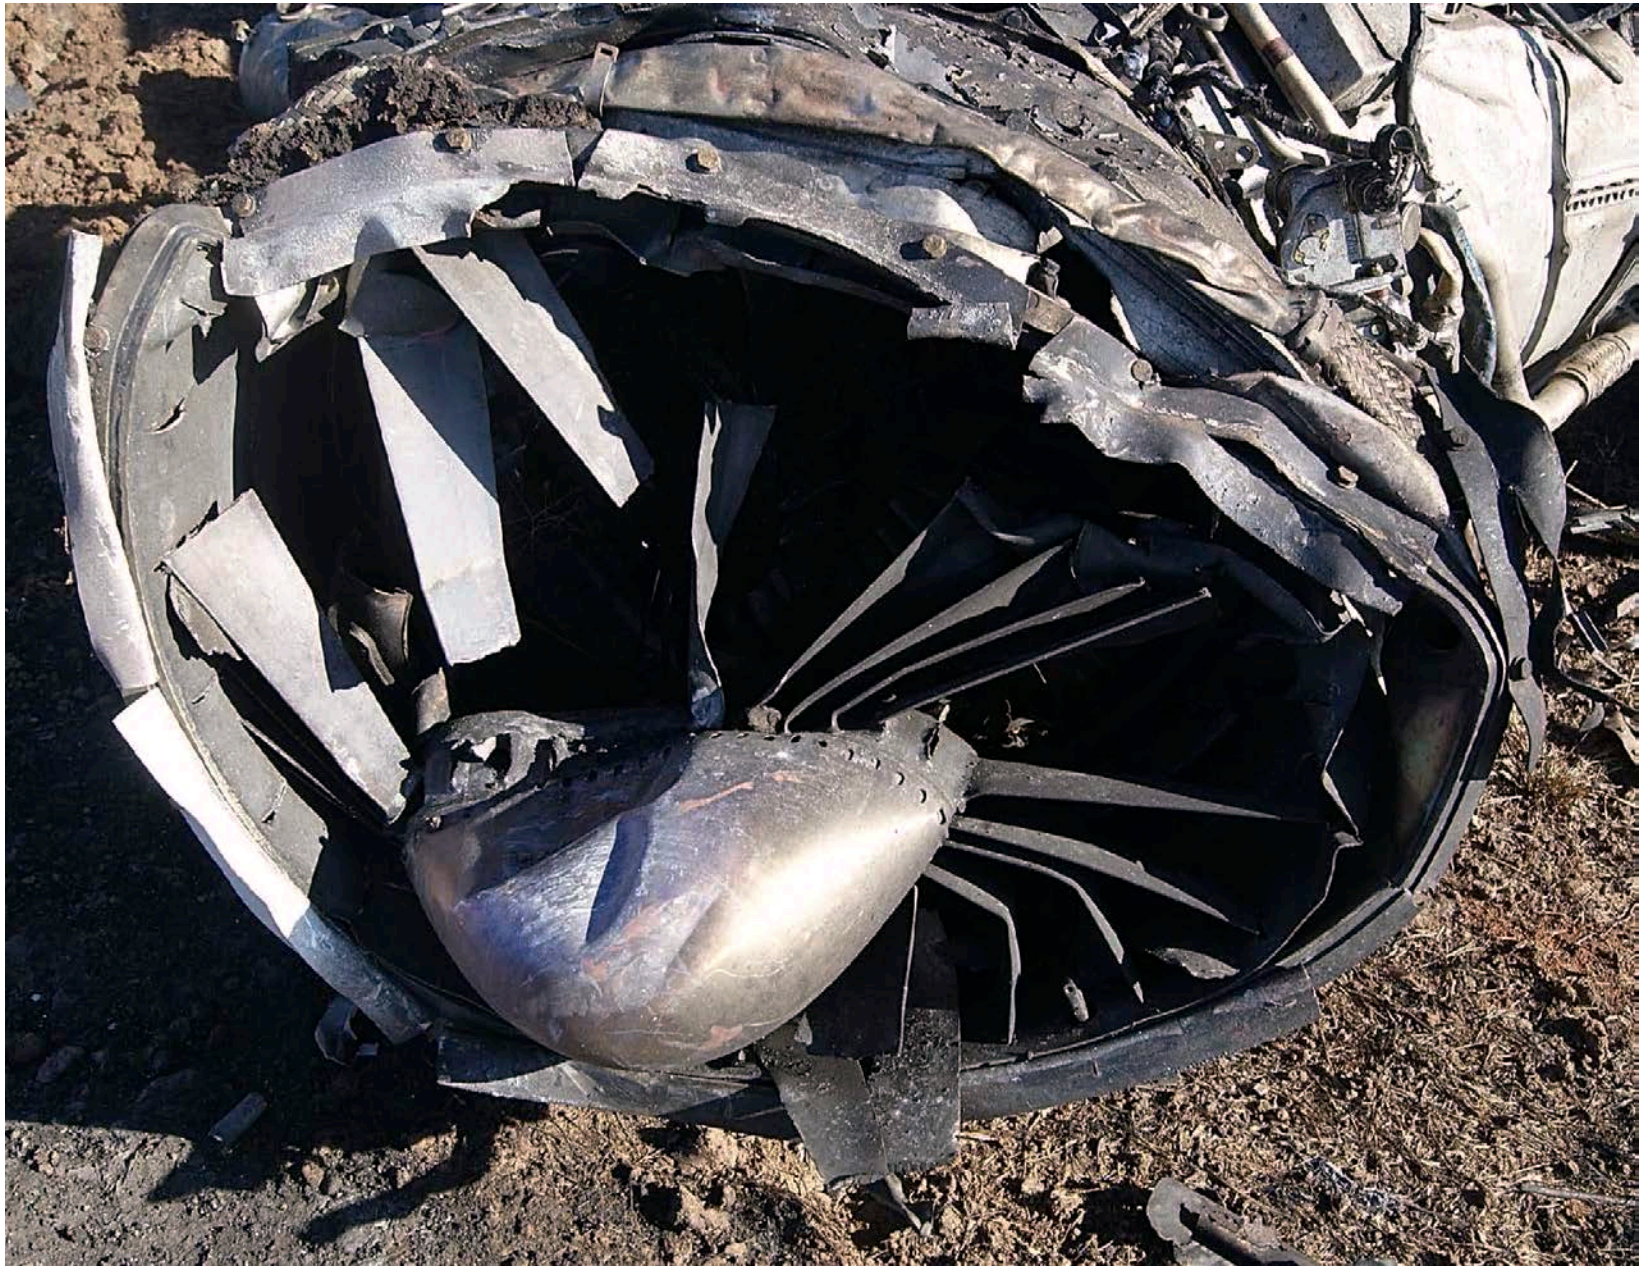
Photo 8 – Compressor section of engine.

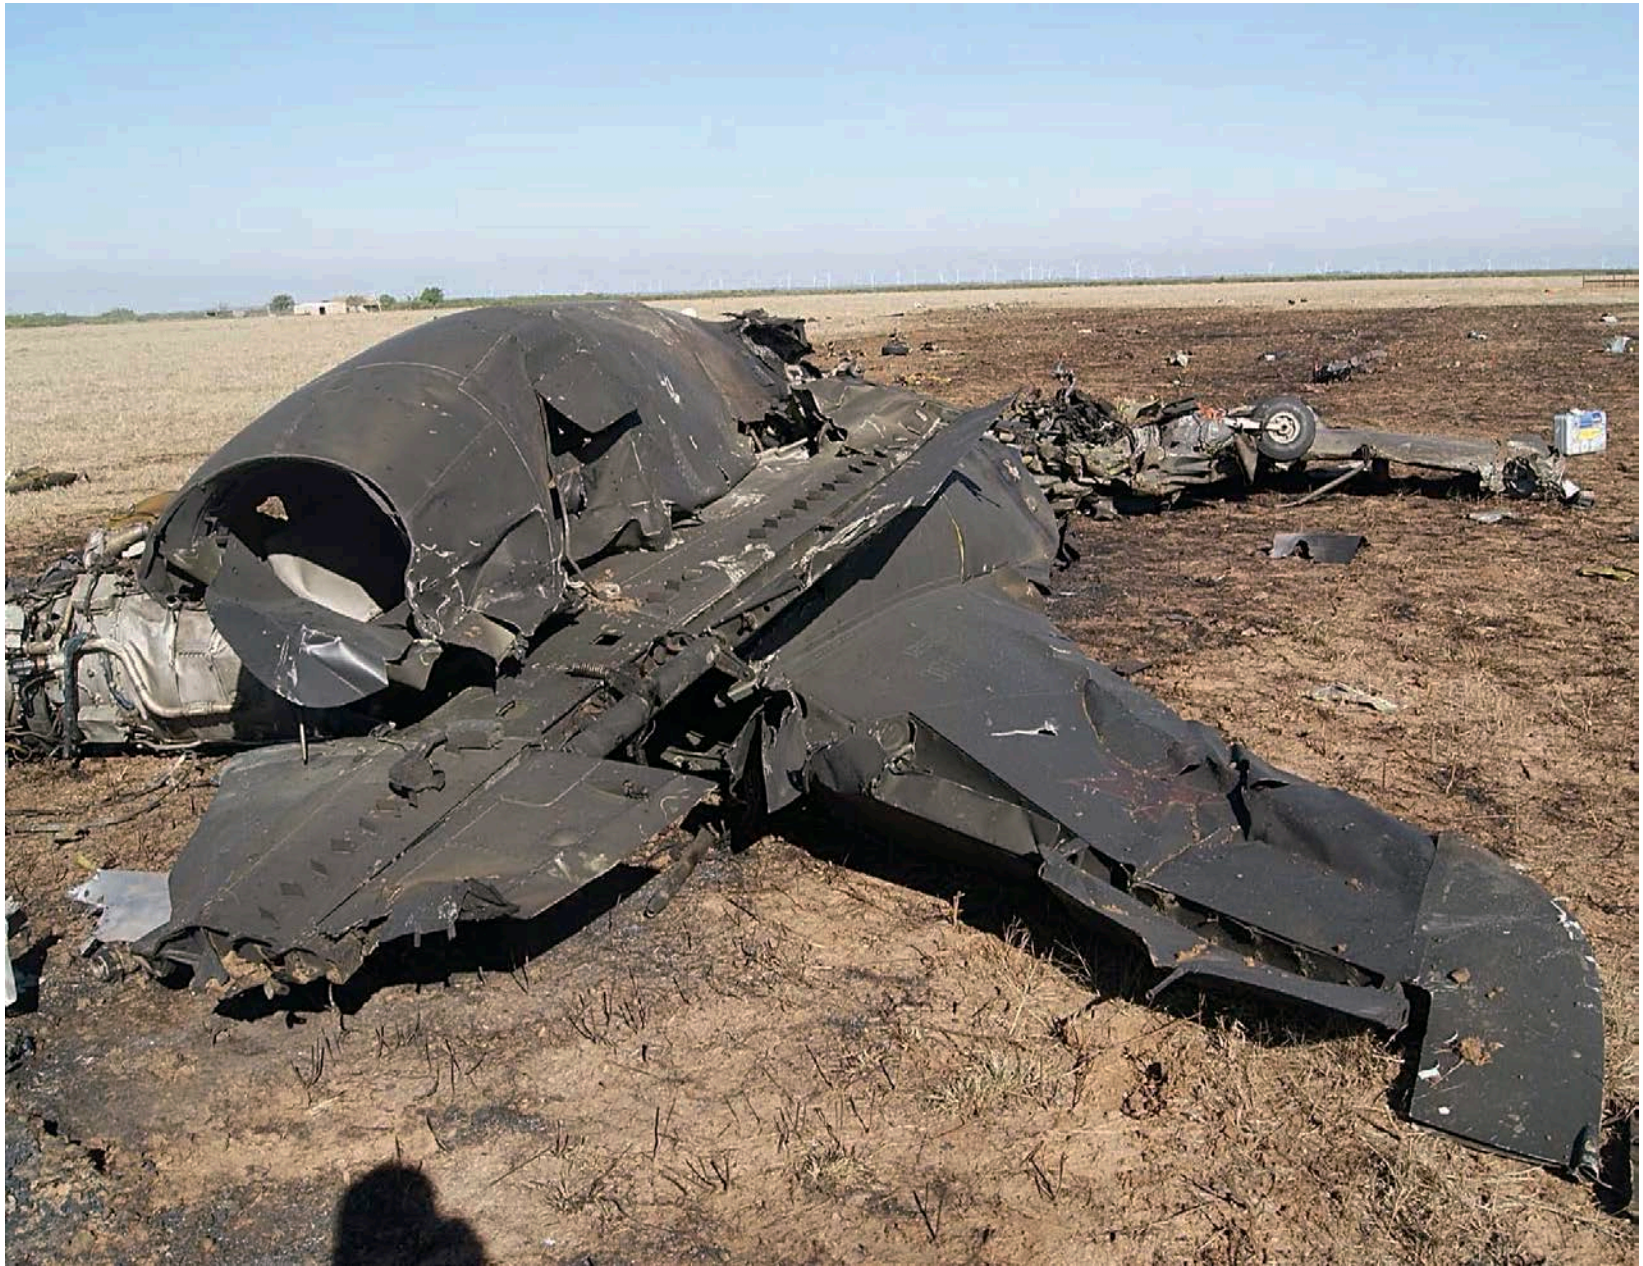
Photo 9 – Empennage and vertical stabilizer.

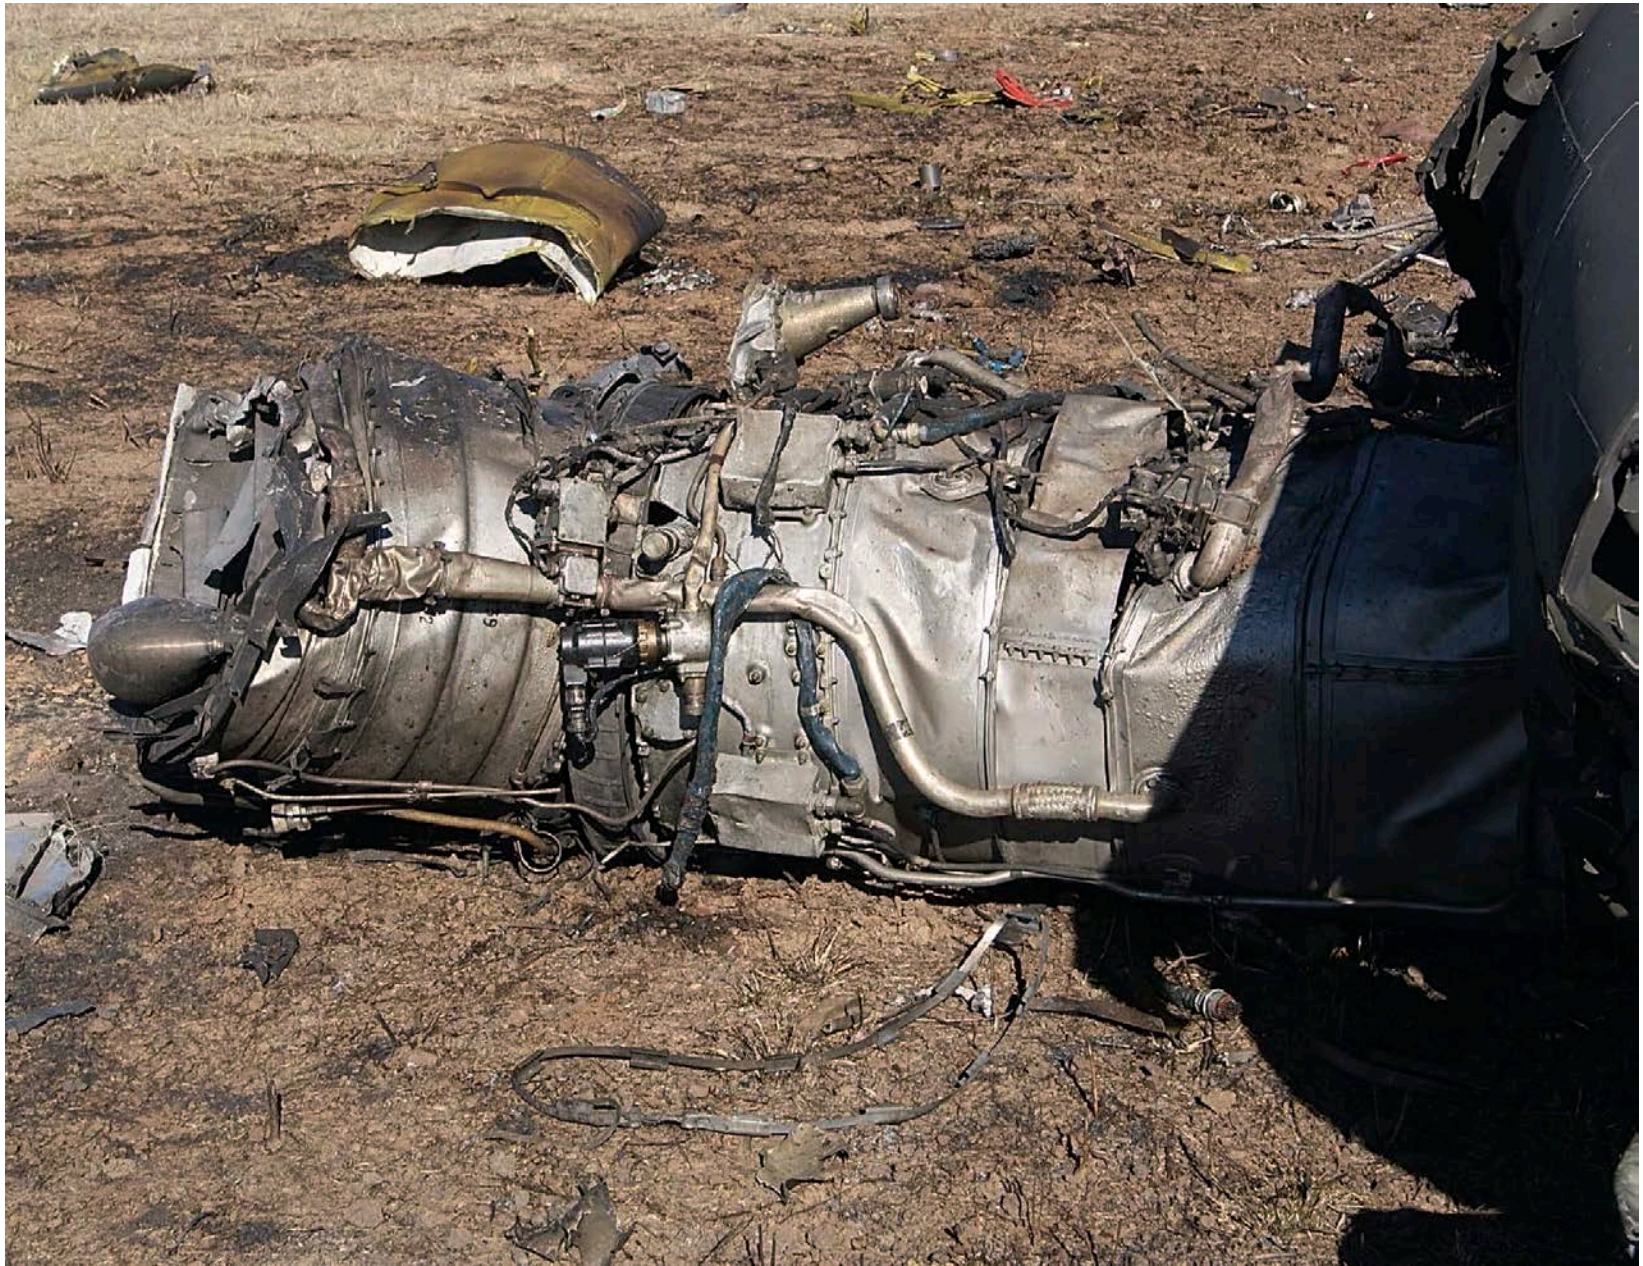
Photo 10 – The engine.
