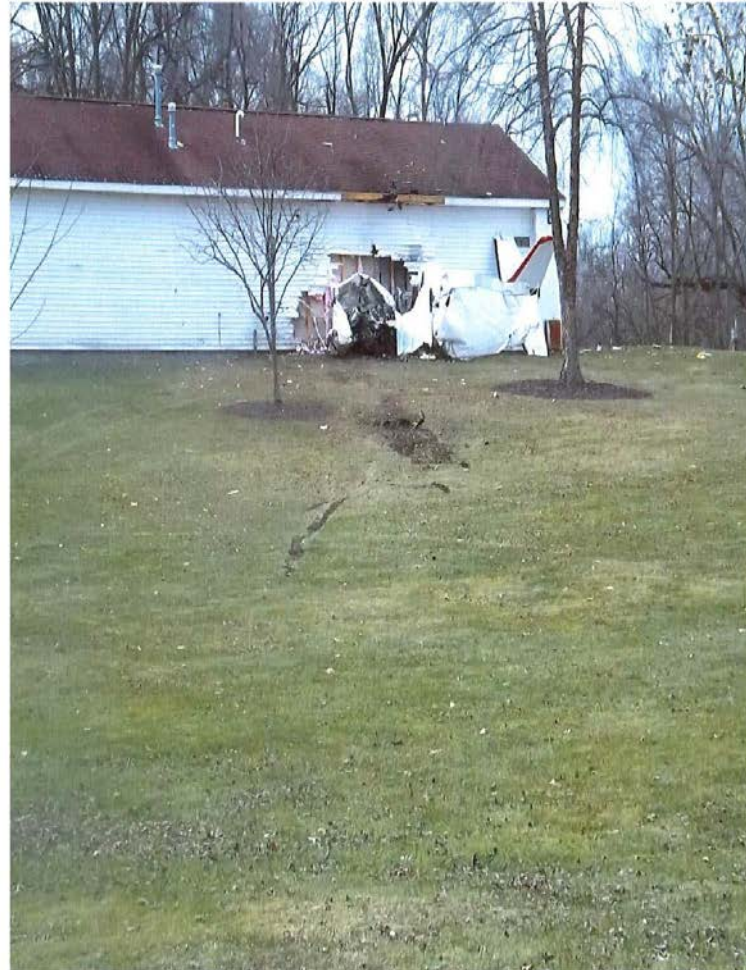
Photo 1 - Overall accident scene. Wreckage is up against building (background). Note ground skid marks.

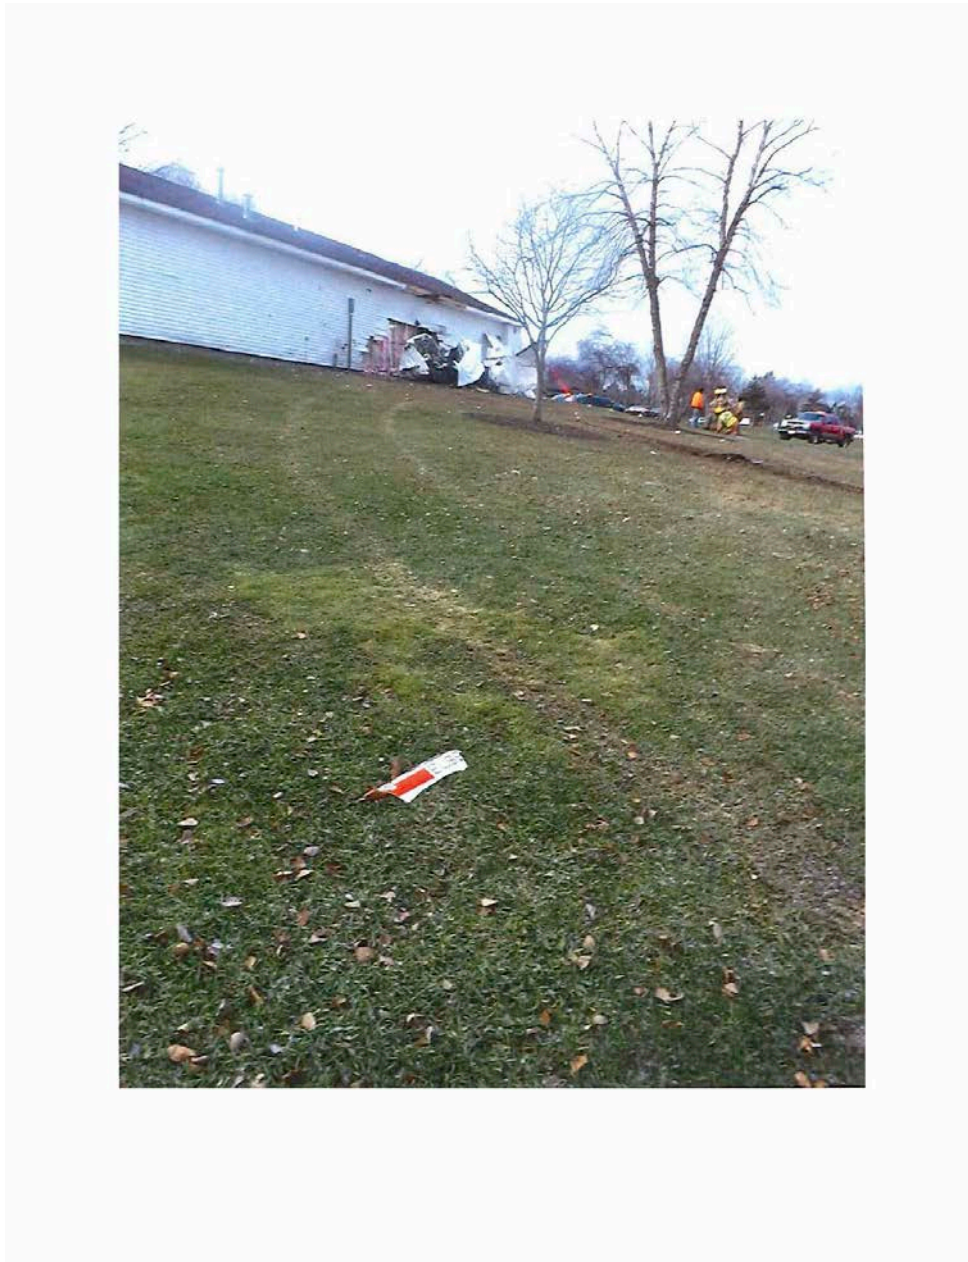
Photo 2 – Left wing tip separated when wing struck the ground.

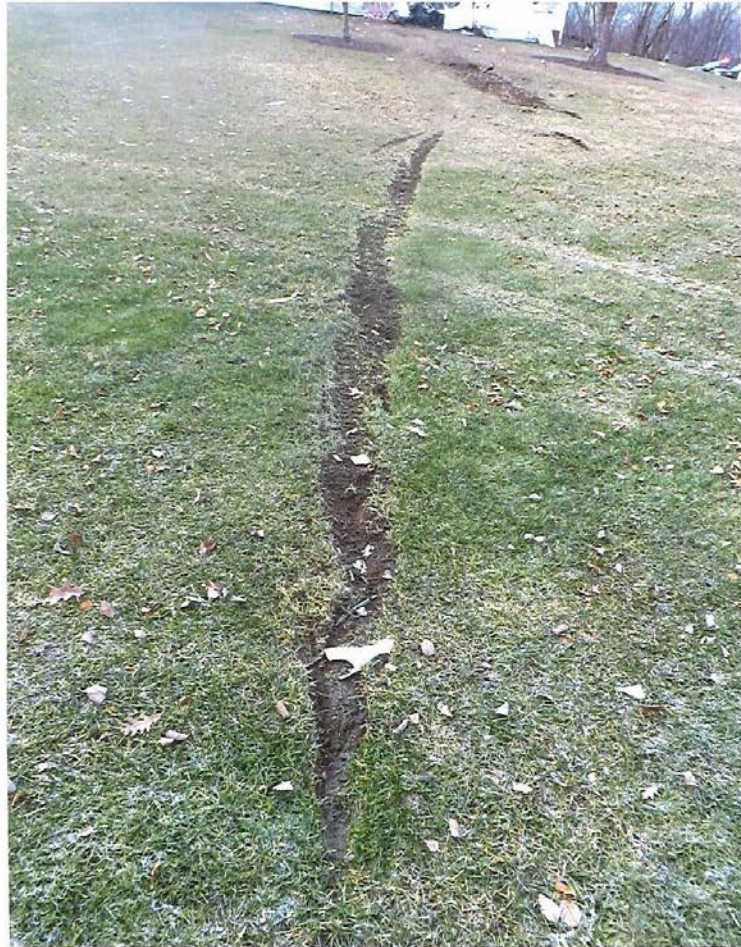
Photo 3 - Skid mark created by left wing tip contacting the ground.

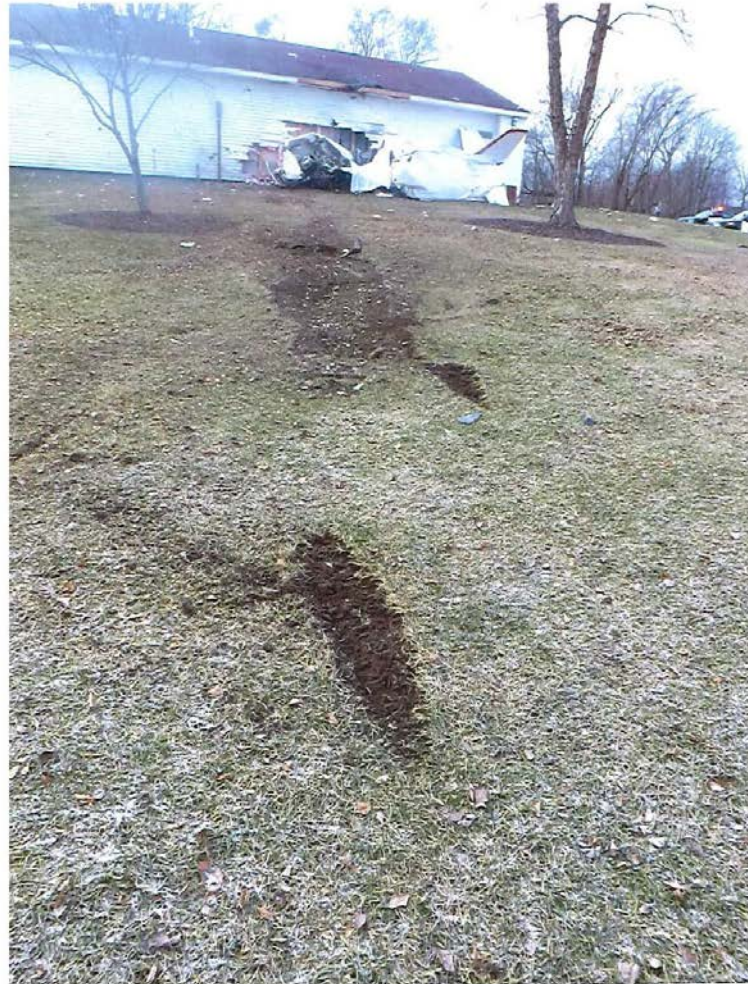
Photo 4 - Closer view of heavier skid marks.

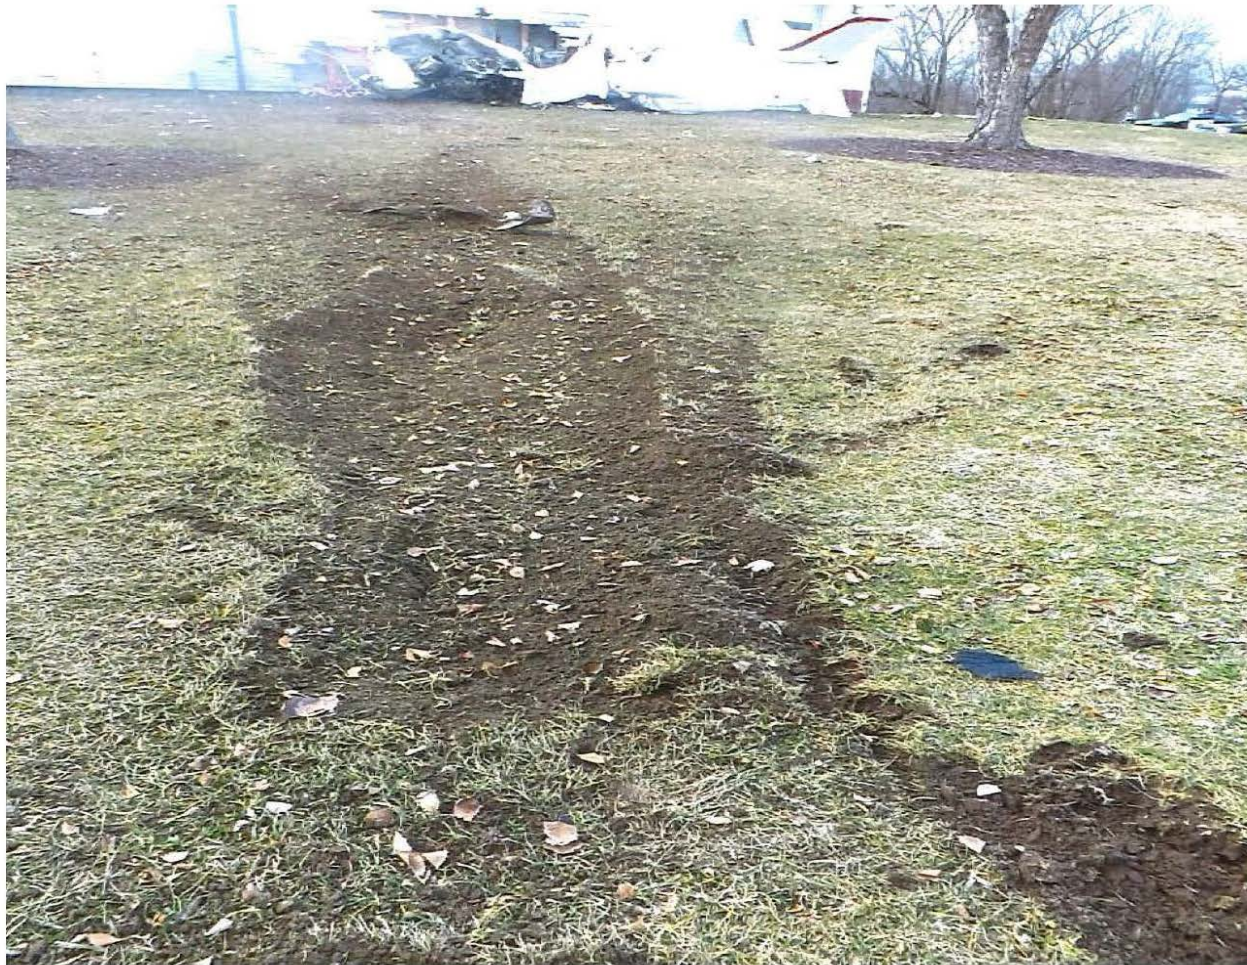
Photo 5 - Close-up view of main impact point.

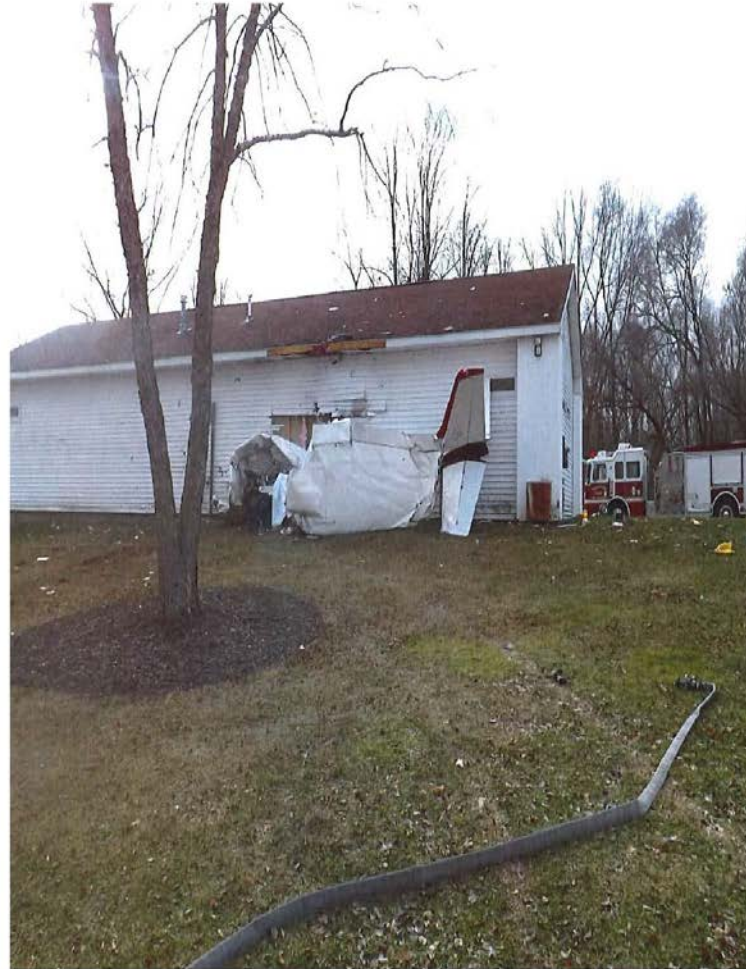
Photo 6 - N1095V rests against building.

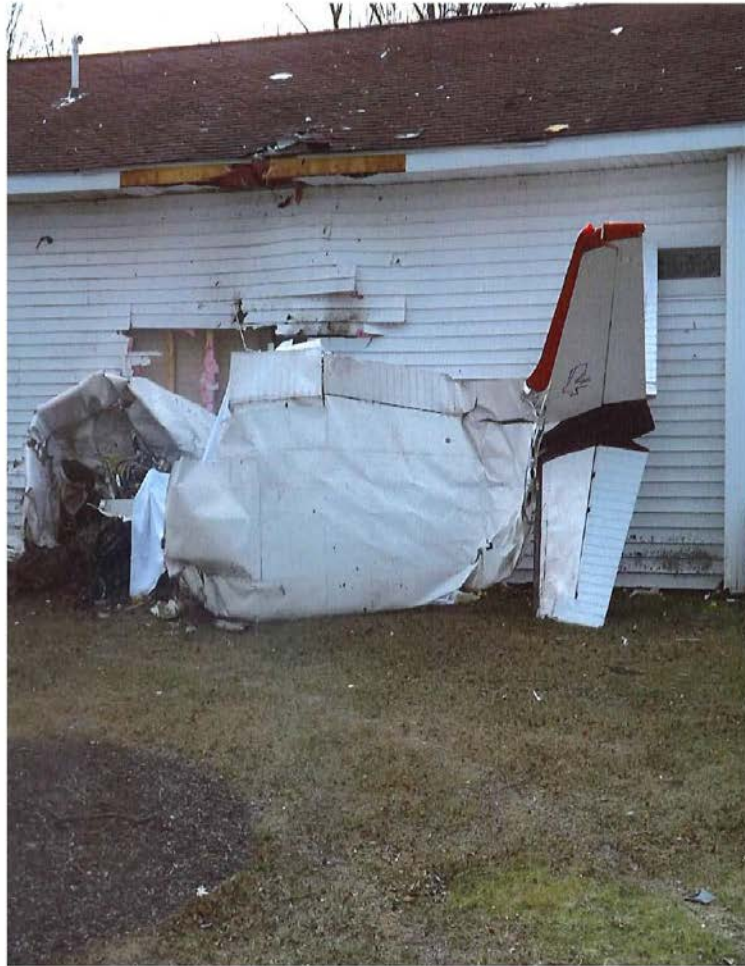
Photo 7 - Another view of N1095V.

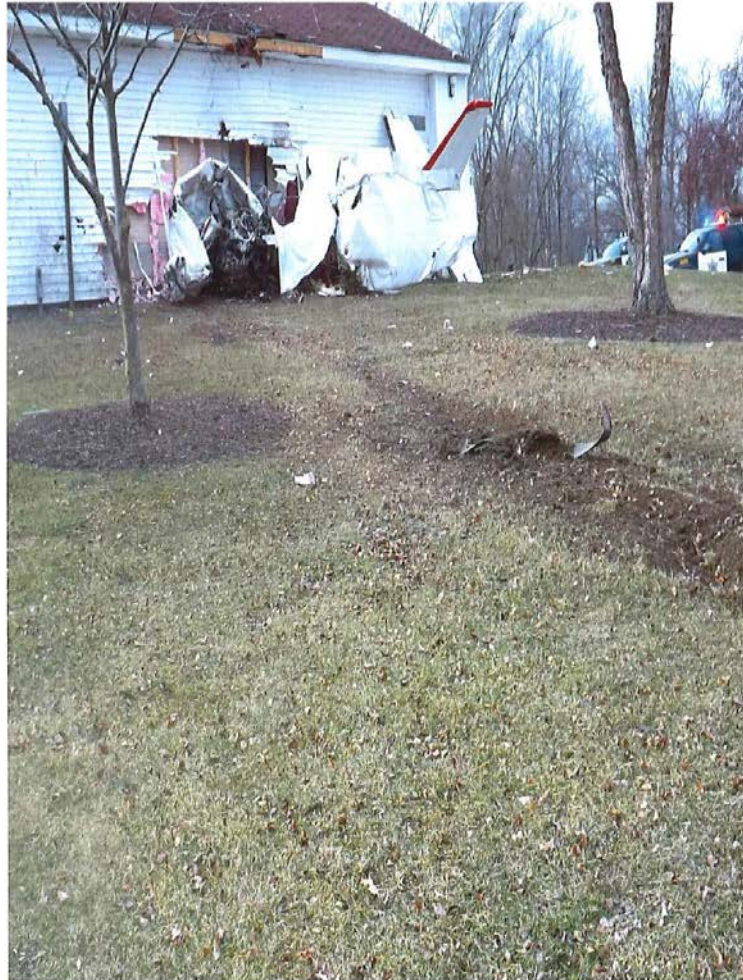
Photo 8 - The detached propeller at main impact point.

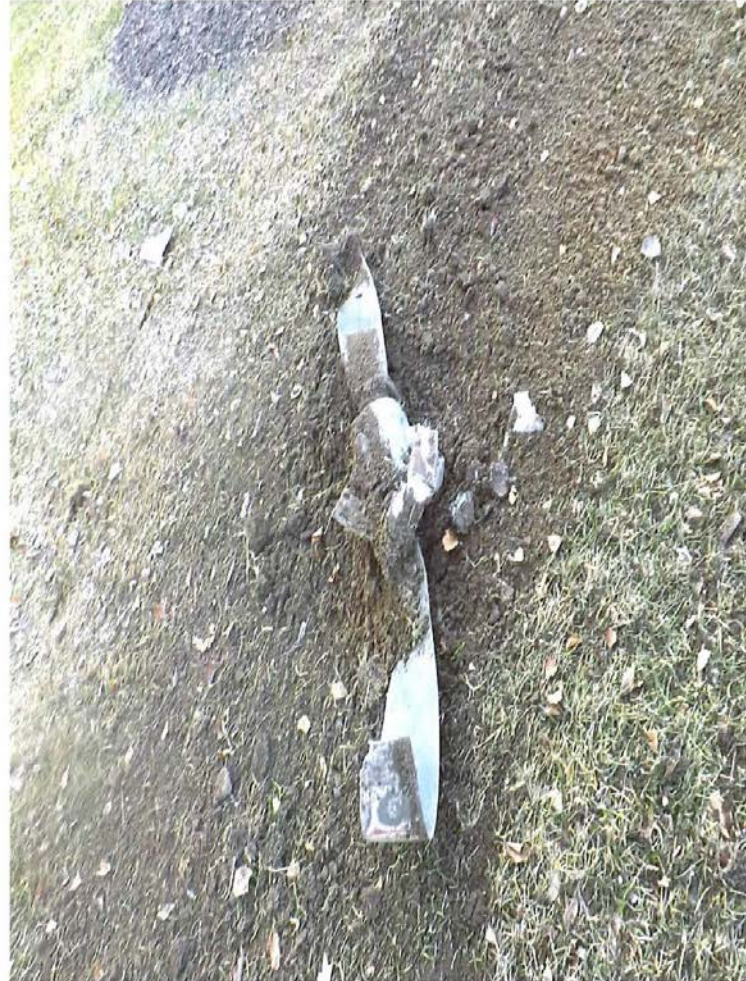
Photo 9 - Close-up view of the detached propeller.

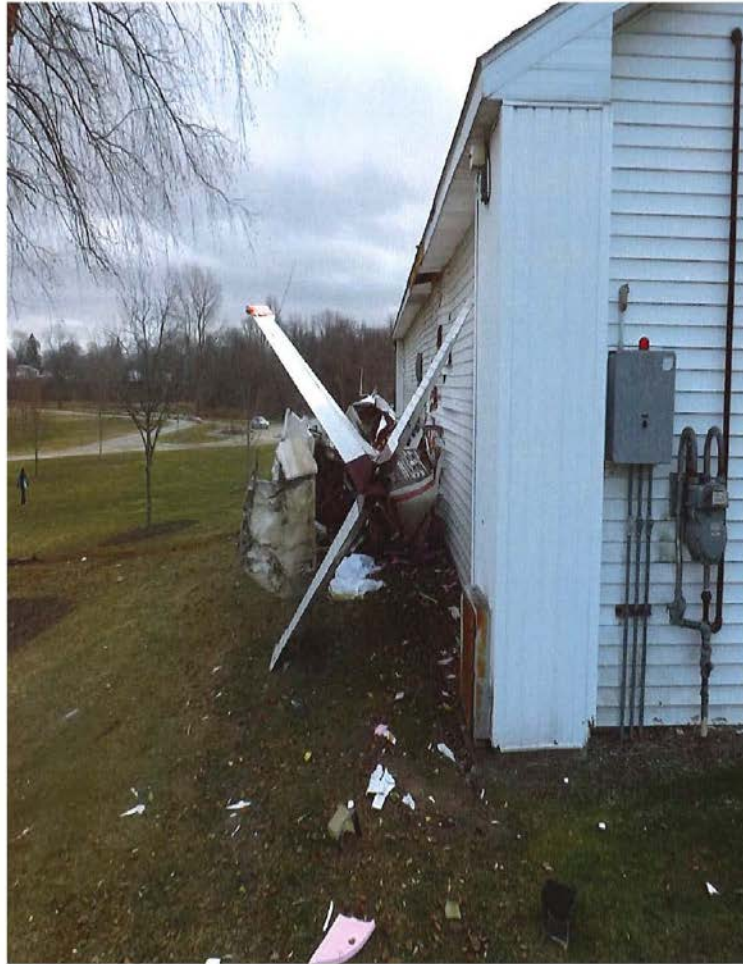
Photo 10 - Rear view of N1095V.

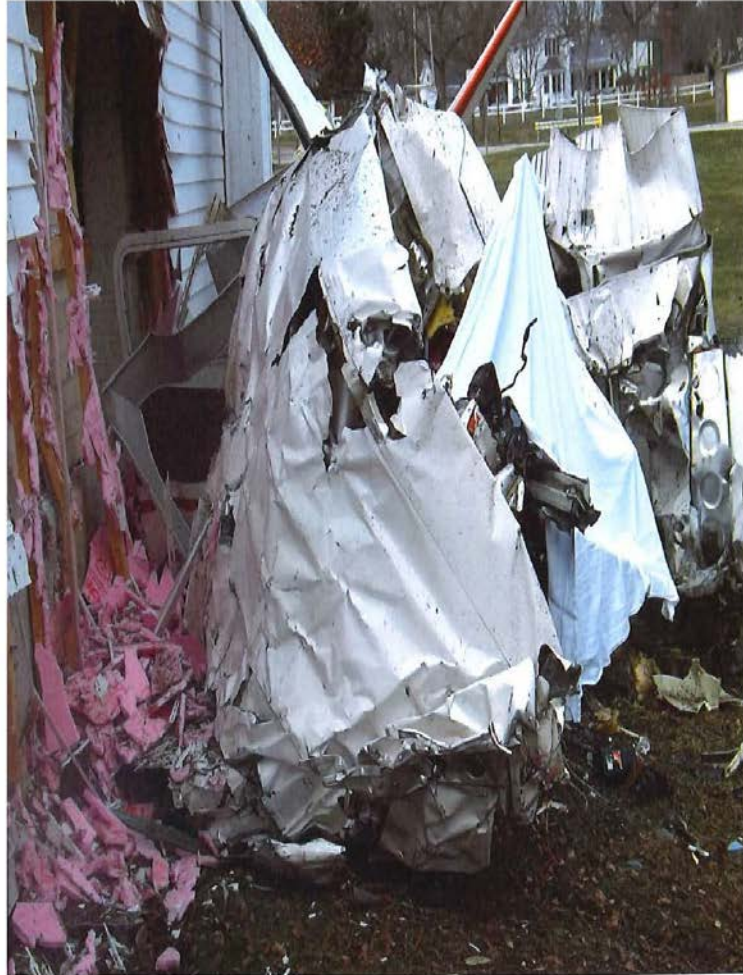
Photo 11 - Frontal view of N1095V.
