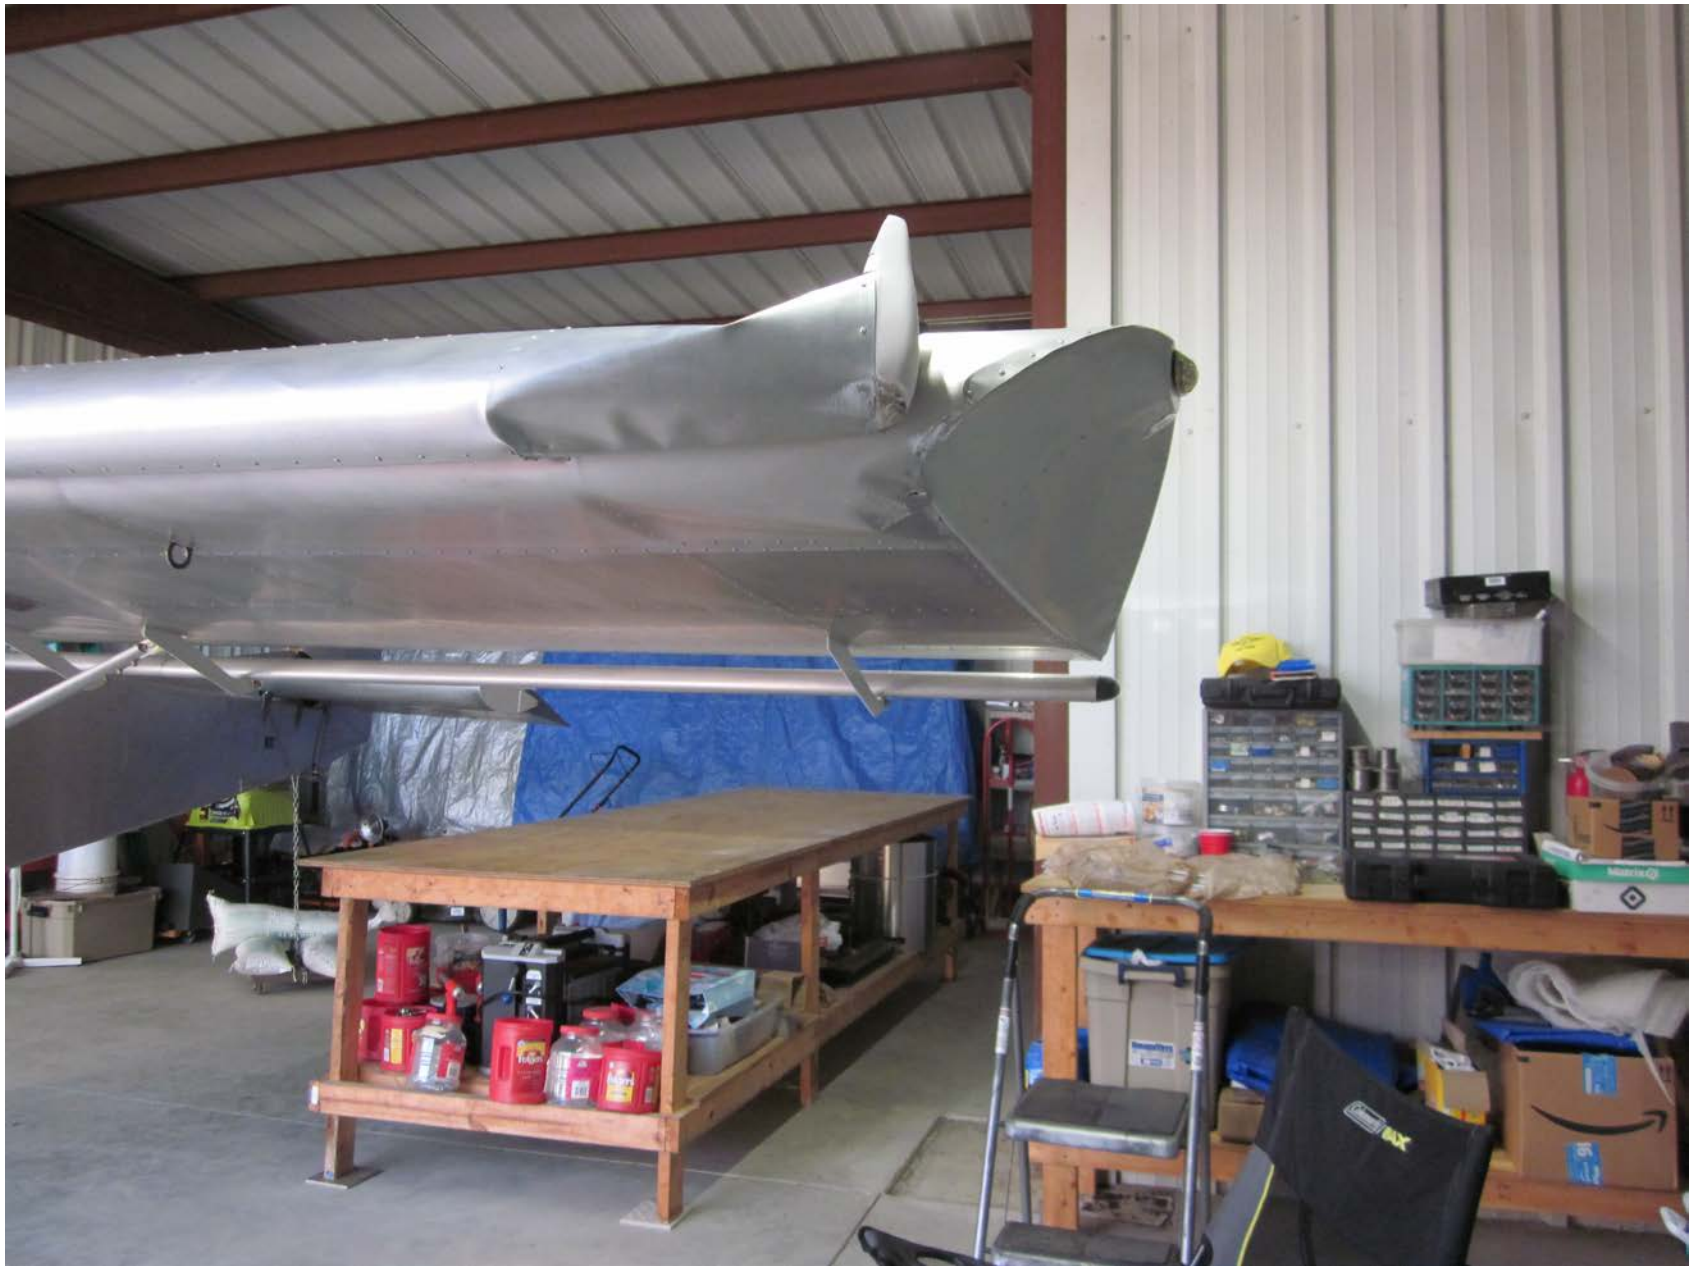
**Photo 1 – Left wing tip damage (FAA photo)**

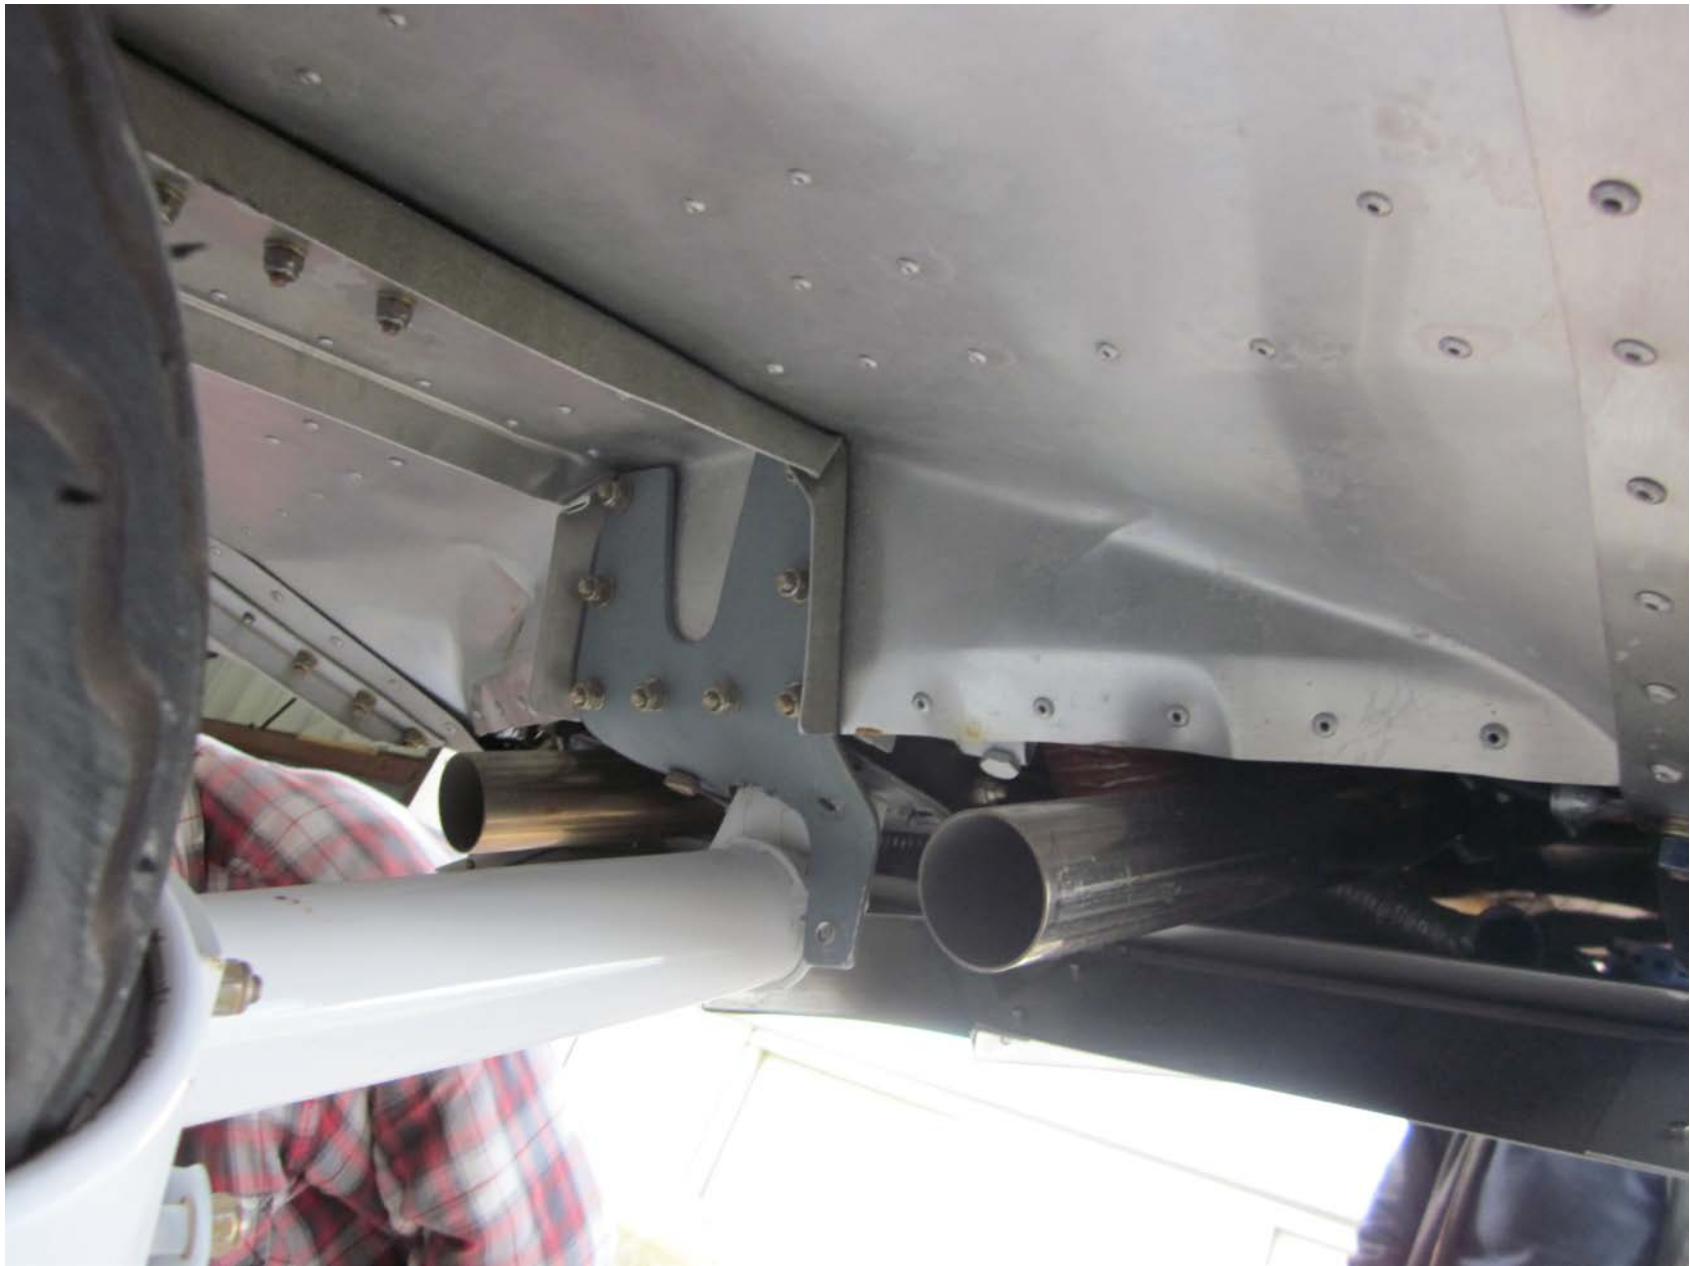
**Photo 2 - Nose landing gear folded the “U” channel is supposed to be strait not a 90 degree bend (FAA photo)**

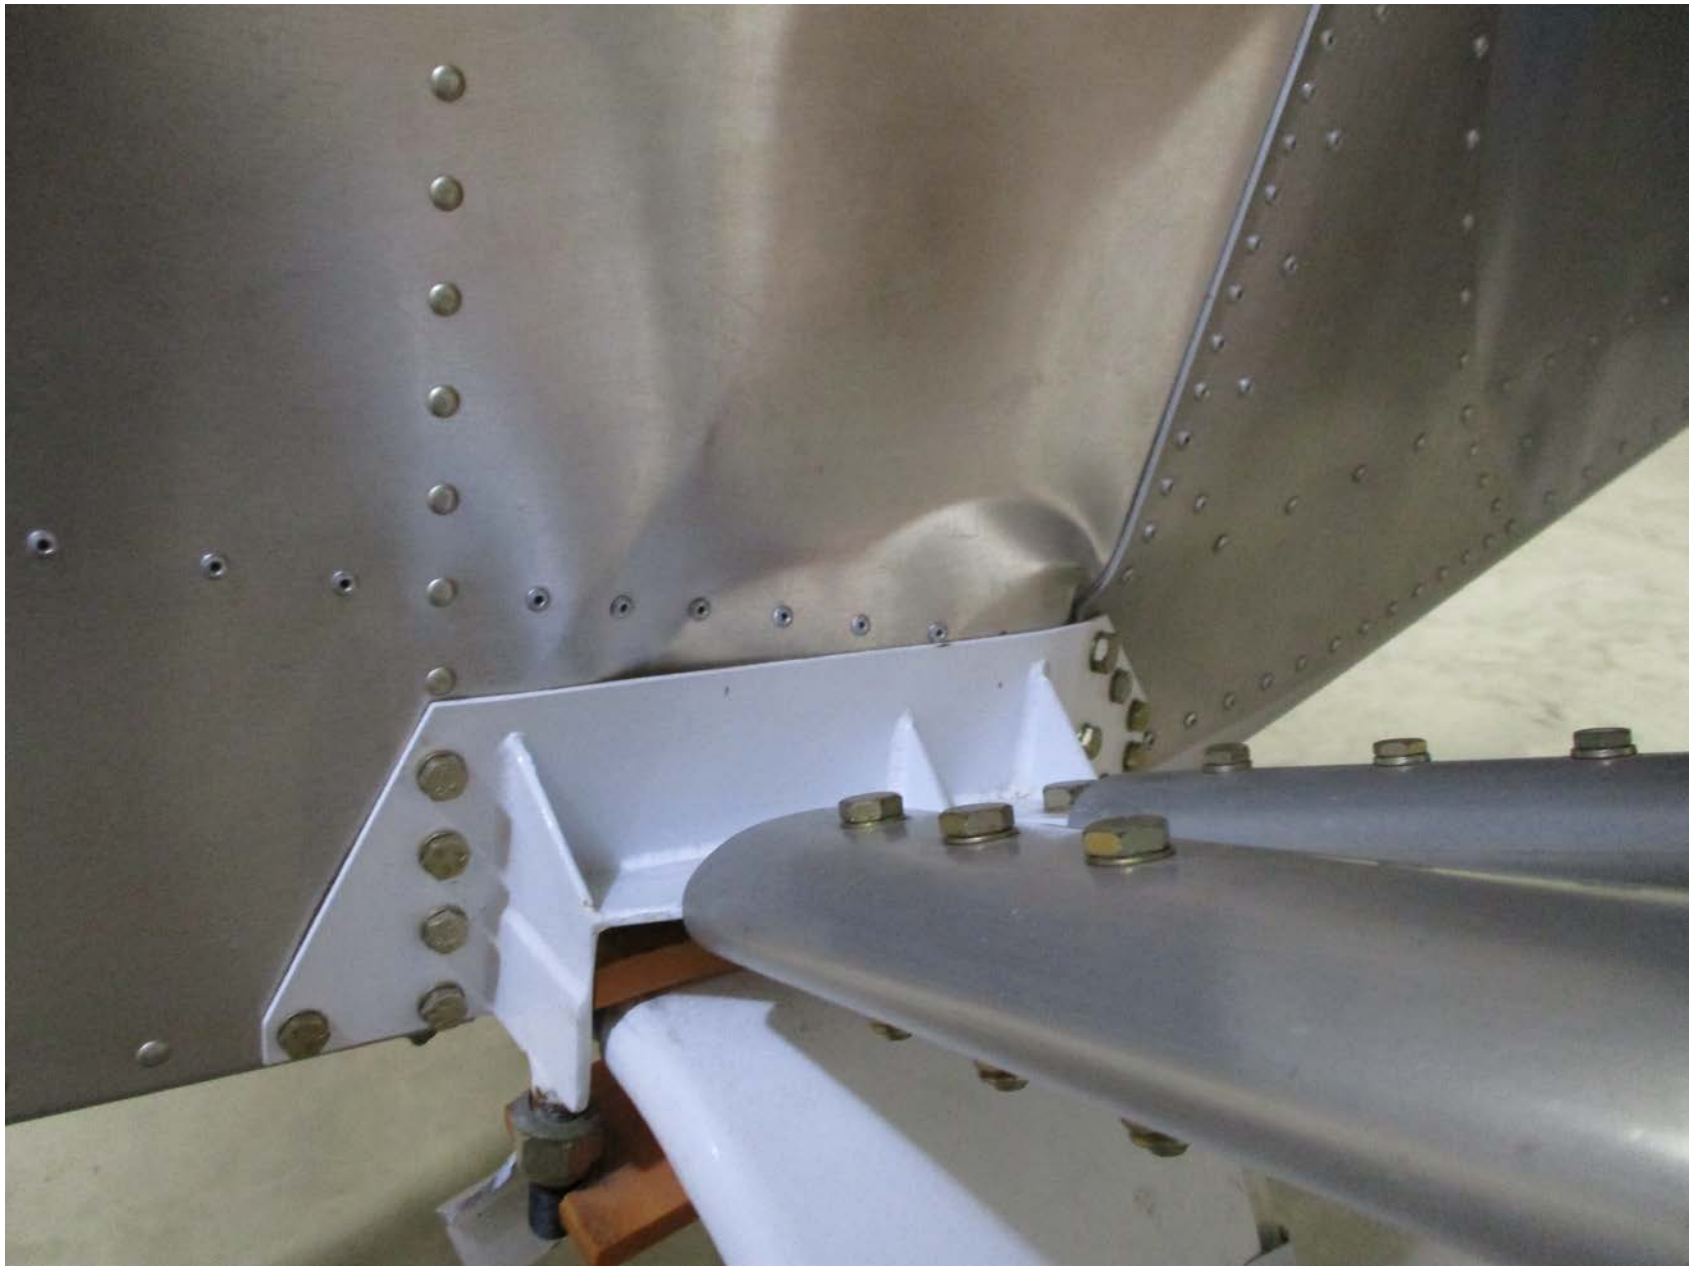
**Photo 3 - Left wing strut attachment point. Note skin buckling (FAA photo)**

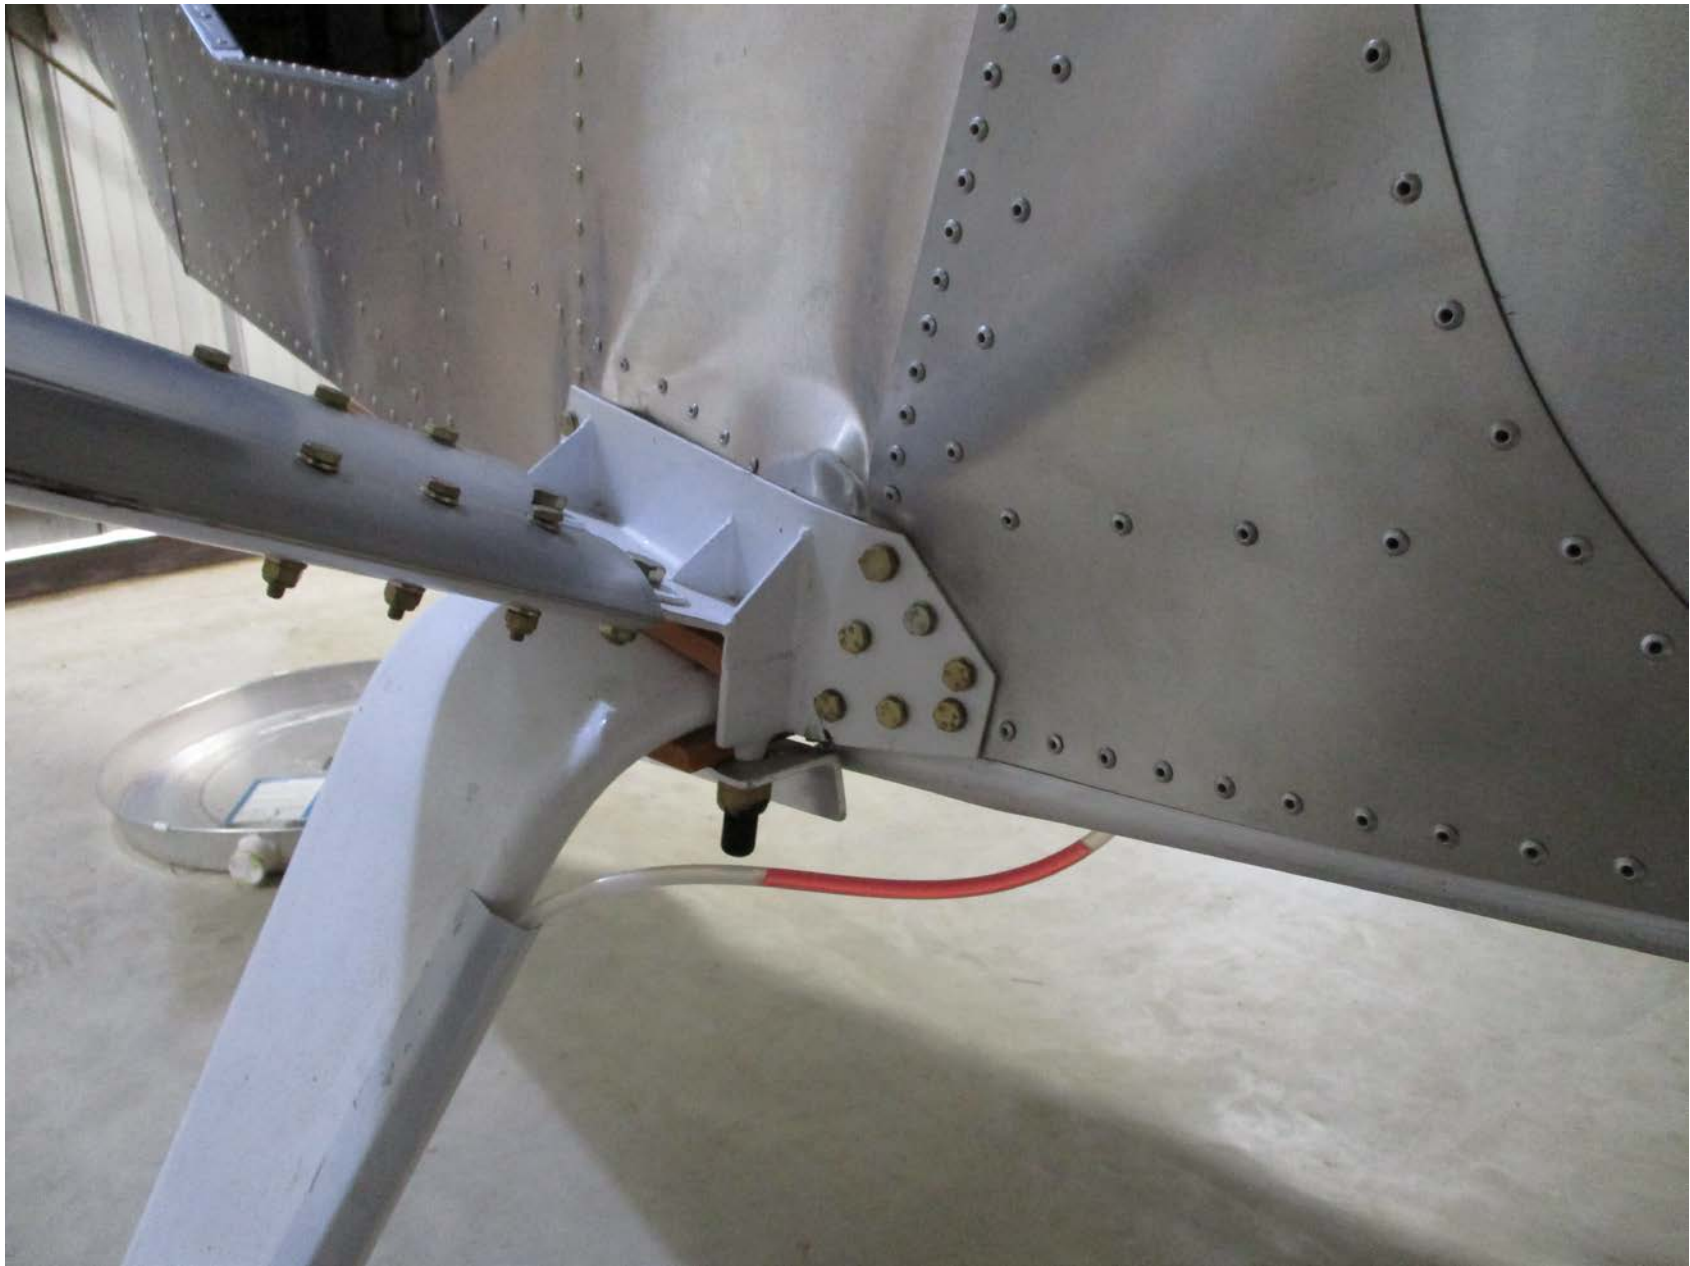
**Photo 4 – Left main landing gear and wing strut attachment. Note skin buckling (FAA photo)**
