Photo 1 – Pre-accident photo of N60RK, a Beech 60 Duke.

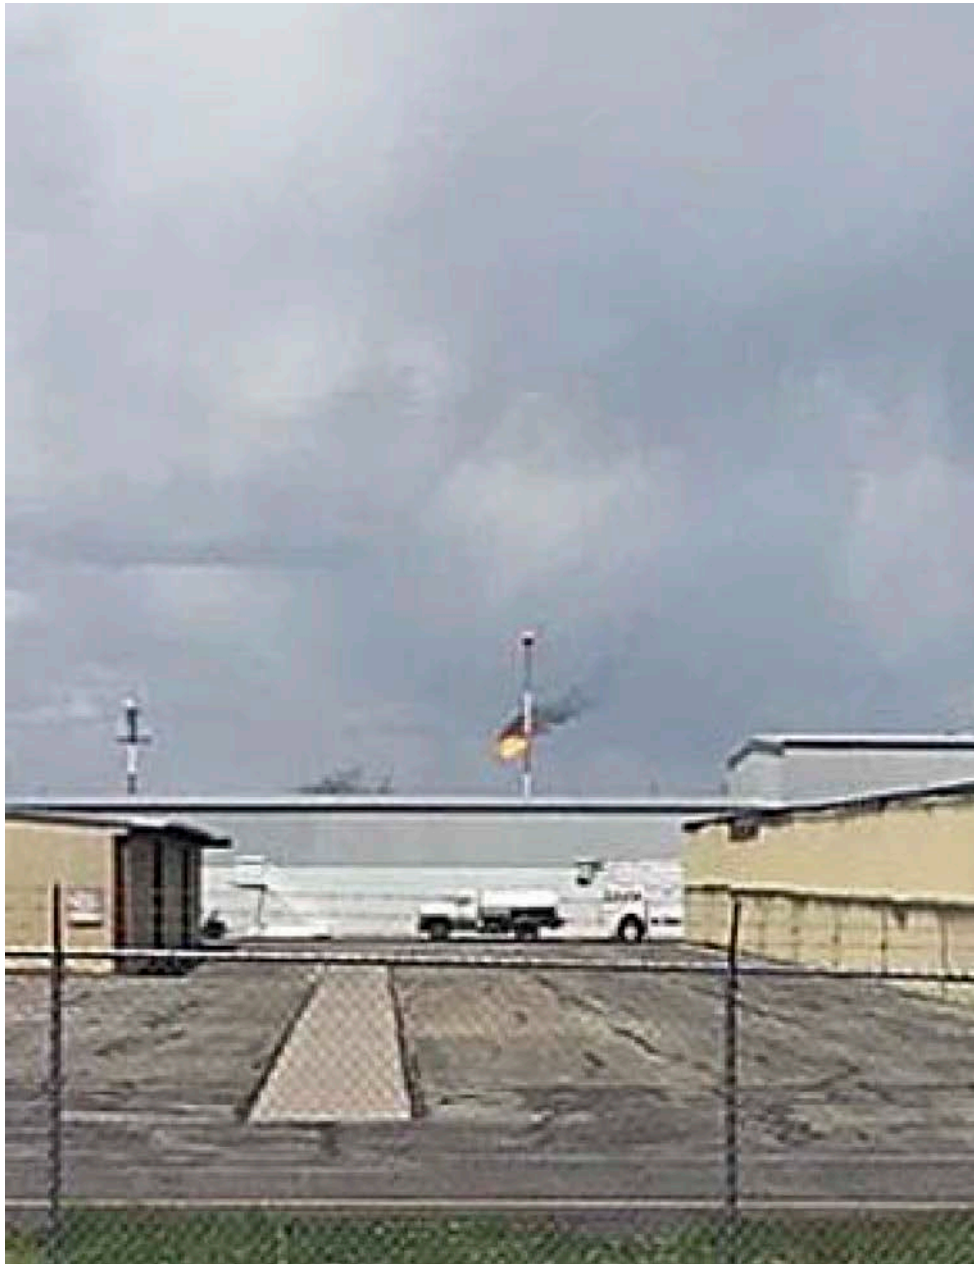
Photo 2 – N60RK, uncontrollable descent, on fire, in flight.

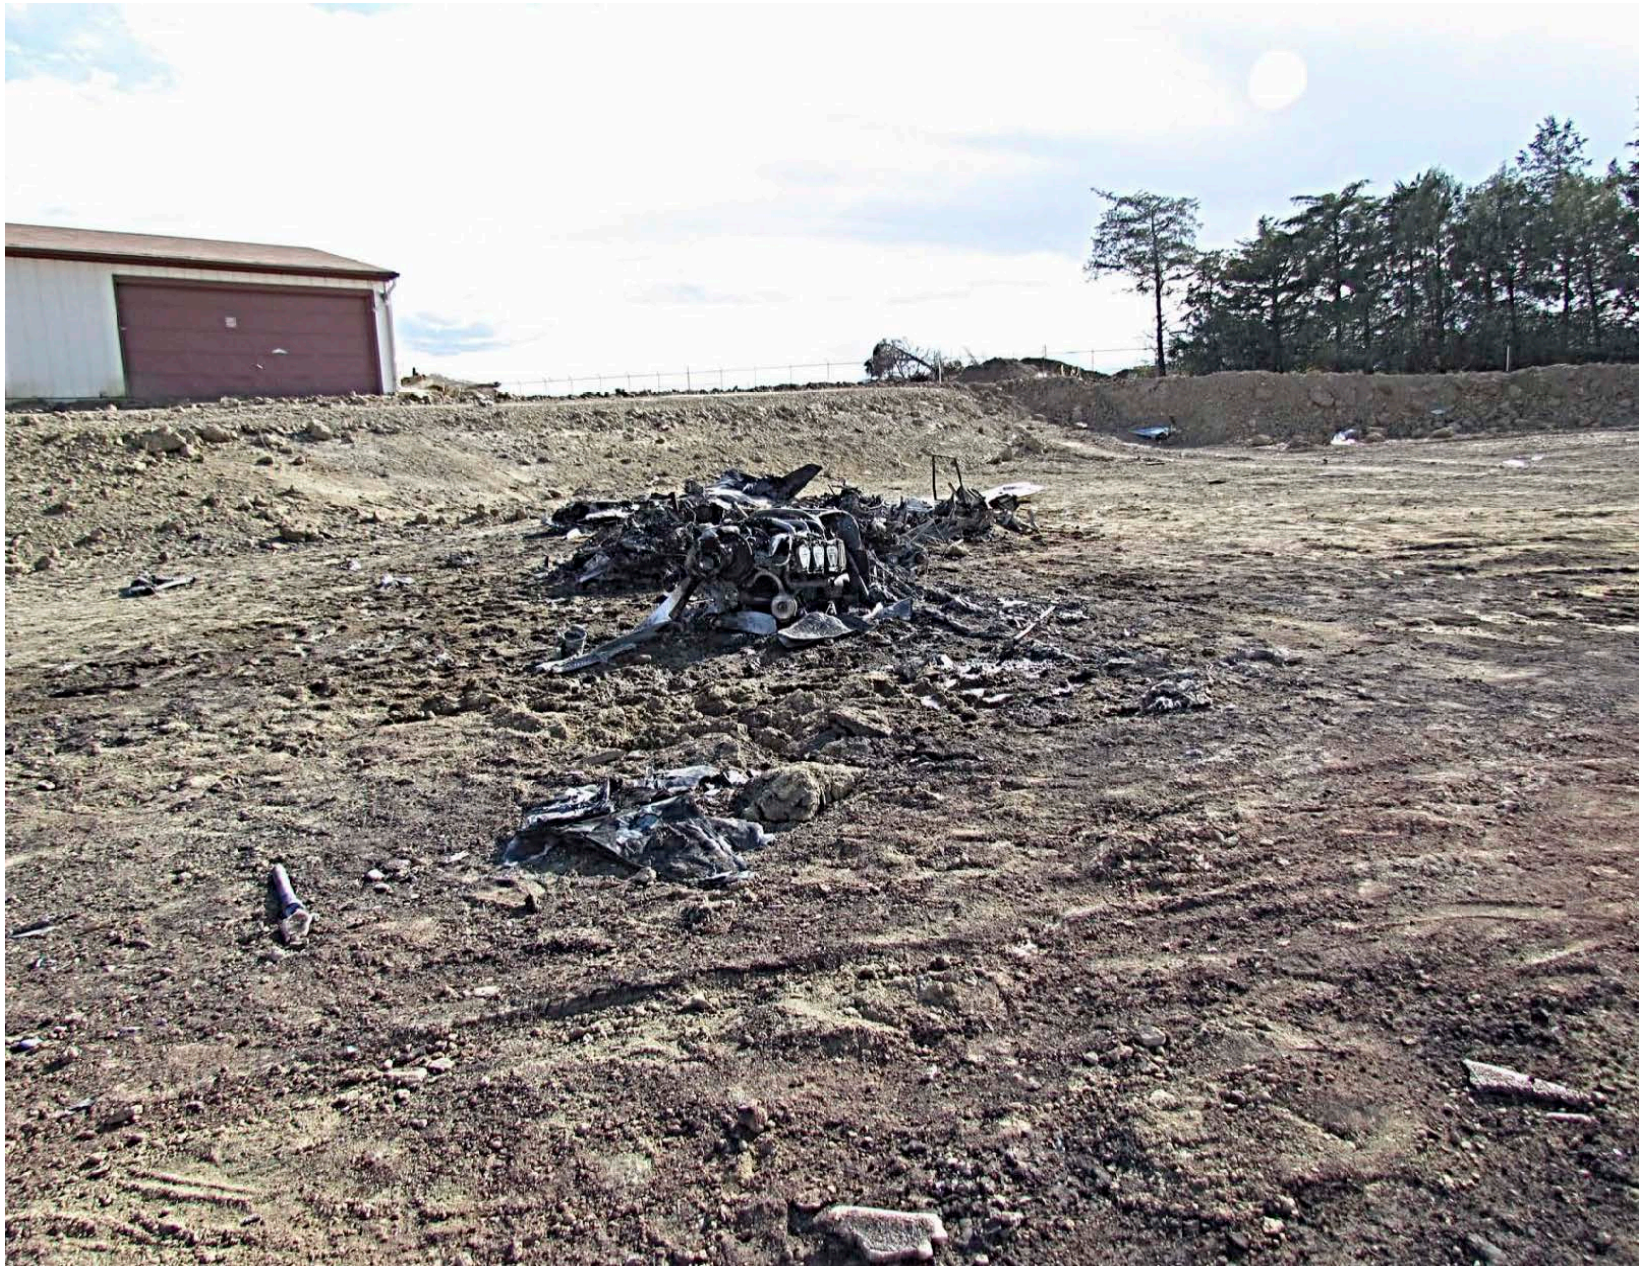
Photo 3 – The overall accident scene.

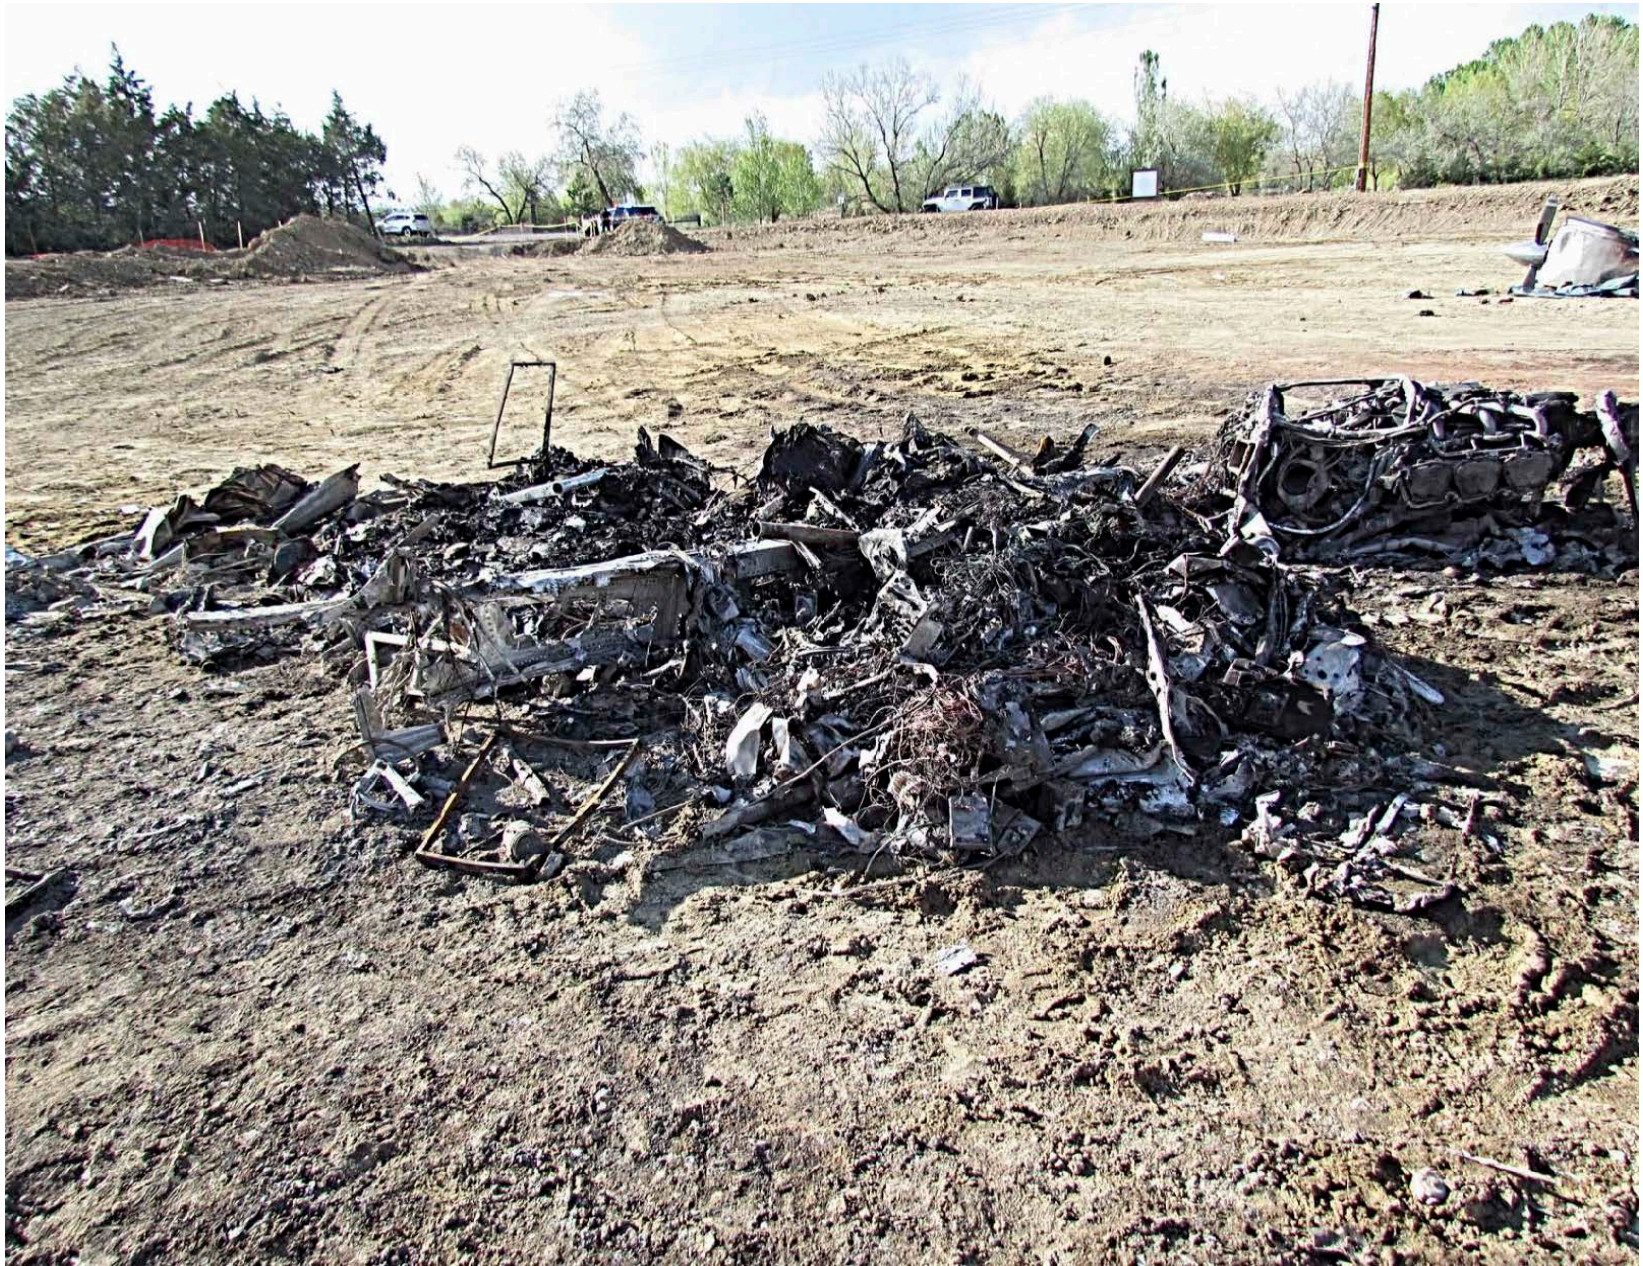
Photo 4 – Overall view of the wreckage.

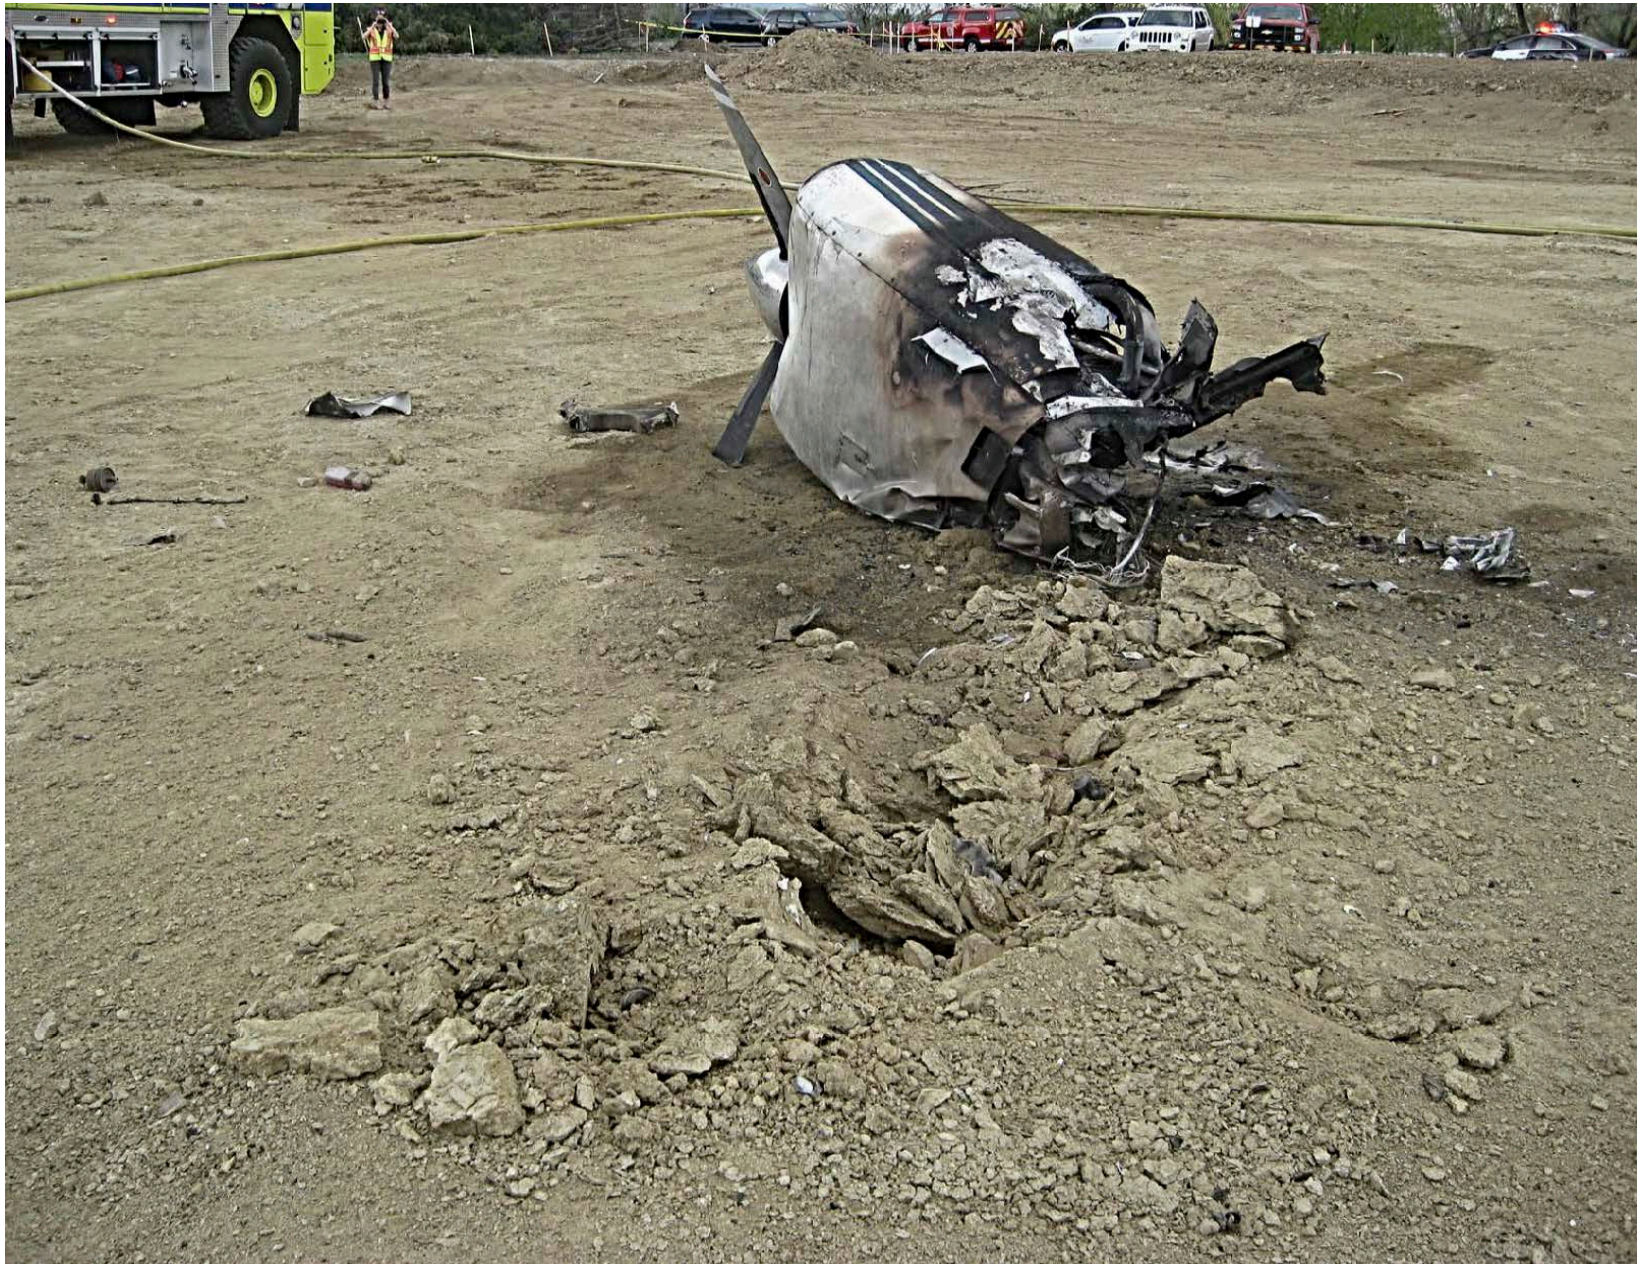
Photo 5 – The right engine and impact marks.

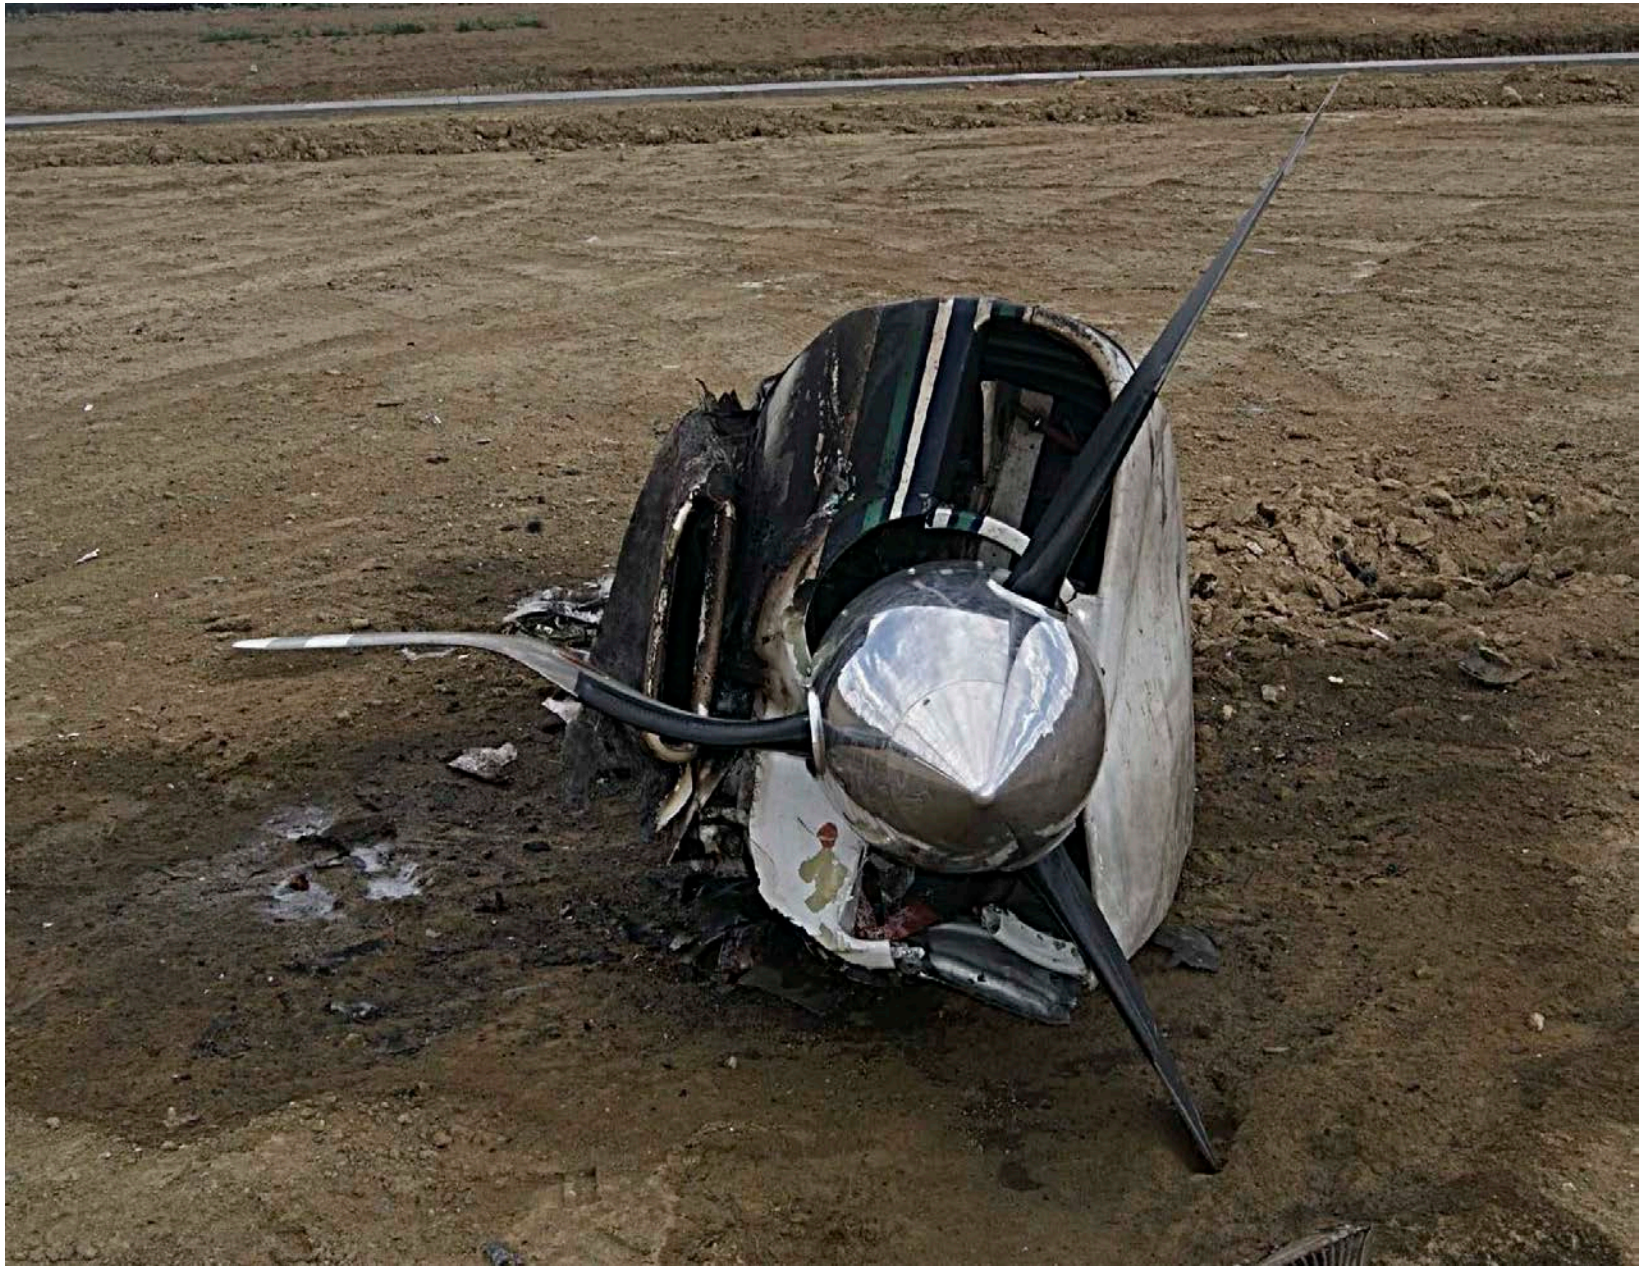
Photo 6 – The right engine. Note propeller is feathered.

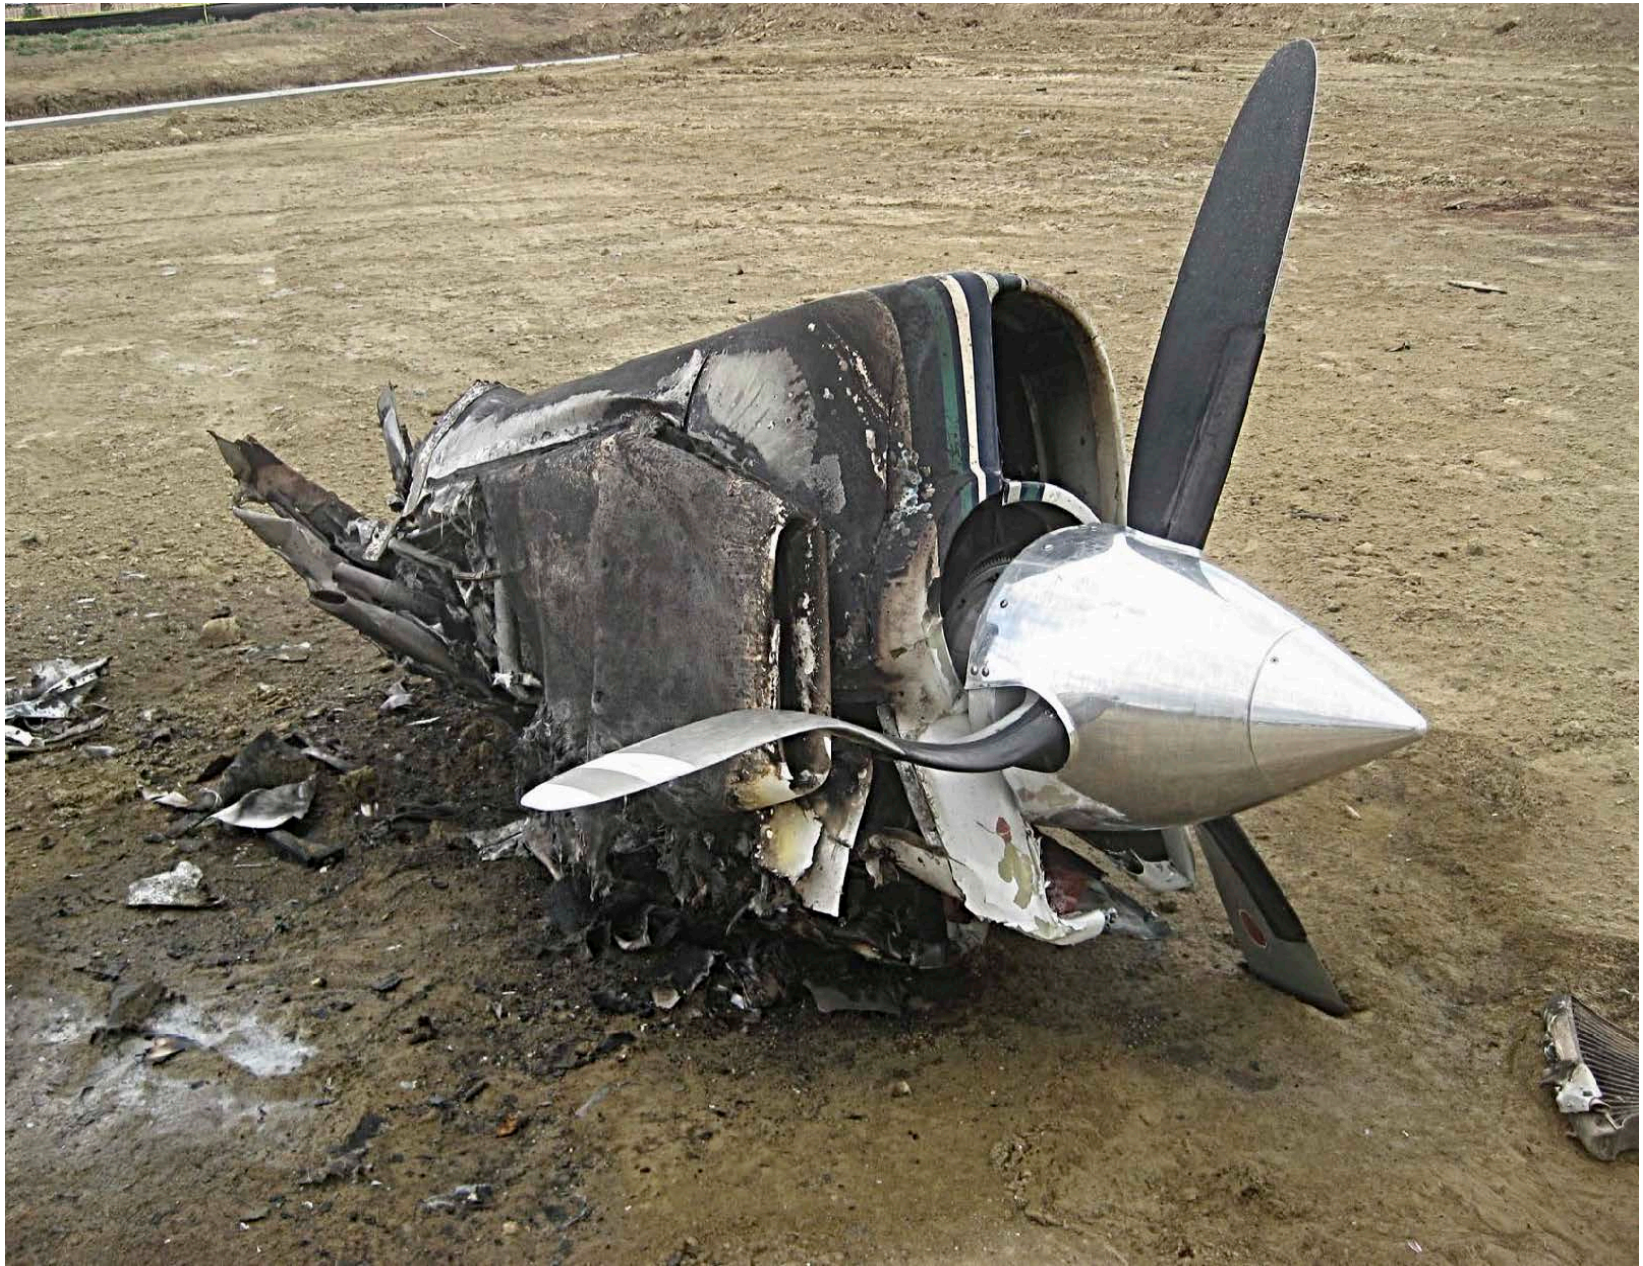
Photo 7 – Thermal damage to underside of right engine nacelle.

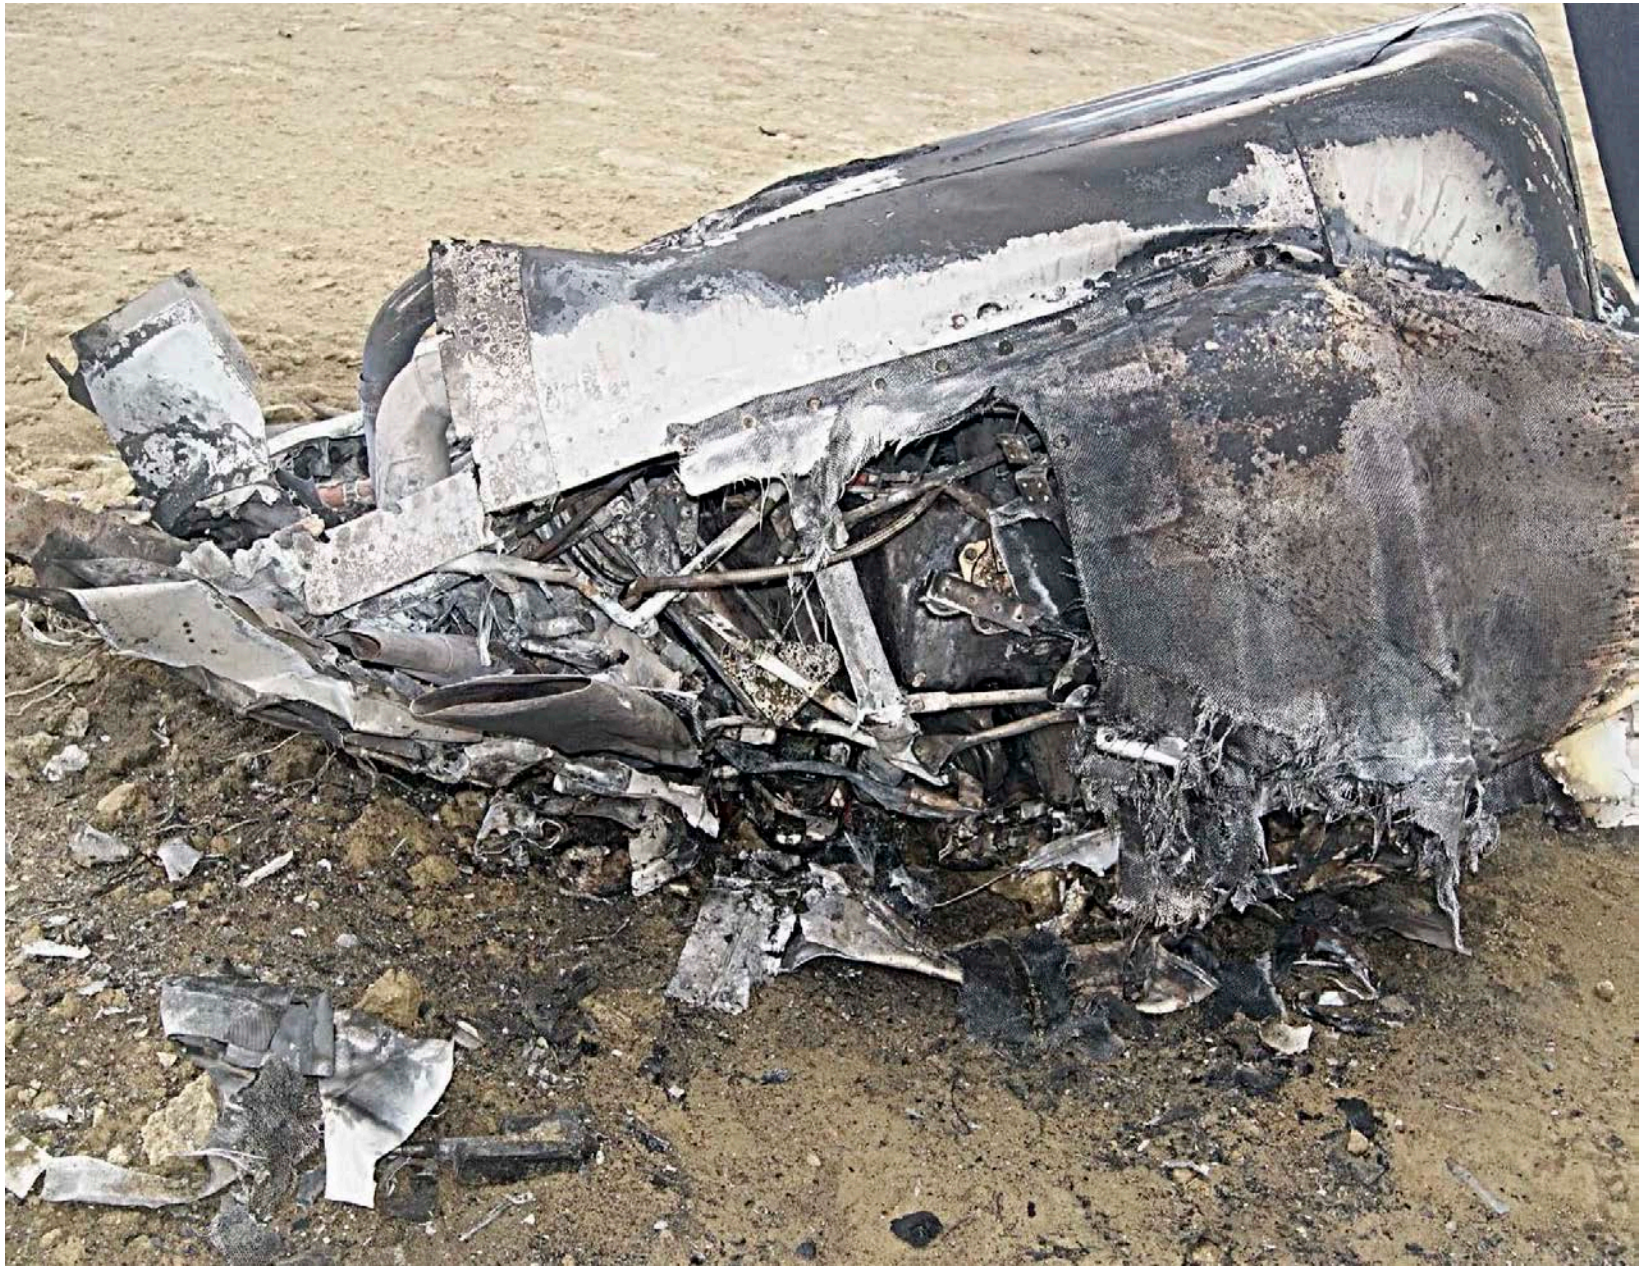
Photo 8 – Thermal damage to right rear area of right engine.

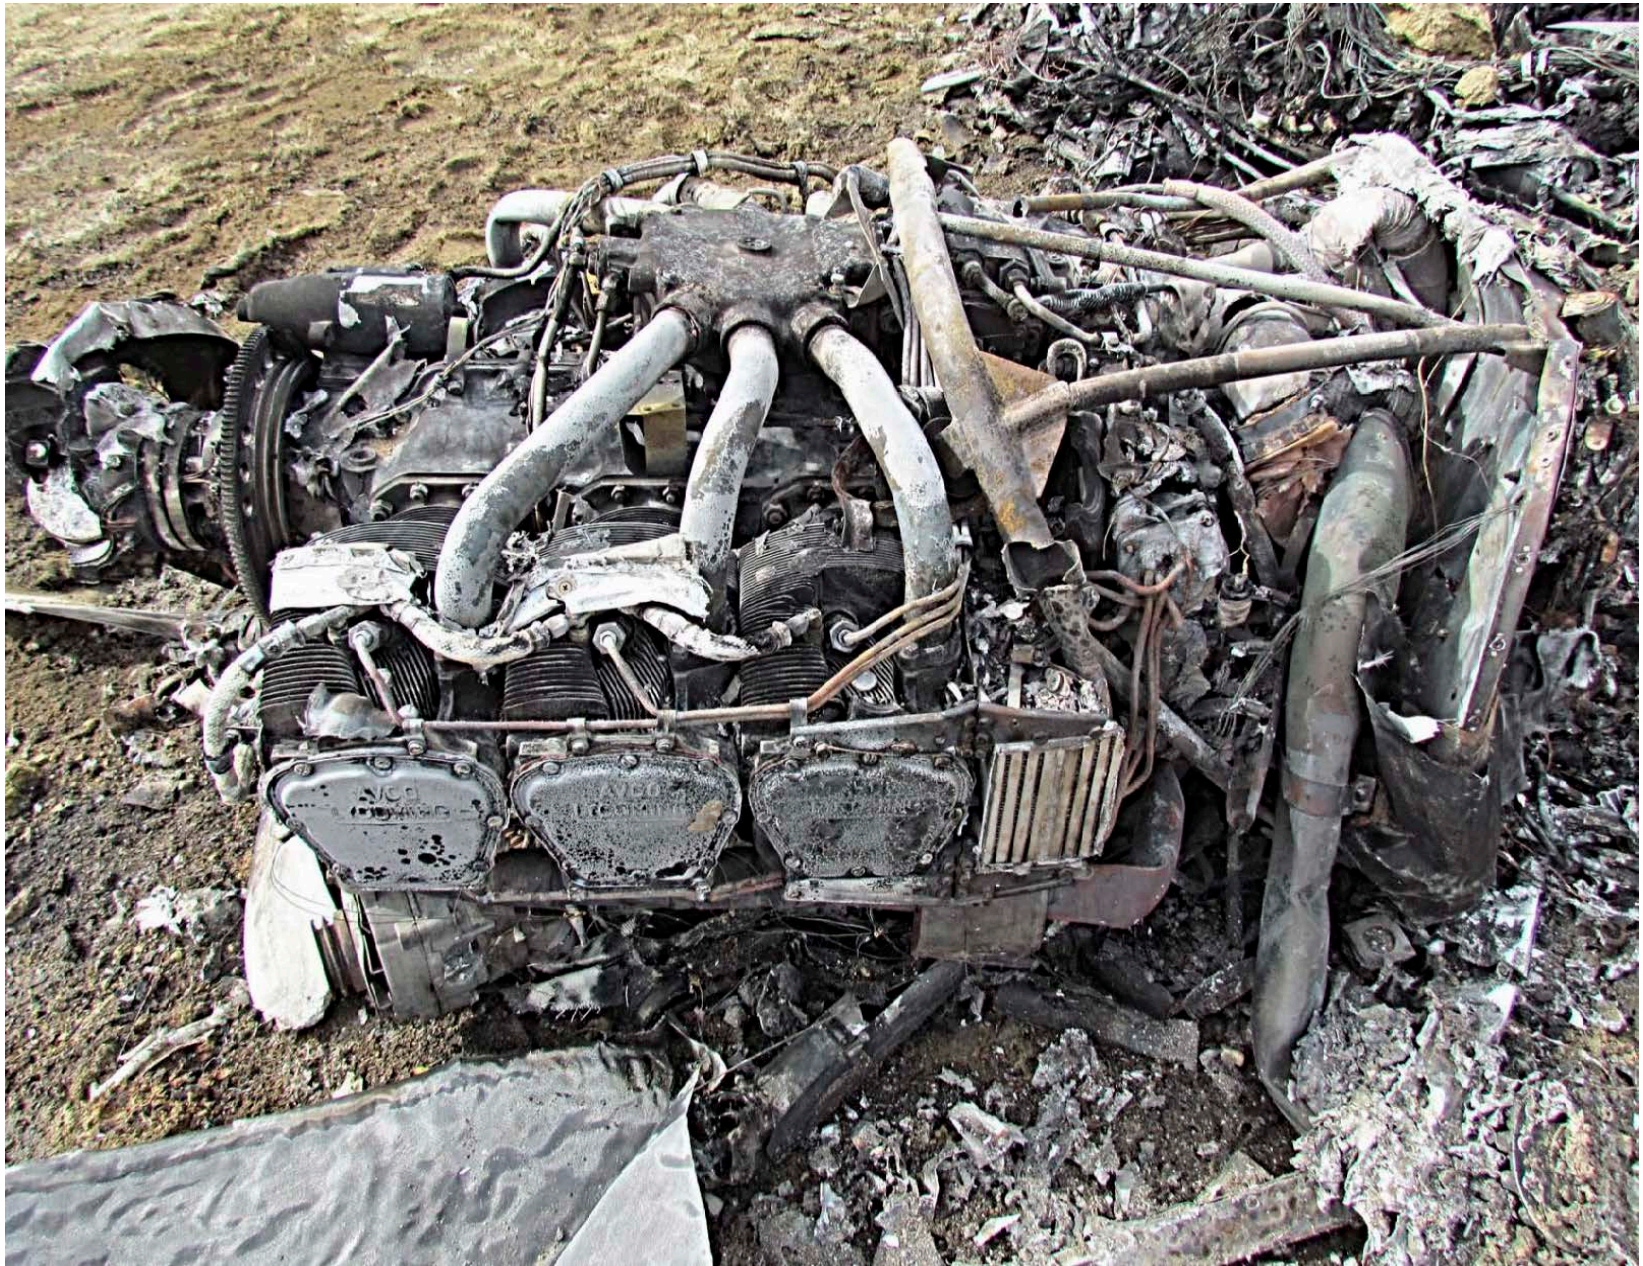
Photo 9 – The left engine.

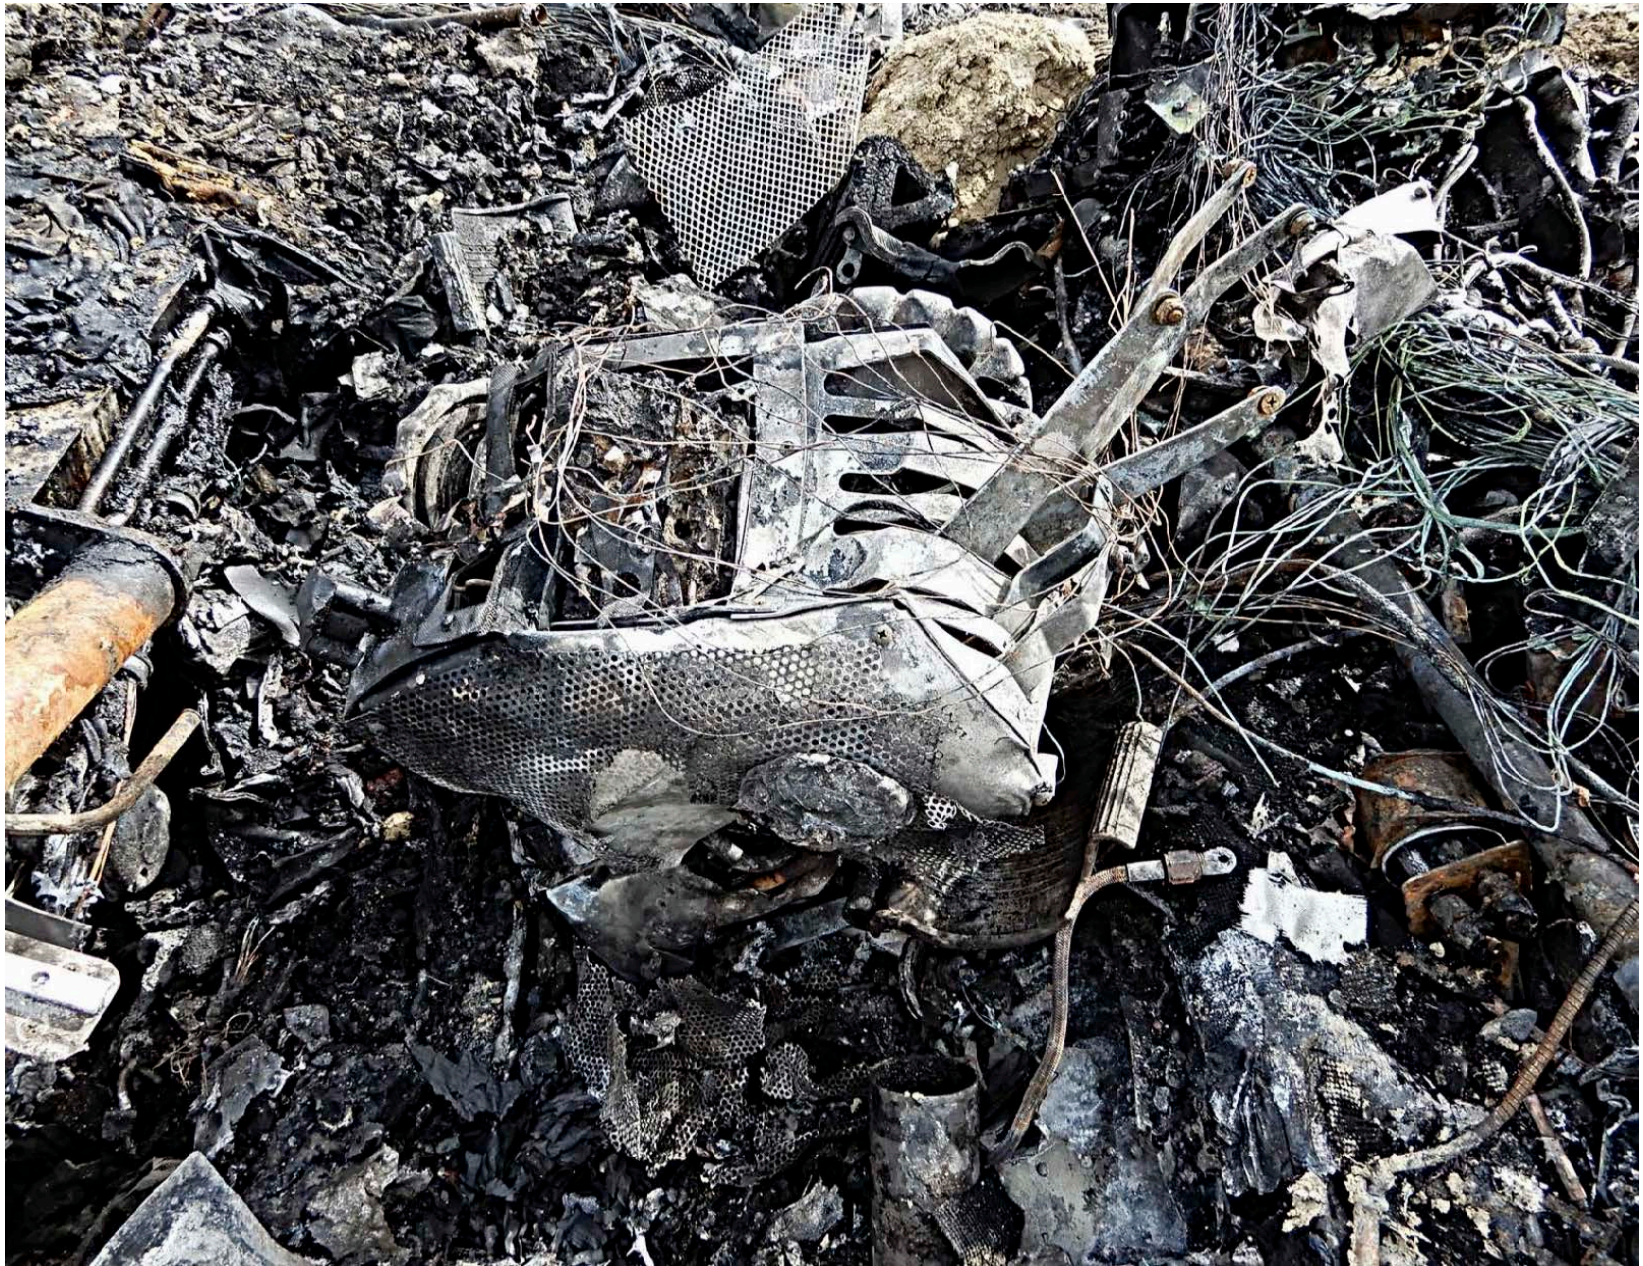
Photo 10 – The power quadrant.

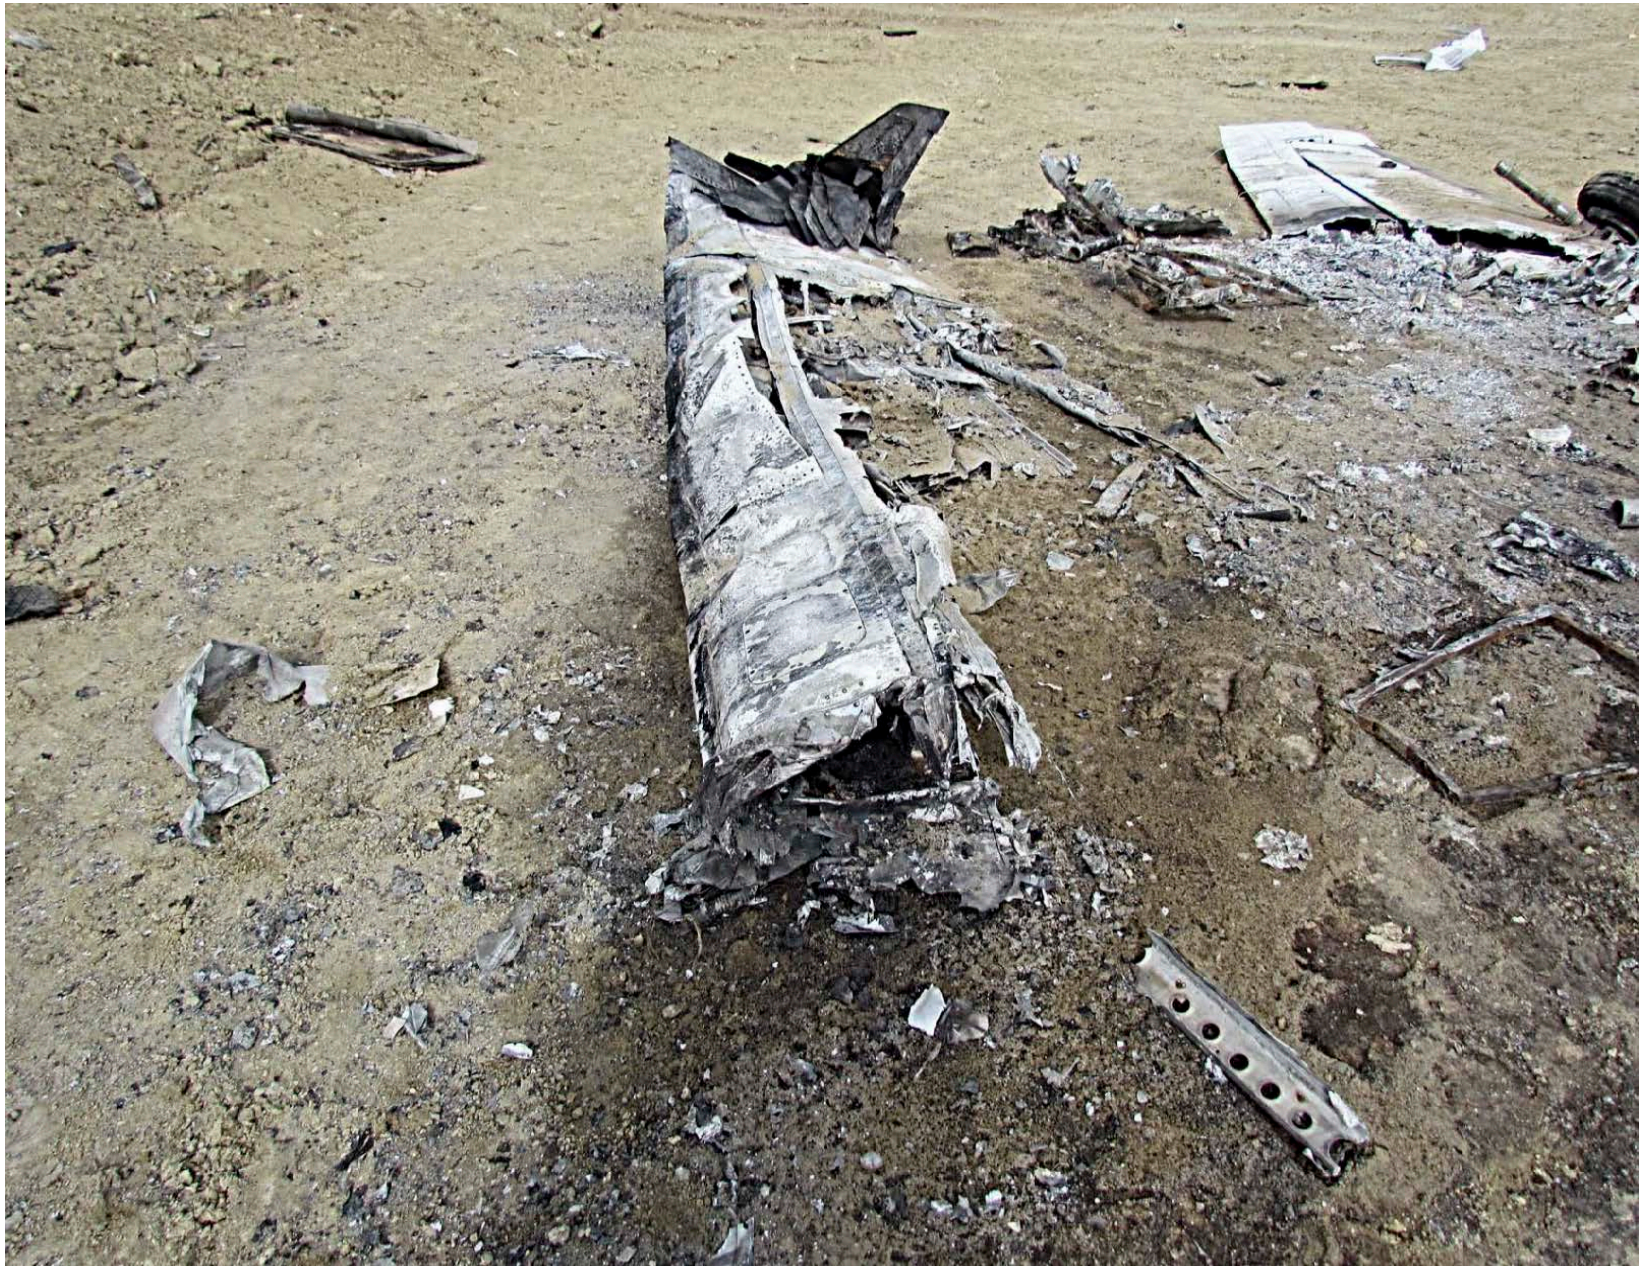
Photo 11 - Right wing leading edge. Vertical stabilizer and rudder are in background.

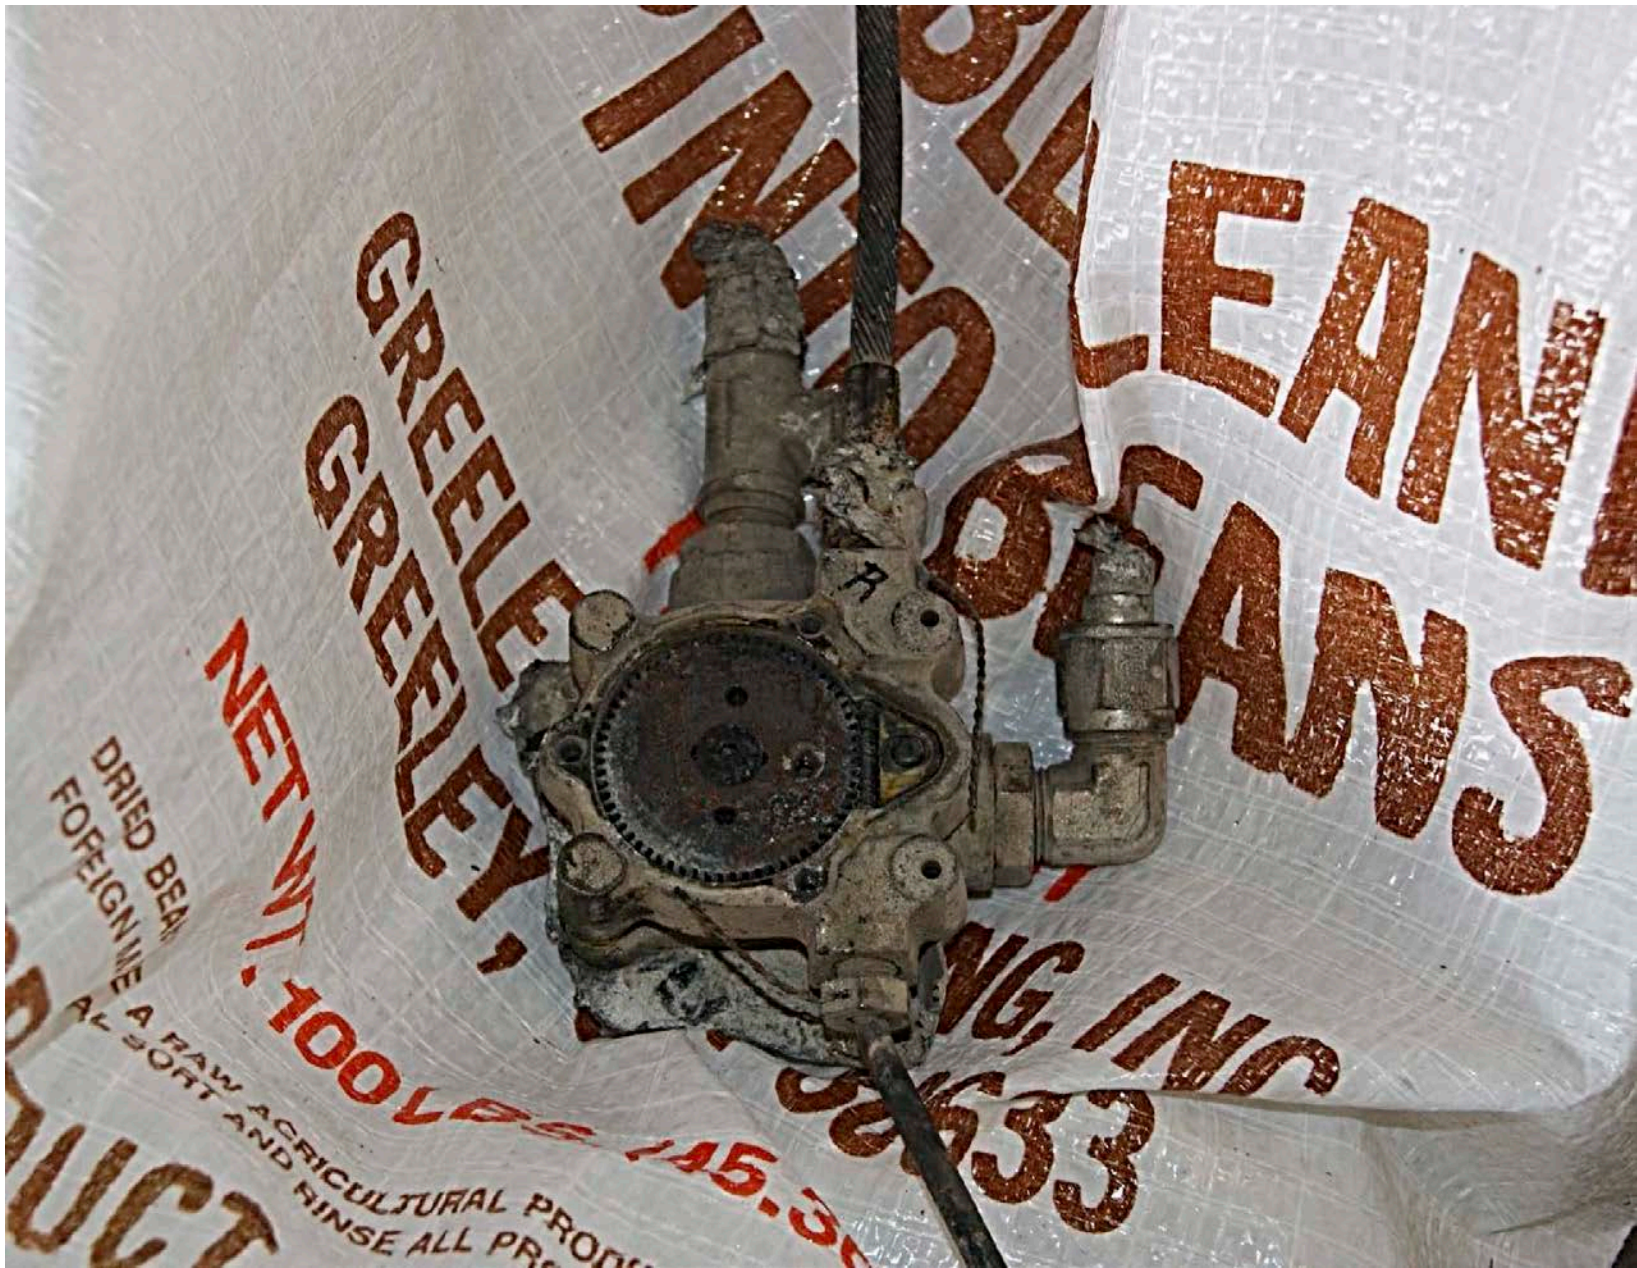
Photo 12 – Right engine fuel selector positioned on the right main tank.
