Photo 1 – Pre-accident photo of N60RK, a Beech 60 Duke.

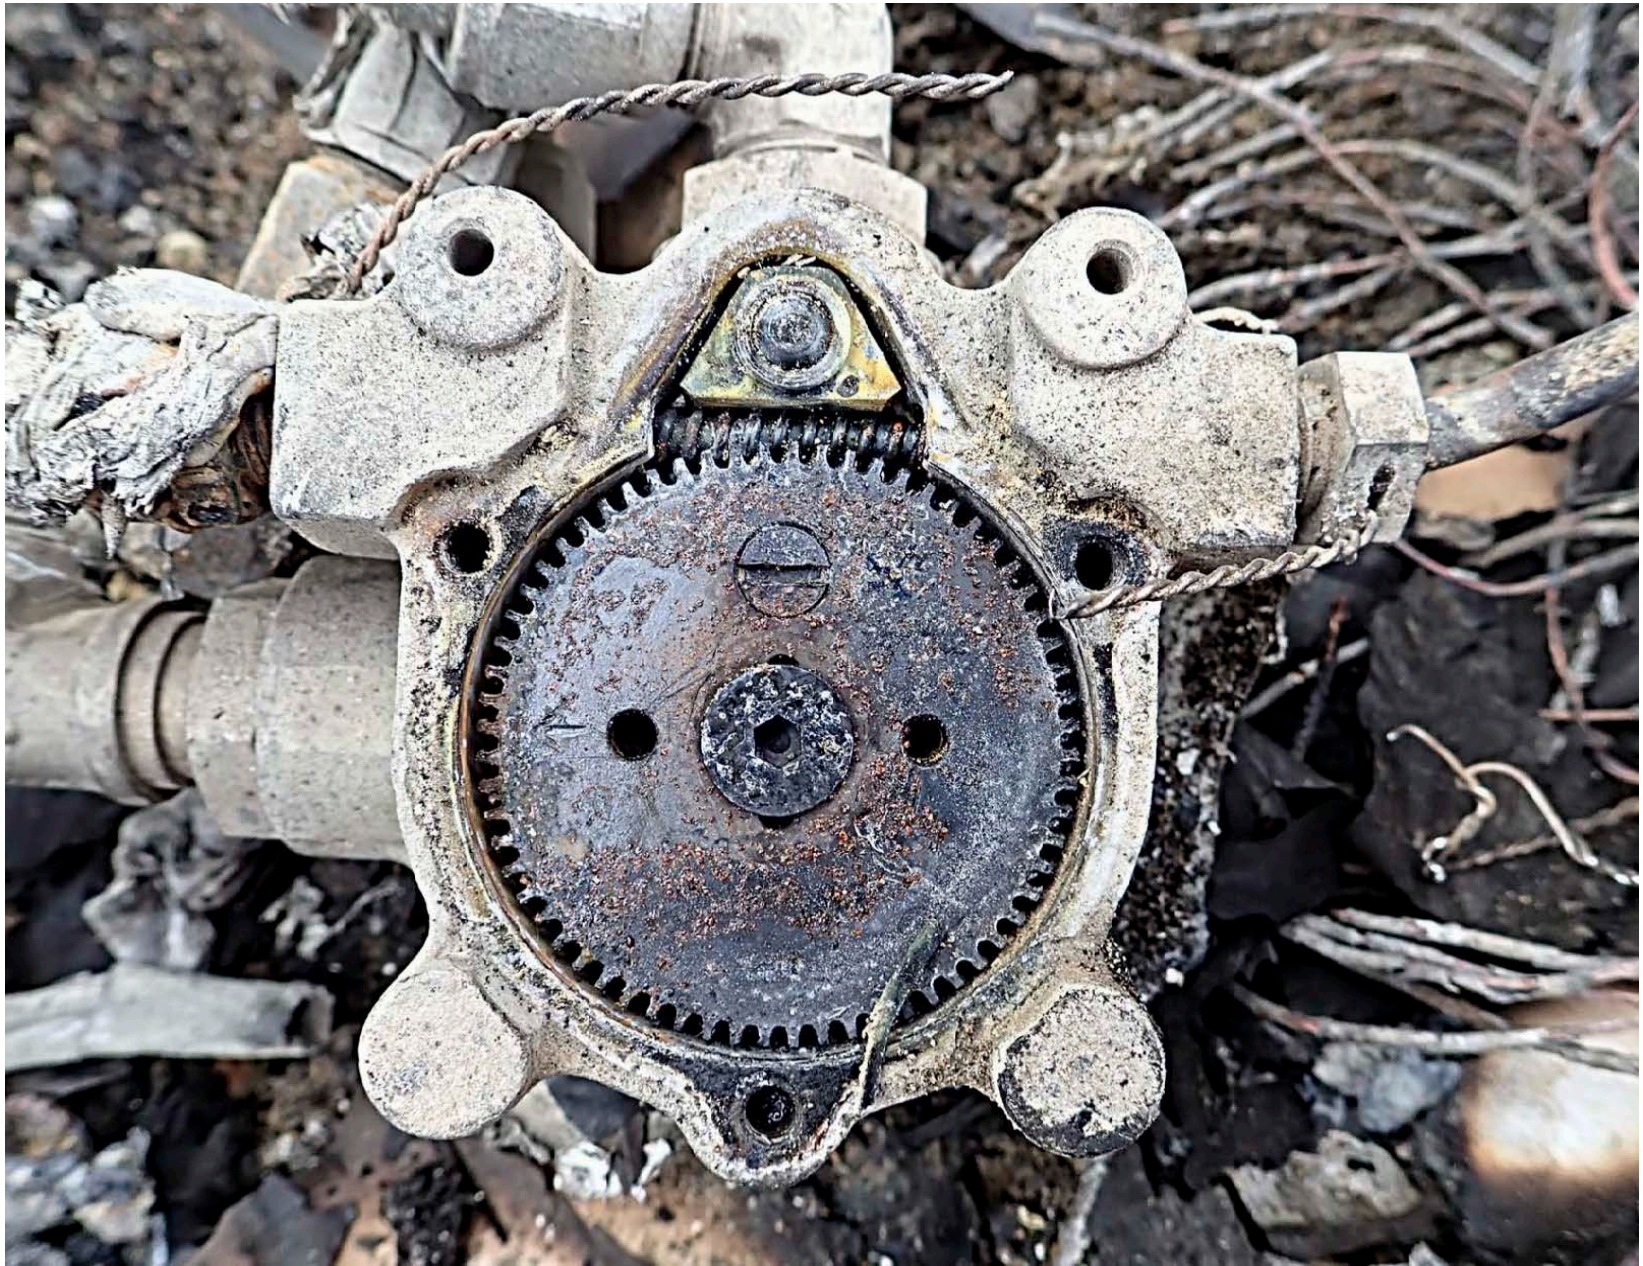
Photo 13 - Left engine fuel selector positioned on the left main tank.

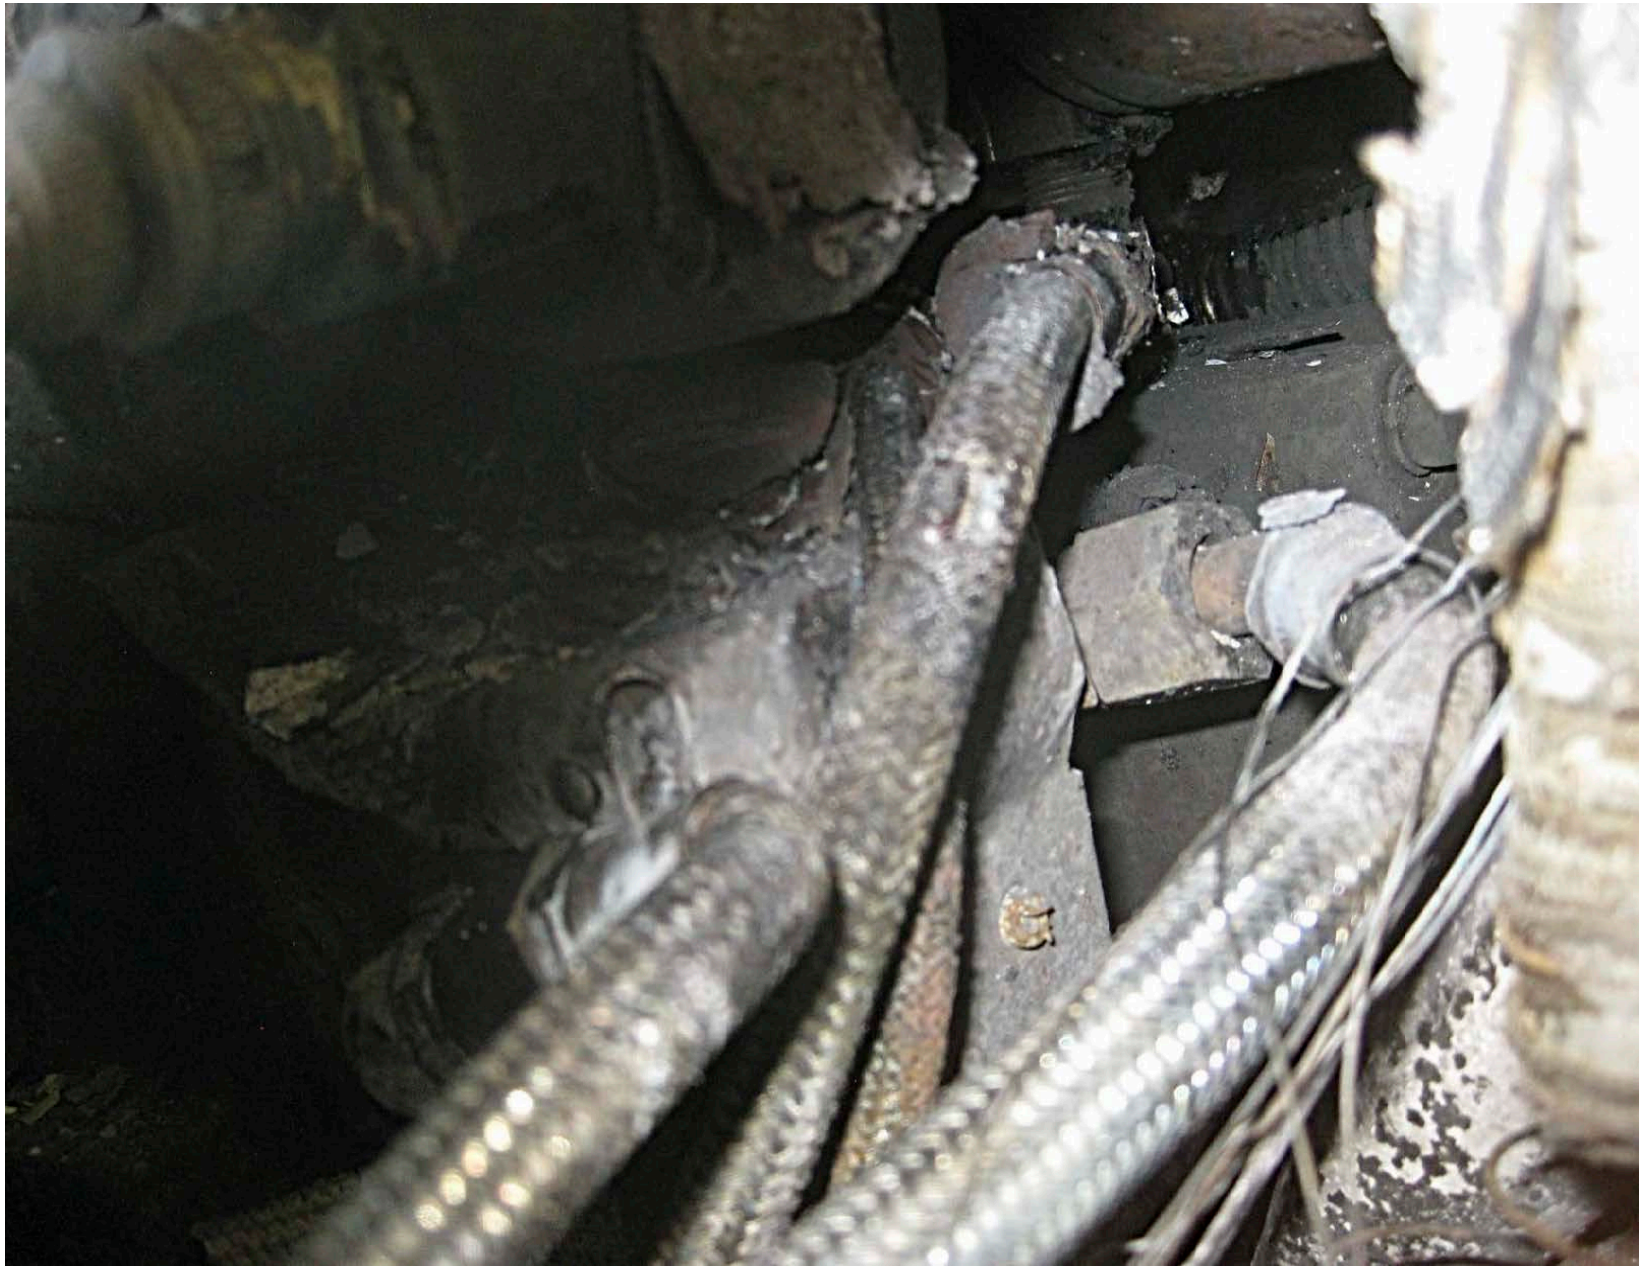
Photo 14 - Fuel lines going into and out of the fuel pump.

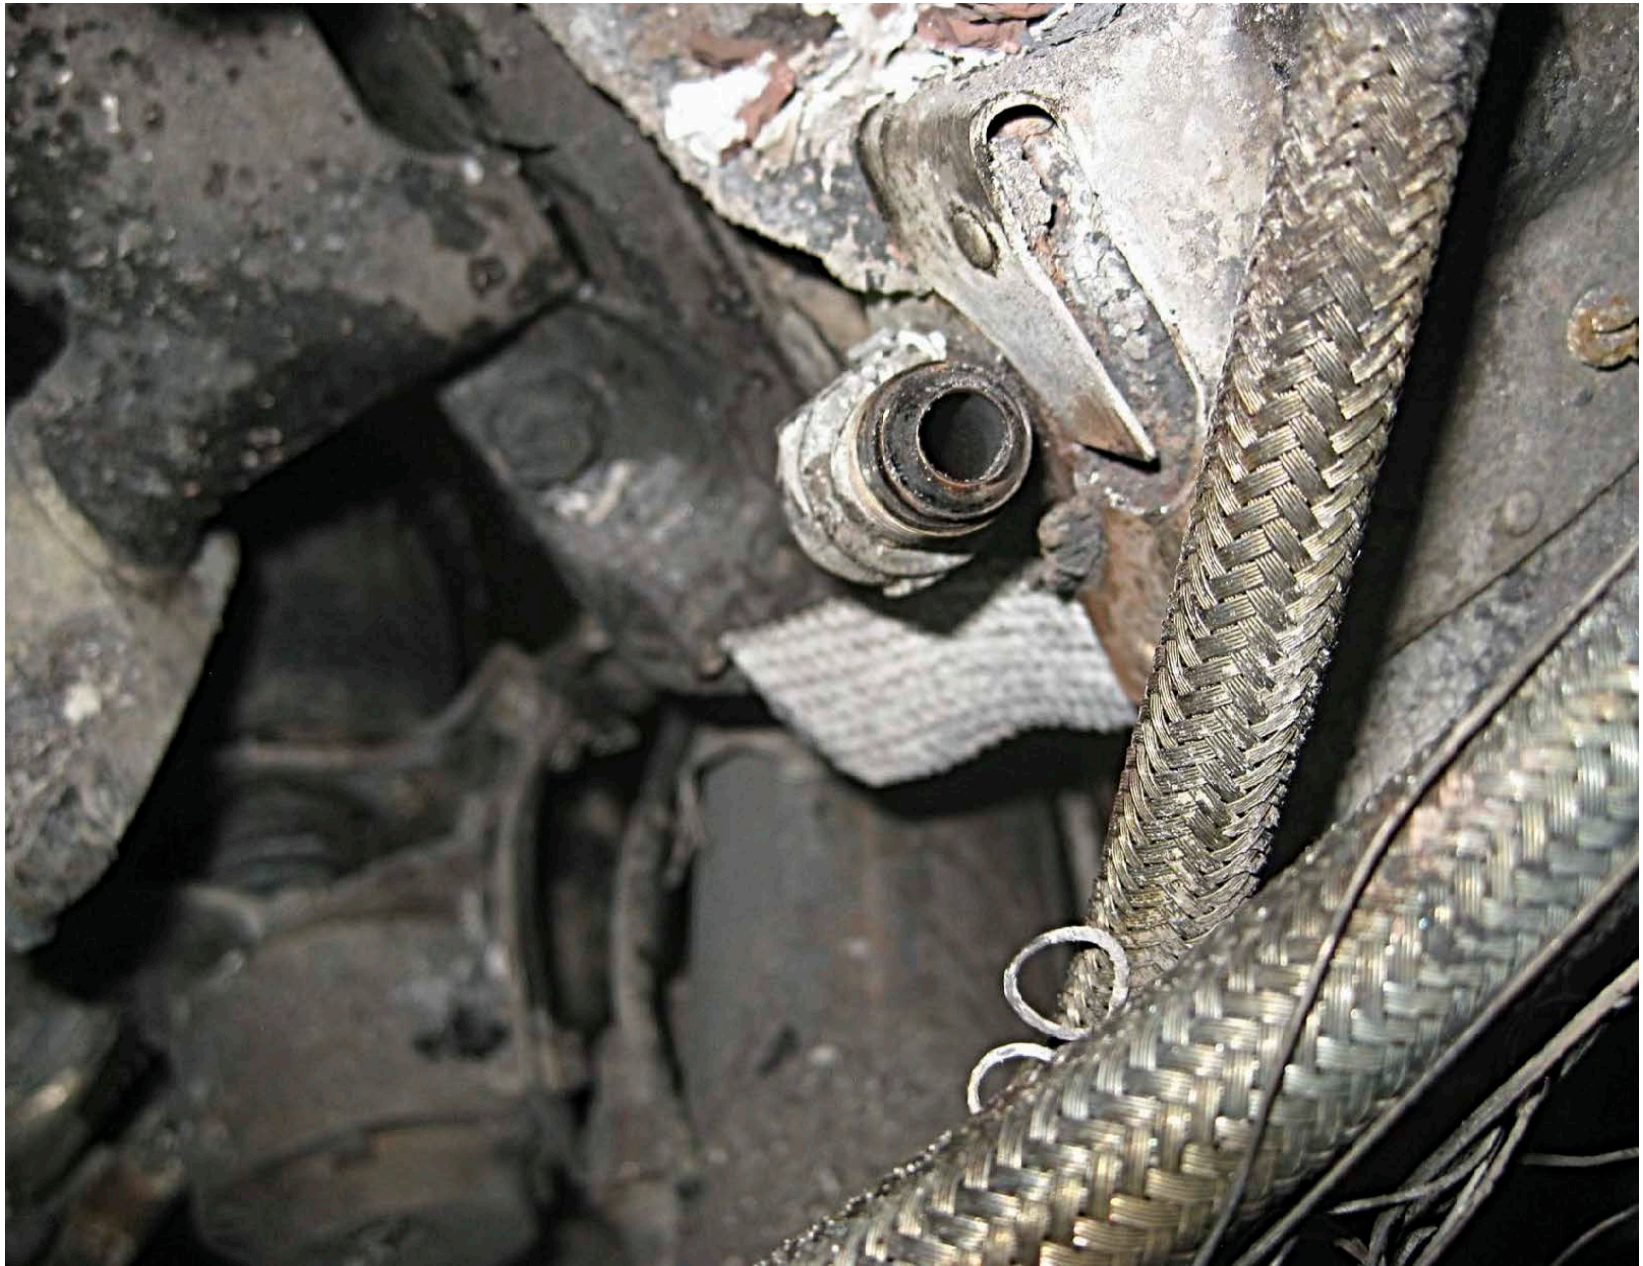
Photo 15 – Fuel pump discharge after line removal.

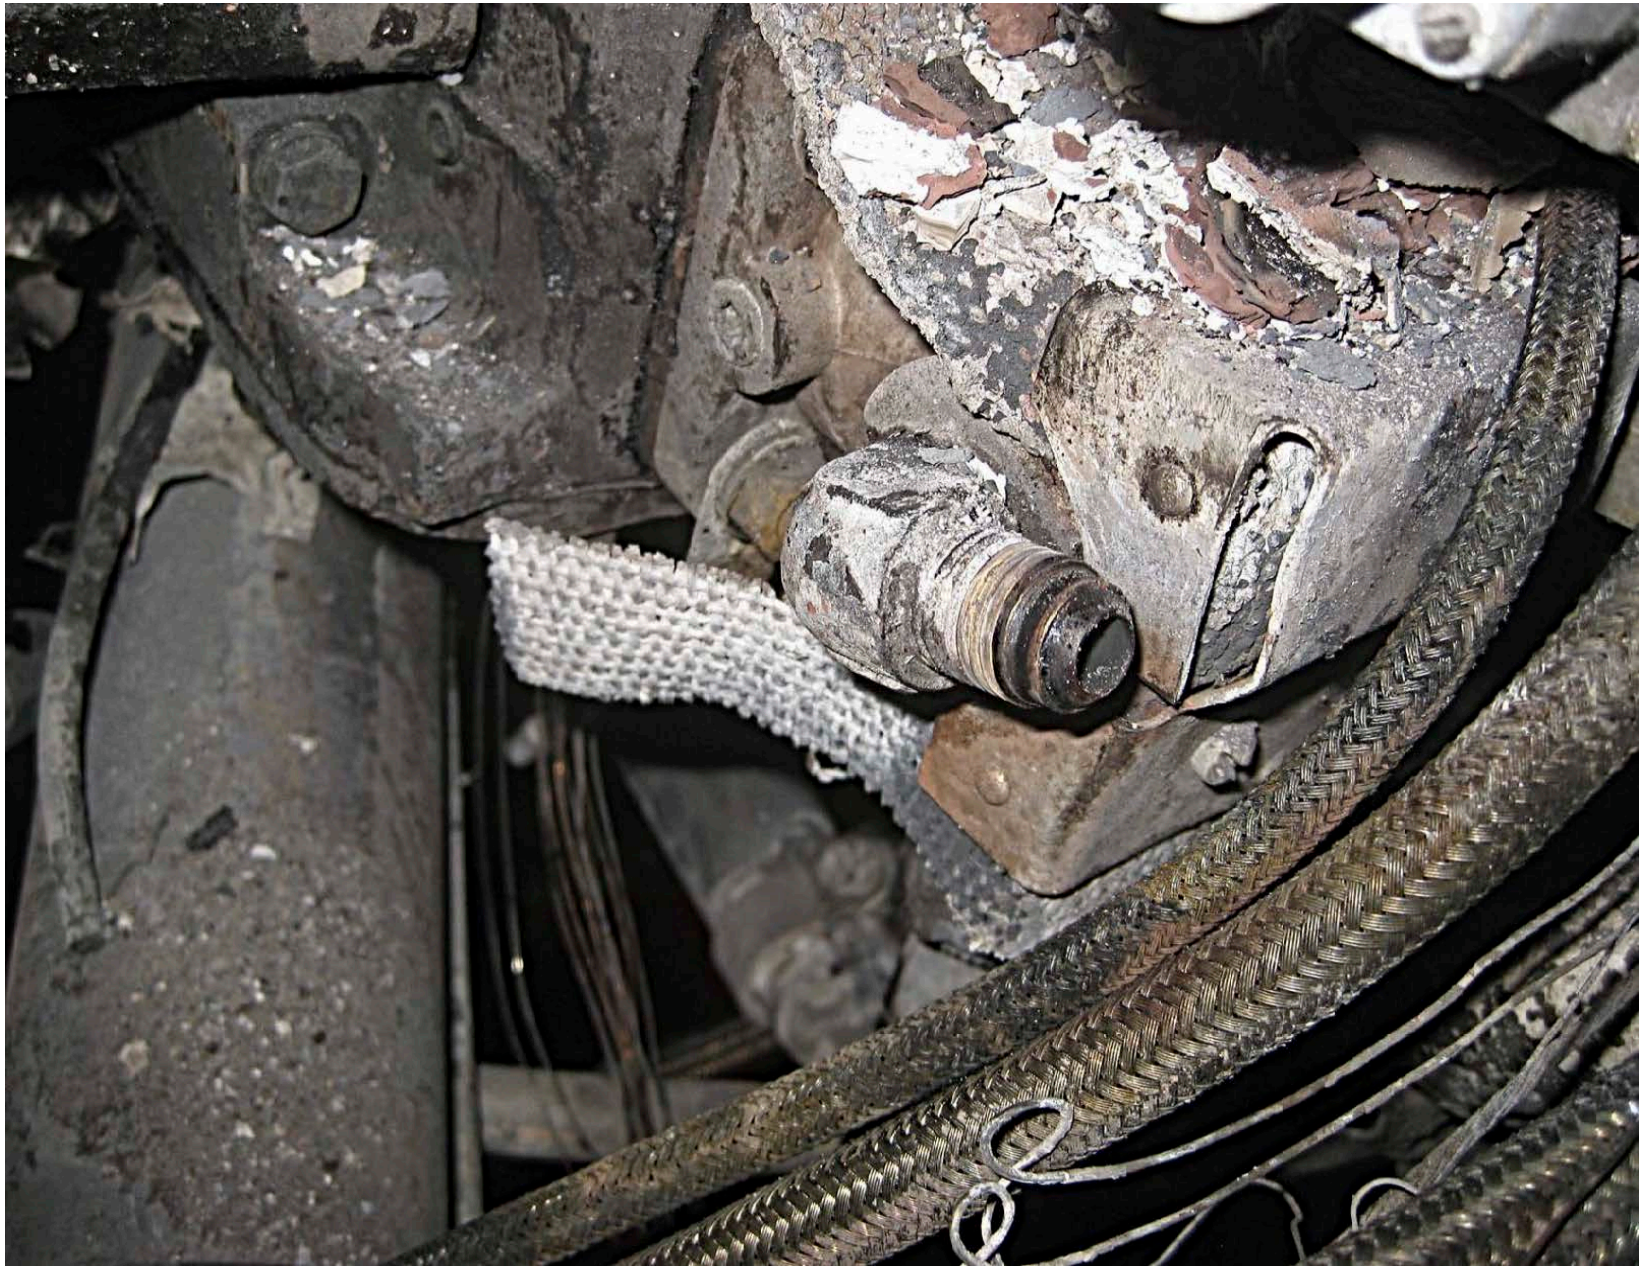
Photo 16 - Another view of the fuel pump discharge after line removal.

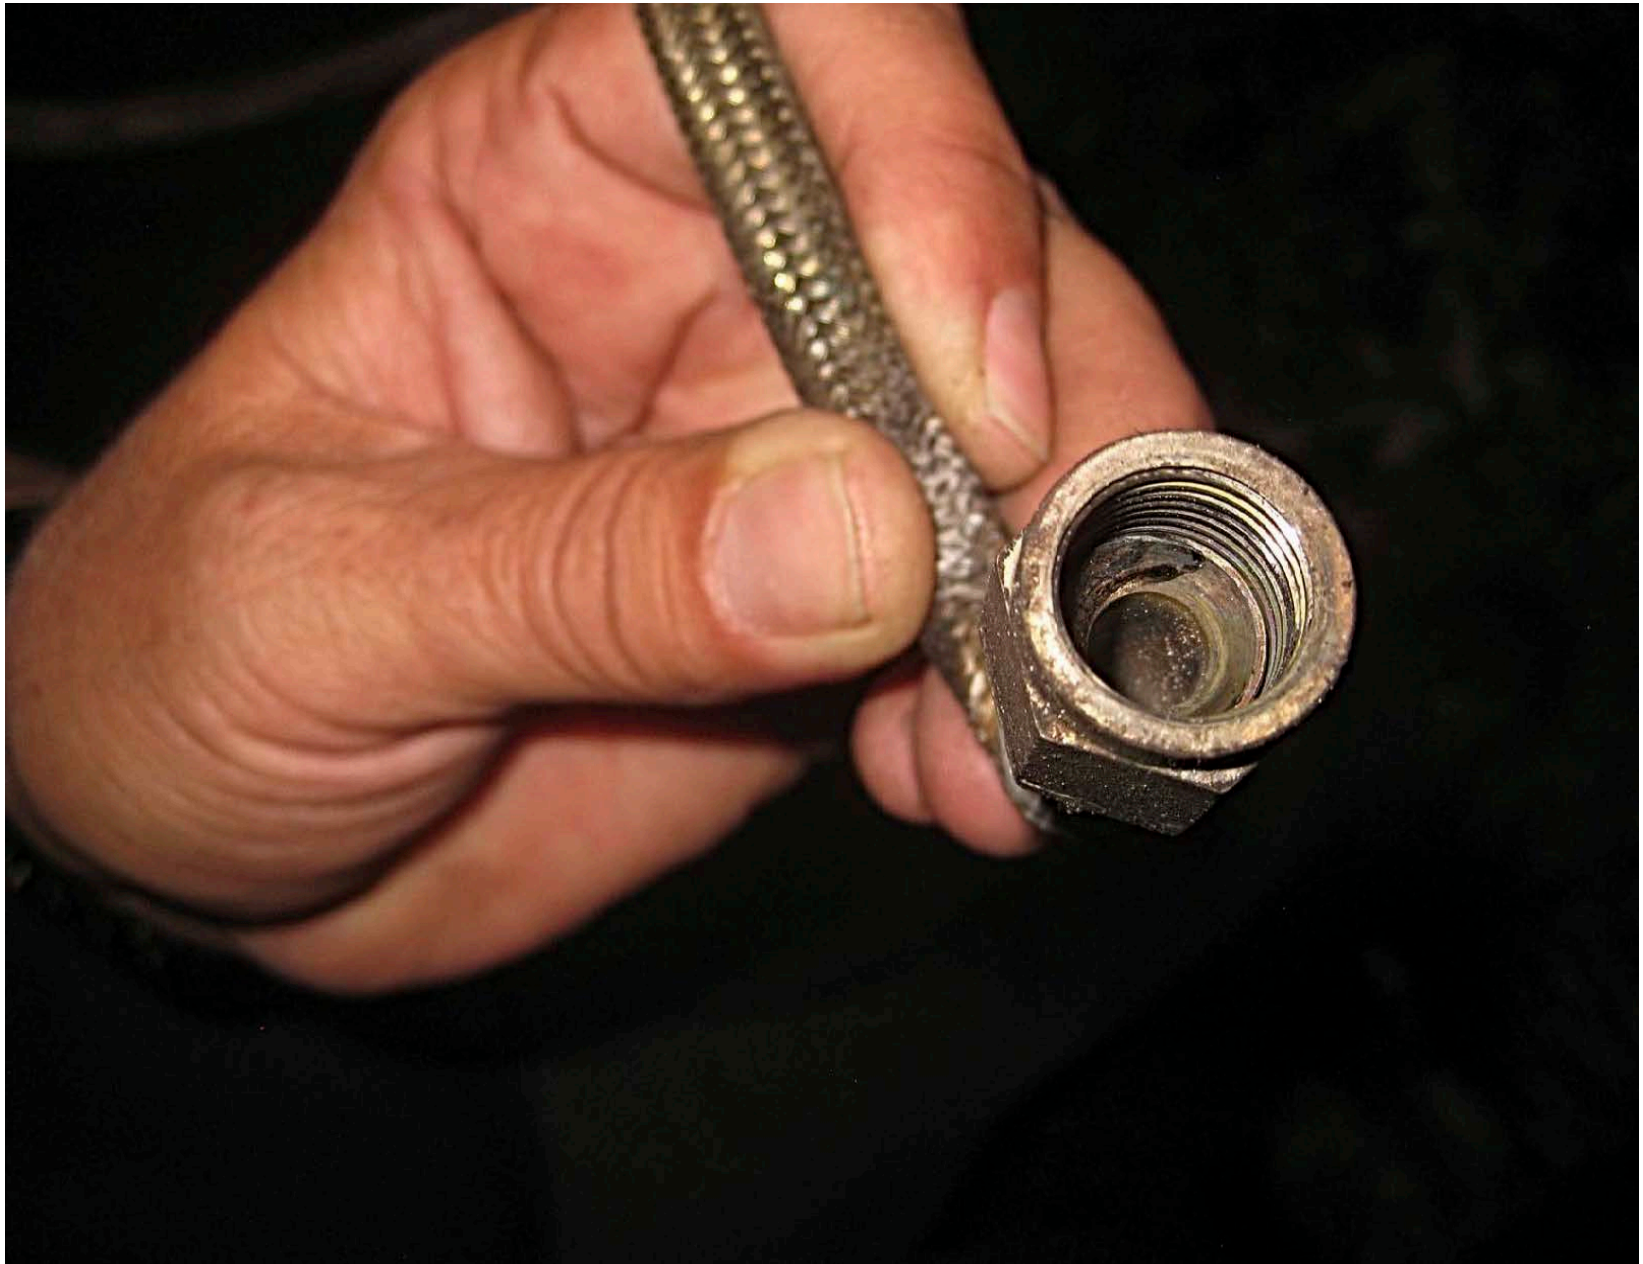
Photo 17 - Fuel pump discharge line. Note carbon deposits.
