Hawker Beechcraft Corporation
P.O. Box 85
Wichita, Kansas
67201-0085 USA

Subject: Hawker Beechcraft Corporation Model G35 Bonanza, Serial Number D-4807, Registration Number N4615D, accident in Easton, Massachusetts on August 12, 2008 at 1017 EDT (1417 UTC).

Reference: NTSB Preliminary Report MIA08FA163

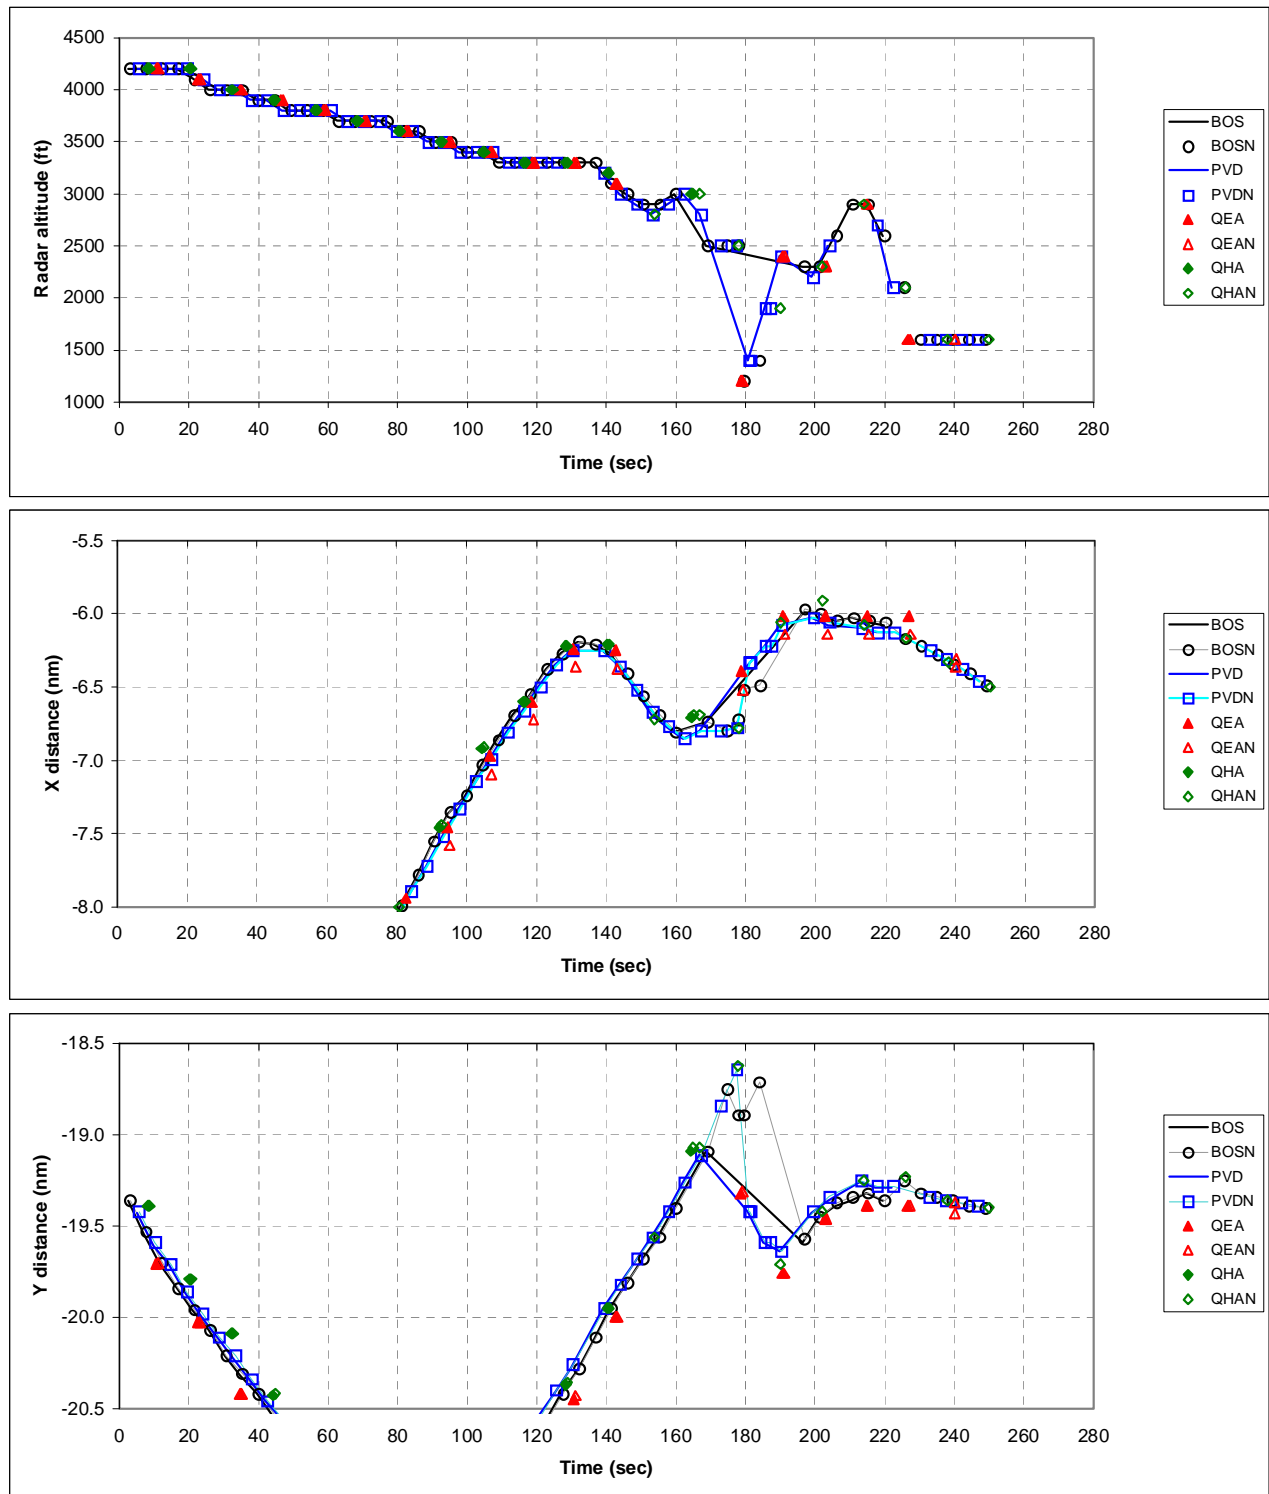
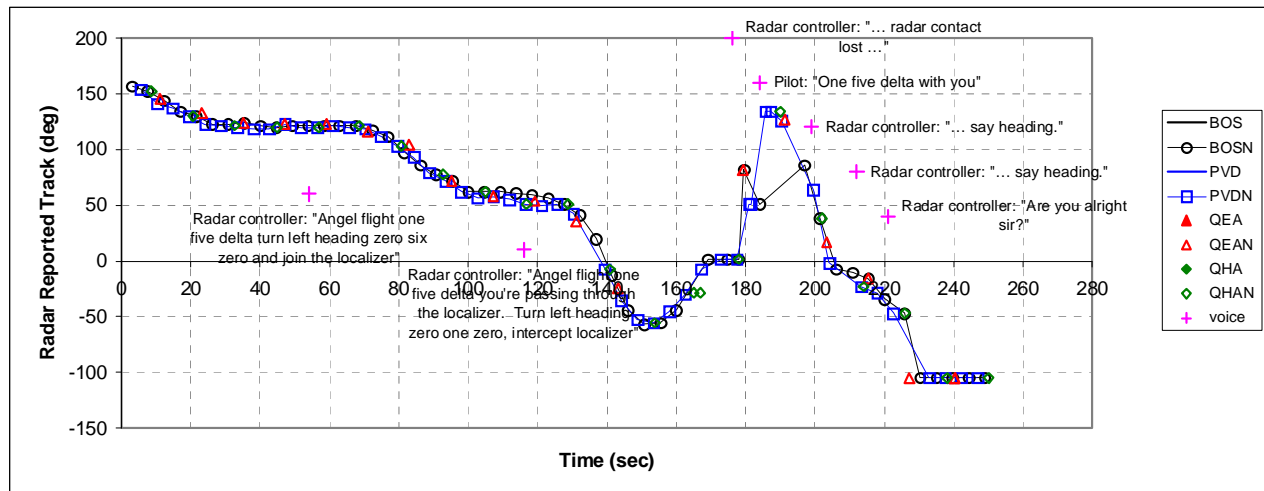
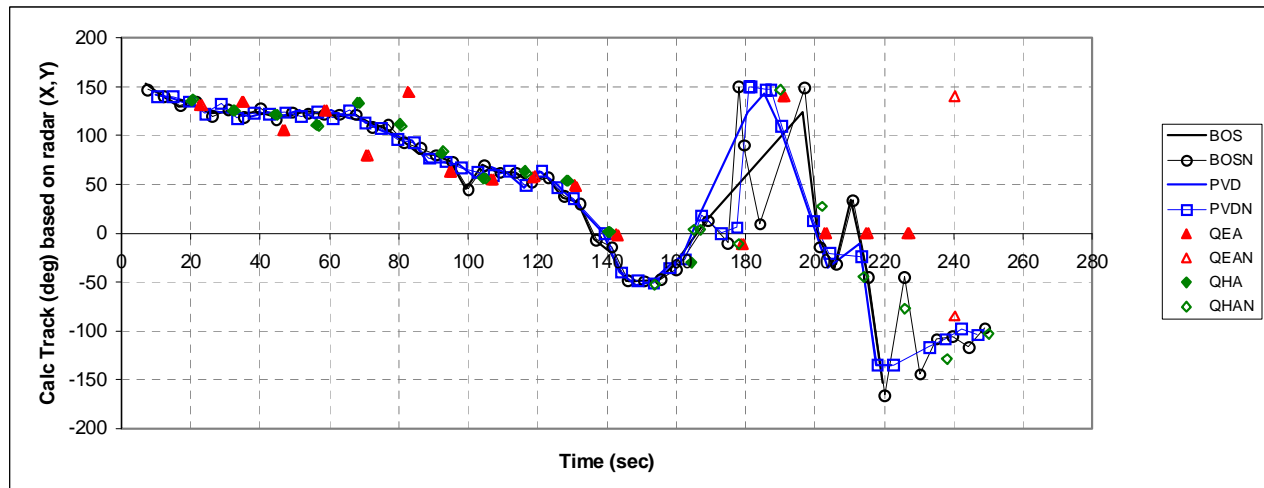
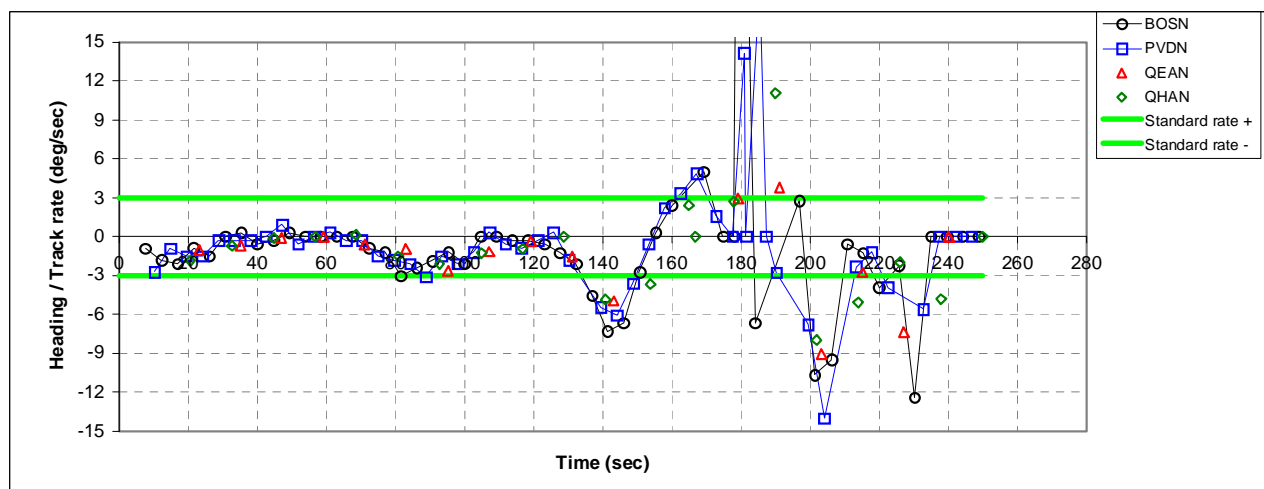
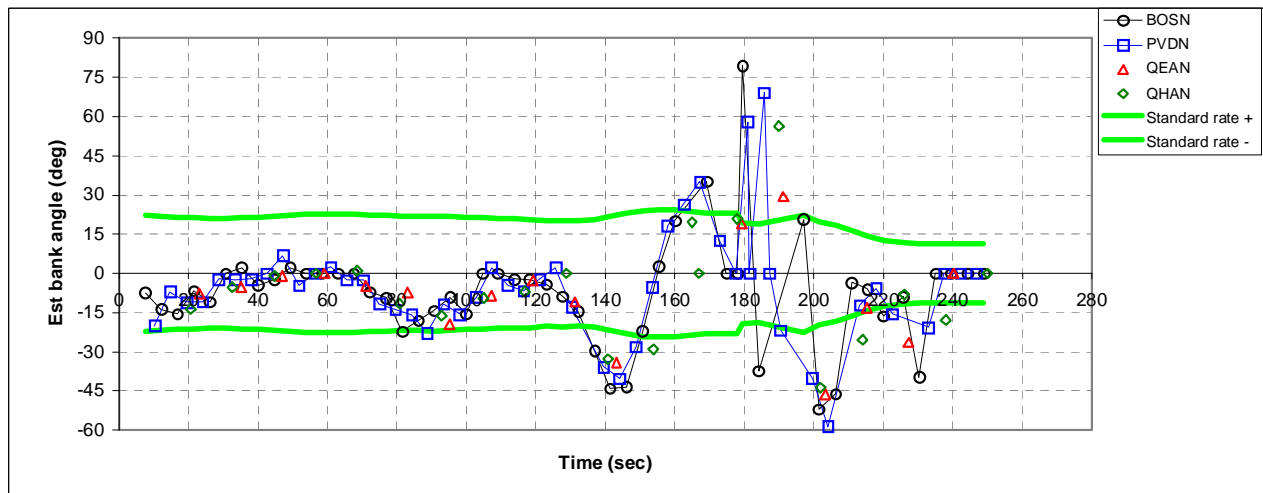
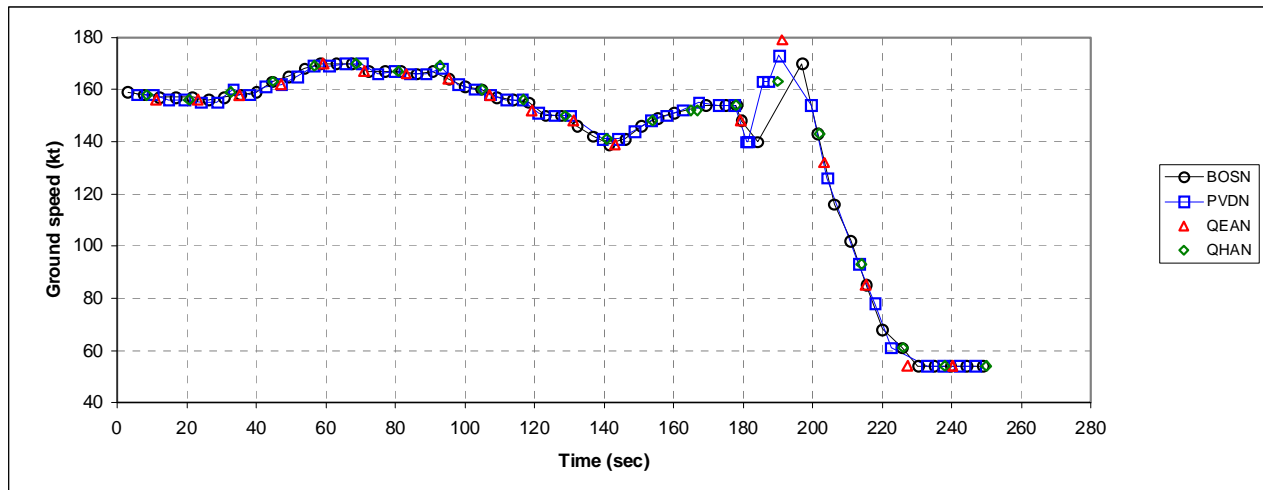
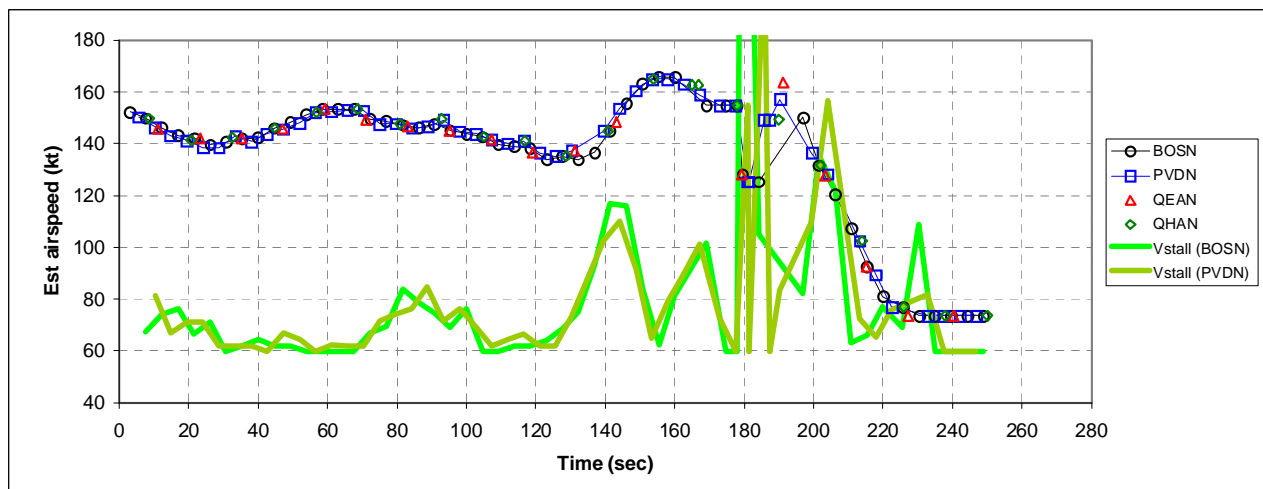
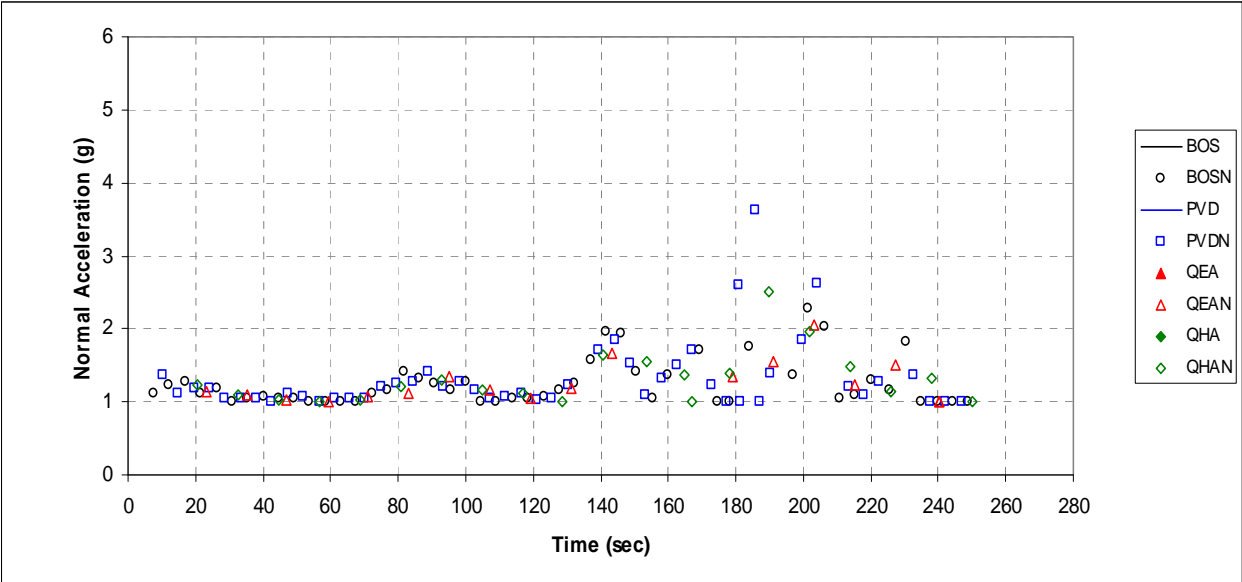
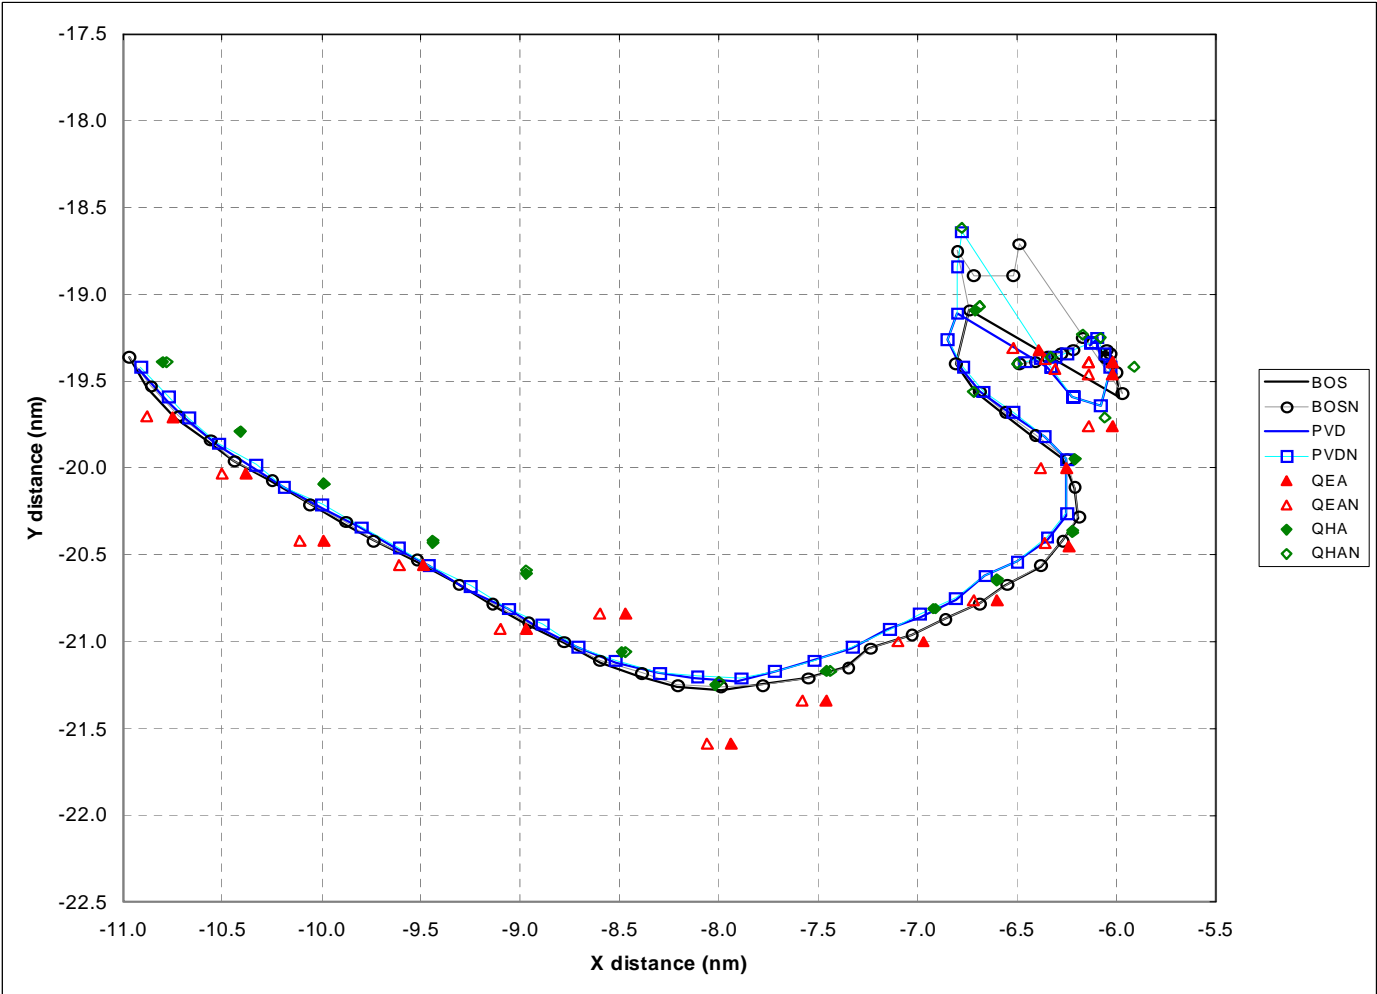
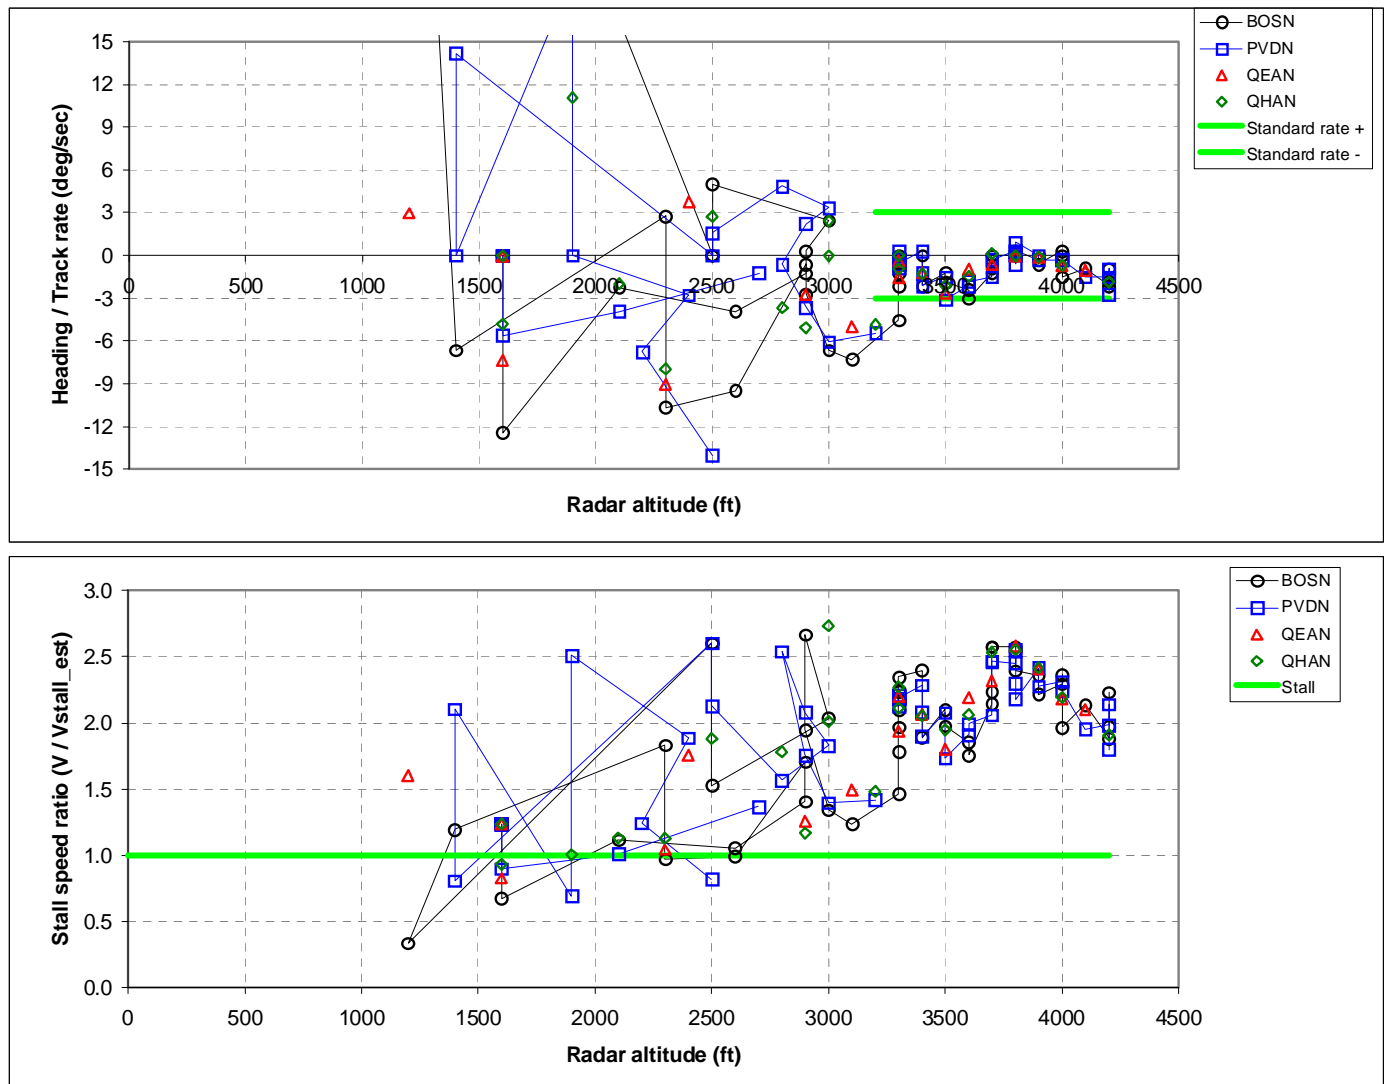
It is evident that following the radar controller's request to "turn left heading zero six zero" at 14:14:44, the pilot entered a left turn at rates at or below standard rate. The aircraft did stabilize on approximately the requested heading. The controller subsequently requested "turn left heading zero one zero". The aircraft entered a left turn, which quickly exceeded standard rate. The bank angle for a standard rate turn at that speed was approximately 21°, however estimated bank angles reached 35° to 45°. Subsequently the aircraft entered a right turn at estimated bank angles up to 35°, where standard rate at that speed corresponded to 23°. In the following seconds, the aircraft lost several hundred feet of altitude, and estimated bank angles became unreliable, commensurate with the discrepant reported radar locations when radar contact was lost. The following plots illustrate the final minutes of the flight.
