Continental Motors

ENGINE FIELD INSPECTION REPORT

ENGINE MODEL	IO-520-L46B
ENGINE SERIAL	1000795
AIRCRAFT MAKE & MODEL	Cessna 210L
AIRCRAFT SERIAL NUMBER	21061454
AIRCRAFT REGISTRATION	N732EJ
FILE NUMBER	13-386

The engine sustained impact-related damage that fractured the crankshaft aft of the propeller flange and deformed the crankcase, cylinders, and oil sump, all of which precluded crankshaft rotation. However, examination of identified components did not reveal any pre-existing anomalies that would have prevented normal engine operation and production of rated power.

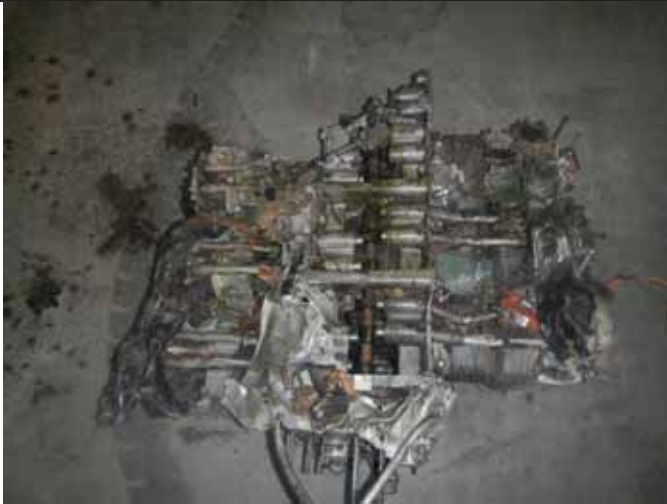
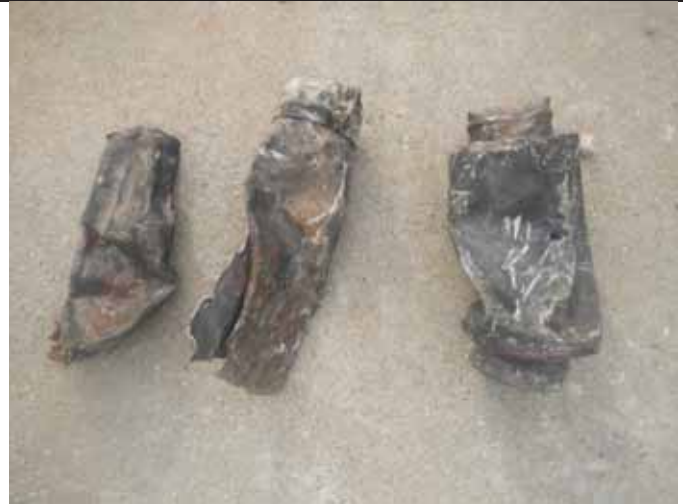
EXHAUST SYSTEM

The exhaust risers remained attached to the engine, but sustained deformation damage that flattened the tubes. The exhaust manifolds were also flattened and located within the debris field. Only one exhaust muffler was located at the accident site and it too sustained deformation damage.

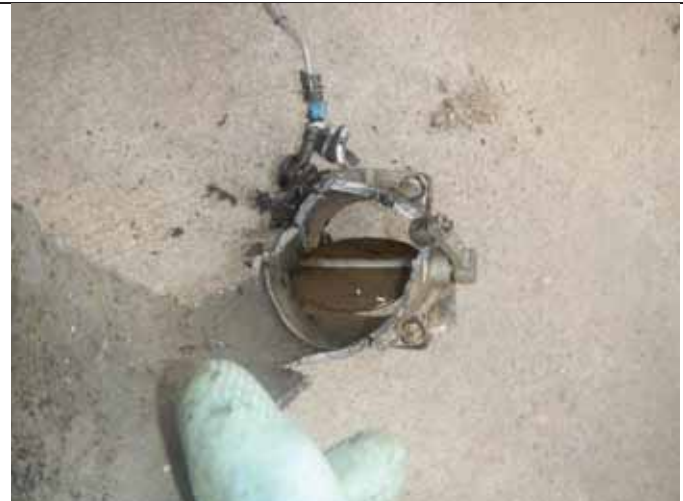
INDUCTION SYSTEM

The induction system was destroyed. Portions of intake manifolds were identified at the accident site. The intake filter sustained deformation damage, but its foam filter remained in place. The throttle body was fractured and the throttle lever remained attached to the shaft of the throttle valve.

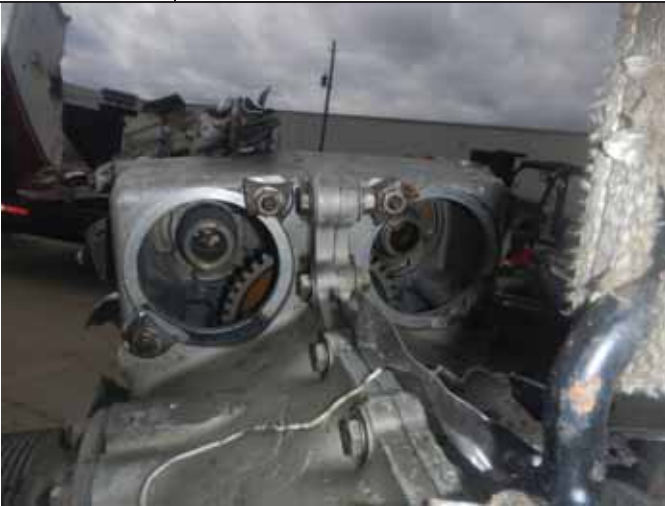
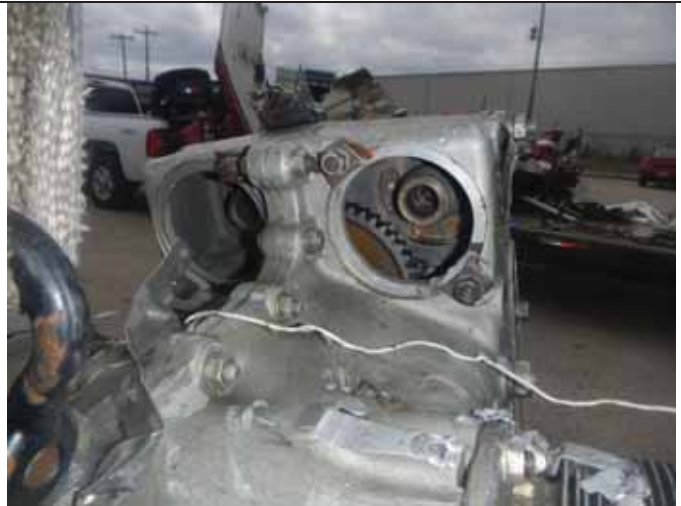
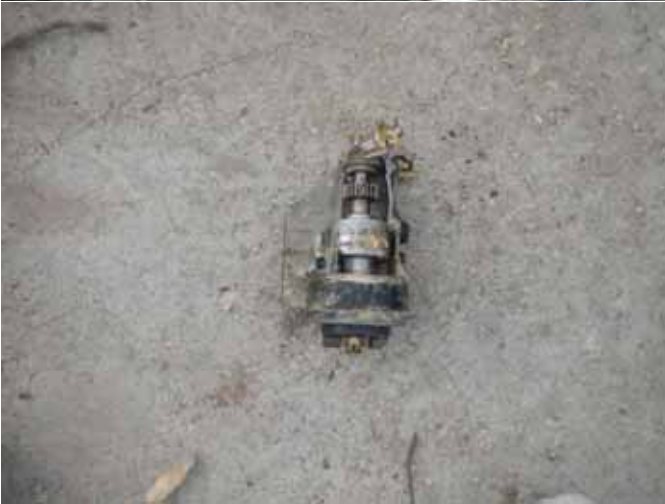
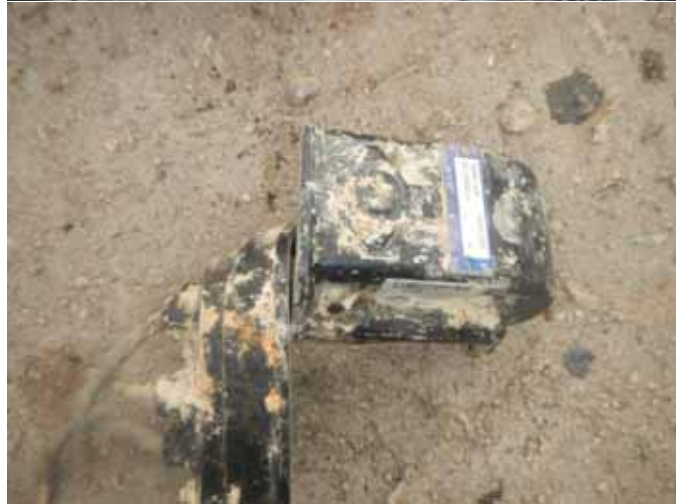
RIGHT MAGNETO

Both magnetos were separated from the engine and all ignition leads were separated from the magnetos. The magneto housings were fractured, the distributor caps were separated, and some of the internal components were missing. Functional testing was not possible. One data plate was observed on the remains of a magneto housing. The part number and serial number of that magneto matched the numbers for what was listed as the right magneto on Continental Motors' Engine Component Information Sheet for the accident engine.

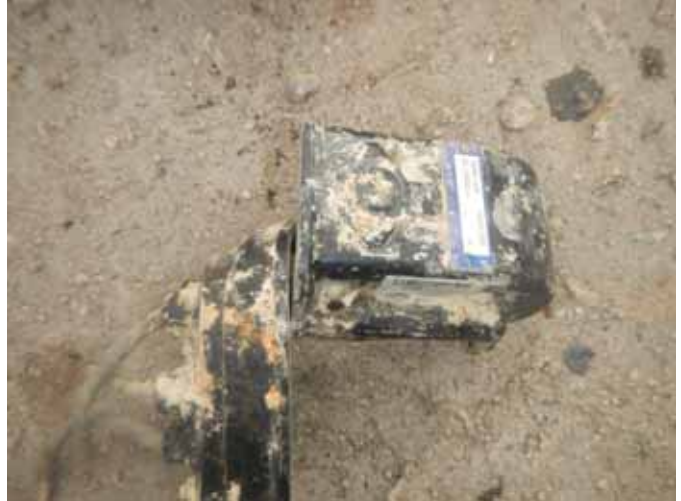
**LEFT
MAGNETO**

Both magnetos were separated from the engine and all ignition leads were separated from the magnetos. The magneto housings were fractured, the distributor caps were separated, and some of the internal components were missing. Functional testing was not possible.

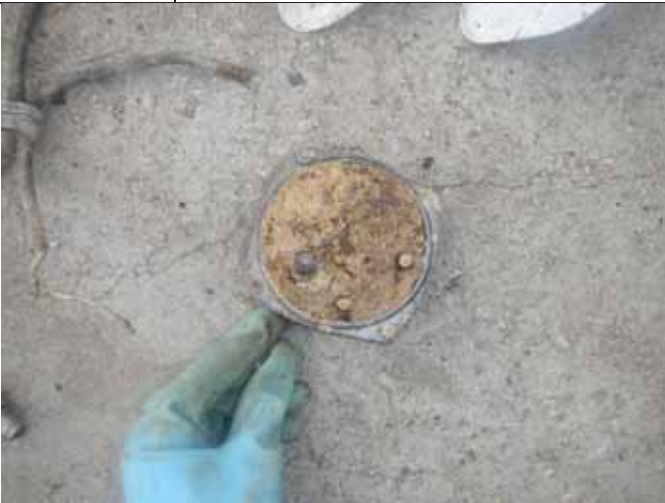
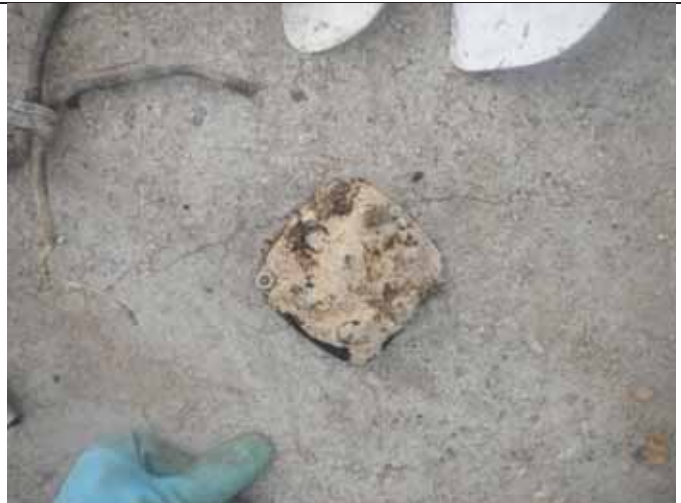
**IGNITION
HARNESS**

The ignition harnesses were destroyed and only portions were observed at the accident site and during the engine examination.

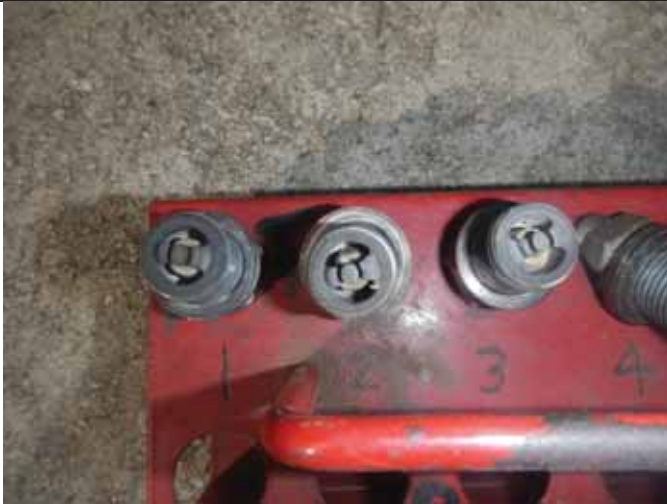
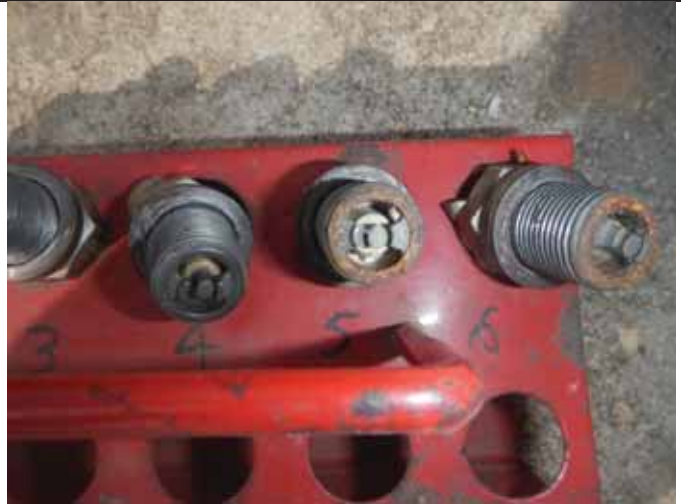
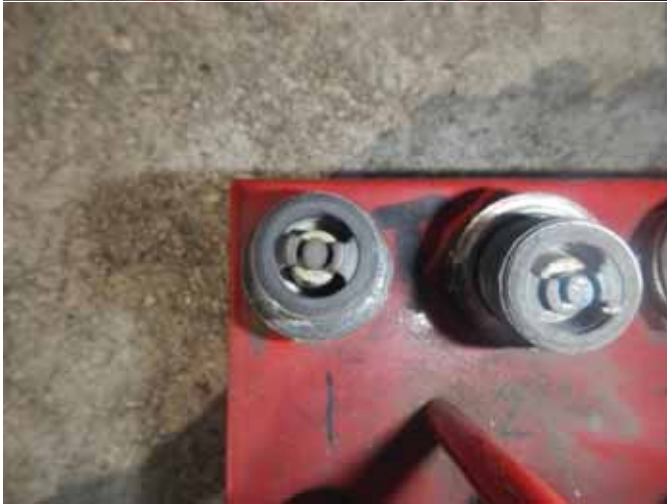
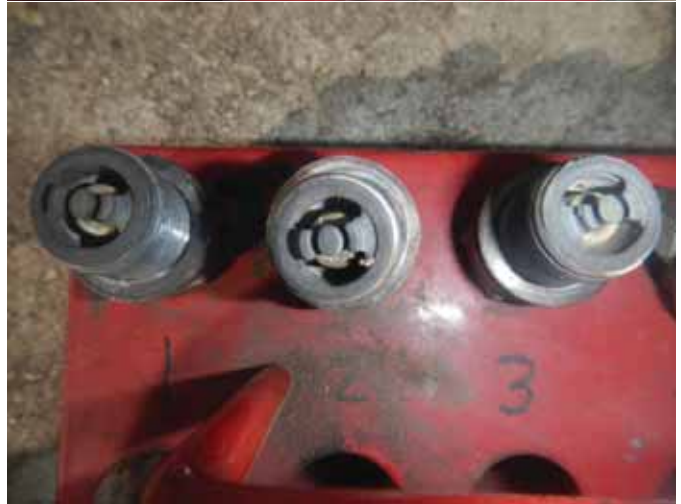
SPARK PLUGS

The #2, #4, #5, and #6 bottom sparkplugs were separated from their respective cylinders. Some of the sparkplugs that remained attached to the engine sustained deformation damage or were fractured. The top sparkplugs were removed and examined. The sparkplugs displayed a normal worn condition and no signs of lead or carbon fouling. The #2 and #5 top sparkplugs contained some organic debris on the electrodes and the #6 top sparkplug was rusted.

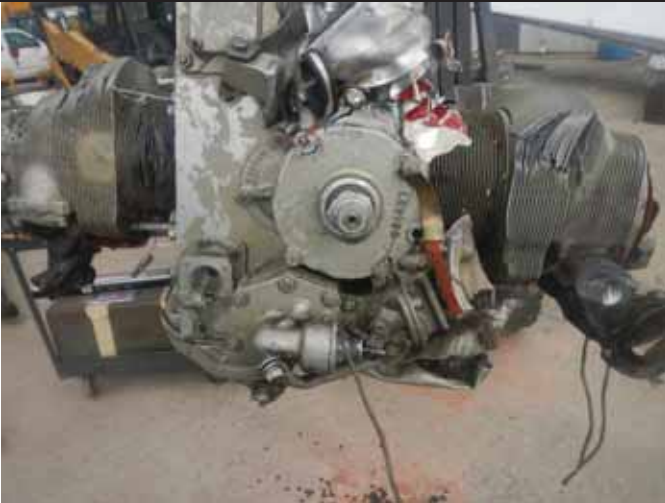
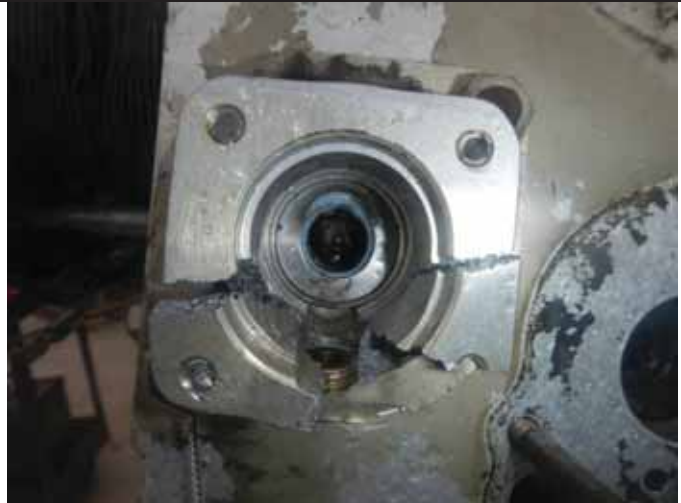
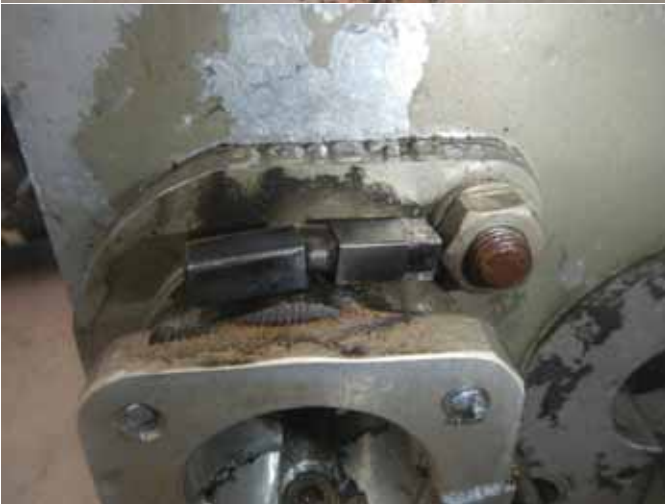
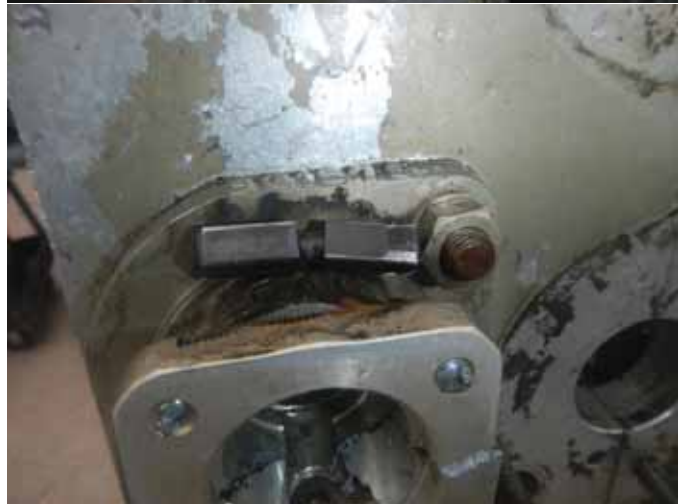
FUEL PUMP

The fuel pump was fractured with only the fuel pump adapter remaining attached to the engine. The adapter was fractured and the sheered remains of the fuel pump assembly bolts remained with the adapter. The fuel pump drive coupling remained inserted in the drive gear. Removal of the drive coupling from the adapter revealed that it was intact but bent, with fresh scrape marks visible on one end of the drive. The remaining fuel pump components were not observed at the accident site and were not located within the retrieved components at the salvage facility.

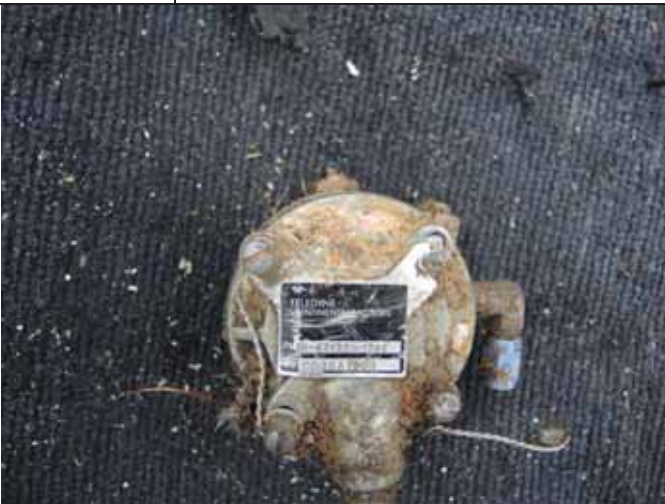
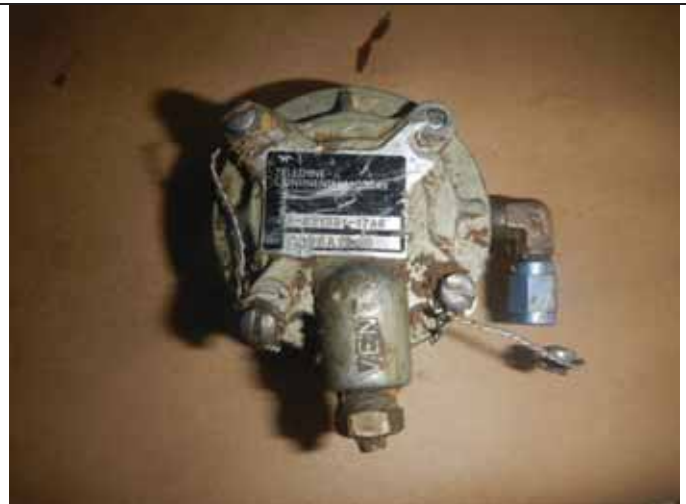
FUEL MANIFOLD VALVE

The fuel manifold was separated from the engine and all of the fuel injector lines were separated from the manifold body. The manifold valve cap remained attached to the housing. Three of the four screws securing the housing remained intact but were deformed. The fourth screw was sheered. The manifold valve was disassembled. The diaphragm was intact and pliable. The plunger remained secured to the diaphragm and the spring was intact and in place. Removal of the diaphragm revealed that a screen that was in place, intact, and free from blockage.

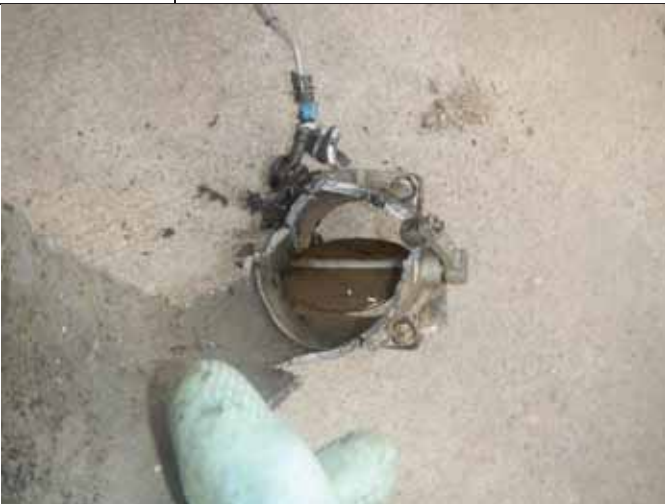
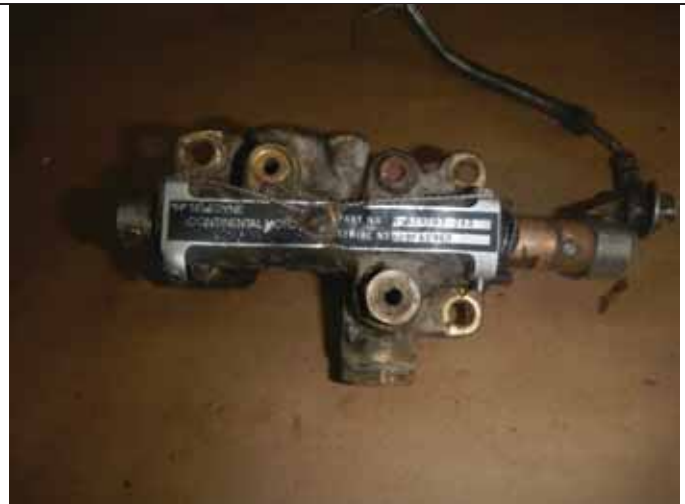
THROTTLE BODY METERING UNIT

The throttle body was fractured and the metering unit was separated. The throttle valve remained intact within the fractured throttle body housing and the throttle control lever remained attached, though it was bent. The mixture control lever remained attached to the mixture control shaft, but the mixture shaft and cam were partially pulled out from the housing, past its retaining screw. All of the fittings were fractured from the metering unit housing. The inlet fuel screen was removed and organic material was found inside the fuel screen, clumped on one side. The organic material was consistent with that found at the accident site. The fuel metering unit was disassembled. The fuel metering plug was intact and its o-rings were in place. No anomalies were noted with the mixture and throttle cams.

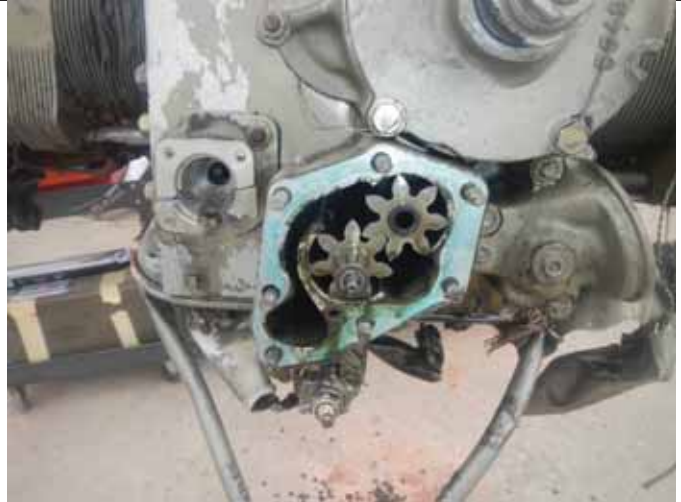
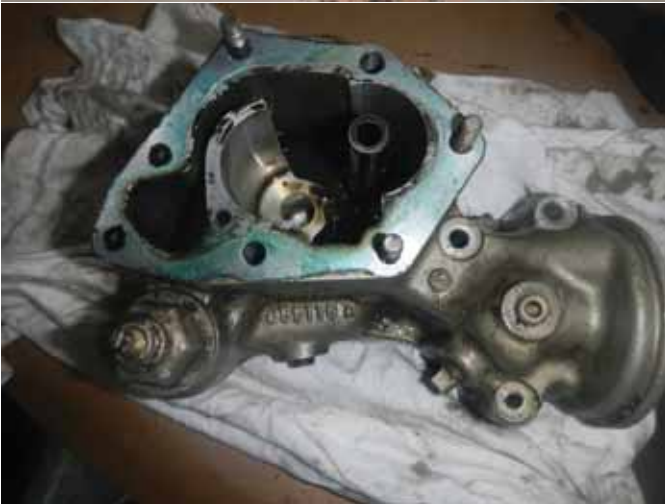
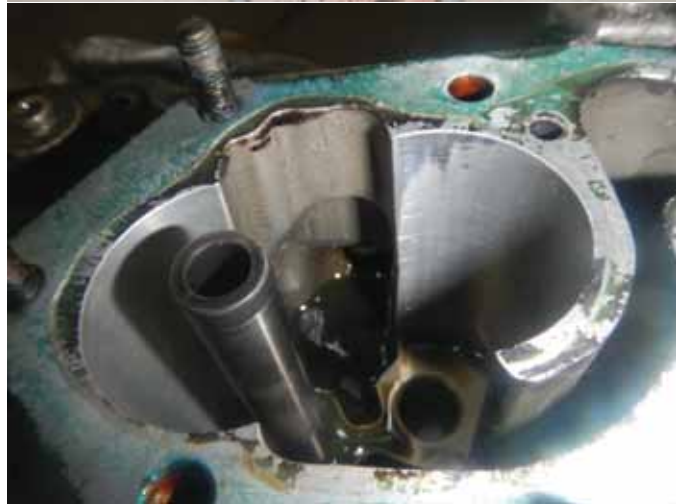
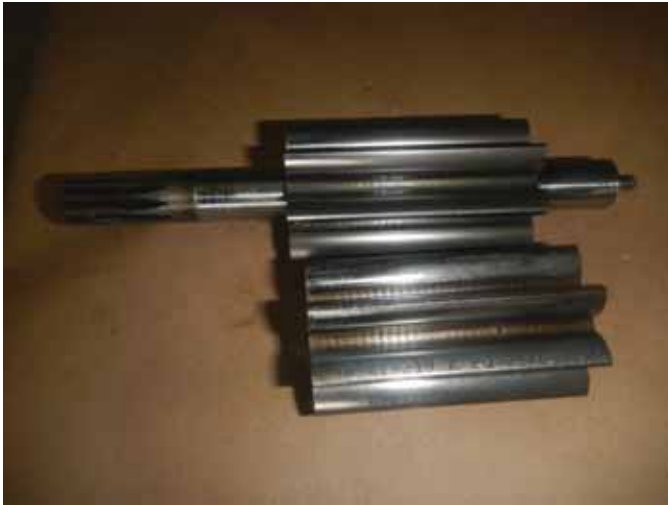
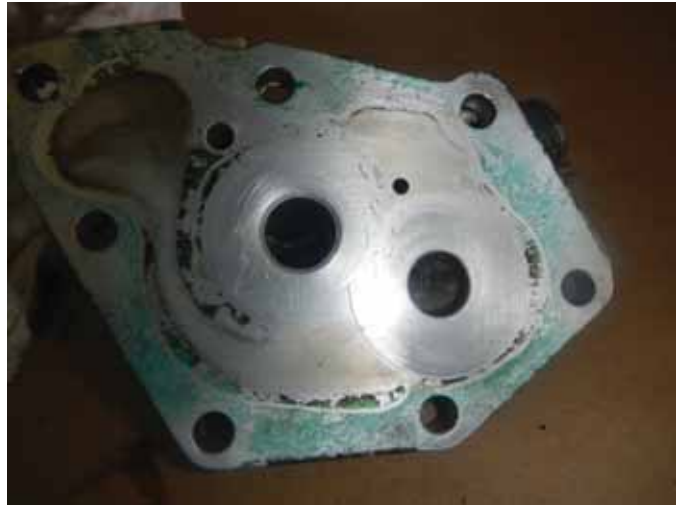
OIL PUMP

The oil pump housing remained intact and attached to the backside of the engine. The pump was removed and the gears were intact and the oil pump walls were free from contaminants. There was light scoring on the oil pump walls. A ½-inch arch of material was shaved from the housing wall in an area adjacent to the drive gear. Residual oil was found in the oil pump housing.

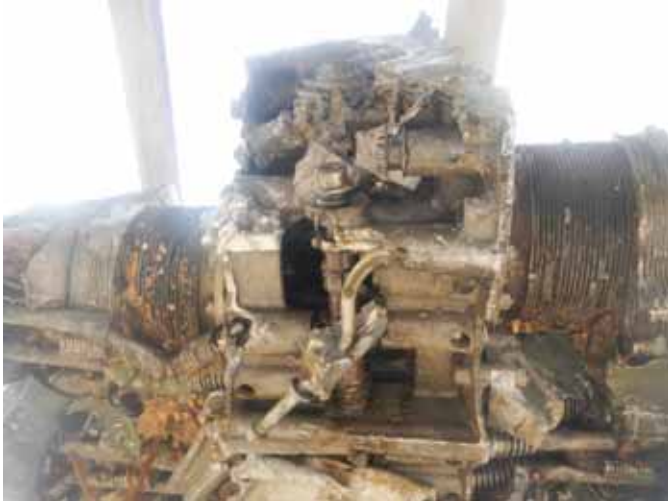
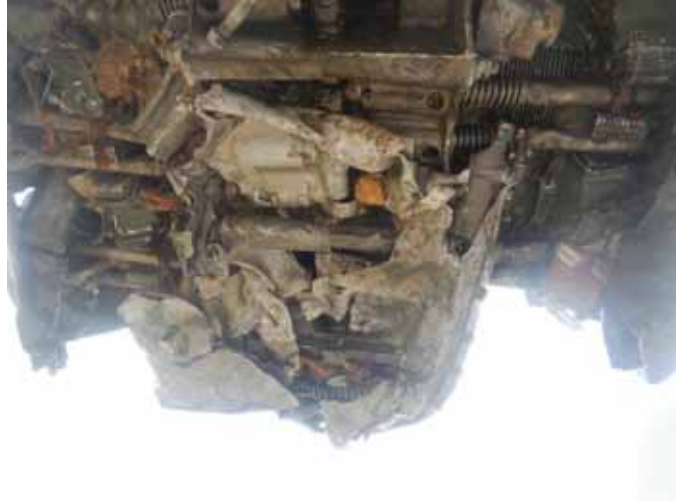
OIL SUMP

The oil sump was fractured and deformed around the bottom side of the engine.

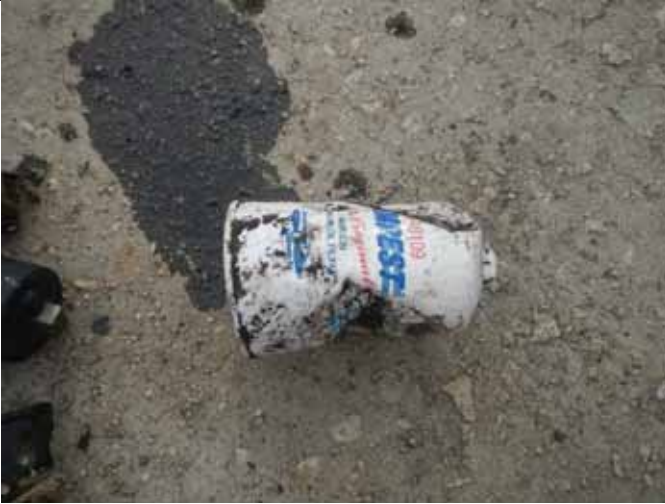
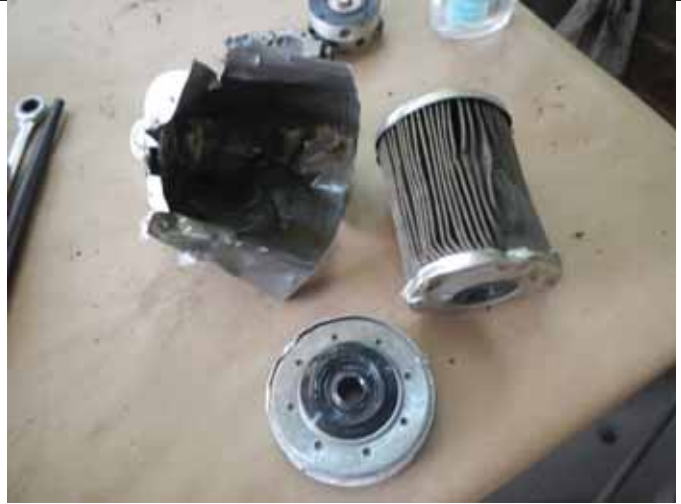
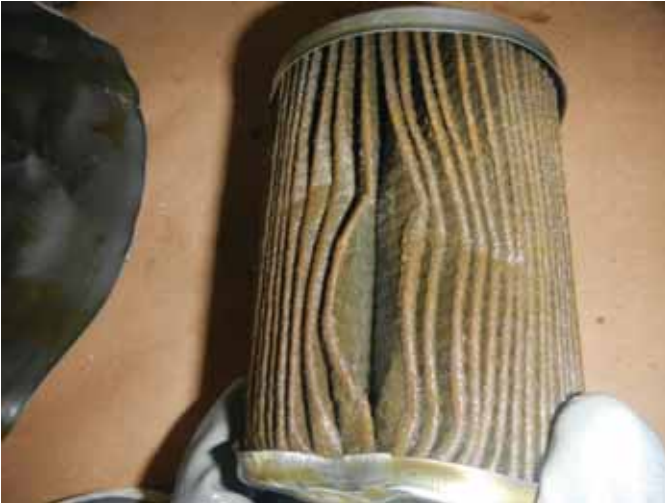
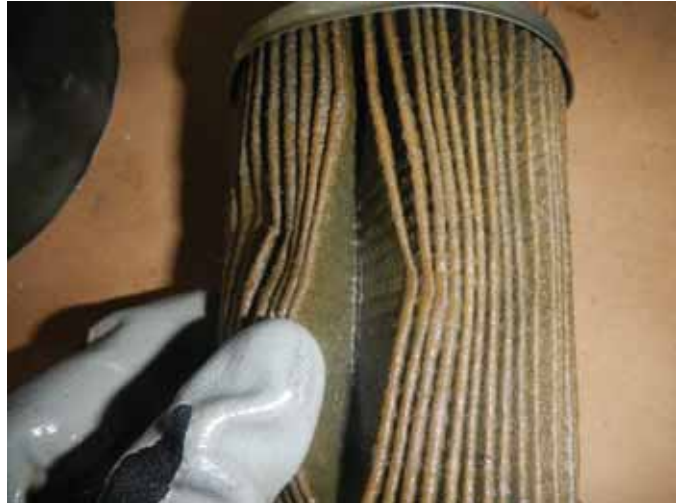
OIL FILTER

The oil filter was separated from the oil filter adapter and sustained deformation damage. The oil filter was cut open to remove the pleated paper filter element. There were no visible signs of contamination or metallic particulates within the pleats.

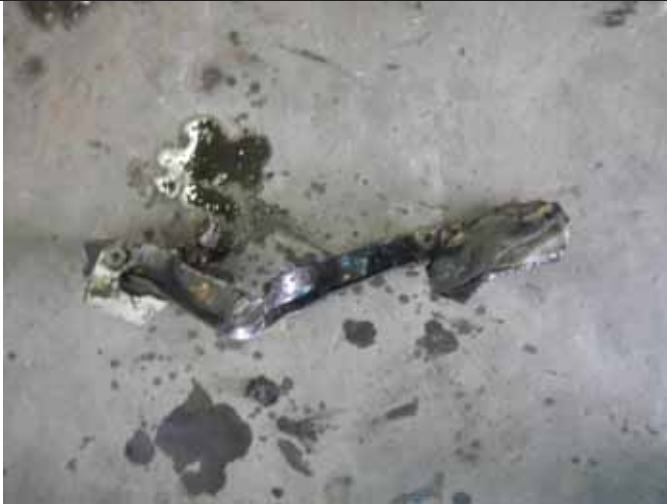
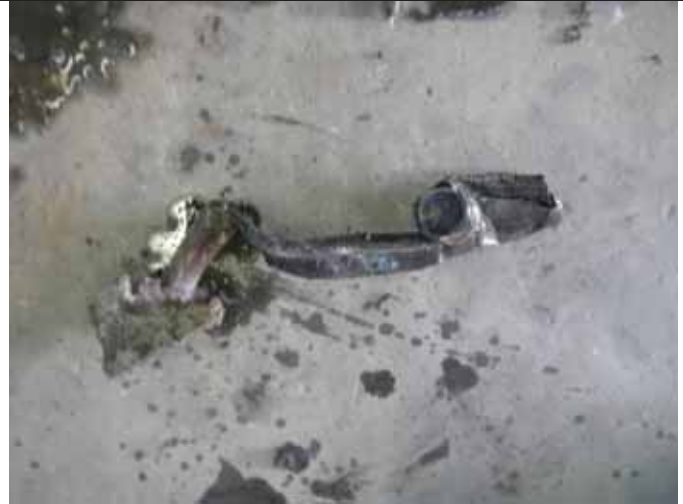
**OIL PICK-UP
TUBE &
SCREEN**

The oil pickup tube and screen were separated from the bottom side of the engine. The tube and screen sustained deformation damage. No pre-existing anomalies were noted.

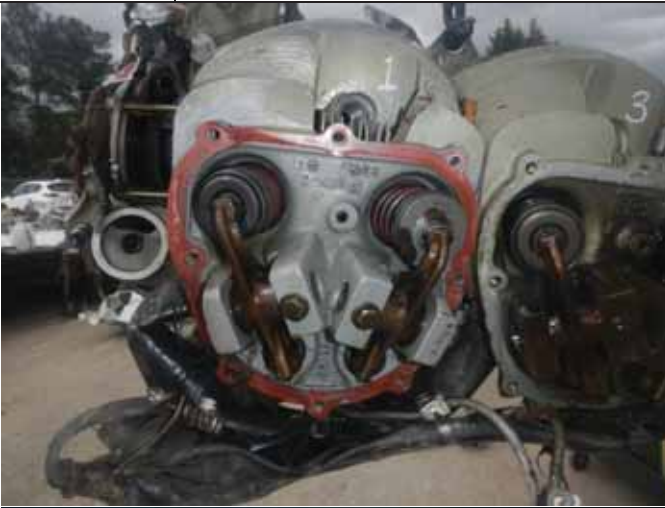
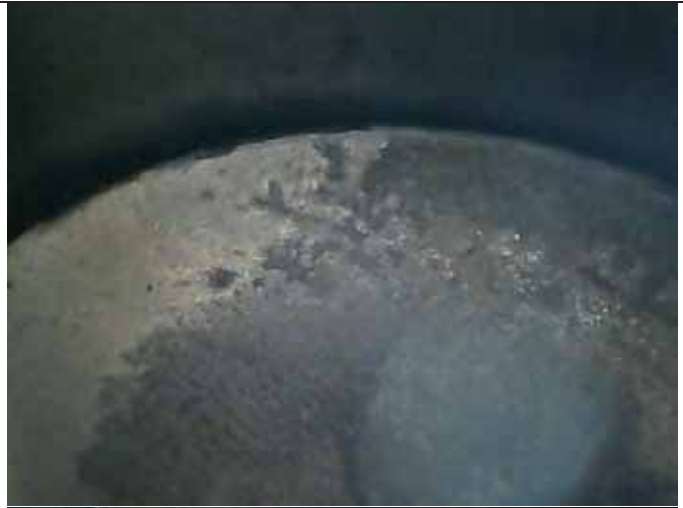
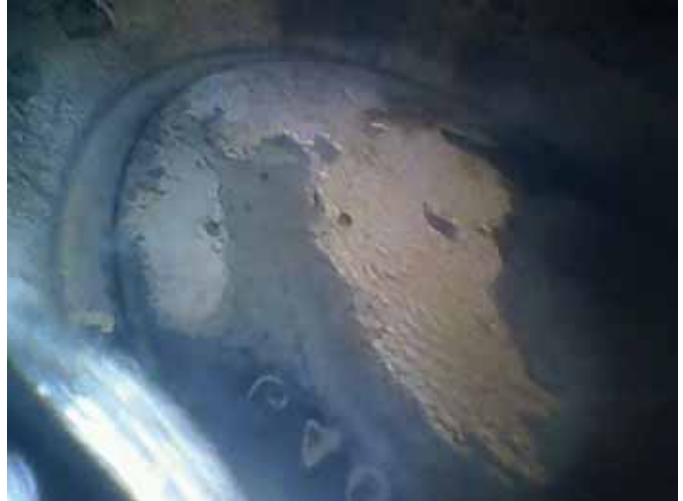
CYLINDER #1	P/N: Unknown	S/N: Unknown	Head Date: Unknown
Work Orders:	Unknown		
Condition:	Cylinder #1 remained attached to the engine and the rocker cover was in place. Numerous cooling fins were cracked and deformed. Removal of the rocker cover revealed that the head was cracked through the pushrod entry holes. The crack was irregular in shape and jagged. The cylinder was borescoped and no anomalies were noted with the piston, barrel, or valves.

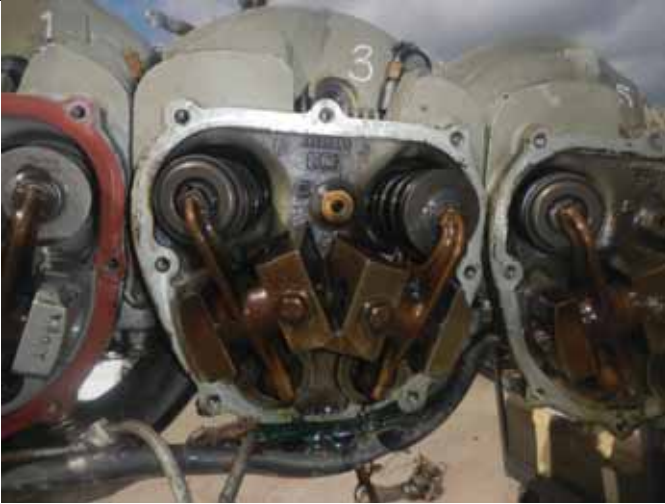
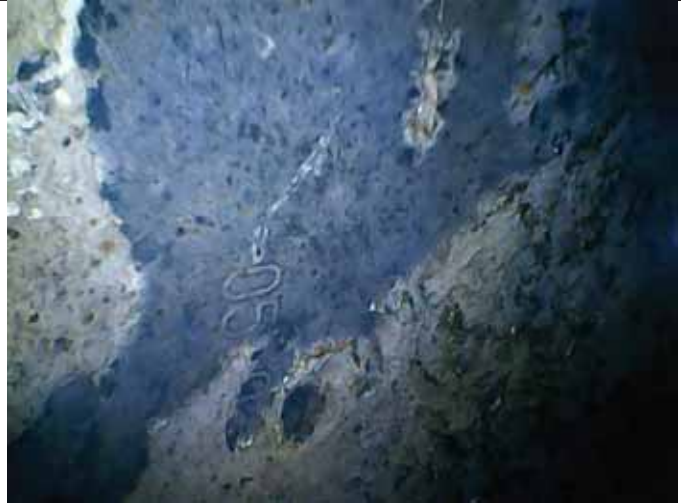
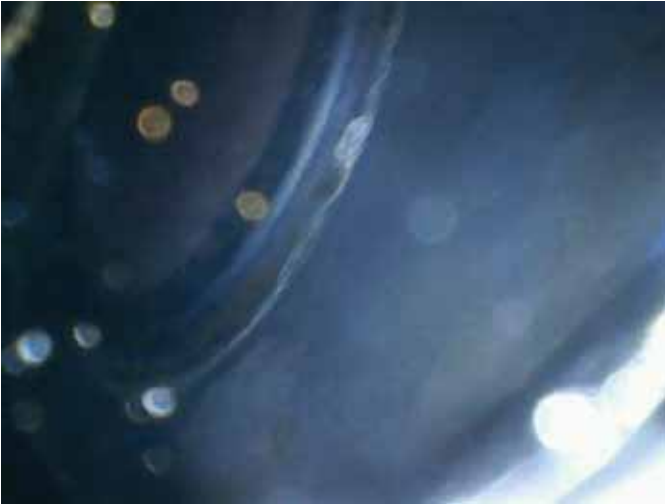
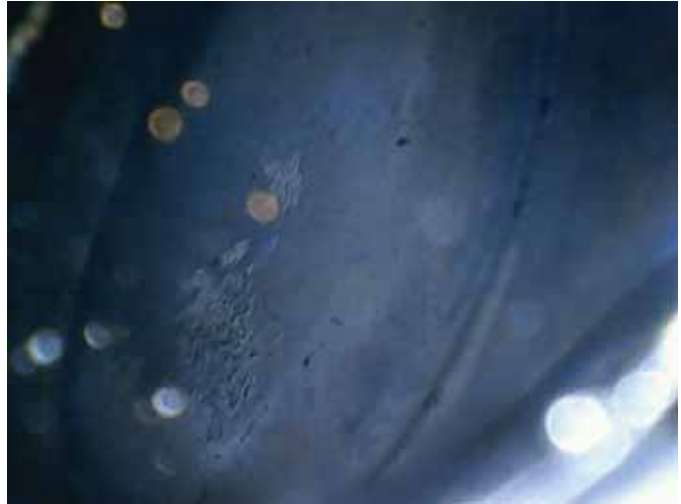
CYLINDER #3

The #3 cylinder remained attached to the crankcase and was intact. Numerous cooling fins were cracked and deformed. No pre-accident external or internal anomalies were noted with the cylinder, piston, barrel, or valves.

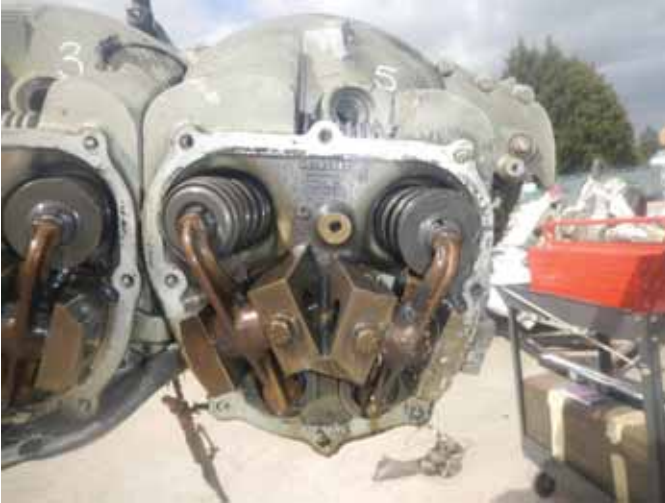
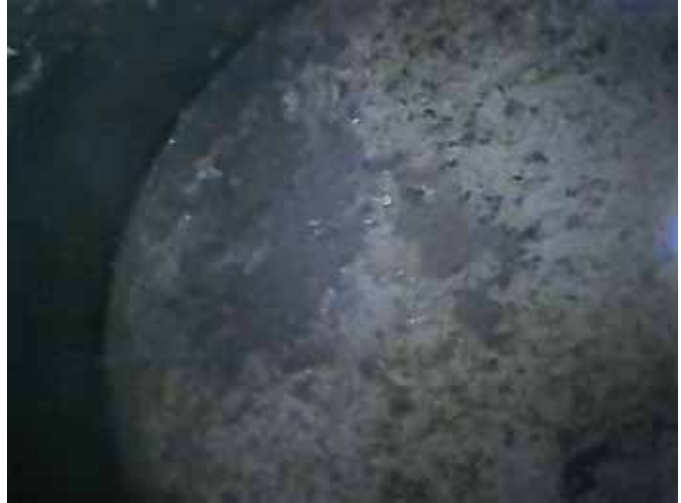
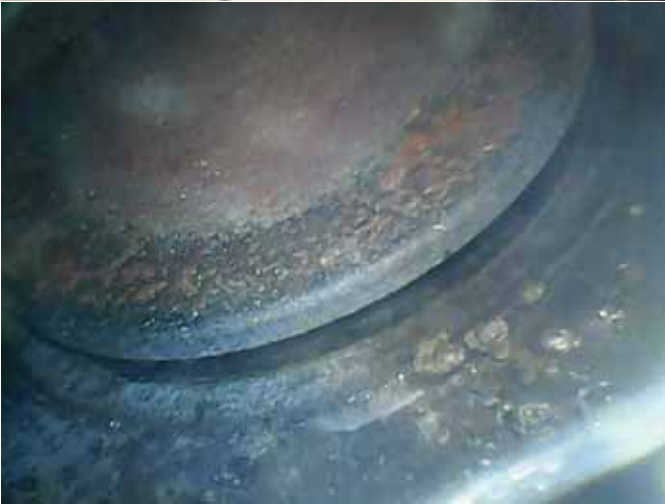
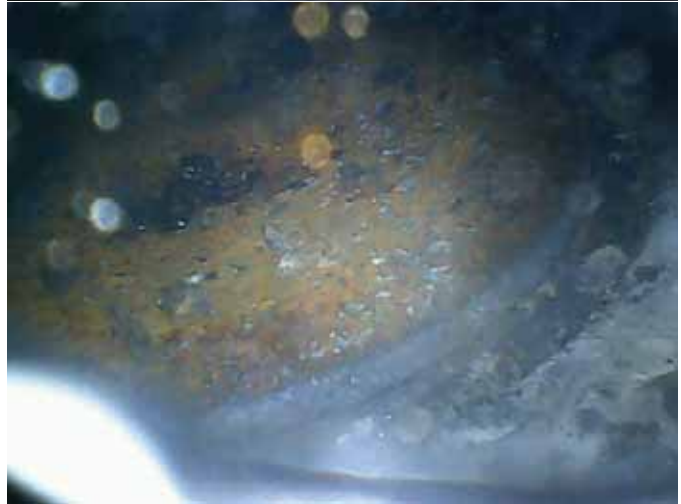
CYLINDER #5

The #5 cylinder remained attached to the crankcase and was intact. Numerous cooling fins were cracked and deformed. No pre-accident external or internal anomalies were noted with the cylinder, piston, barrel, or valves.

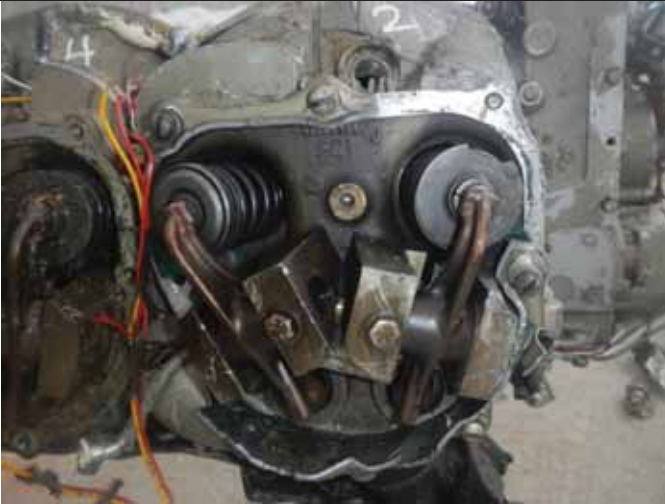
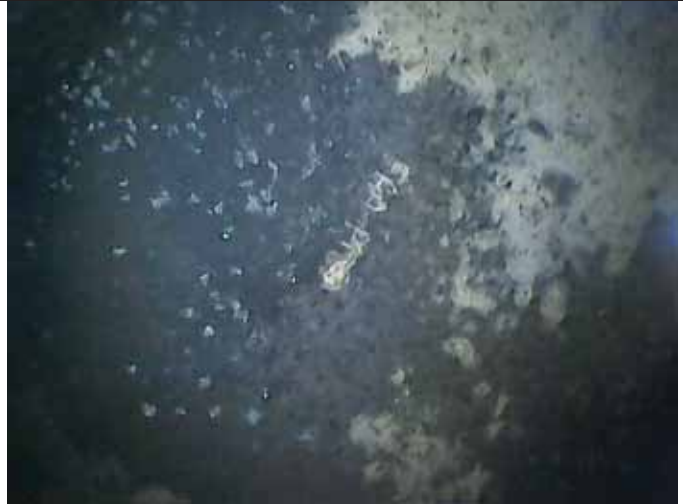
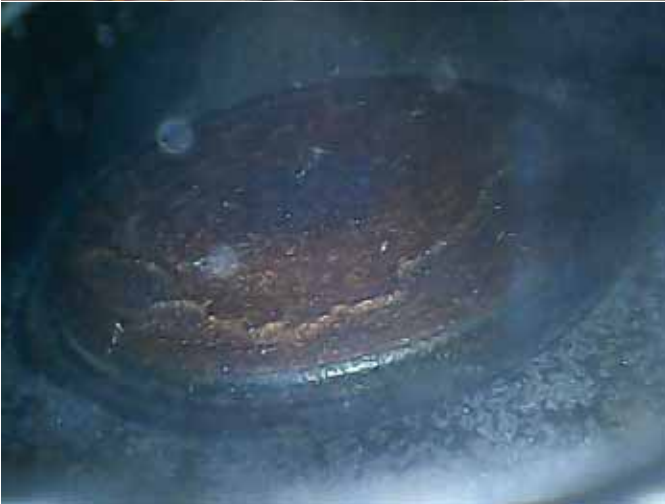
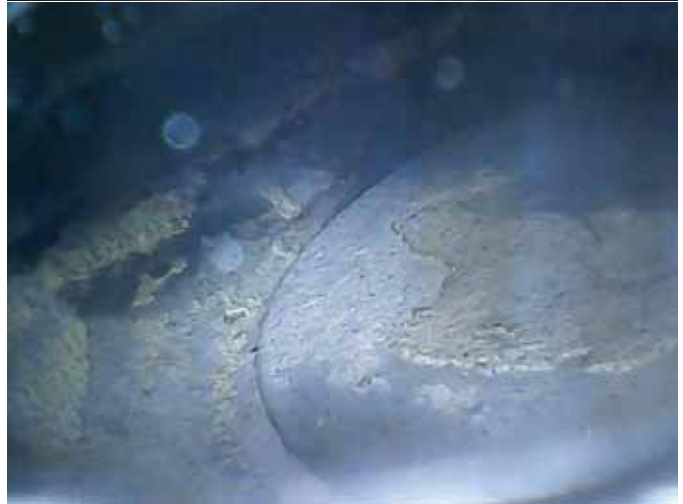
CYLINDER #2

The #2 cylinder remained attached to the crankcase. Numerous cooling fins were cracked and deformed. The rocker cover was destroyed. The cylinder was borescoped and no anomalies were noted with the piston, barrel, or valves.

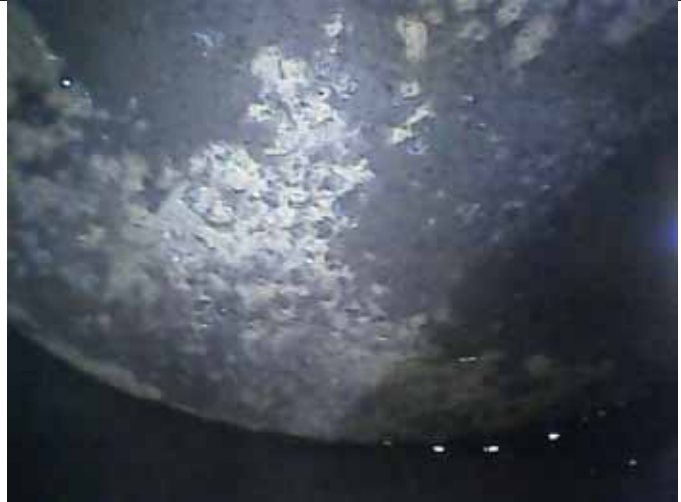
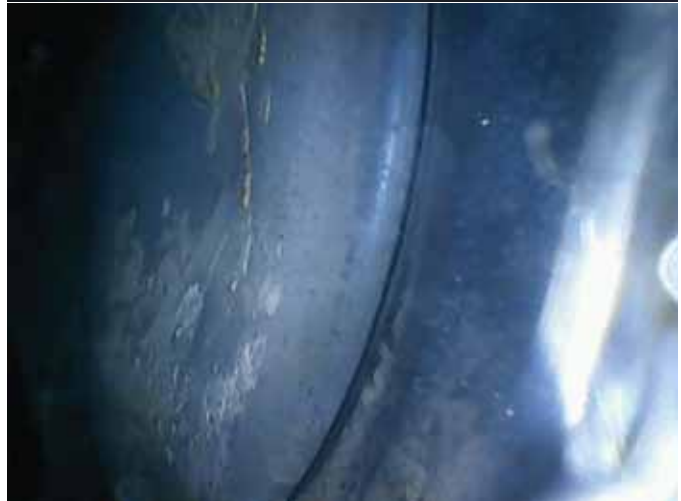
CYLINDER #4

The #4 cylinder remained attached to the crankcase. Numerous cooling fins were cracked and deformed. The rocker cover was fractured and dirt was located in the rocker area. No pre-accident external or internal anomalies were noted with the cylinder, barrel, piston or valves.

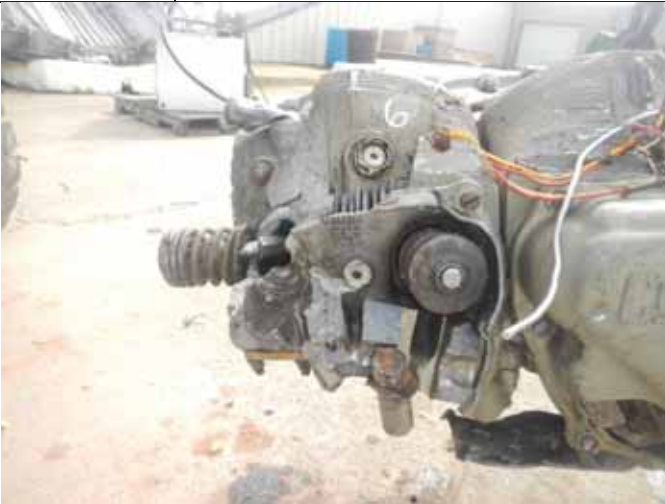
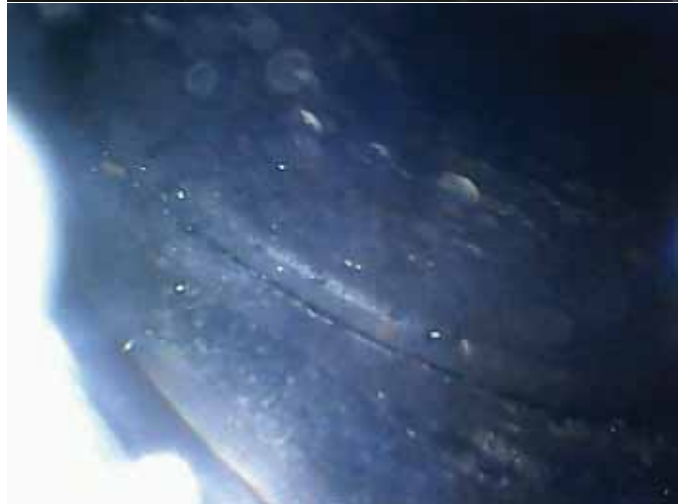
CYLINDER #6

The #6 cylinder was fractured and the rocker arms were missing. The exhaust valve stem was bent and the guide was fractured and displaced from the cylinder head. The exhaust valve springs remained with the valve. The intake rocker shaft remained attached to the cylinder. The cylinder barrel was depressed inward on the topside. A borescope inspection of the cylinder revealed dirt in the cylinder barrel. No pre-accident anomalies were noted with the piston, or valves.

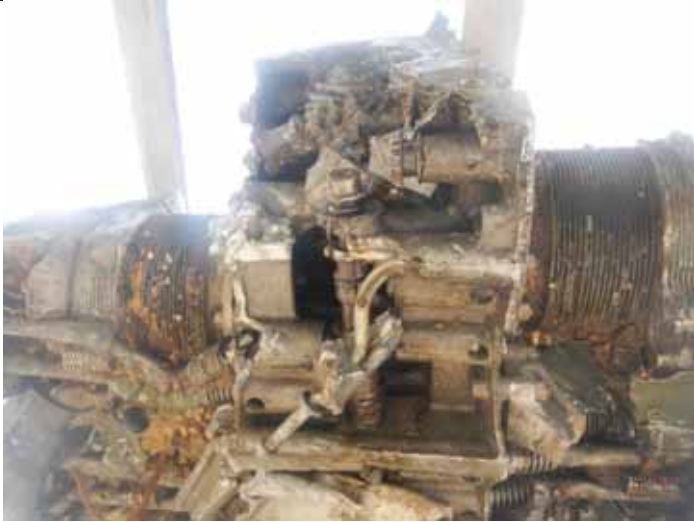
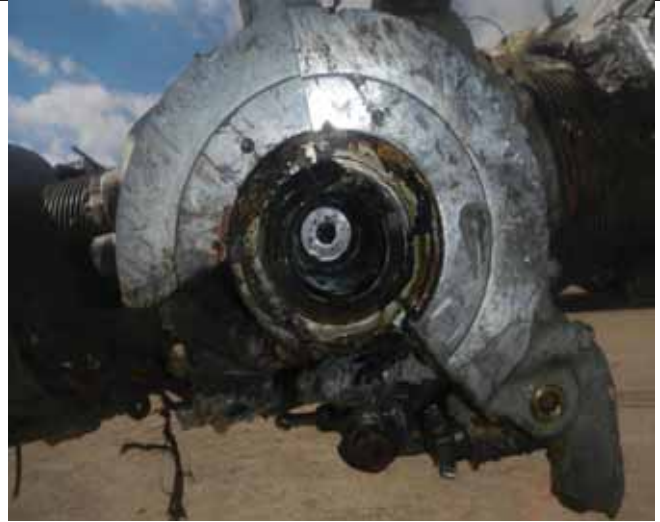
CRANKCASE	Casting Number:	1-3-5: 653961	2-4-6: 653960	S/N: Unknown
Condition:	The crankcase halves remained attached, but both were fractured on the front and bottom sections, exposing some of the internal engine components. No pre-accident anomalies were noted with the crankcase.

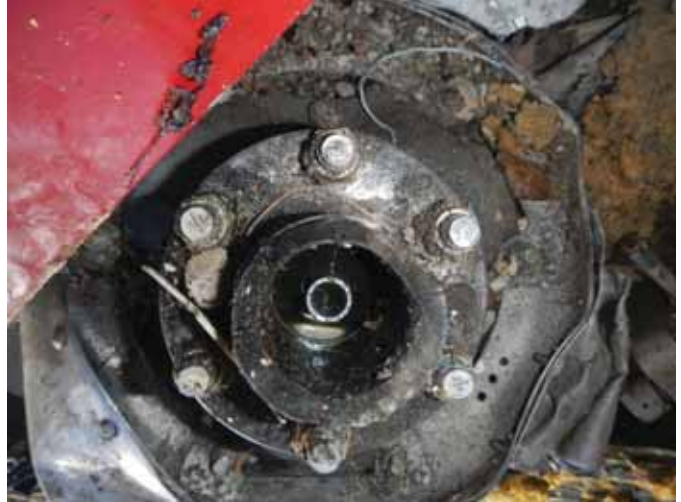
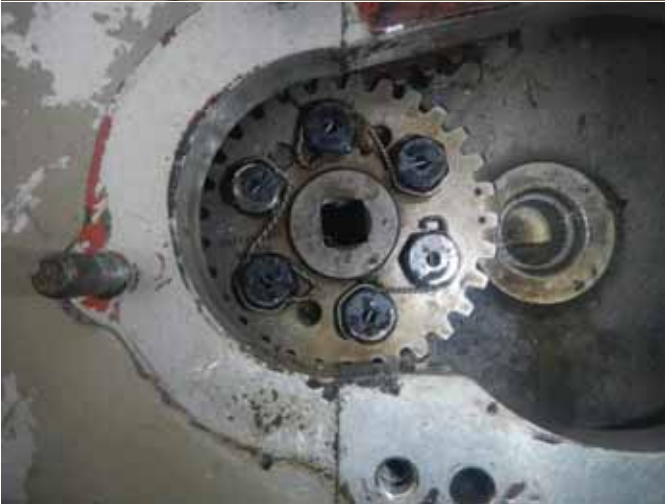
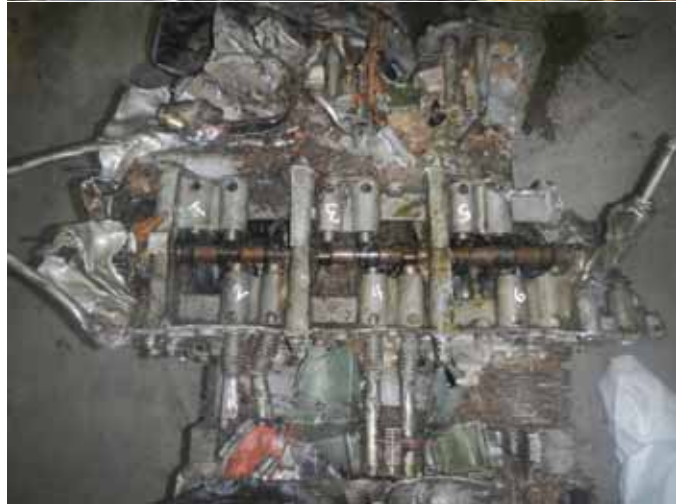
CRANKSHAFT

The crankshaft was fractured aft of the propeller mounting flange in the area where the crankshaft enters the crankcase. The fracture surfaces were irregular in shape and displayed 45° shear lips. Examination of the crankshaft through the bottom of the engine did not reveal any pre-accident anomalies with the crankshaft. The crankshaft gear remained attached and secured to the crankshaft.

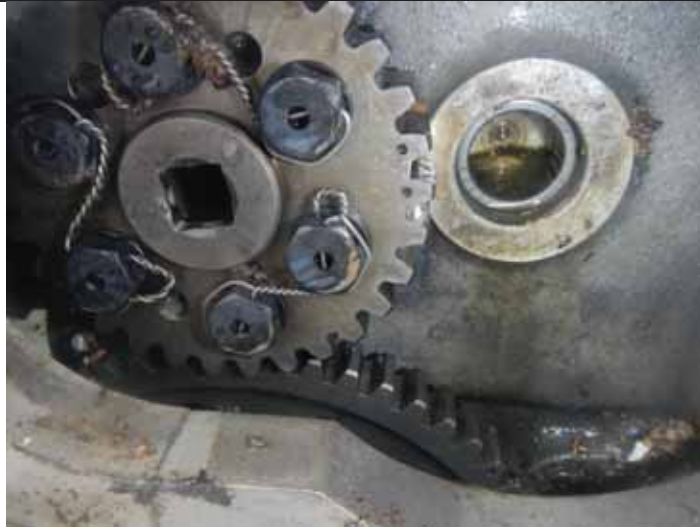
**INTERNAL
TIMING**

Condition: The internal engine timing was correct.
