Continental Motors

ENGINE FIELD INSPECTION REPORT

ENGINE MODEL	IO-520-L46B
ENGINE SERIAL	1000795
AIRCRAFT MAKE & MODEL	Cessna 210L
AIRCRAFT SERIAL NUMBER	21061454
AIRCRAFT REGISTRATION	N732EJ
FILE NUMBER	13-386

The engine sustained impact-related damage that fractured the crankshaft aft of the propeller flange and deformed the crankcase, cylinders, and oil sump, all of which precluded crankshaft rotation. However, examination of identified components did not reveal any pre-existing anomalies that would have prevented normal engine operation and production of rated power.

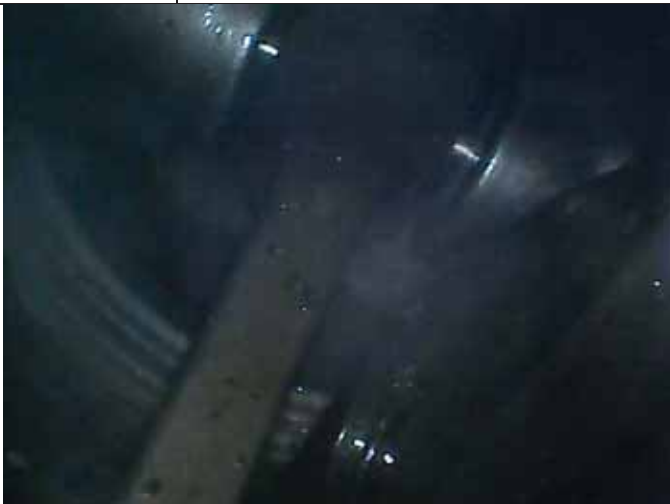
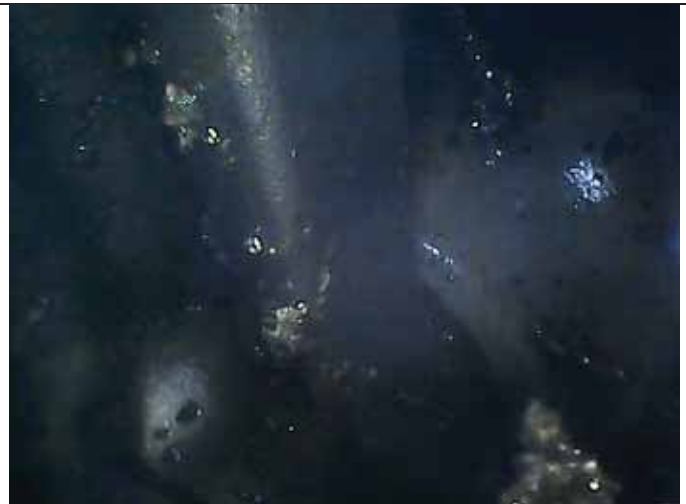
**CONNECTING
RODS**

Condition: The connecting rods were examined through the bottom of the engine. Using a lighted borescope it appeared that all six connecting rods remained attached to their respective connecting rod journal and piston pins. There was no sign of operational or heat distress on any of the connecting rods (the photos below are of the connecting rods #1 through #6, in that order).

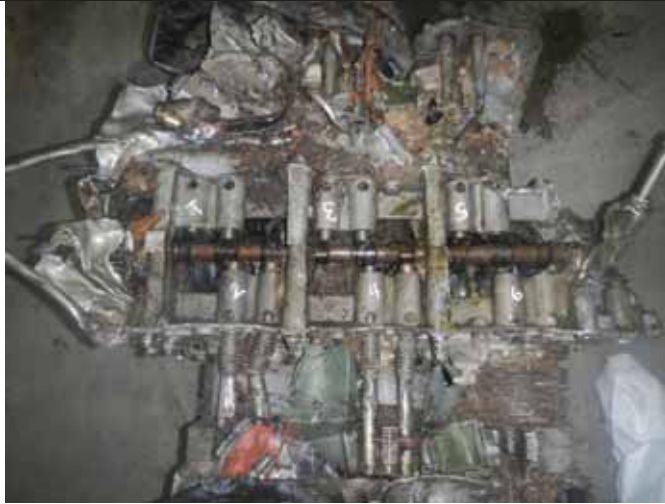
CAMSHAFT

The camshaft remained intact but sustained impact damage that separated the governor drive gear. No pre-impact anomalies were noted with the camshaft or the lobes.

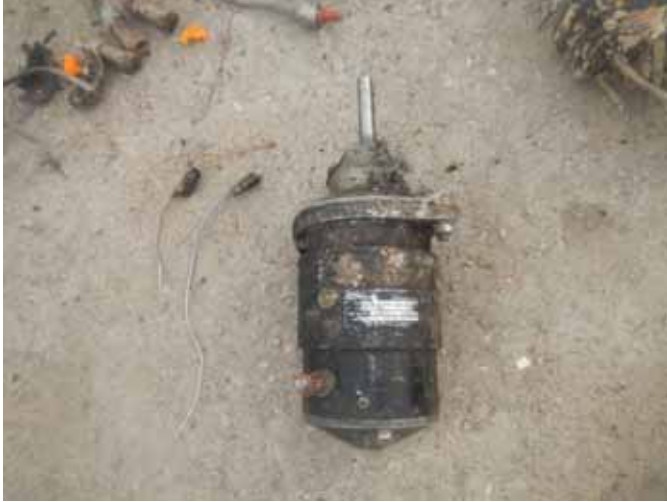
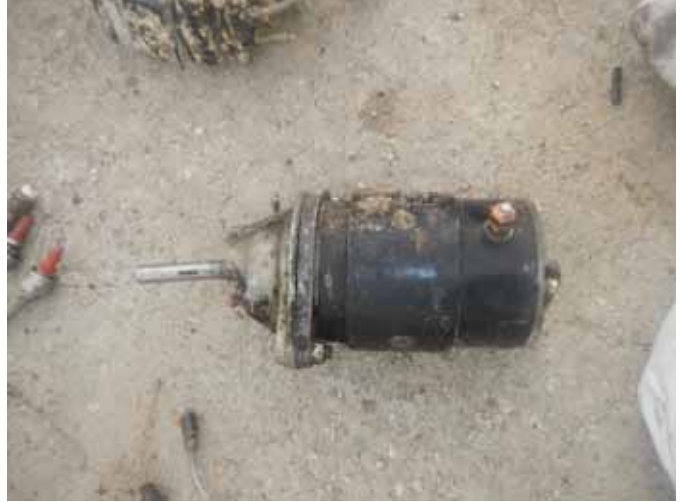
STARTER

The starter motor was separated from the starter adapter. There were no signs of pre-accident anomalies with the starter motor.

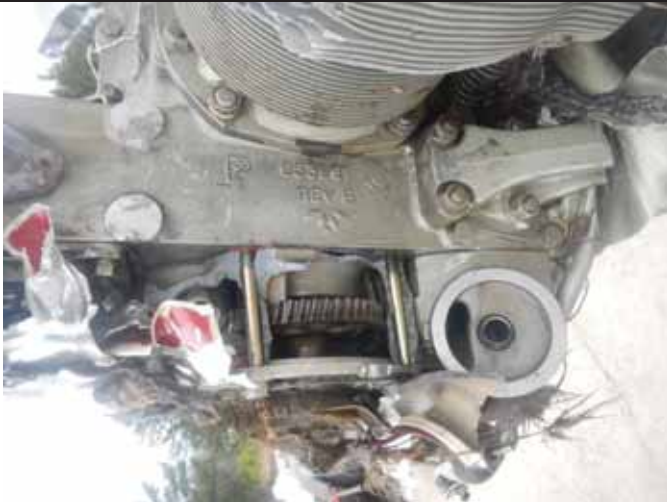
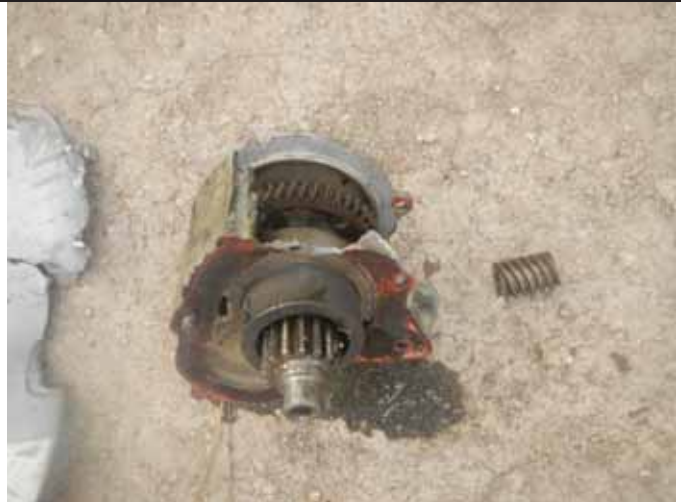
STARTER ADAPTER

The starter adapter remained attached to the backside of the engine, but sustained impact damage to the housing, which fractured a section. The internal gears were visible through the fractured housing. Removal of the starter adapter from the backside of the engine revealed no signs of operational distress with the gears.

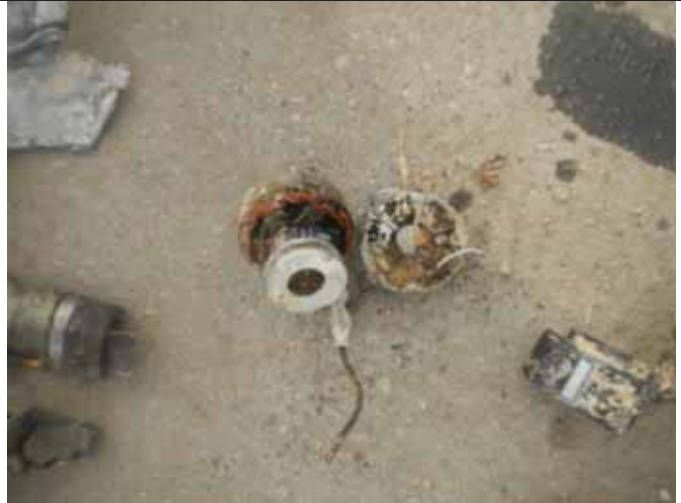
ALT/GEN #1

The alternator was separated from the engine and fractured.
