**Evaluation of Auxiliary Fuel Boost Pump
Part Number: 2003-B, Serial Number: 103252
From Make: BR Legend LLC, Model: Turbine Legend, Aircraft: N42BR
for NTSB Case: ERA15FA221**

Evaluated 06/May/2016

1.0 SCOPE

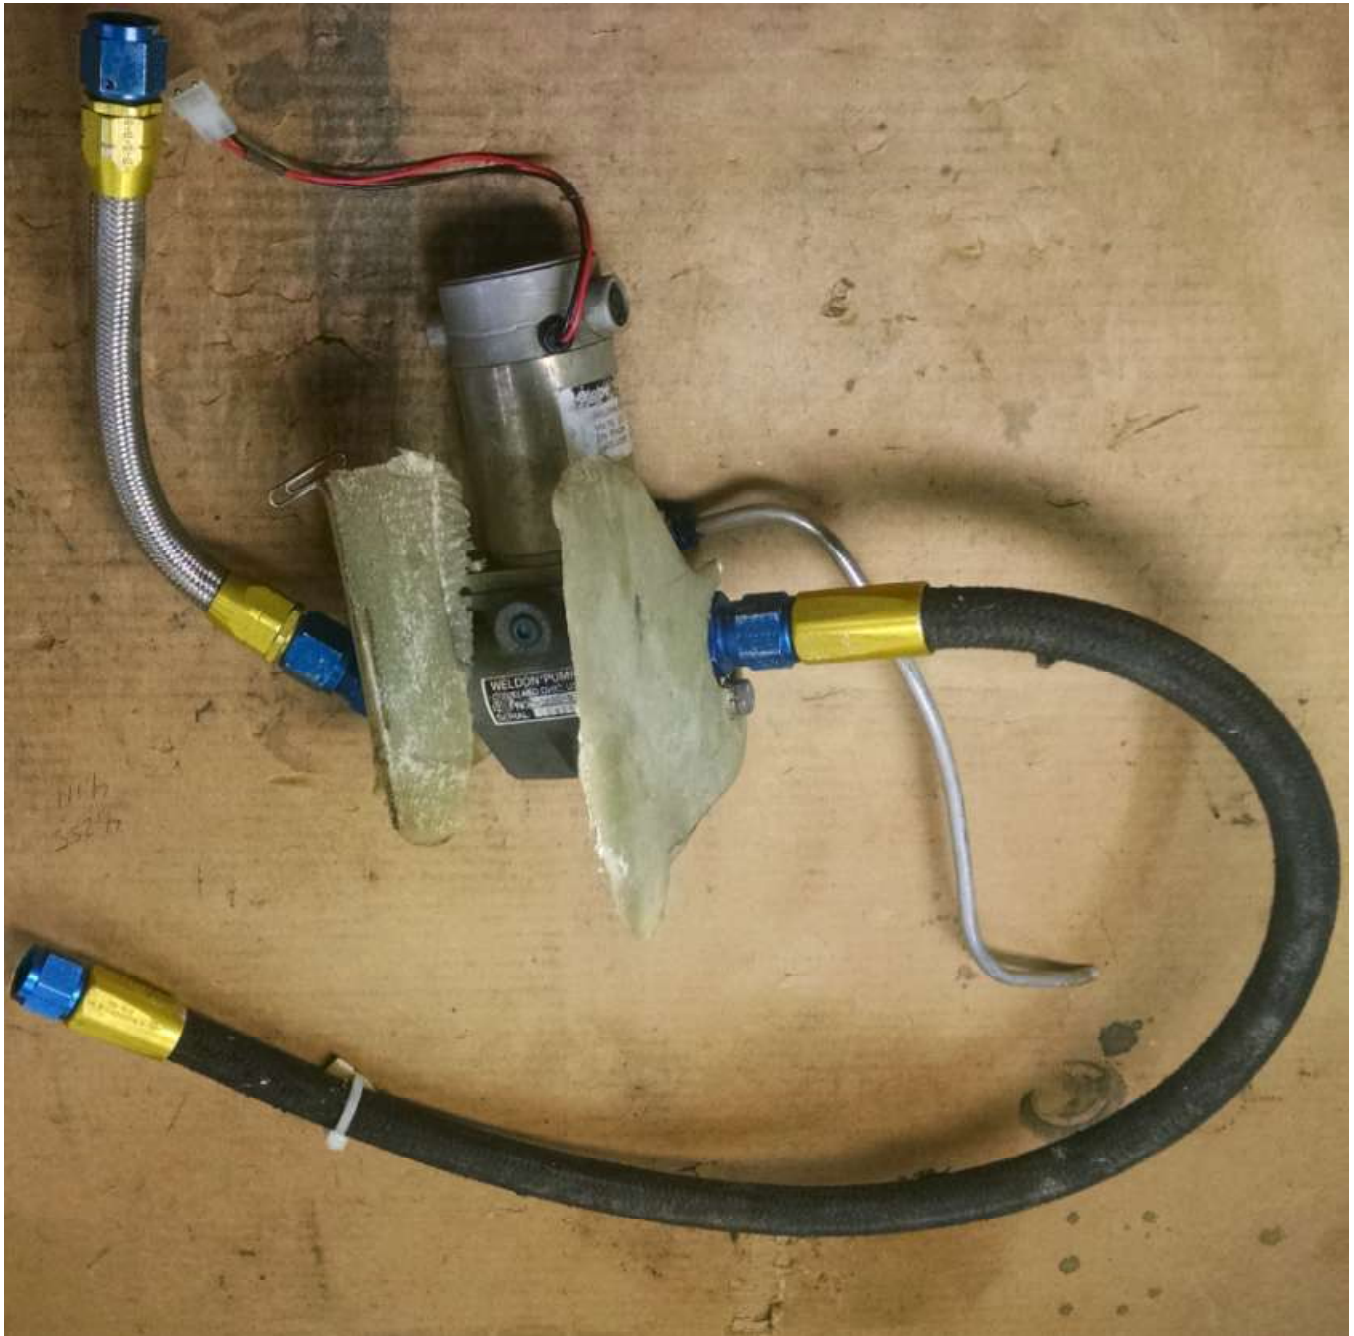
Figure I shows non-Weldon supplied parts connected/installed to/on/in the pump-motor assembly:

non-Weldon supplied parts connected/installed to/on/in the pump-motor assembly

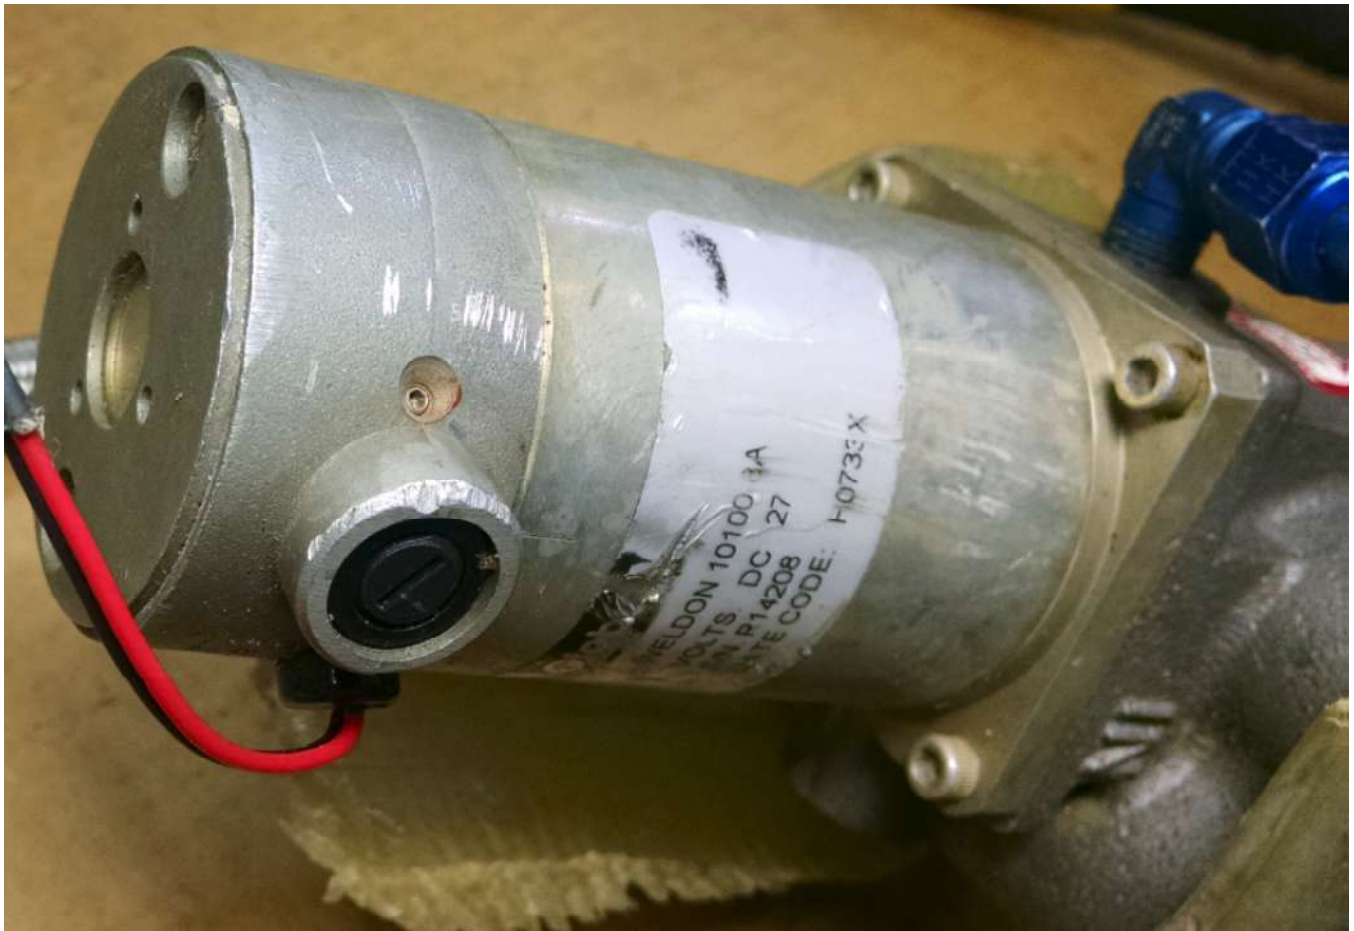
Figure II

- Damage/abrasion/trauma to the motor assembly's commutation end frame on the brush holder boss located on the inlet side of the pump as illustrated in Figure II.
- One out of two of the motor's brush caps being of red material indicates that this article was last serviced/configured by other than the Weldon Pump Factory and/or Weldon Pump Factory Repair station utilizing factory supplied spare subcomponents as illustrated in Figure III.

Damage/abrasion/trauma to the motor assembly's commutation end frame on the brush holder boss located on the inlet side of the pump

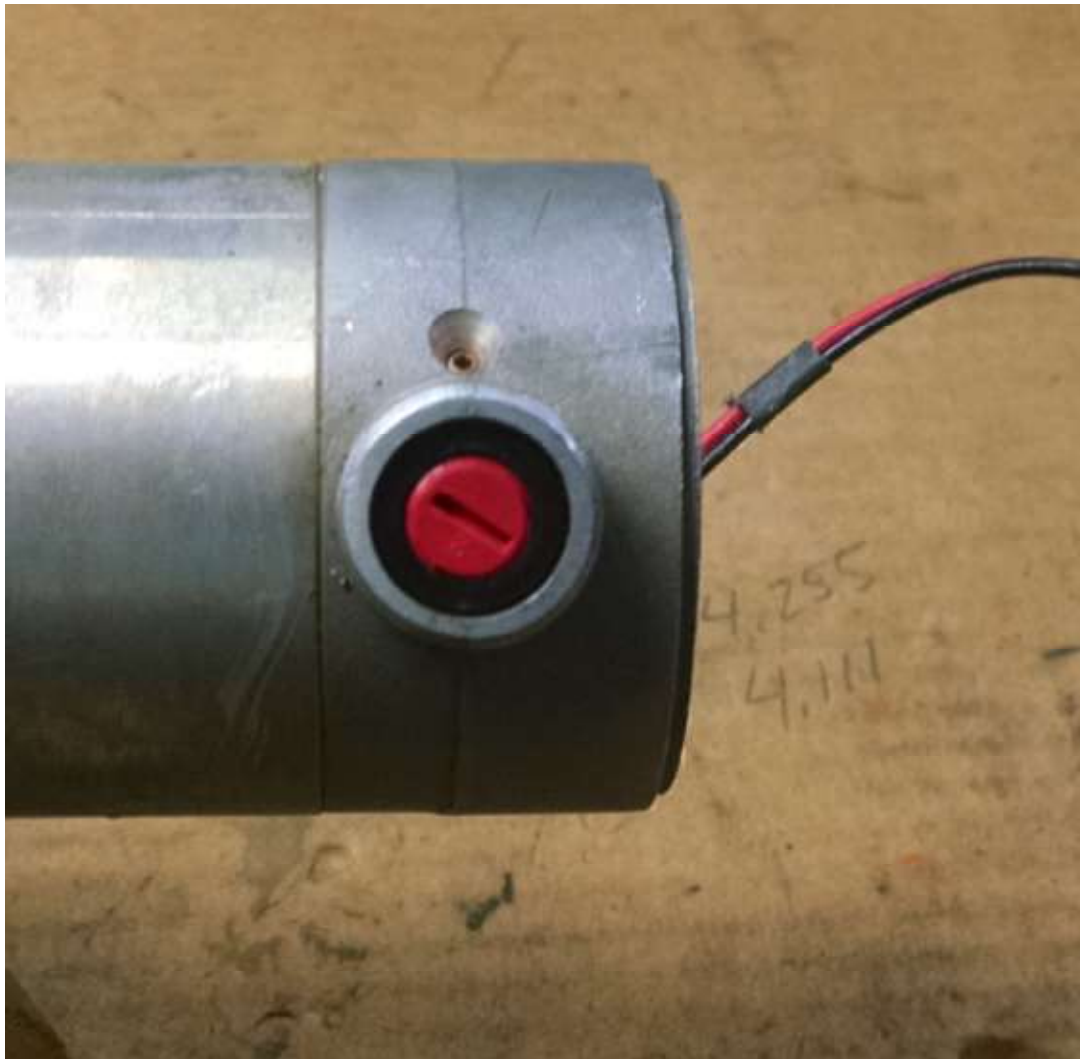
Figure III

One out of two of the motor's brush caps being of red material indicates that this article was last serviced/configured by other than the Weldon Pump Factory and/or Weldon Pump Factory Repair station utilizing factory supplied spare subcomponents

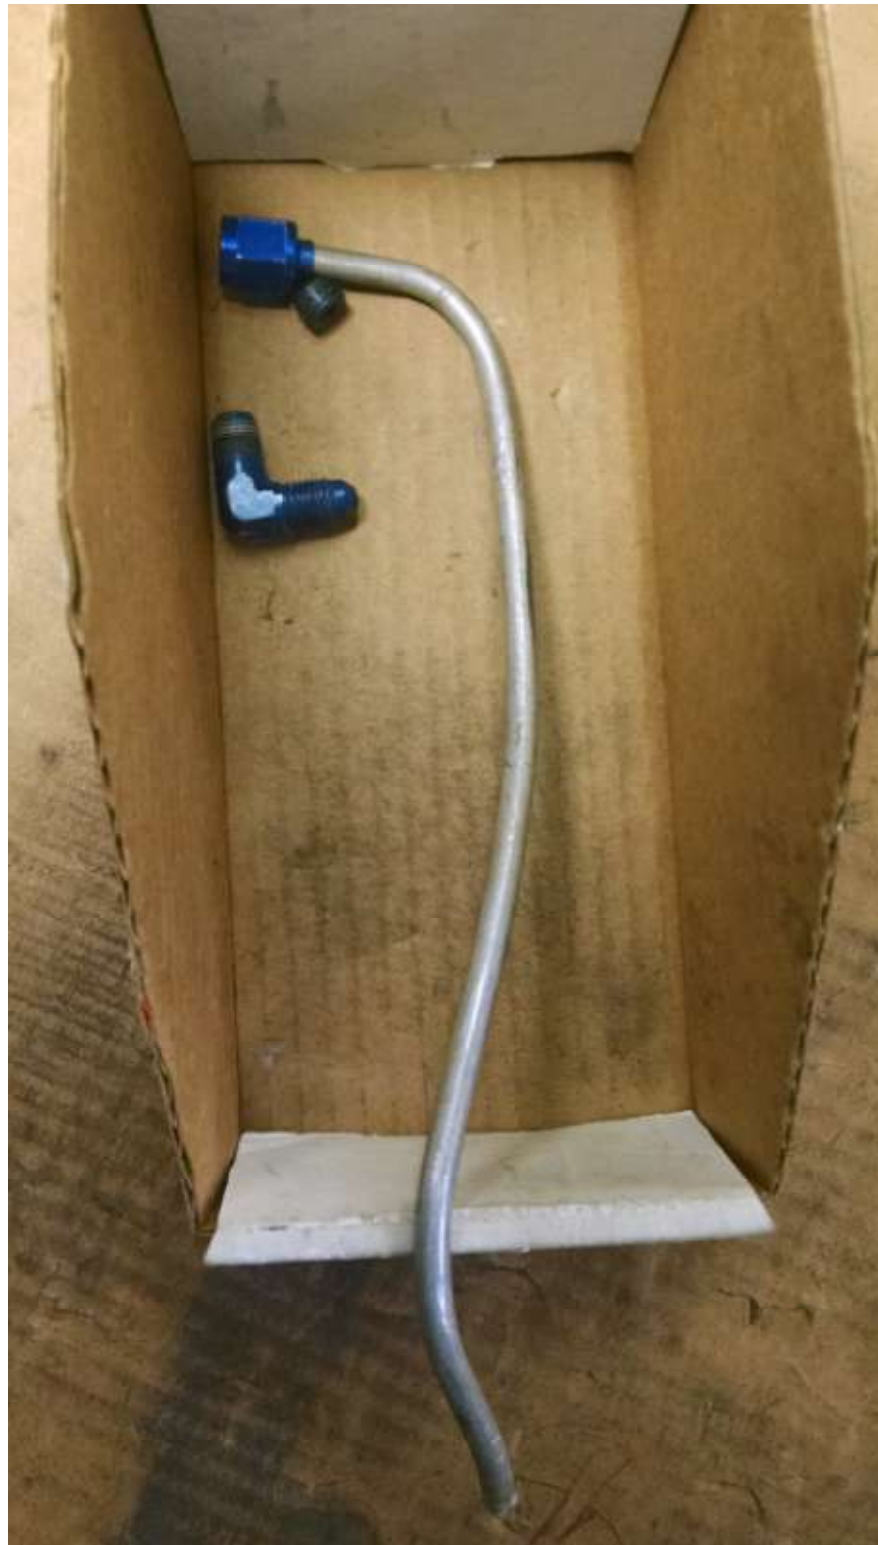
Figure IV

- All hardware, as previously defined, was removed from both of the Overboard seal drain ports to allow monitoring for the potential of a dynamic shaft seal leak during the acceptance testing. See Figure IV. Note, the overboard drain line was loose and could easily spin as supplied for this evaluation.

All hardware, as previously defined, was removed from both of the Overboard seal drain ports

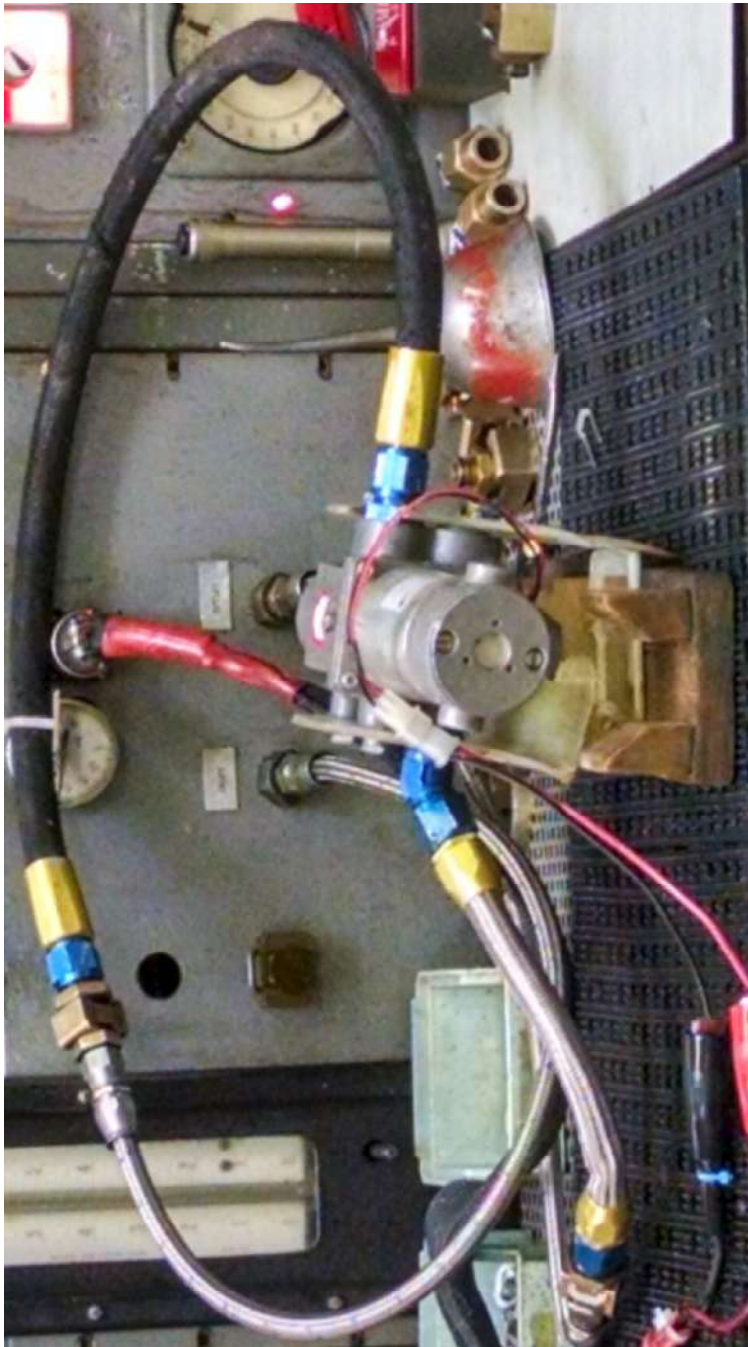
Figure V

- The Pump-motor assembly was installed on Weldon's "L" style production test stand in order to perform the elevated inlet seal testing portion of the acceptance test. See Figure V. The pump was run with a 10 PSIG inlet & 25 PSIG outlet for 2:00 minutes while the overboard drain ports were monitored for signs of a fluid leak, no leak was present. The Pump-Motor assembly passed this test.

The Pump-motor assembly was installed on Weldon's "L" style production test stand

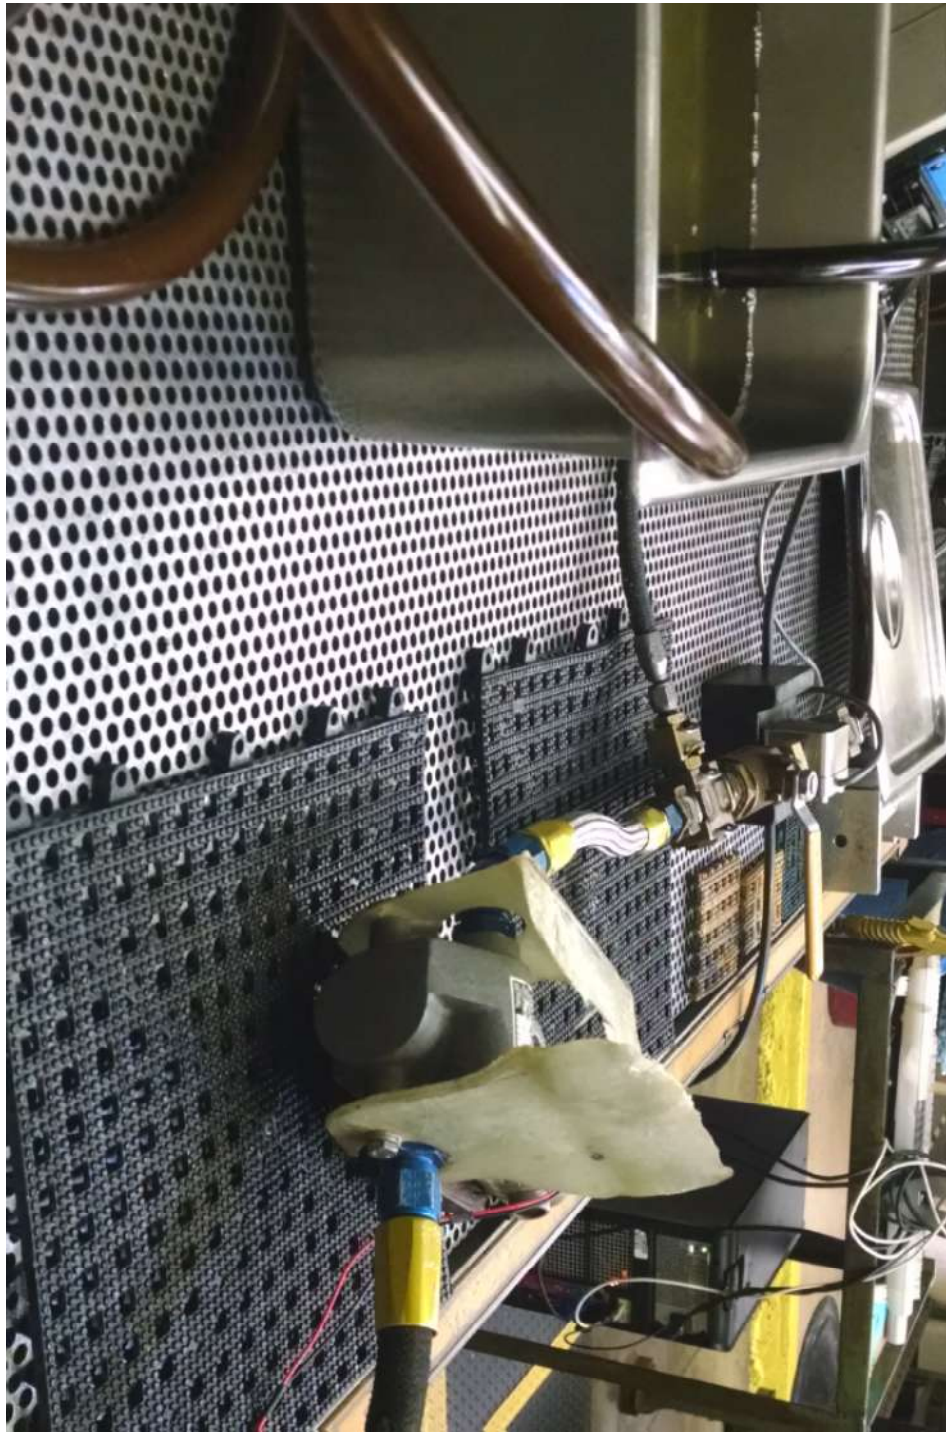
Figure VI

- The Pump-motor assembly was removed from the "L" style stand and moved to the test bench next to the "J" style stand for the remainder of the acceptance testing. See Figure VI. The Pump-motor assembly was provided 28 VDC and allowed to prime. Next the full relief was tested via the closure of a ball valve on the outlet. The full relief was measured at 23 PSIG @ 28 VDC & 3.25 amps. Note, Weldon's production test records show that this serial number pump left the factory with the full relief set at 30 PSIG @ 28 VDC & 3.9 amps. Next the valve on the

oulet was adjusted to the specified 15 PSIG operating pressure & the flow was recorded at 55 GPH @ 3.15 amps. Note, the minimum required flow at 15 PSIG for the 2003-B model is 105 GPH, therefore this pump had failed the acceptance test. In order to "rule out" that by testing with the lines and fittings that would not have been present during the original factory tests having caused a few PSI pressure drop & therefore the overall acceptance test failure the pump was then measured at 10 PSIG operating @ 72 GPH then at 5 PSIG @ 86.8 GPH both results still constitute a failure of the required flow. Finally vacuum was tested @ 28 VDC dry & found to be 10 in/Hg. With the pump wetted the vacuum would spike to 20 in/Hg then drop. The Vacuum was originally measured at 24 in/Hg when the pump was factory new.

The Pump-motor assembly installed on test bench next to the "J" style stand

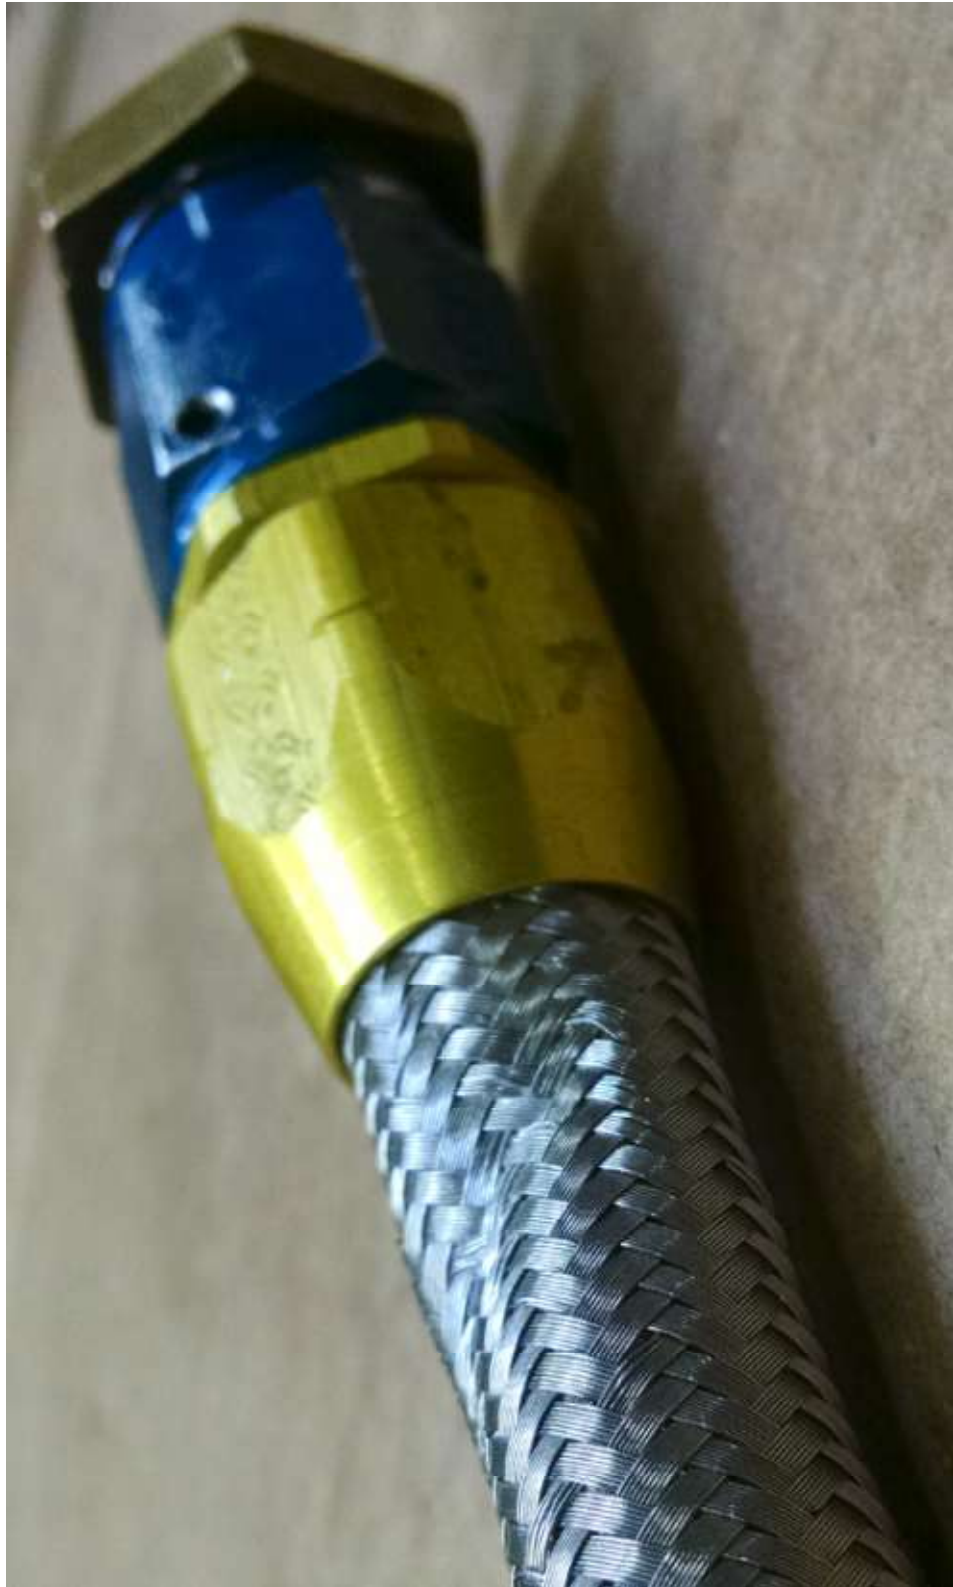
Figure VII

Slight crimp in the 1/2" stainless steel over braided flexible fluid line

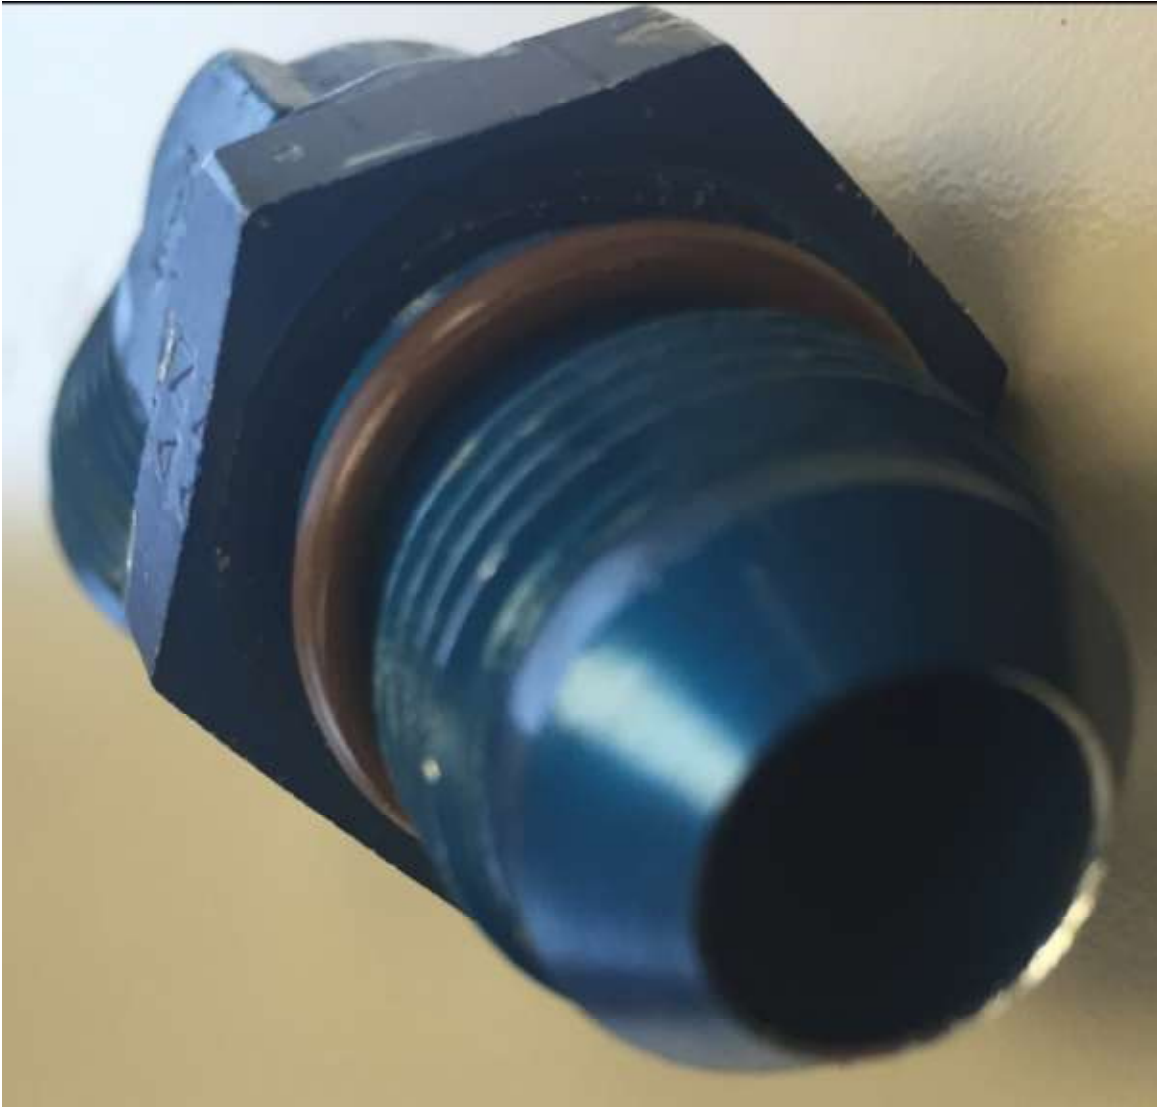
Figure VIII

- The Pump-motor assembly was removed from the test set-up and the inlet & outlet lines and fitting were removed. A slight crimp in the 1/2" stainless steel over braided flexible fluid line was more apparent although not of concern, see figure VII. Note, also at this time it was discovered that the outlet fitting, being of the universal type, was installed further/deeper than what is instructed within the AND10064 spec governing this type of interface. The end of the fitting had been contacting the Pump-motor assembly's valve poppet, see Figure VIII, Figure IX, Figure X-A, & Figure X-B.

1st The end of the fitting had been contacting the Pump-motor assembly's valve poppet

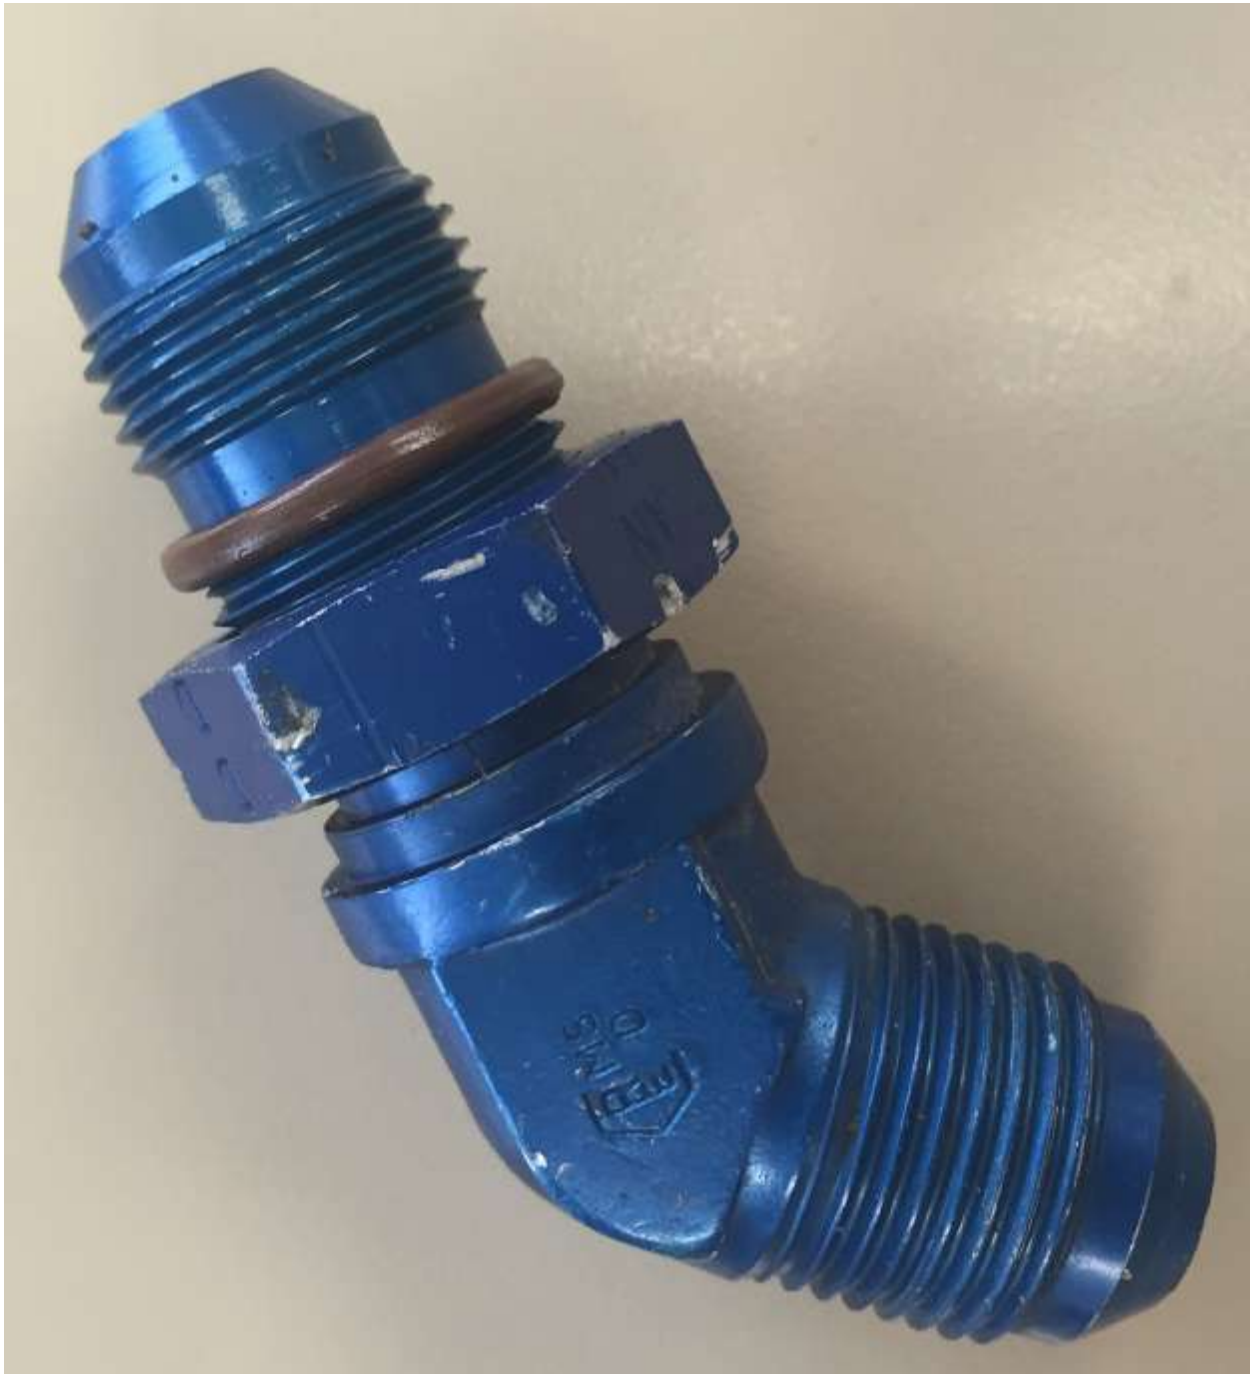
Figure IX

2nd The end of the fitting had been contacting the Pump-motor assembly's valve poppet

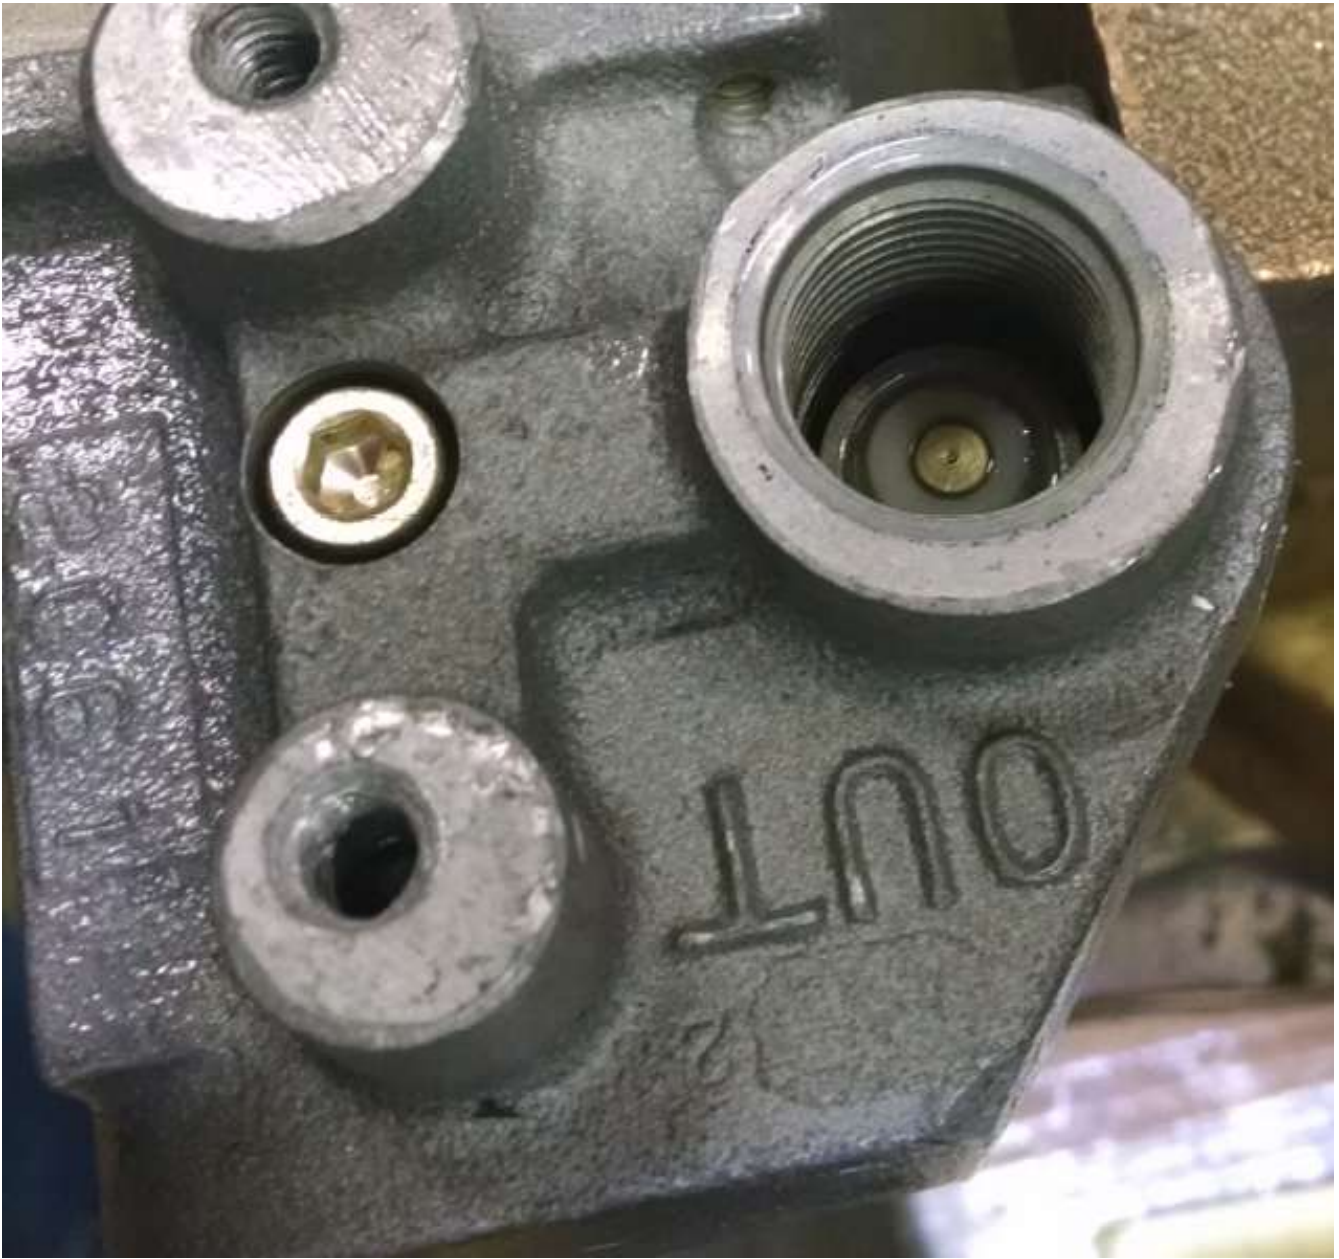
Figure X-A

3rd The end of the fitting had been contacting the Pump-motor assembly's valve poppet

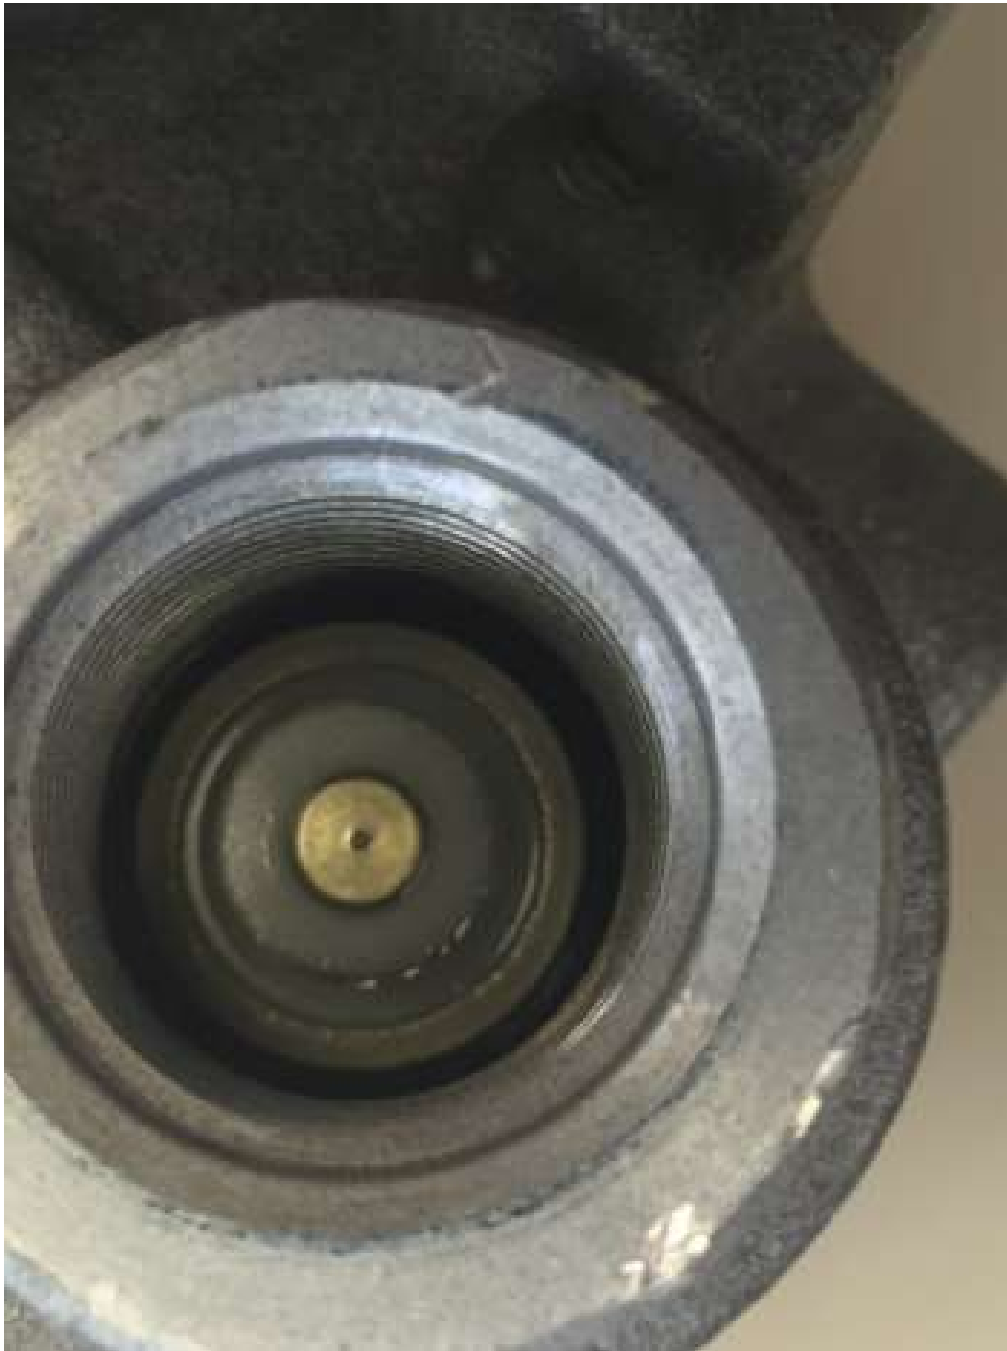
Figure X-B

3rd The end of the fitting had been contacting the Pump-motor assembly's valve poppet
