**Air Tractor, Inc.**  
Accident Investigation

**AILERON DEFLECTION ANALYSIS**

**ERA18FA088**

**2/26/18**  
**Greenwood, MS**

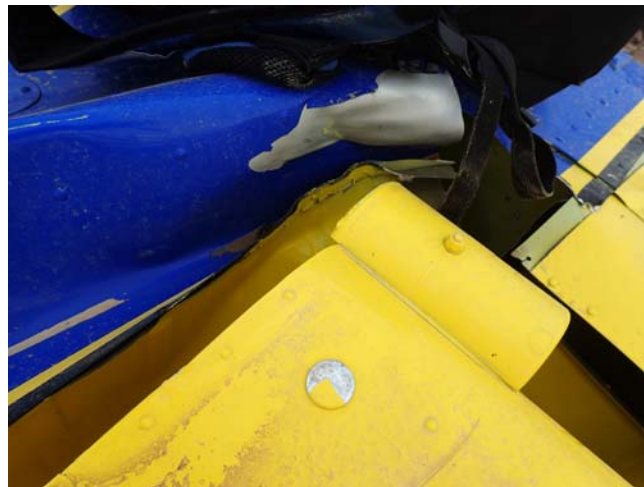
The outboard end of the righthand aileron exhibited a crease that corresponded to contact with the wing trailing edge rib. There were also markings of the aileron counterweight making contact with the lower surface of the wing trailing edge. Both of these are indications that the righthand aileron was deflected upward at the moment that contact was made with the wing trailing edge.

**Contact of Righthand Aileron Counterweight with Trailing Edge Skin**

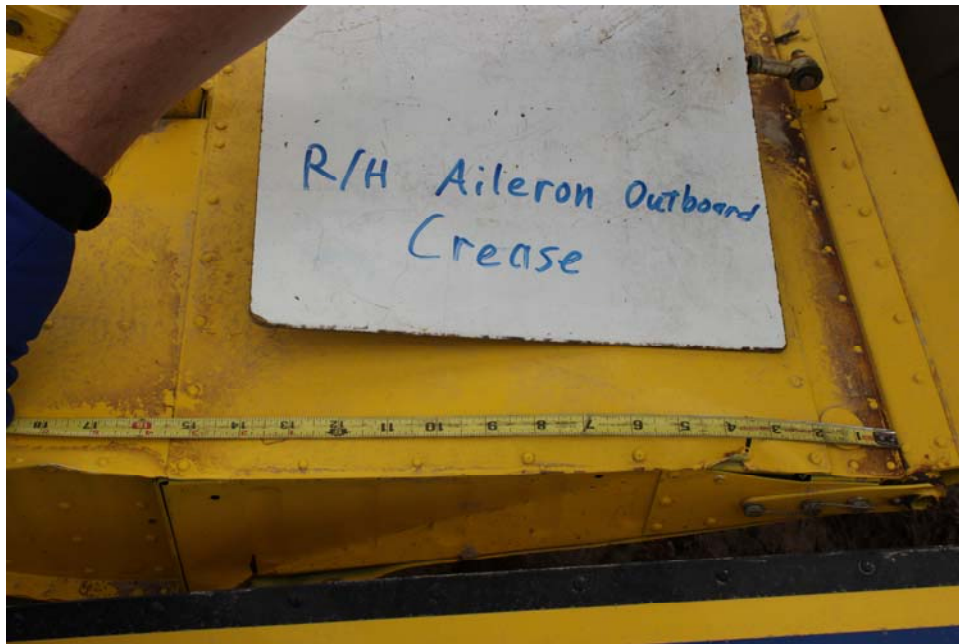
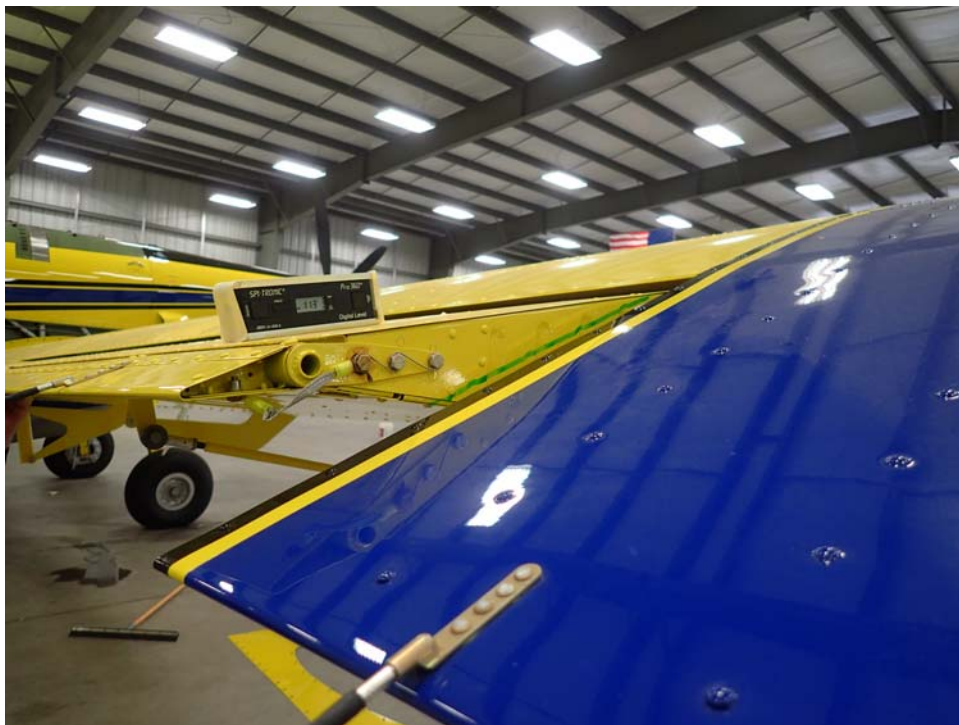
The crease in the aileron was represented by a green line on the exemplar AT-802A. The aileron was then deflected to align this green line with the wing trailing edge. This deflection was then measured and found to be 11.4° upward deflection of the aileron.

**Crease on Outboard Righthand Aileron**

**Deflection of Righthand Aileron on Exemplar AT-802A**

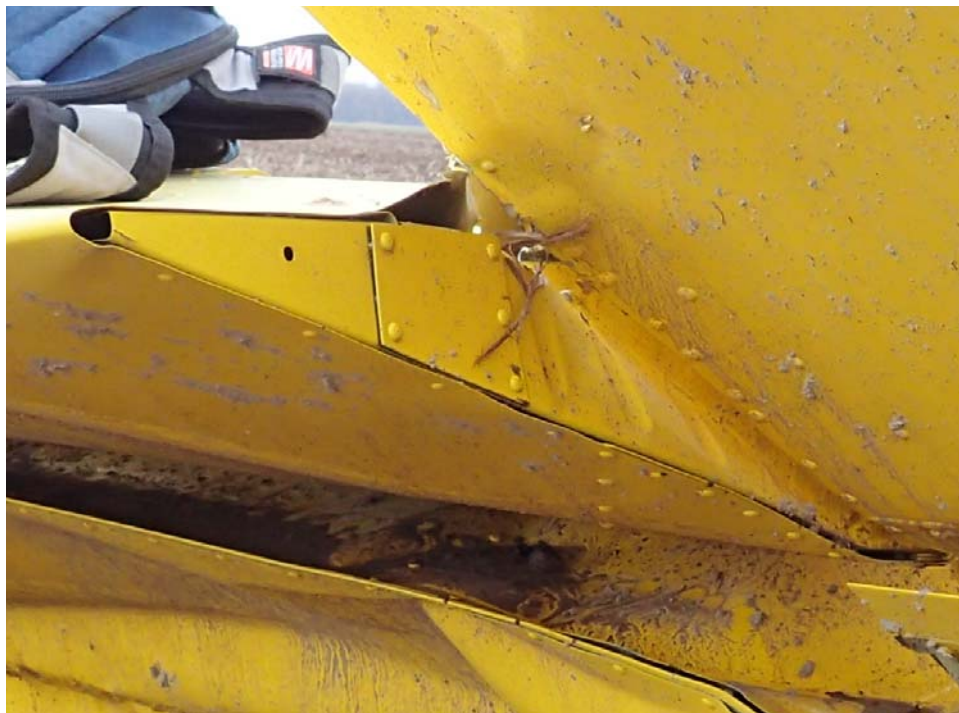
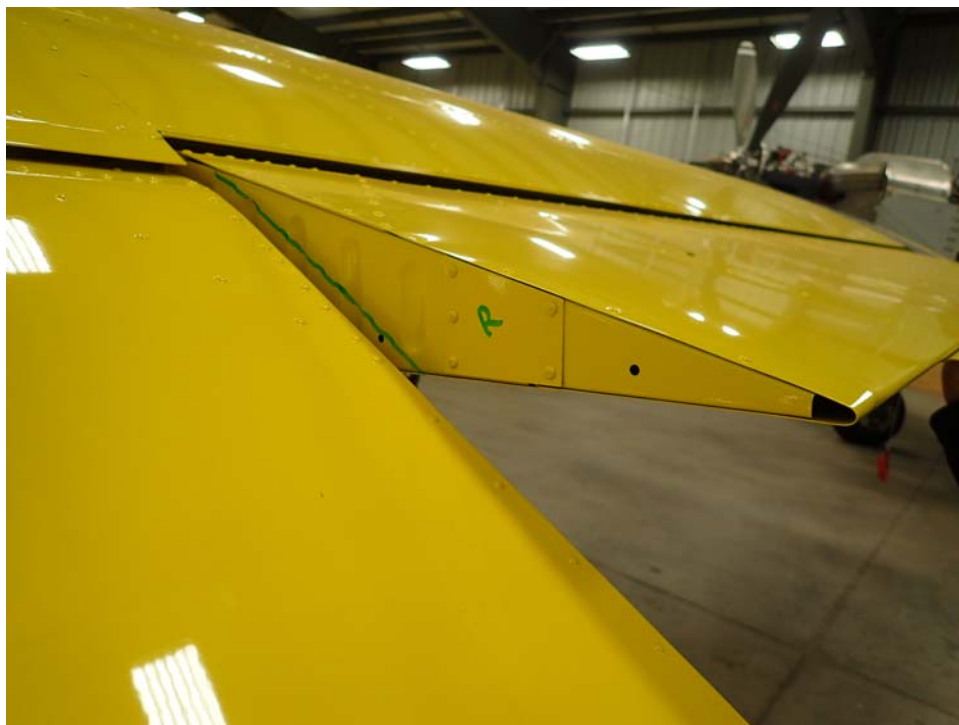
Likewise, the crease on the inboard end of the righthand aileron was measured and recreated on the exemplar AT-802A by a green line. The aileron was deflected to align this green line with the outboard edge of the flap. This alignment resulted in a deflection of 14.8° upward deflection of the aileron.

**Crease on Inboard Righthand Aileron**

**Deflection of Righthand Aileron on Exemplar AT-802A**

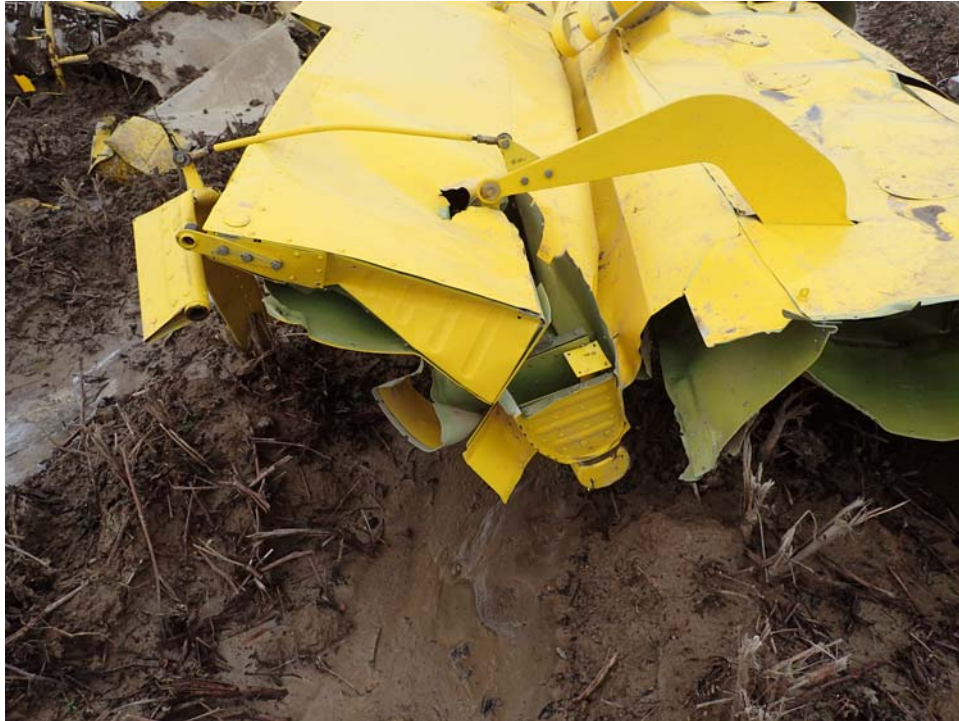
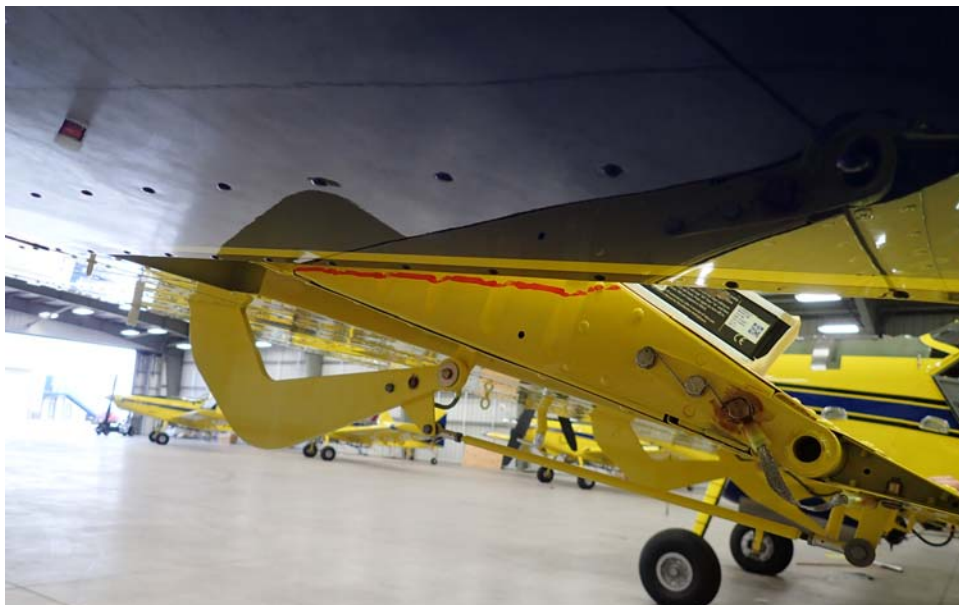
The crease on the outboard end of the lefthand aileron was examined. This crease was represented on the exemplar AT-802A by a red line. This line was aligned with the lefthand wing trailing edge. This alignment corresponded with an 11.3° downward deflection of the aileron.

**Crease on Outboard Lefthand Aileron**

**Deflection of Lefthand Aileron on Exemplar AT-802A**

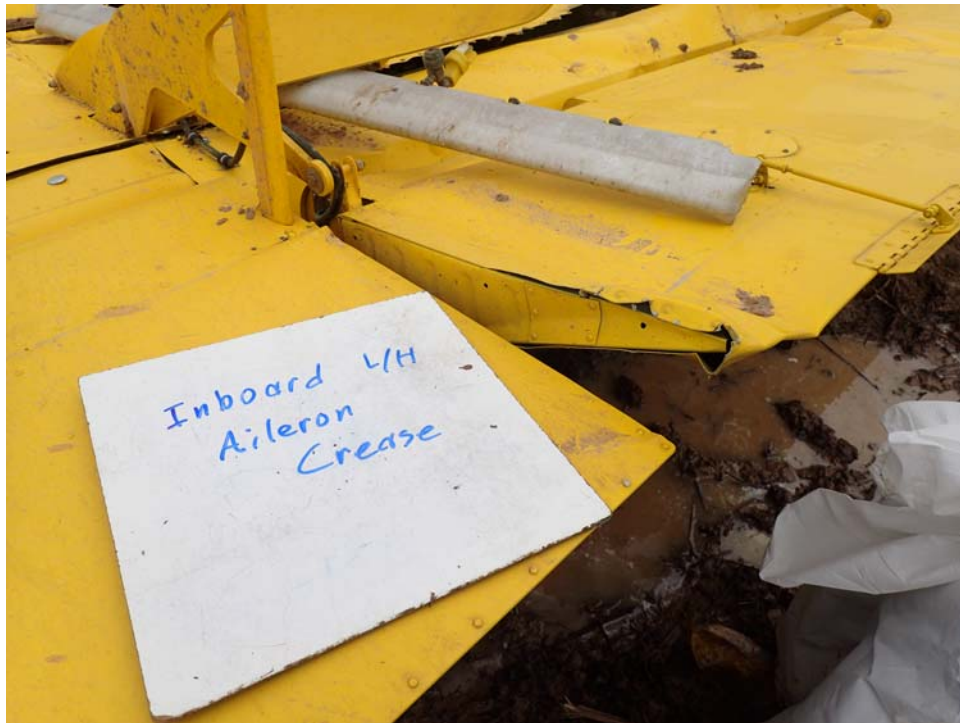
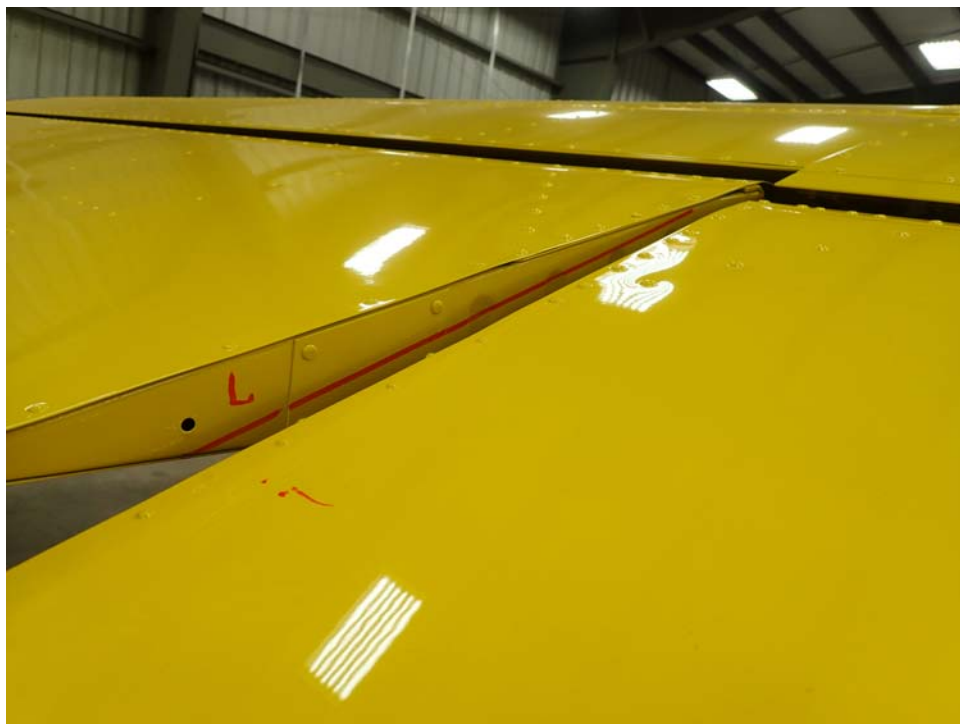
Likewise, the crease on the inboard end of the lefthand aileron was examined. This crease was represented on the exemplar AT-802A by a red line. This line was aligned with the outboard end of the lefthand flap. This alignment corresponded with a 3.7° upward deflection of the aileron.

**Crease on Inboard Lefthand Aileron**

**Deflection of Lefthand Aileron on Exemplar AT-802A**
