**Report
Aviate Raptor 503
NTSB file MIA08LA105
Aircraft Registration
N74TK**

Preliminary held June 18,2008

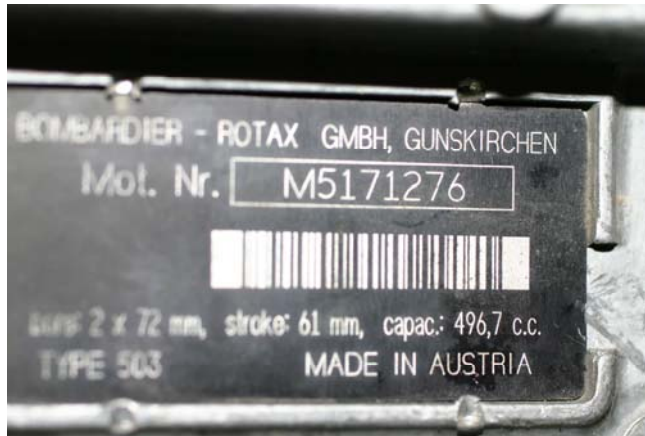
Data Plate as found on aircraft

The engine data plate indicates the model and type from 1999 production. No modifications seen on the engine. Equipped with dual Bing 54 carburetion and single exhaust with B type gearbox of 2.58 ratio.
