AR19-338

**Accident Investigation Report
N83AU
Experimental Unmanned Aircraft**

Prepared by:
Aurora Flight Sciences Corporation
9950 Wakeman Drive,
Manassas, Virginia 20110
www.aurora.aero

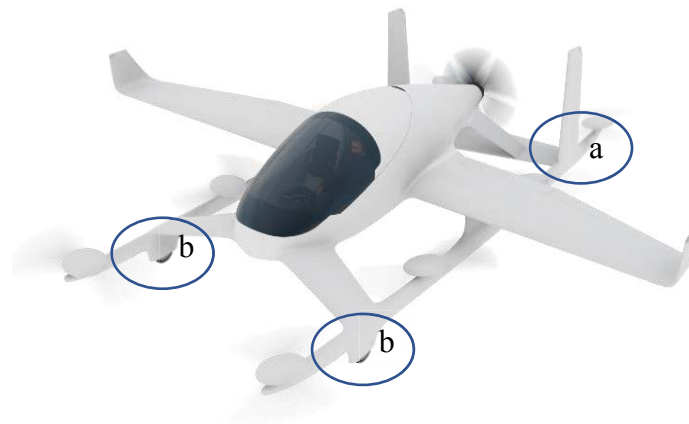
N83AU exhibits significant damage from the hard landing. Structural damage evident on the booms, horizontal tail, vertical tails, and warping of the main aircraft structure. The two aft-most lift motors and the associated aft section of booms were separated from the main booms (a) as well as the (4) landing gear noted as (b). It is improbable to cost effectively restore N83AU to flight test status. (Simplified illustration for clarity):
