Memo: To George Petterson
From: Mike Melvill
Regarding: Long-EZ, N228VS

5 January, 1998

Hi George, sorry it has taken me so long to get this report to you, on my investigation of the John Denver accident, at the Jet Center, at Del Monte Aviation, on the morning of October 14, 1997. As you will remember, I flew my own Long-EZ, N26MS, up from my home in Tehachapi, CA, at your request, so that it might be used as an exemplar aircraft, to possibly assist in identifying the various pieces of wreckage. I have included my weight and balance calculations, together with some CAD drawings showing the fuel system as it was in the Denver Long-EZ, as well as the fuel system as called out in the Long-EZ plans. I have also included a set of photos that I took during my visit to Monterey. I hope this information will be useful to you, and please do not hesitate to contact me if there is anything more that I can help with.

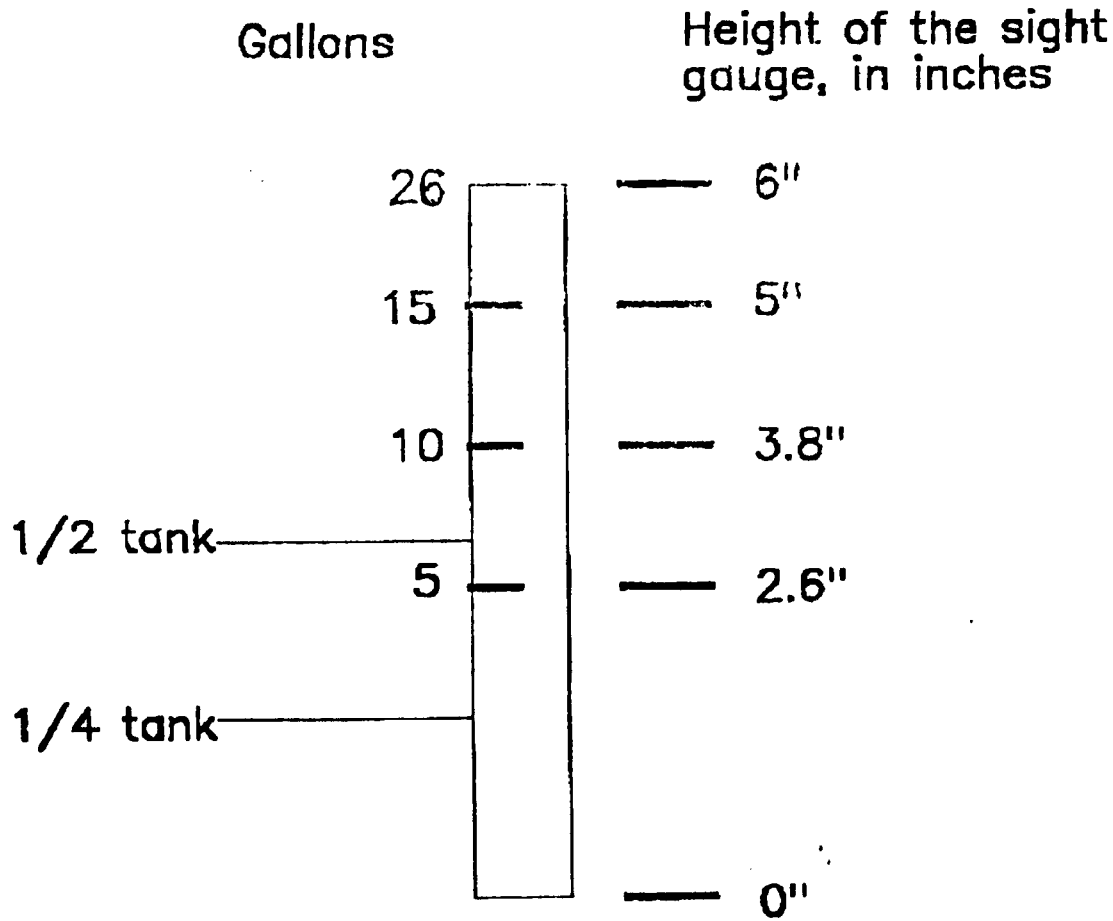
This is an accurate depiction of the Fuel sight gauge in my Long-EZ, N26MS, and is probably fairly representative of the average long EZ, although there is still the individual workmanship factor to consider, which could change the calibration up OR down.

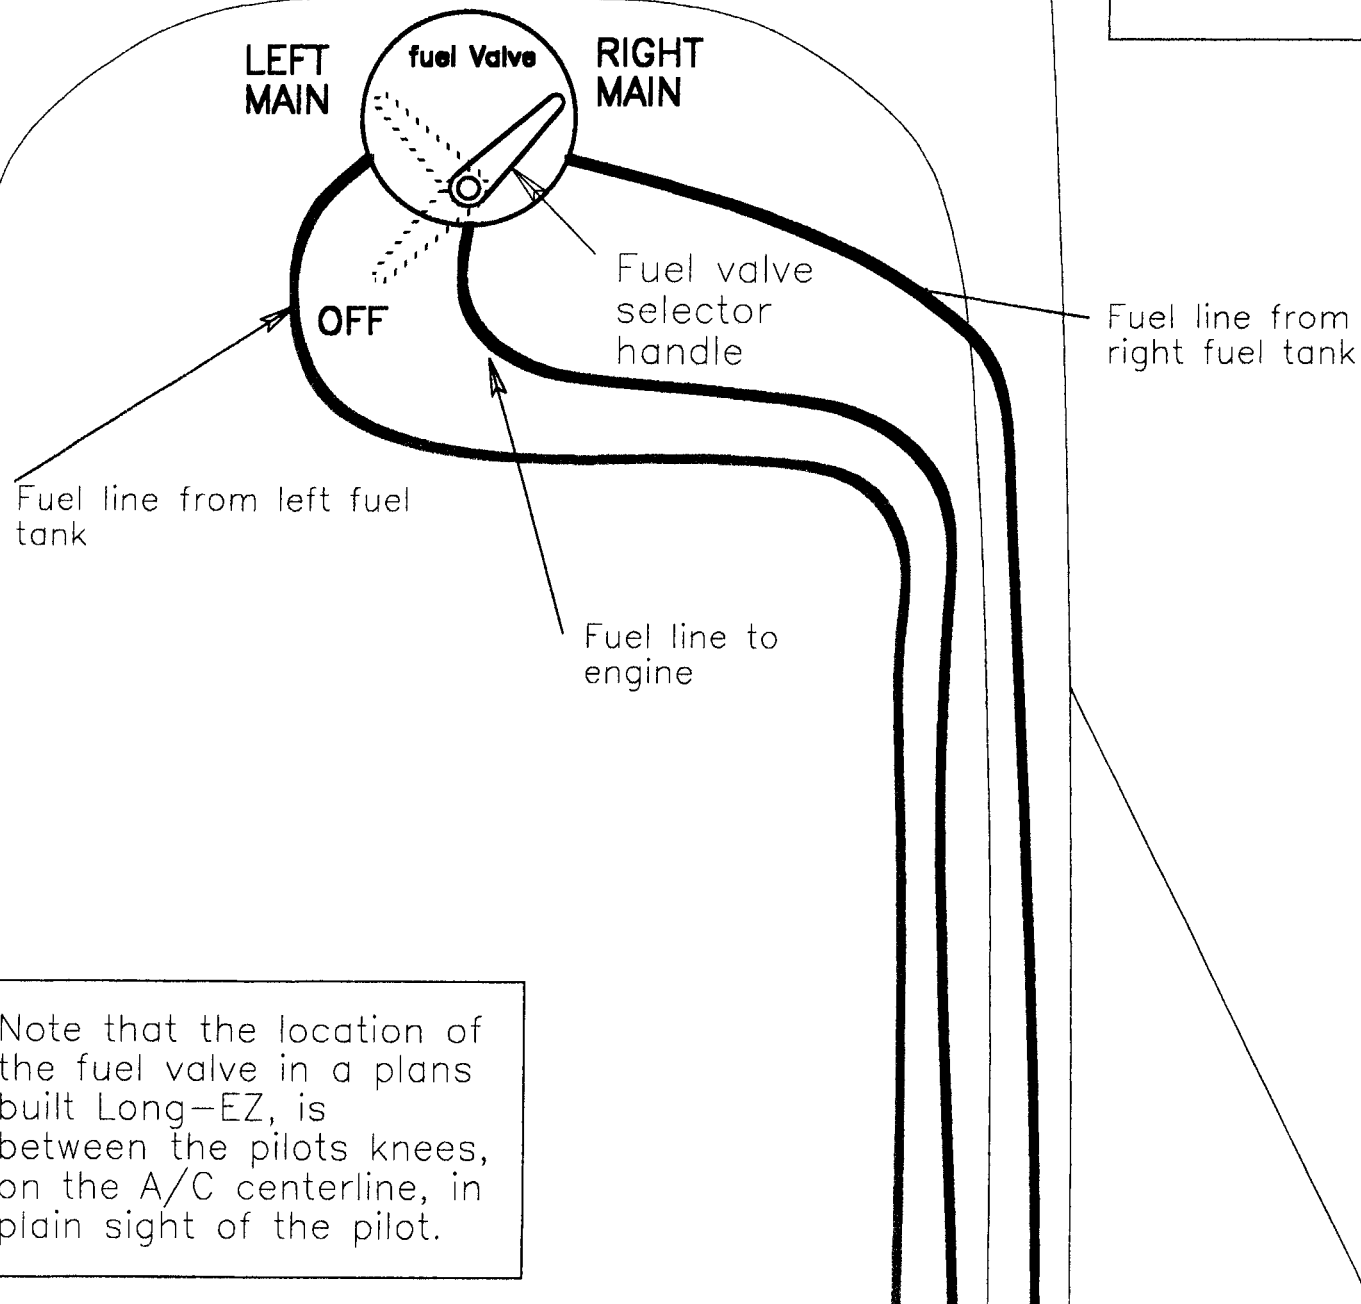
Top view of the fuel system called out in the Long-EZ plans

Note that the location of the fuel valve in a plans built Long-EZ, is between the pilots knees, on the A/C centerline, in plain sight of the pilot.
