EGYPTIAN CIVIL AVIATION AUTHORITY

REPORT OF INVESTIGATION OF ACCIDENT

EgyptAir Flight 990

Boeing 767-300ER SU-GAP

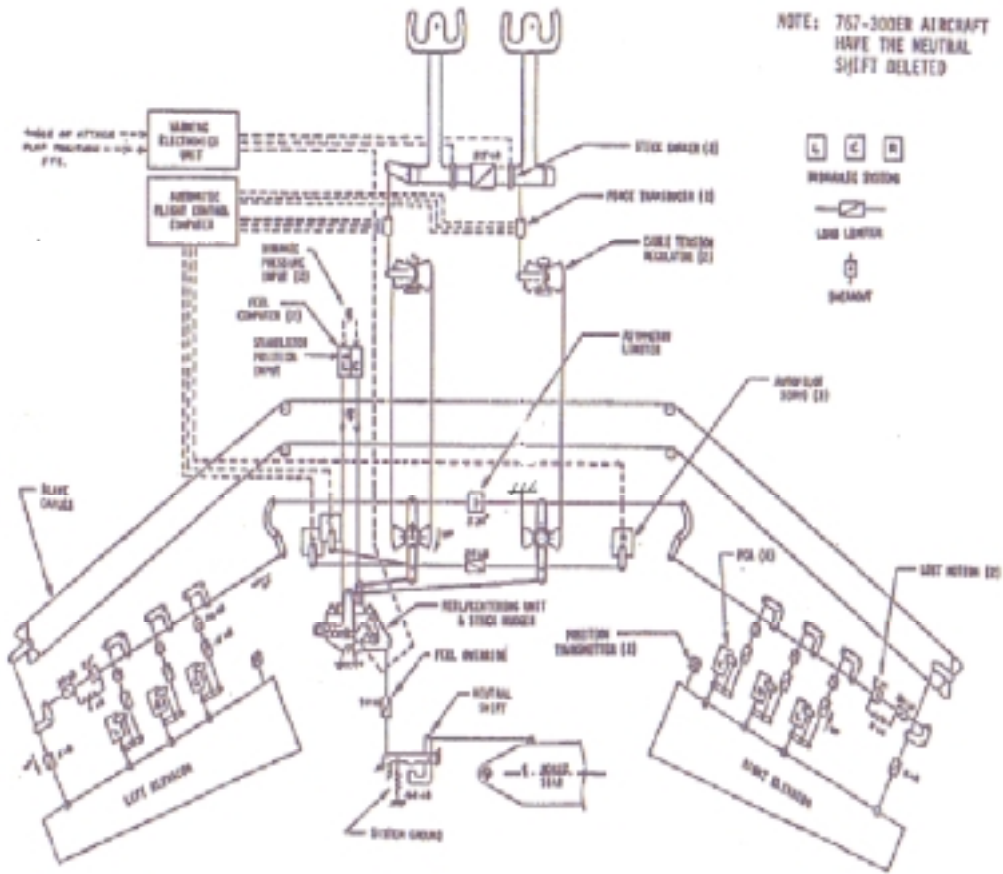
Figure 1 Aft cable break, Aft cable jam condition at the left First Officer Cable

- Analysis of the tests results show that the following conditions:
 - Aft cable break, Aft cable jam condition at the left First Officer Cable (Figure 1)
 - Fwd cable break, Aft cable jam condition at the left First Officer Cable (Figure 3)

are not consistent with the accident scenario, as they result in aircraft pitch up in contrary of aircraft behavior. Therefore, these conditions are excluded as plausible causes.

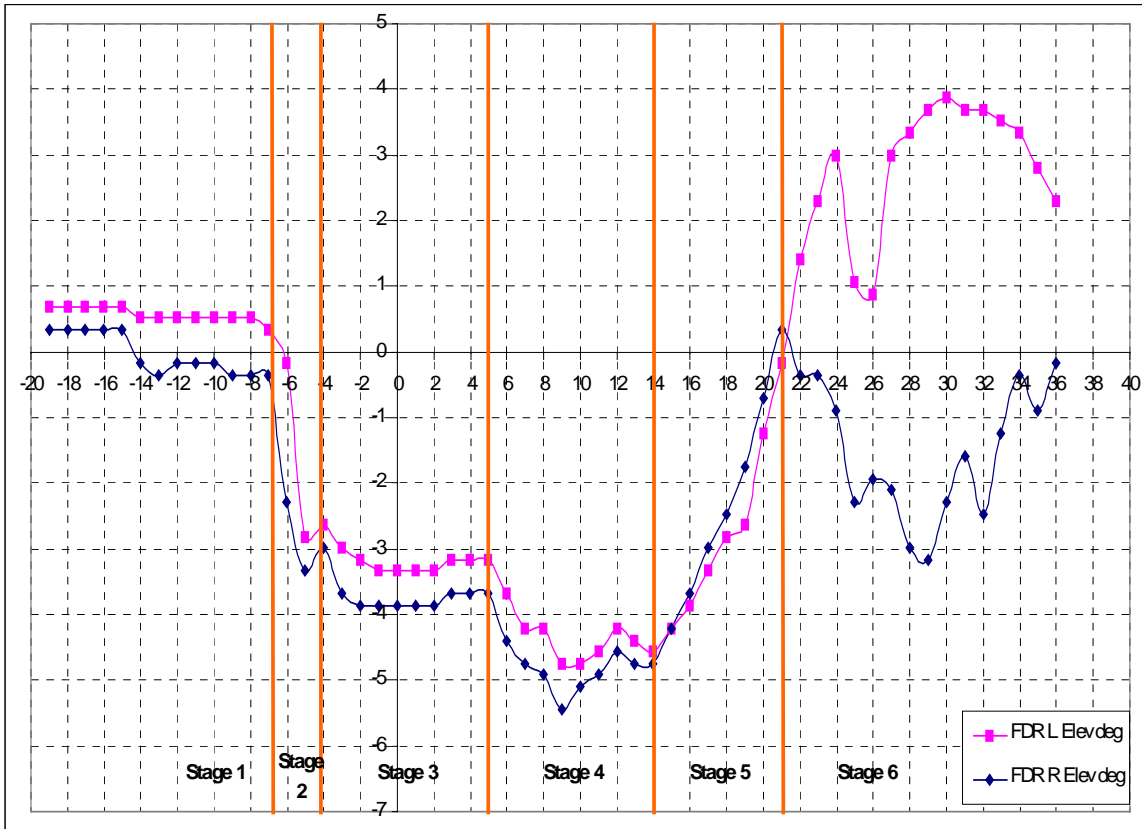
Figure 5, Elevator stages during the dive

For reference, Figure 5 shows the different stages for the dive

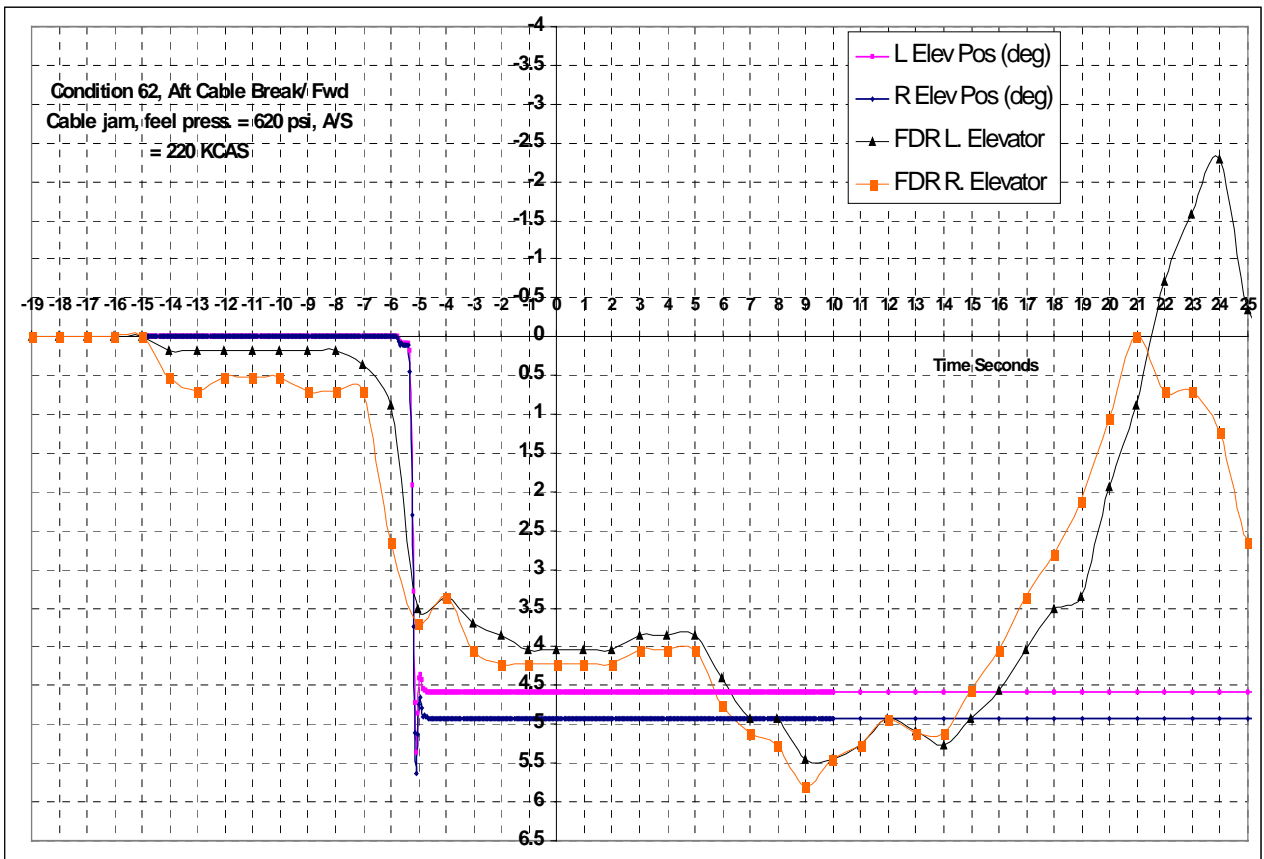
Figure 6, Condition 62 transient response

Figure 6 is an extract of the test condition 62 “Aft cable break, forward cable jam with elevator feel pressure = 620 psi, Airspeed = 220 KCAS”

These figures are constructed by removing all the initial biases for the elevator data extracted from the Ground Tests and the initial biases for the elevator data extracted from MS990 FDR to start with zero elevator deflection, for an objective comparison. These Figures show that the above shown failures result in rapid movement of the elevator surfaces, which is consistent the accident scenario.

- For evaluating stage 3 (First elevator position after the elevator rapid movement), Figures 6,7,8 (Conditions 62,122,150 respectively), also show the values of the first elevator position as shown by the FDR, and the elevator position resulting from inserting the failure during ground test.

Elevator Position- FDR		Elevator Position- Ground Test.	
		Left Elevator	R Elevator	Left Elevator	R Elevator
Stage 3	Condition 62	4 degree	4.2 degree	4.6 degree	4.9 degree
Stage 3	Condition 122	4 degree	4.2 degree	4.47 degree	4.78 degree
Stage 3	Condition 150	4 degree	4.2 degree	4.1 degree	4.42 degree

The elevator positions as obtained from the FDR show slightly smaller values compared to the elevator Position as obtained from Ground Test, suggesting that the a pre-load force was exerted by the F/O.

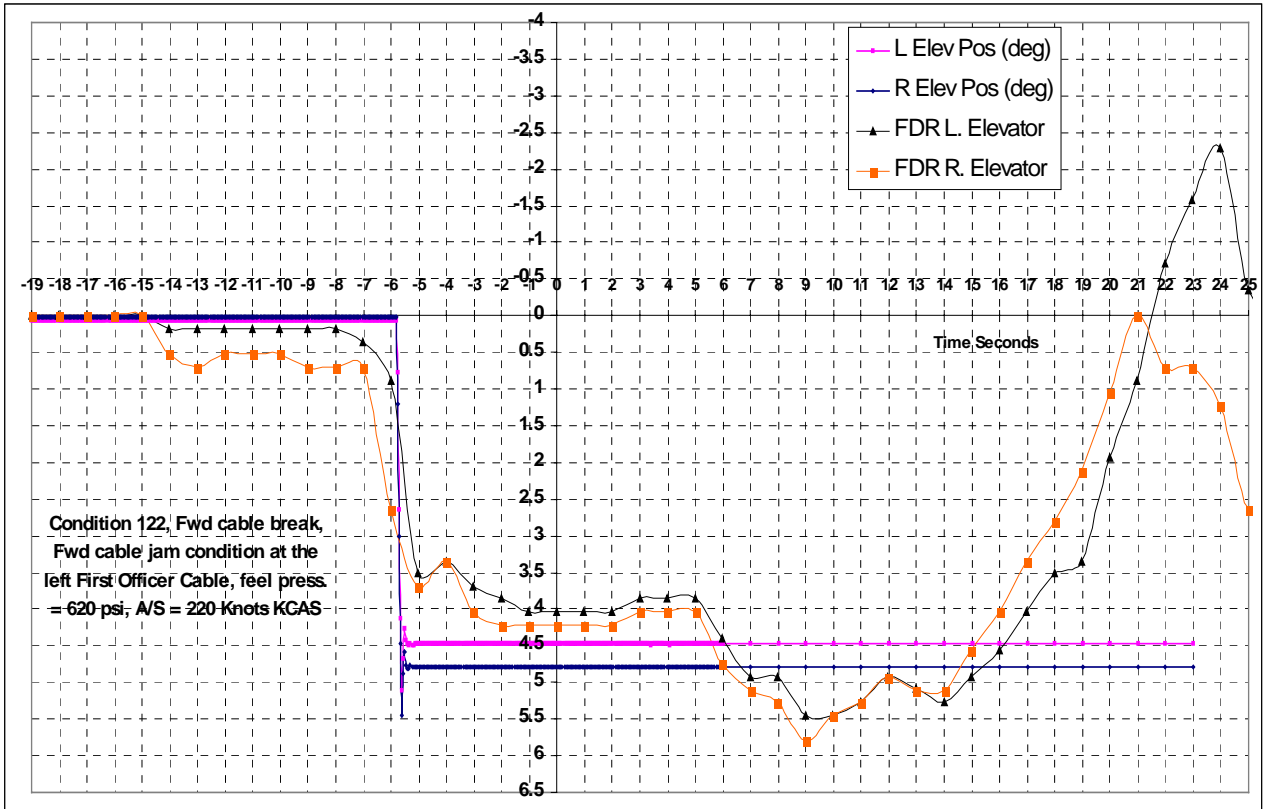
Figure 7, Condition 122 transient response

Figure 7 is an extract of the test condition 122 “ Fwd cable break, forward cable jam with elevator feel pressure = 620 psi, Airspeed = 220 KCAS “

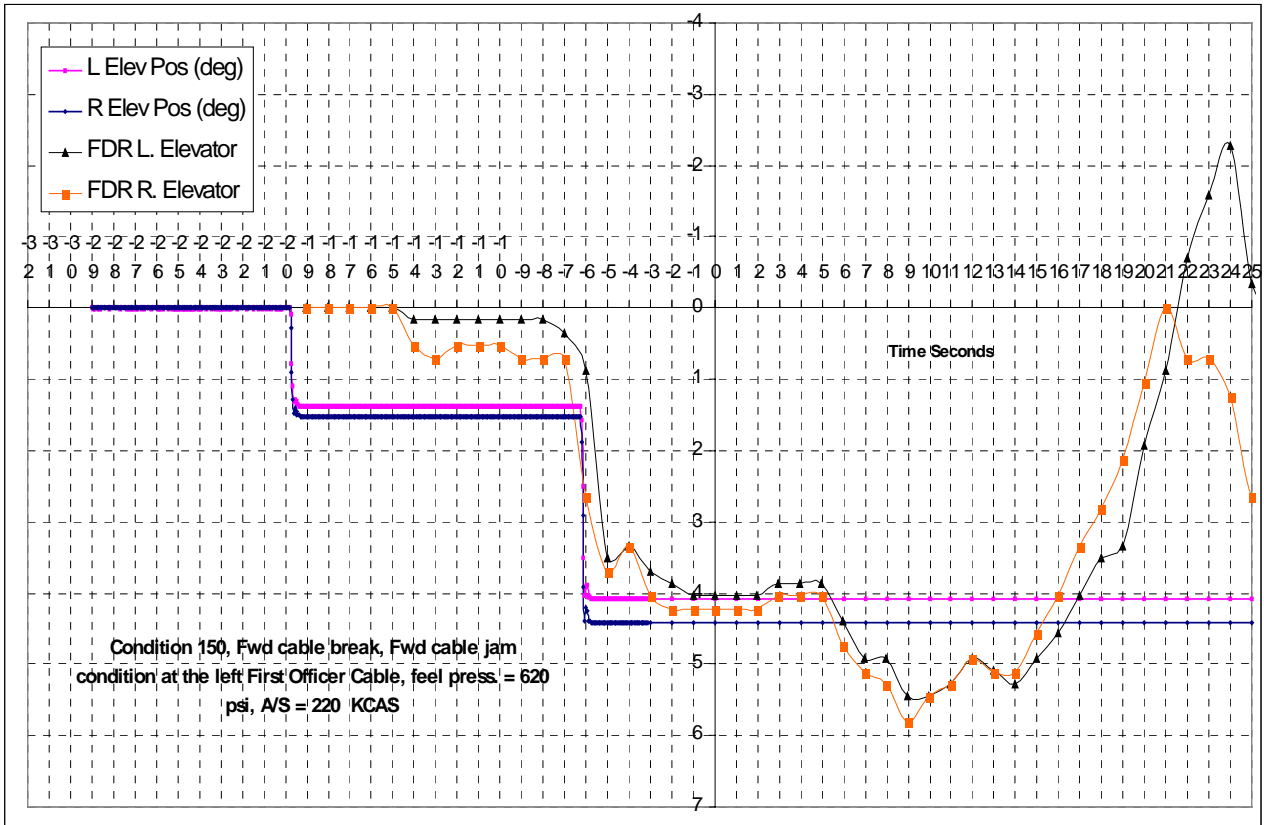
Figure 8, Condition 150 transient response

Figure 8 is an extract of the test Condition 150 ” Fwd cable break, forward cable jam with elevator feel pressure = 620 psi, Airspeed = 220 KCAS, transient response with R A/P, then A/P is disengaged”

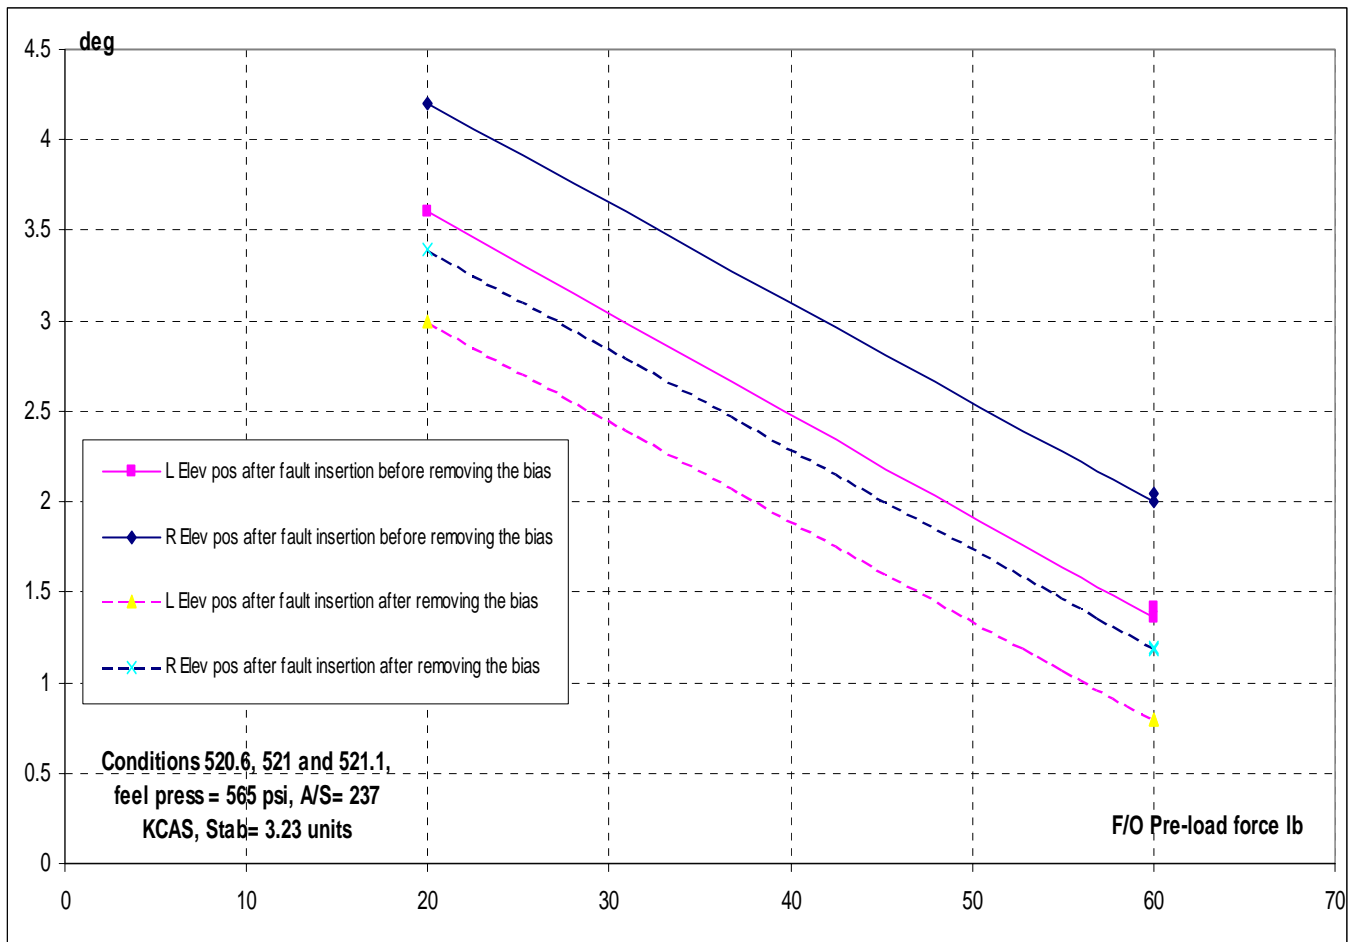
Figure 15, F/O pre load, condition 520.6, 521, 521.1

The above shown figures show that the shown failures can produce elevators deflection consistent with the FDR data with a pre-load force on the F/O elevator column

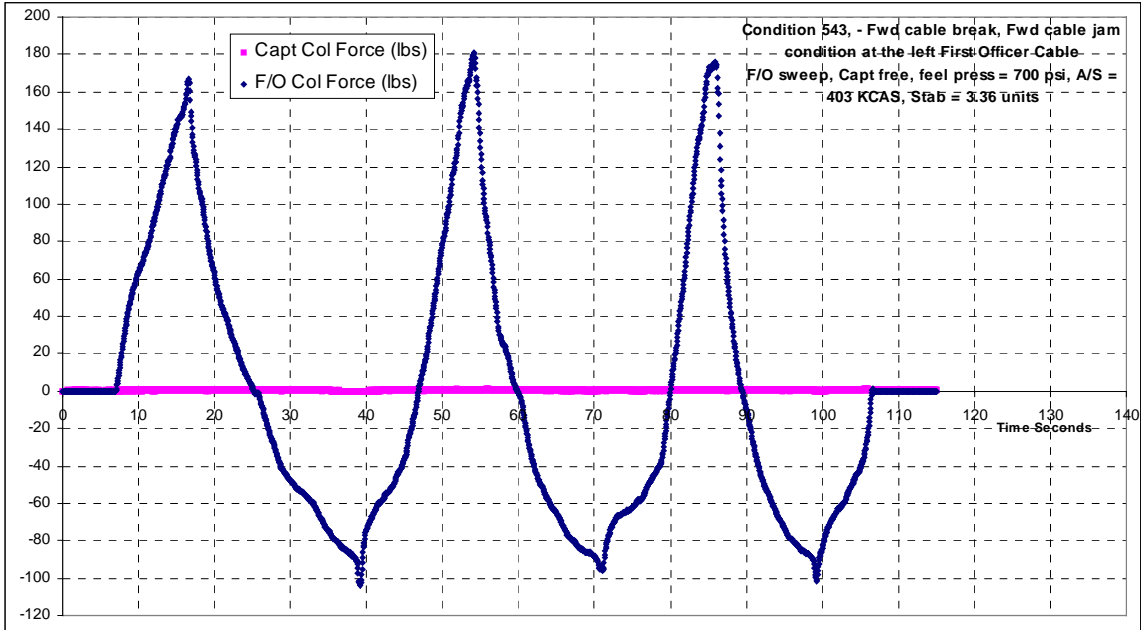
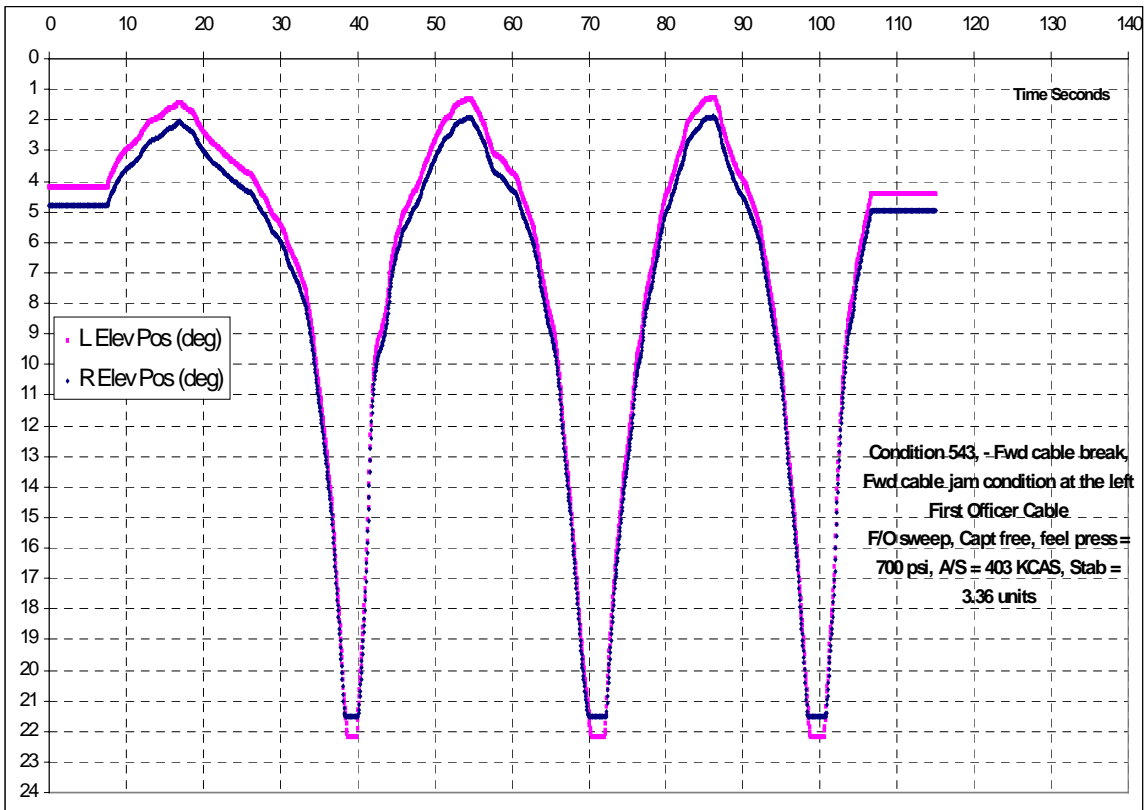
Figure 17, F/O sweep, condition 543

Figures 17,18 show different conditions of F/O sweep (conditions 543, 541). Maximum upward elevators travels are shown in these figures.

It is to be noted that with the failure conditions 543, 541 “Fwd elevator cable break with fwd end of broken cable jammed”, it was possible to drive the two elevators symmetrically, but it was not possible to drive the elevators to the neutral position from the F/O side.

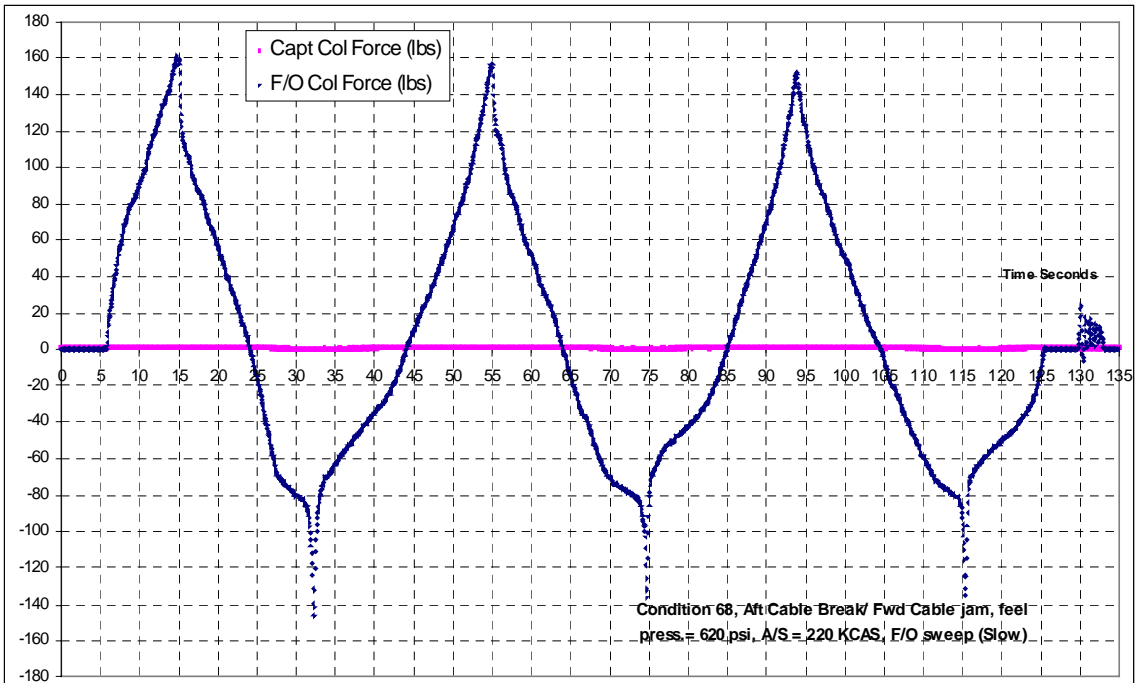
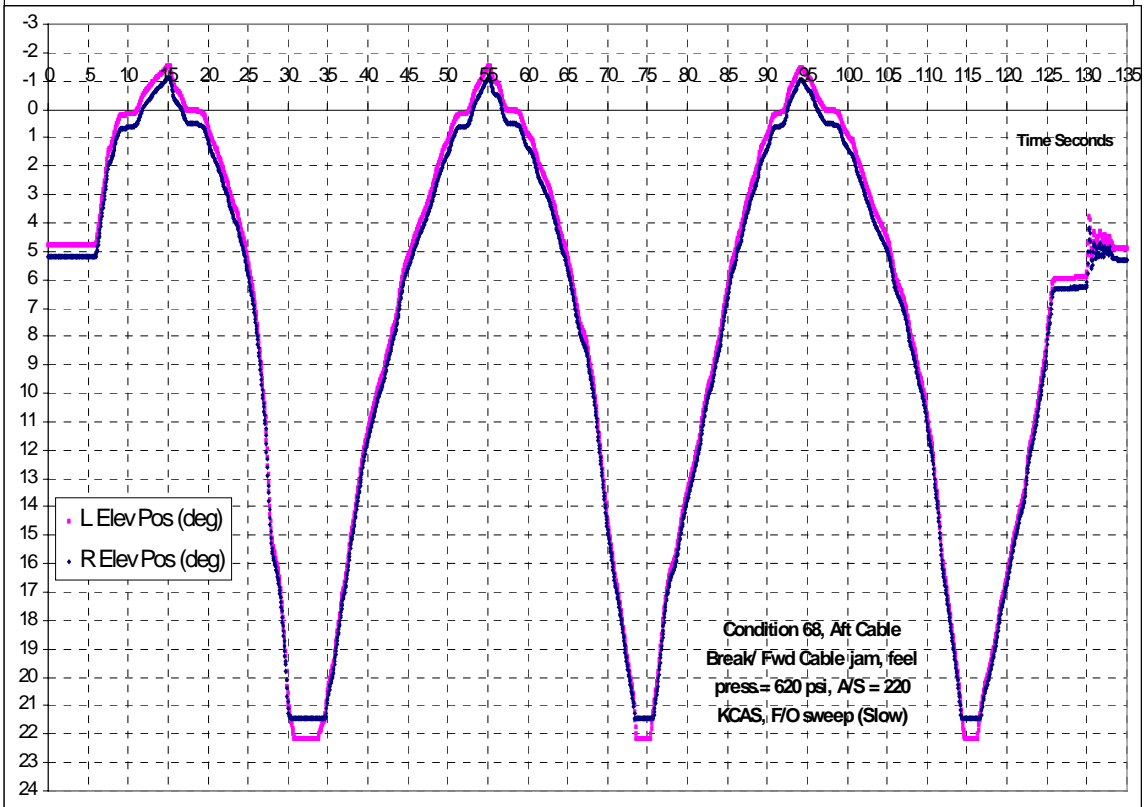
Figure 19, F/O sweep, condition 68 “Aft elevator cable break with fwd end of broken cable jammed”. The figure shows that it is possible to drive the elevators from the F/O elevator column and reach the neutral position (about 1 degree TEU).

Based on the limited available test data processed by the Egyptian Investigation Team, the failure condition “Aft elevator cable break with fwd end of broken cable jammed”, shows a very close consistency with the elevators FDR data during the dive warranting further tests.

Due to the above data which shows similarity of this scenario with the accident FDR data, therefore the Egyptian Investigation Team states that, it is imperative to investigate in full this scenario to determine if it is an admissible plausible cause for the accident.

The investigation should include tests to assist in more complete and precise analysis, including more detailed tests for the failure condition “Aft elevator cable break with fwd end of broken cable jammed”, taking into account the dynamic loads on the elevator surfaces, use of more consistent elevator feel pressures.
