**ACCIDENT TO SAHARA INDIA AIRLINES
B-737 AIRCRAFT VT-SIA DURING TRAINING FLIGHT
AT IGI AIRPORT, DELHI
ON 8th MARCH 1994**

**BY
V.K. CHANDNA
INSPECTOR OF ACCIDENT**

**REPORT ON ACCIDENT TO SAHARA INDIA AIRLINES B-737-200 AIRCRAFT
DURING THE TRAINING FLIGHT ON 8.3.94 AT IGI AIRPORT, DELHI**

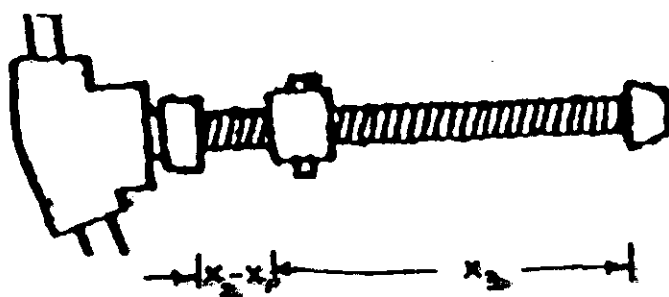
Three flap screw jacks (No. 6, 7 and 8) on the starboard wing were found intact. No. 5 flap screw jack, which was not intact, was identified from the part number. Three screw jacks (No. 1, 3 and 4) were identified from their orientation and attachment. No. 2 flap screw jack could not be located. The measurement of various recovered screw jacks of accident aircraft, as recorded, are given below:

Screw Jack Dimension -	No.	1	2	3	4	5	6	7	8
	X2-X1 (inch)				25.25		25.258		
	X3 (inch)	5			6	7	6.25	4.6

The flap screw jack measurements on the accident aircraft are quite close to the Flap 15 configuration when compared with the dimensions provided in Boeing 737 Control Position Data Document No. D6-19512-1 Rev. 'D'.
