**FACTUAL OBSERVATIONS OF AIRCRAFT MISHAP
ROGERS HELICOPTERS 206L-1 S/N 45434 N10864
MONTELLO, NEVADA
3 AUGUST 2000**

FACTUAL OBSERVATIONS OF AIRCRAFT MISHAP ROGERS HELICOPTERS 206L-1 S/N 45434 N10864 MONTELLO, NEVADA 3 AUGUST 2000

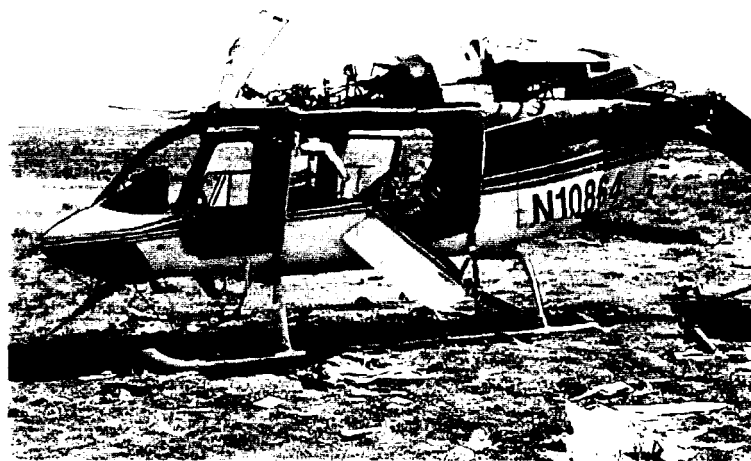
Photo 3.0

The fuselage was observed primarily intact. The majority of damage was observed on the left side of the aircraft. See photo 3.0 The forward windscreens and chin bubbles had been broken and were observed scattered throughout the wreckage area. The forward and aft doorframes and doors on the left side had been separated from the fuselage during the impact sequence. The forward left door had separated from the aircraft and was observed lying aft of the main wreckage. The left aft cabin door had been partially separated with only the lower half remaining attached to the fuselage structure.

Left Side View of Aircraft

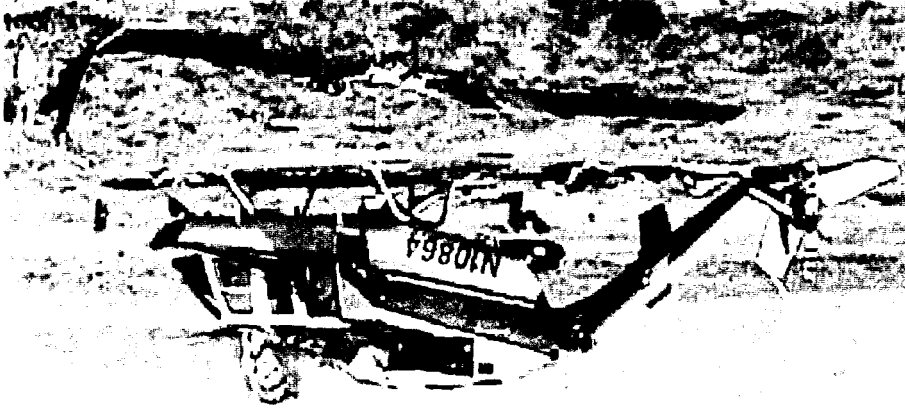
Photo 3.1
 Right Side View of Aircraft

The right side of the aircraft was intact and exhibited minimal damage. See photo 3.1 The aft fuselage had been deformed to the point that the aft door would not securely latch. The cabin roof and was primarily intact the aft pylon mounts had been partially torn from the roof structure on the left side. The oil cooler had been partially separated from its mounting with fairing around the oil cooler had been partially separated from its mounting with

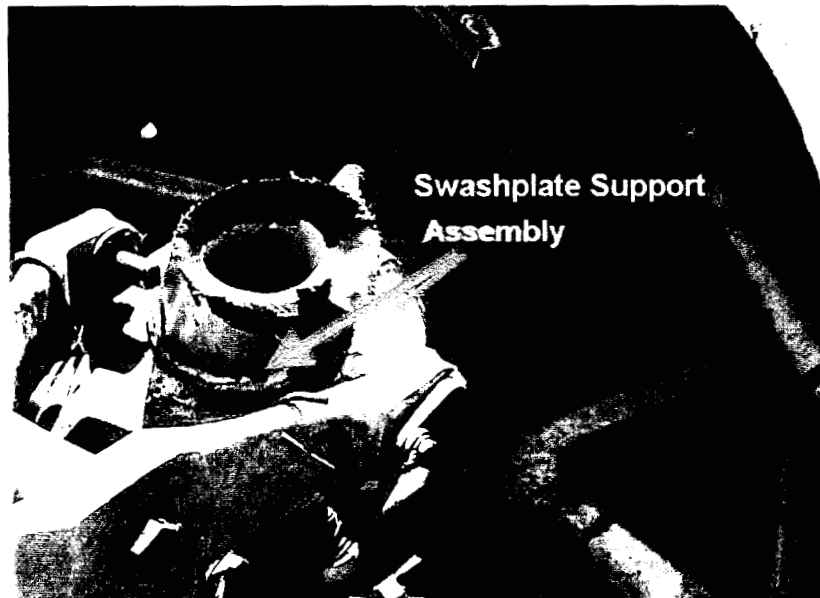
Swashplate Support
Photo 3.8

The swashplate support, which bolts to the top of the transmission case, was observed fractured. The fracture appears to correspond to the mast displacement and fracture. See photo 3.8 The NTSB expressed a interest in possibly sending this component to the NTSB laboratory for a metallurgical examination. A decision as to the disposition of this component is pending as of the time of this report.

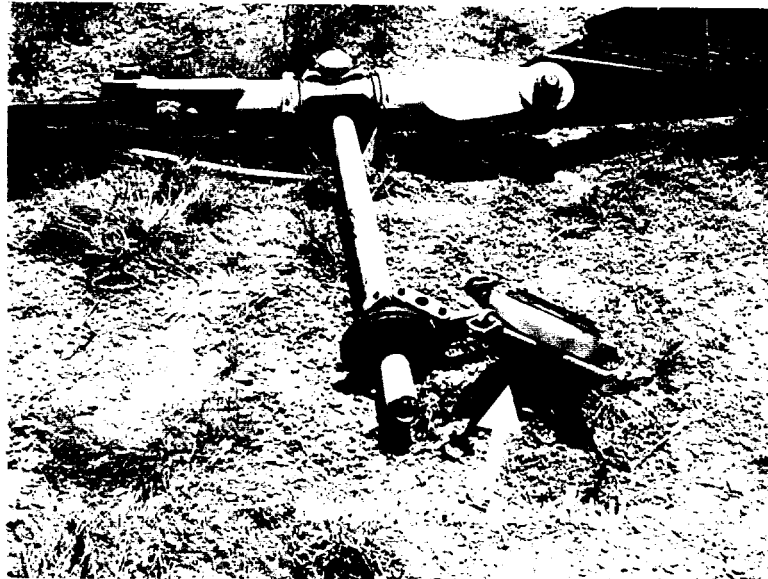
Main Rotor Blades, Hub, and Upper Mast
Photo 3.9

The main rotor blades and hub had separated with the mast during the impact sequence. See photo 3.9 The blade designated the RED main rotor blade exhibited a spar separation approximately two feet from the tip end of the blade. The separated portion of the blade exhibited paint transfer evidence and scoring. The separation appears to be typical of a main rotor blade ground strike. See photo 3.10

The swashplate assembly separated with the mast and was observed attached to the mast. See photo 3.9 The WHITE pitch link attach point on the rotating swashplate was observed fractured. The WHITE pitch link had been broken about mid-span of the pitch link. See photos 3.12

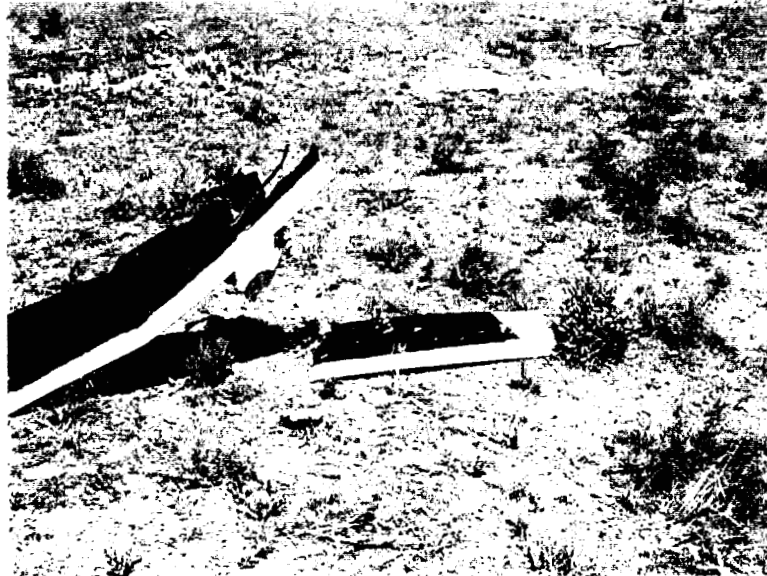
**WHITE Main Rotor Blade
Photo 3.11**

The blade designated the WHITE main rotor blade exhibited a spar separation approximately two feet from the tip end of the blade. The separated portion of the WHITE blade exhibited paint transfer evidence and scoring. The separation appears to be typical of a main rotor blade ground strike. The WHITE blade did exhibit significant downward bending. See photo 3.11

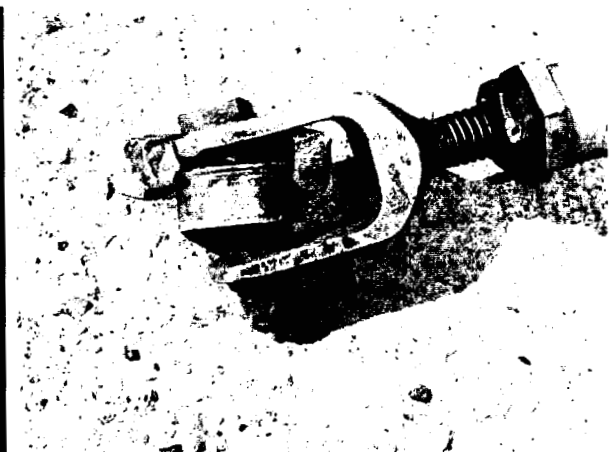
Photos 3.12

WHITE Rotating Swashplate Lug

WHITE Pitch Link and S/P lug half.

The NTSB made the determination to remove these components for metallurgical examination by the NTSB laboratory. As of the date of this report a report has not been released.

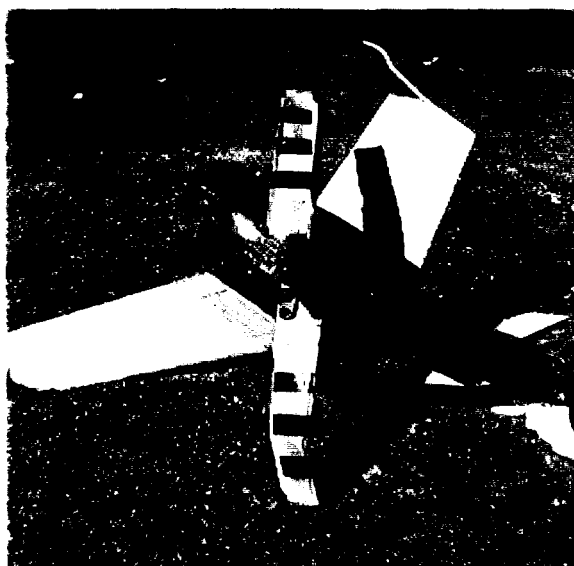
Tail Rotor System
Photo 3.12

The tail rotor system was observed securely mounted to the aft portion of the tail boom. The 90 degree gearbox fairing was intact and the aft section of tail rotor driveshafting was still connected to the input of the gearbox. See photo 3.12 Hand rotation of the tail rotor produced smooth rotation. The tail rotor pitch control system was manually exercised to verify continuity. Impact damage produced two separations within the pitch control system. Continuity was established from fracture point to fracture point. The fractures appeared consistent with overload separations.

The tail rotor blades were securely attached to the tail rotor hub assembly. The one tail rotor blade had been slightly bent approximately eight inches from the tip end. The second tail rotor appeared normal and exhibited minimal damage.

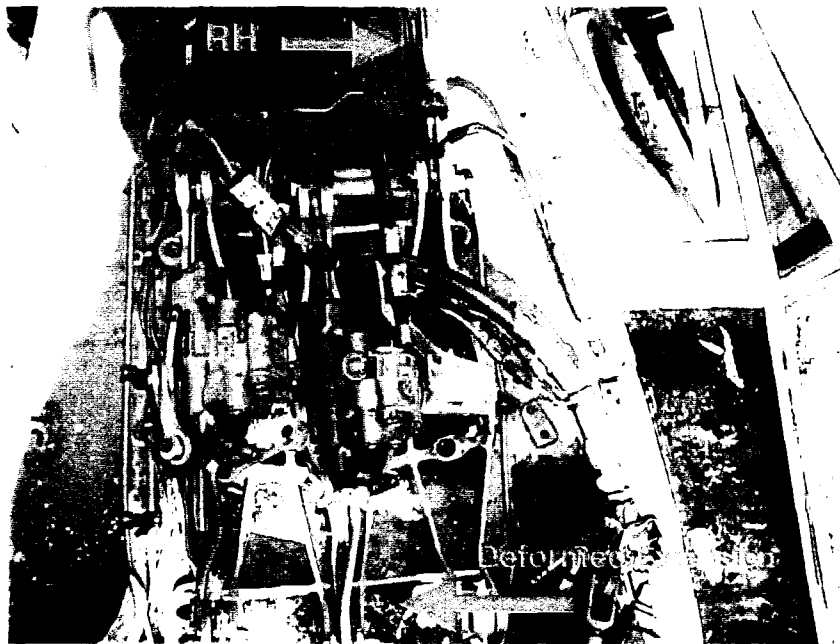
Left Hand Cyclic, Center Collective, and Right Hand Cyclic
Boost Actuators
Photo 3.13

The forward fairing, which covers the roof mounted hydraulic servos, was observed being held open by the right hand cyclic actuator. The control tubes running from the cyclic and collective inputs were observed with all attaching hardware in-place and secured. Continuity was established from the right seat controls to the top of the "broom closet" where the control tubes were attached to the boost actuators. The hydraulic boost actuators had been deformed to the right. The extension arms on the left cyclic actuator and the center collective actuator had been significantly deformed. The right cyclic actuator had separated from its mounting and the extension arms had been bent and broken. See photo 3.13

All three hydraulic boost actuators were removed. The NTSB took a hydraulic fluid sample for laboratory analysis. Hydraulic fluid was observed within the reservoir. The NTSB decided to have a metallurgical examination of the actuator extension arms completed, followed by functional testing of the actuators. To date this has not been completed.

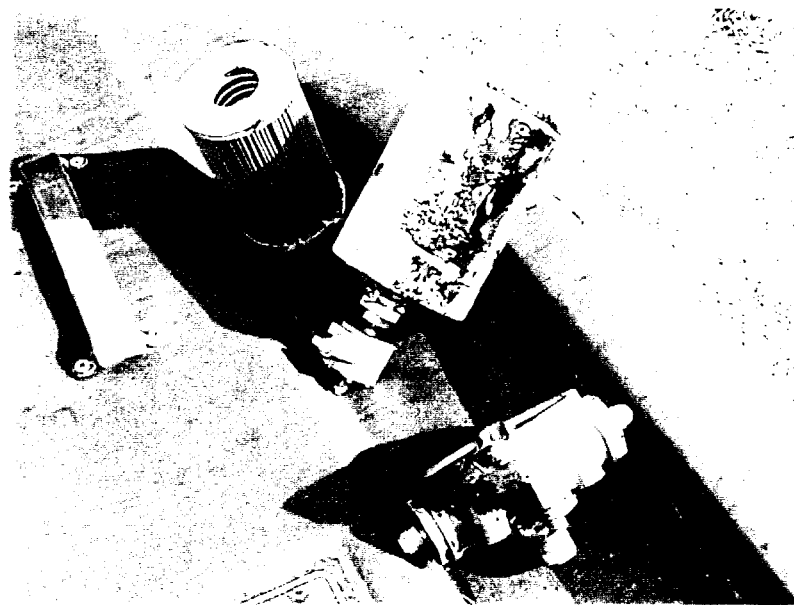
Photo 3.16

The airframe fuel filter was removed and examined. See photo 3.16 The filter element was observed free of debris and the bowl was full of fuel. The side of the filter bowl did have a large amount of grease splatter from the engine side main drive shaft coupling disconnect.

Airframe Fuel Filter Assembly

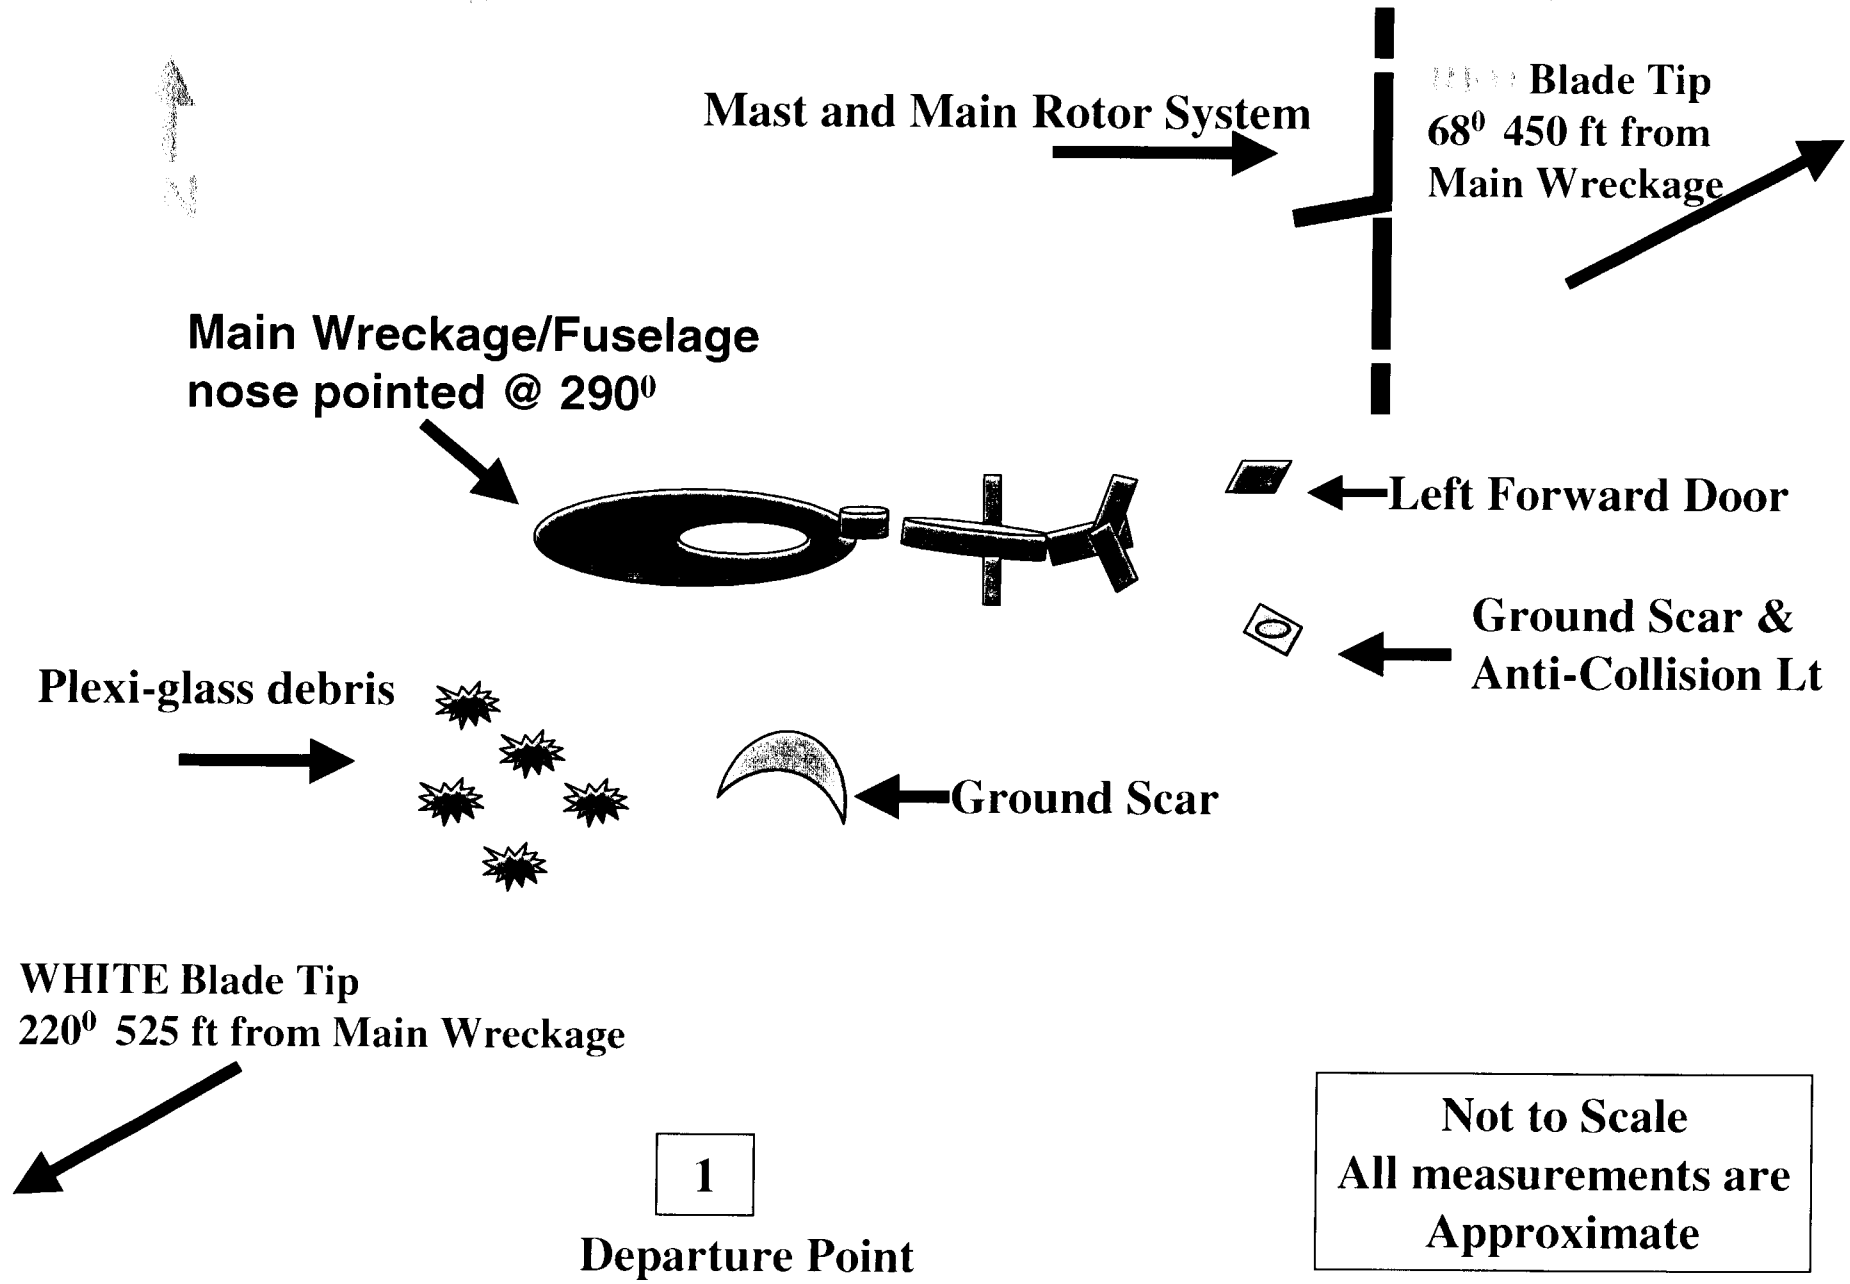
Diagrams

**Main Wreckage/Fuselage
nose pointed @ 290°**

**Blade Tip
 68° 450 ft from
Main Wreckage**

**WHITE Blade Tip
 220° 525 ft from Main Wreckage**
