Accident investigation

On-site investigation
report

Rolls-Royce
Model 250-C30P
Engine CAE 895064

Rogers Helicopters
Montello, Nevada

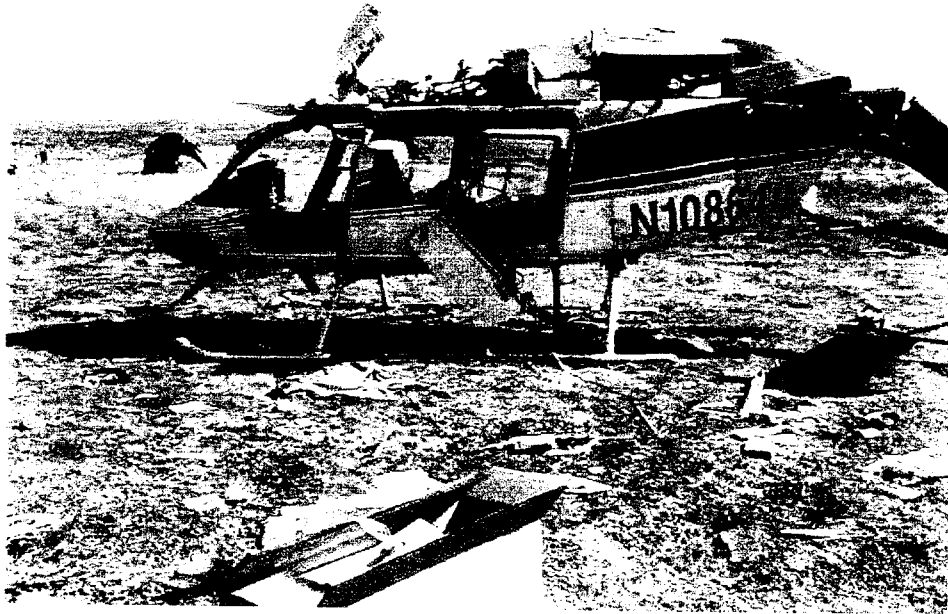
Photo #1 – Left side of the aircraft.

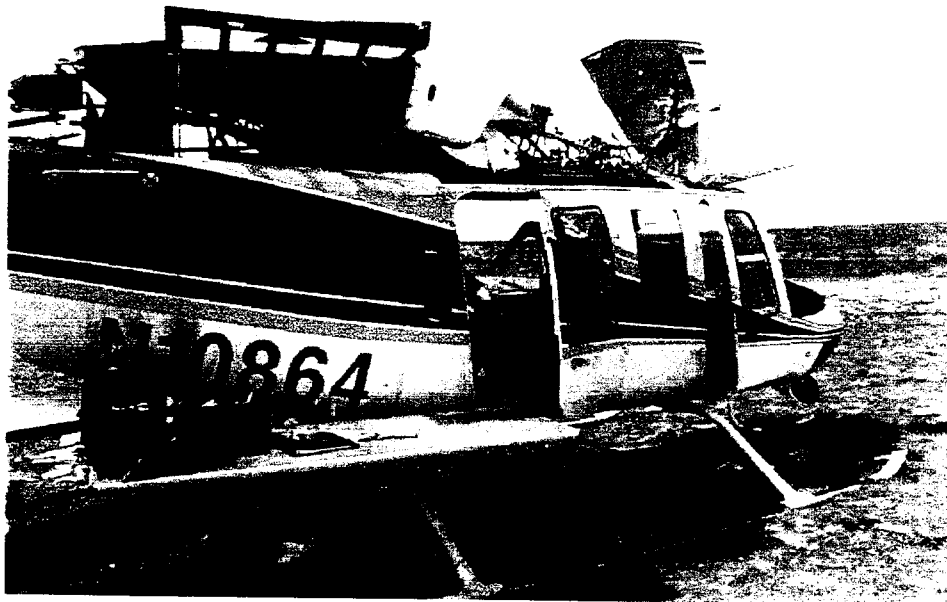
Photo #2 – Right side of the aircraft.

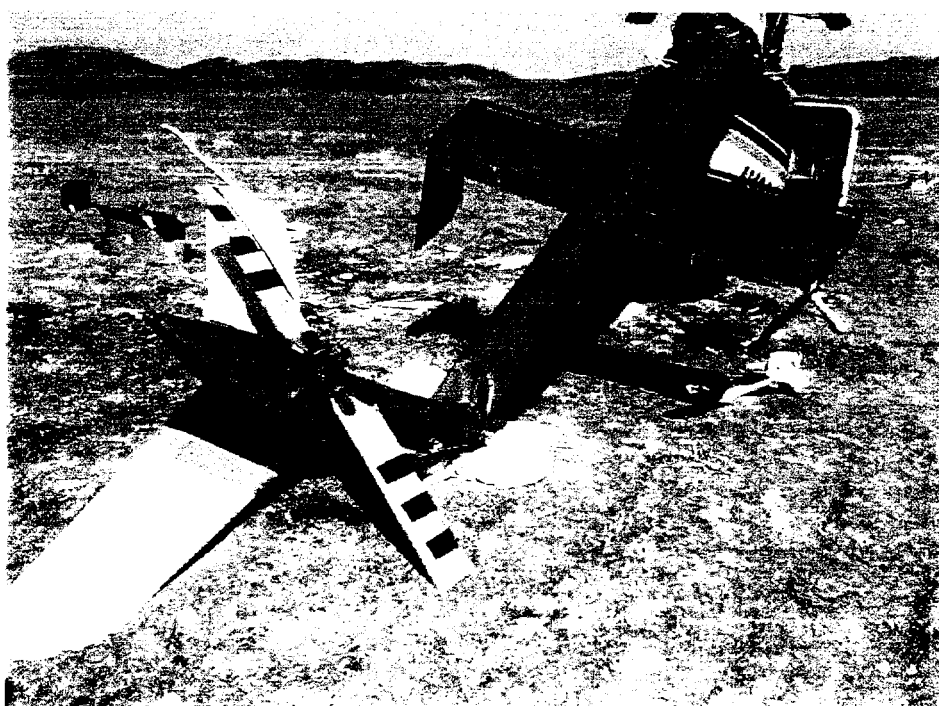
Photo # 4 – Rear of the aircraft.

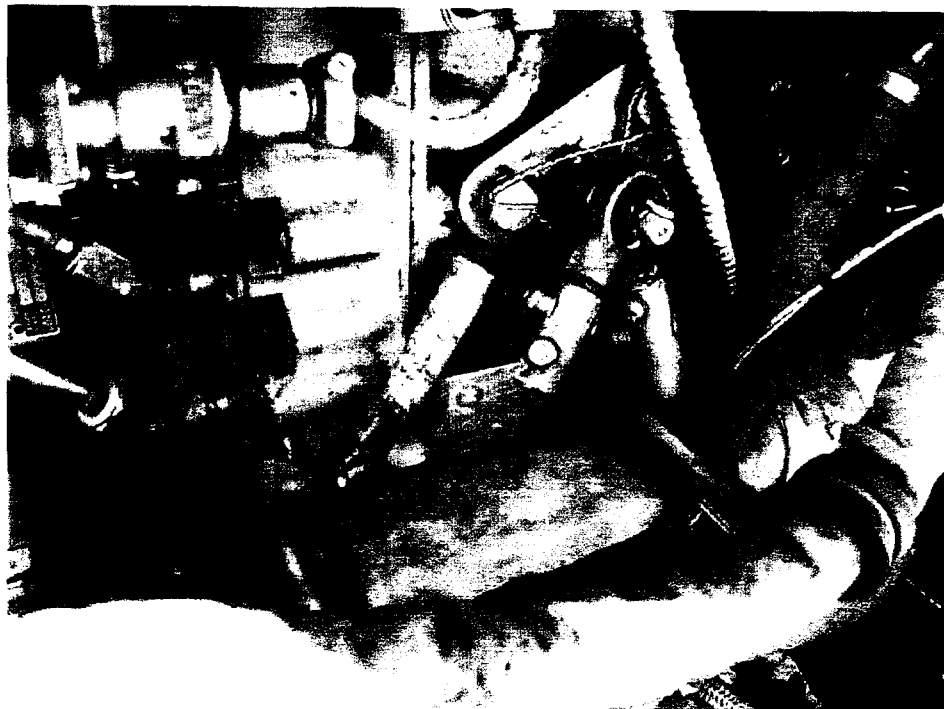
There was no indication of external damages to the engine. The right and left side engine mounts were broken as a result of the accident sequence. N1 rotates and checked continuous to the compressor and starter. N2 rotates and is continuous to the 4th stage turbine wheel and the PTO shaft. All pneumatic plumbing was in good condition. There was no damage to the Fuel control, PTG, Fuel pump assembly, or compressor bleed valve assembly. A fuel control system rigging check was completed and no anomalies were noted. The oil tank and oil cooler blower was damaged as a result of the accident sequence. The accident investigation team, consisting of the NTSB IIC, the Bell Helicopter representative and the author decided not to remove the engine for further examination. The engine was producing power.

Photo # 5 – Right engine mount broken.

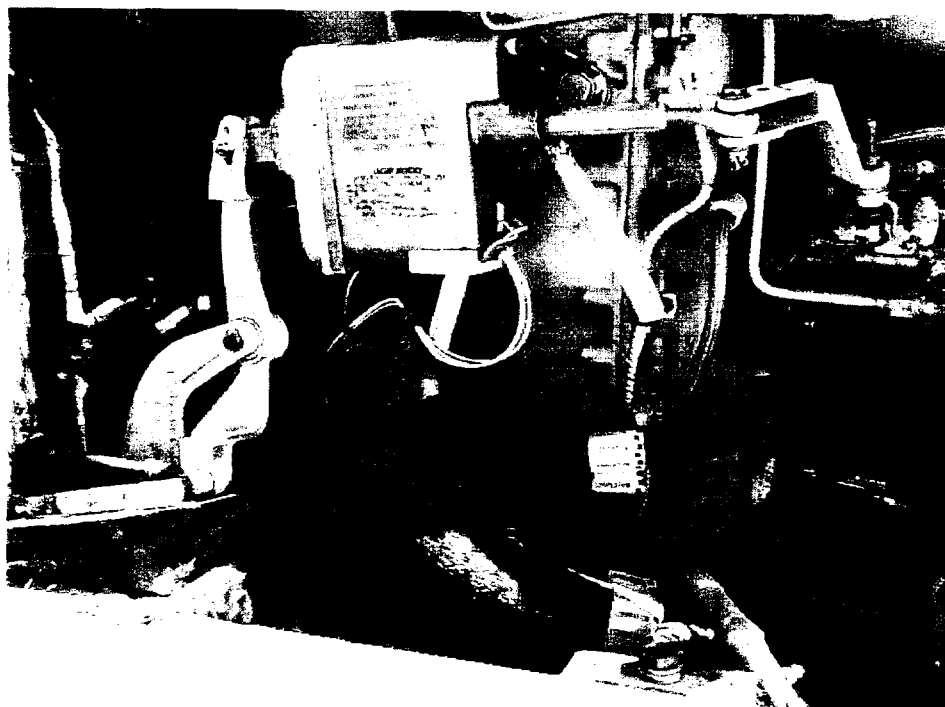
Photo # 6 – Left engine mount broken.

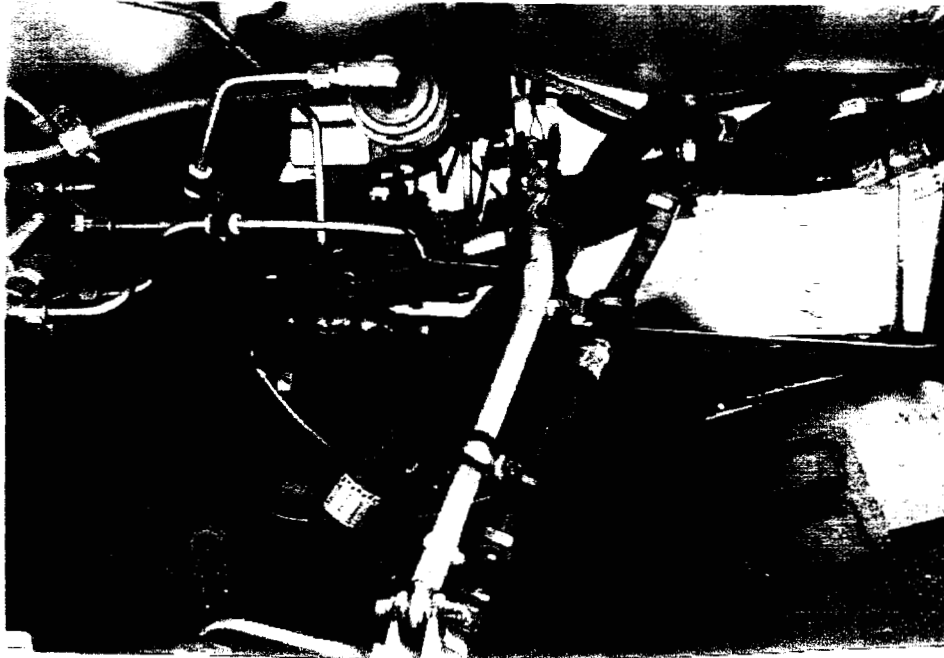
Photo # 7 – Rear engine mount bent.

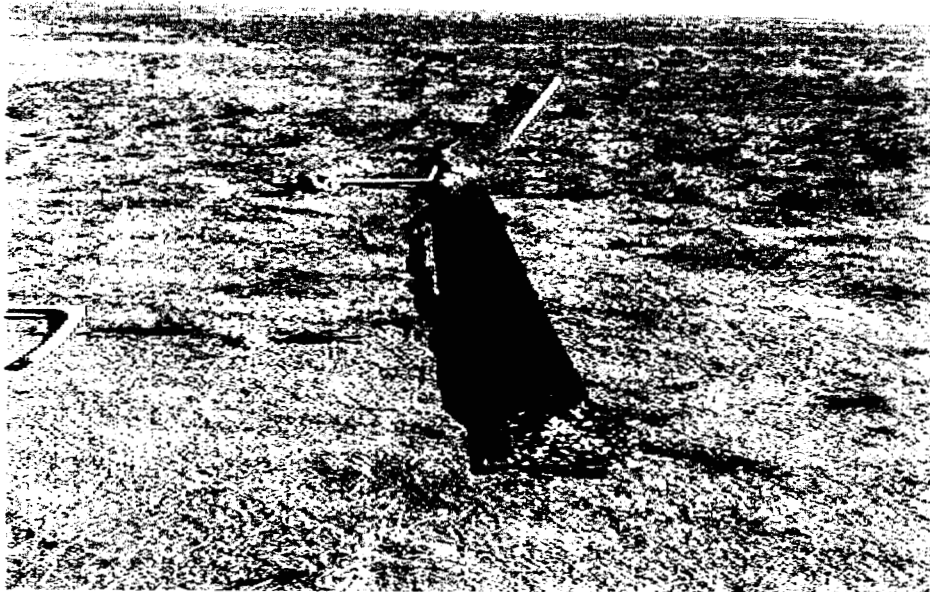
The mast and main rotor head was separated from the aircraft and was lying approximately 20 feet northeast of the wreckage. The aircraft windscreen was severely damaged. The left side forward and aft cabin doors were separated from the aircraft. The tail boom was fractured and resting inverted on the ground. The aircraft skid saddles were partially fractured. The tips of both main rotor blades were broken off and found 180° from each other. The main rotor blade tips were thrown approximately 450 feet from the wreckage. The flight control rods and linkage were broken and twisted at the mounting point areas. The flight control links to the main rotor and swash plate areas were removed by the Bell representative and sent to the NTSB laboratory for testing.

Photo # 8 – Main rotor blade system.

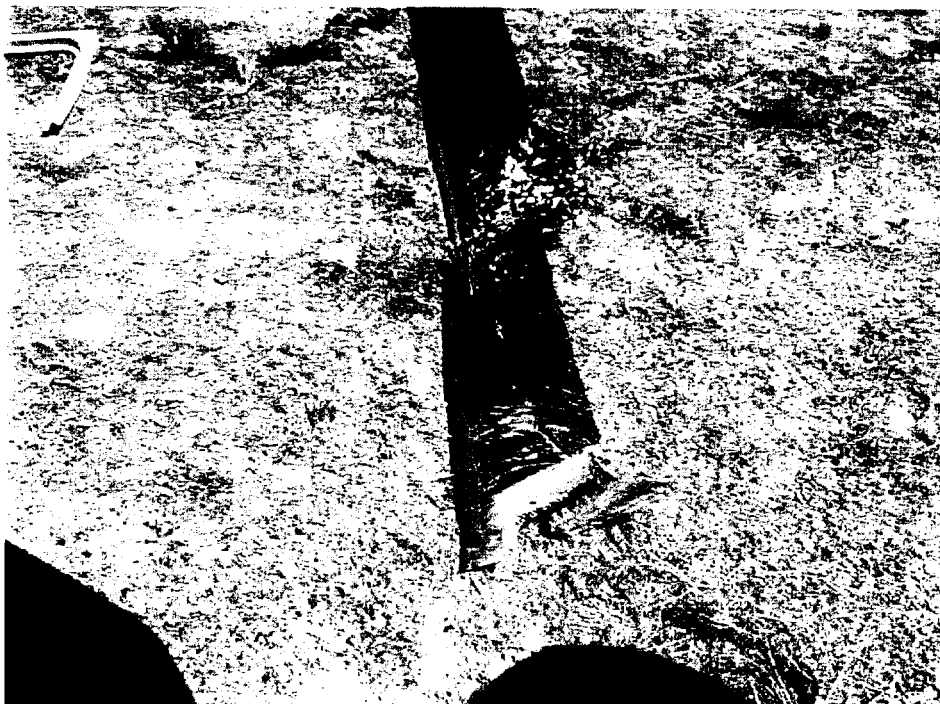
1. The engine was operating during the crash and after final impact.
2. On-Site examination of the engine and accessories did not reveal any evidence of pre-impact mechanical failure.
3. Evidence of engine operation at the time of impact were observed as follows:
 - The main rotor head was separated from the aircraft.
 - The main rotor blade tips were thrown approximately 450 feet after they made contact with the ground.

Photo # 9 – Red main rotor blade tip.

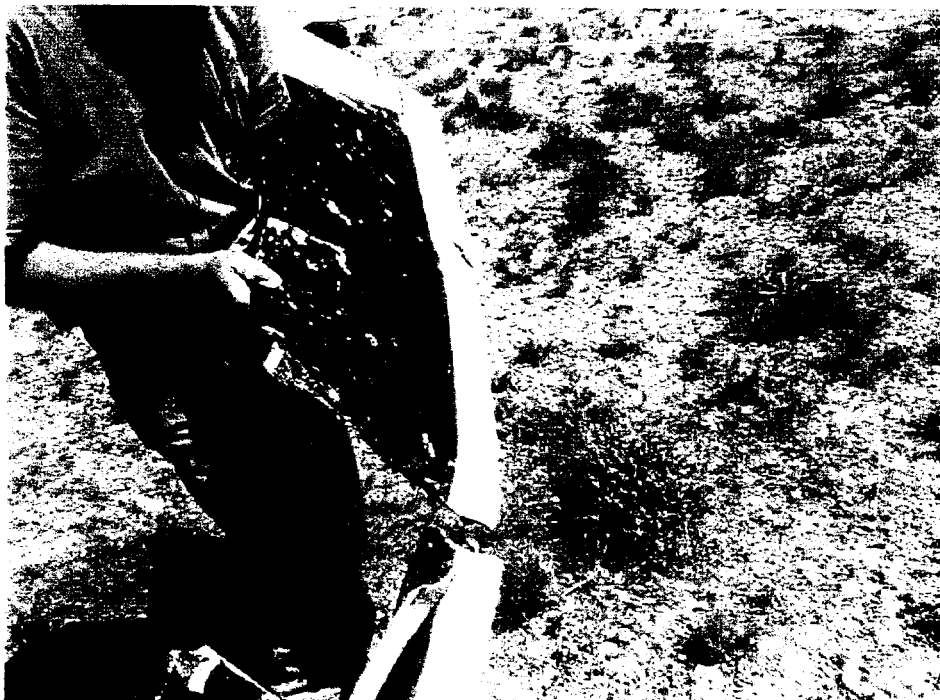
Photo # 10 – White main rotor blade tip.

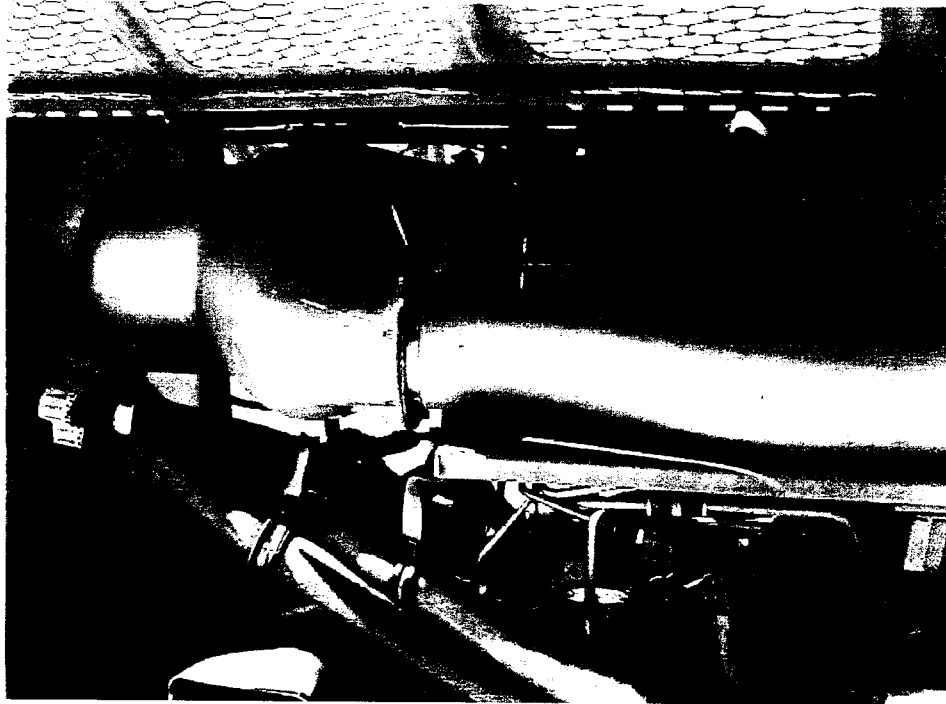
Photo # 11 – Right side of the engine.

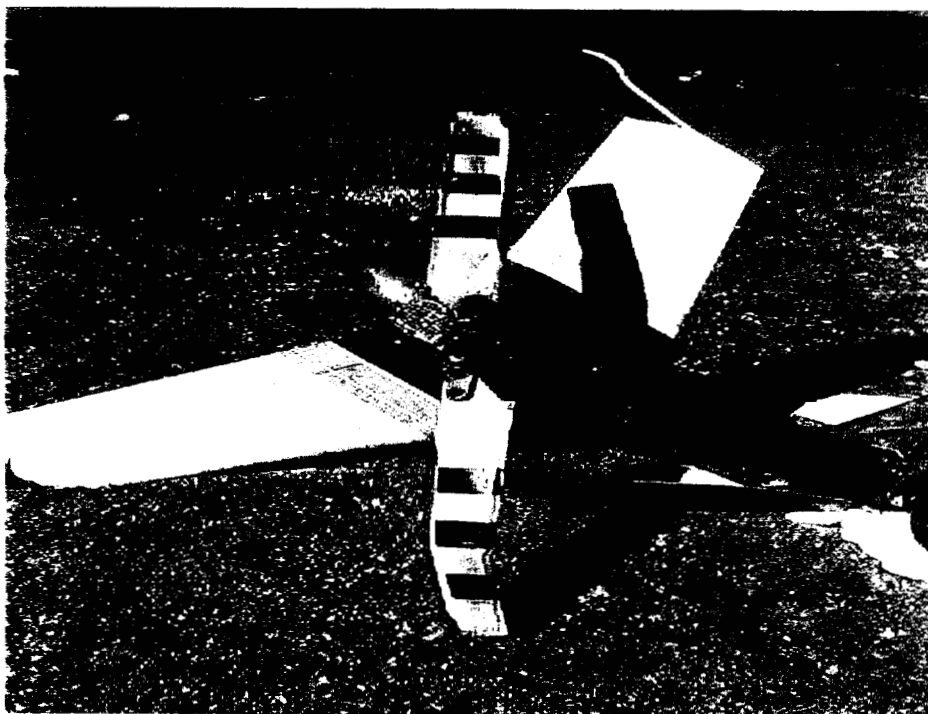
Photo # 15 – Tail rotor system.

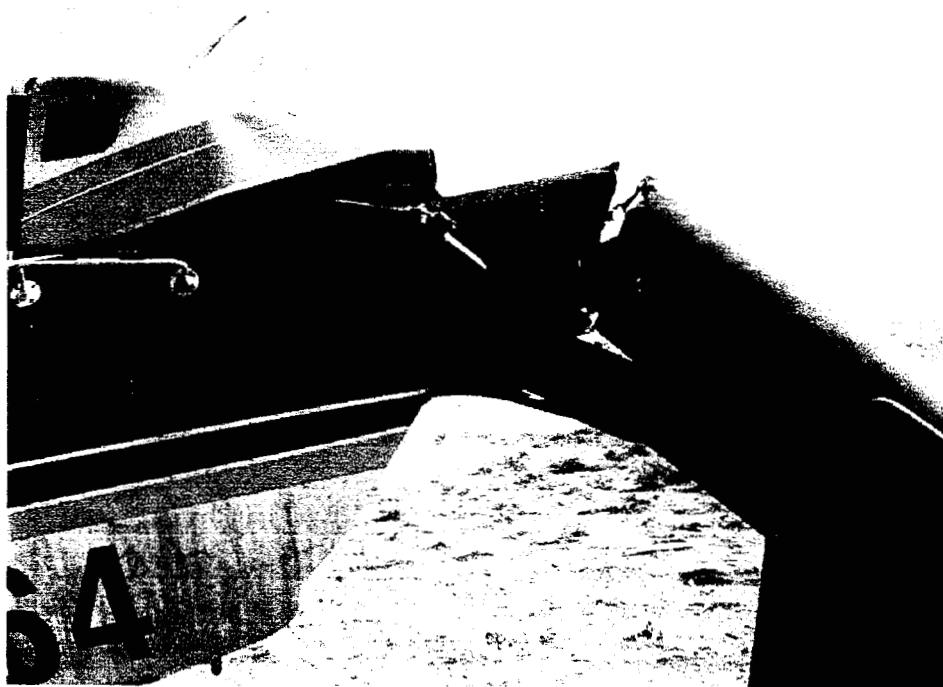
Photo # 16 – Tail boom/Tail rotor drive shaft.
