P/N 95551-00 nose gear mount displays damage to truss. Nose gear strut is partially retracted and is displaced up and aft

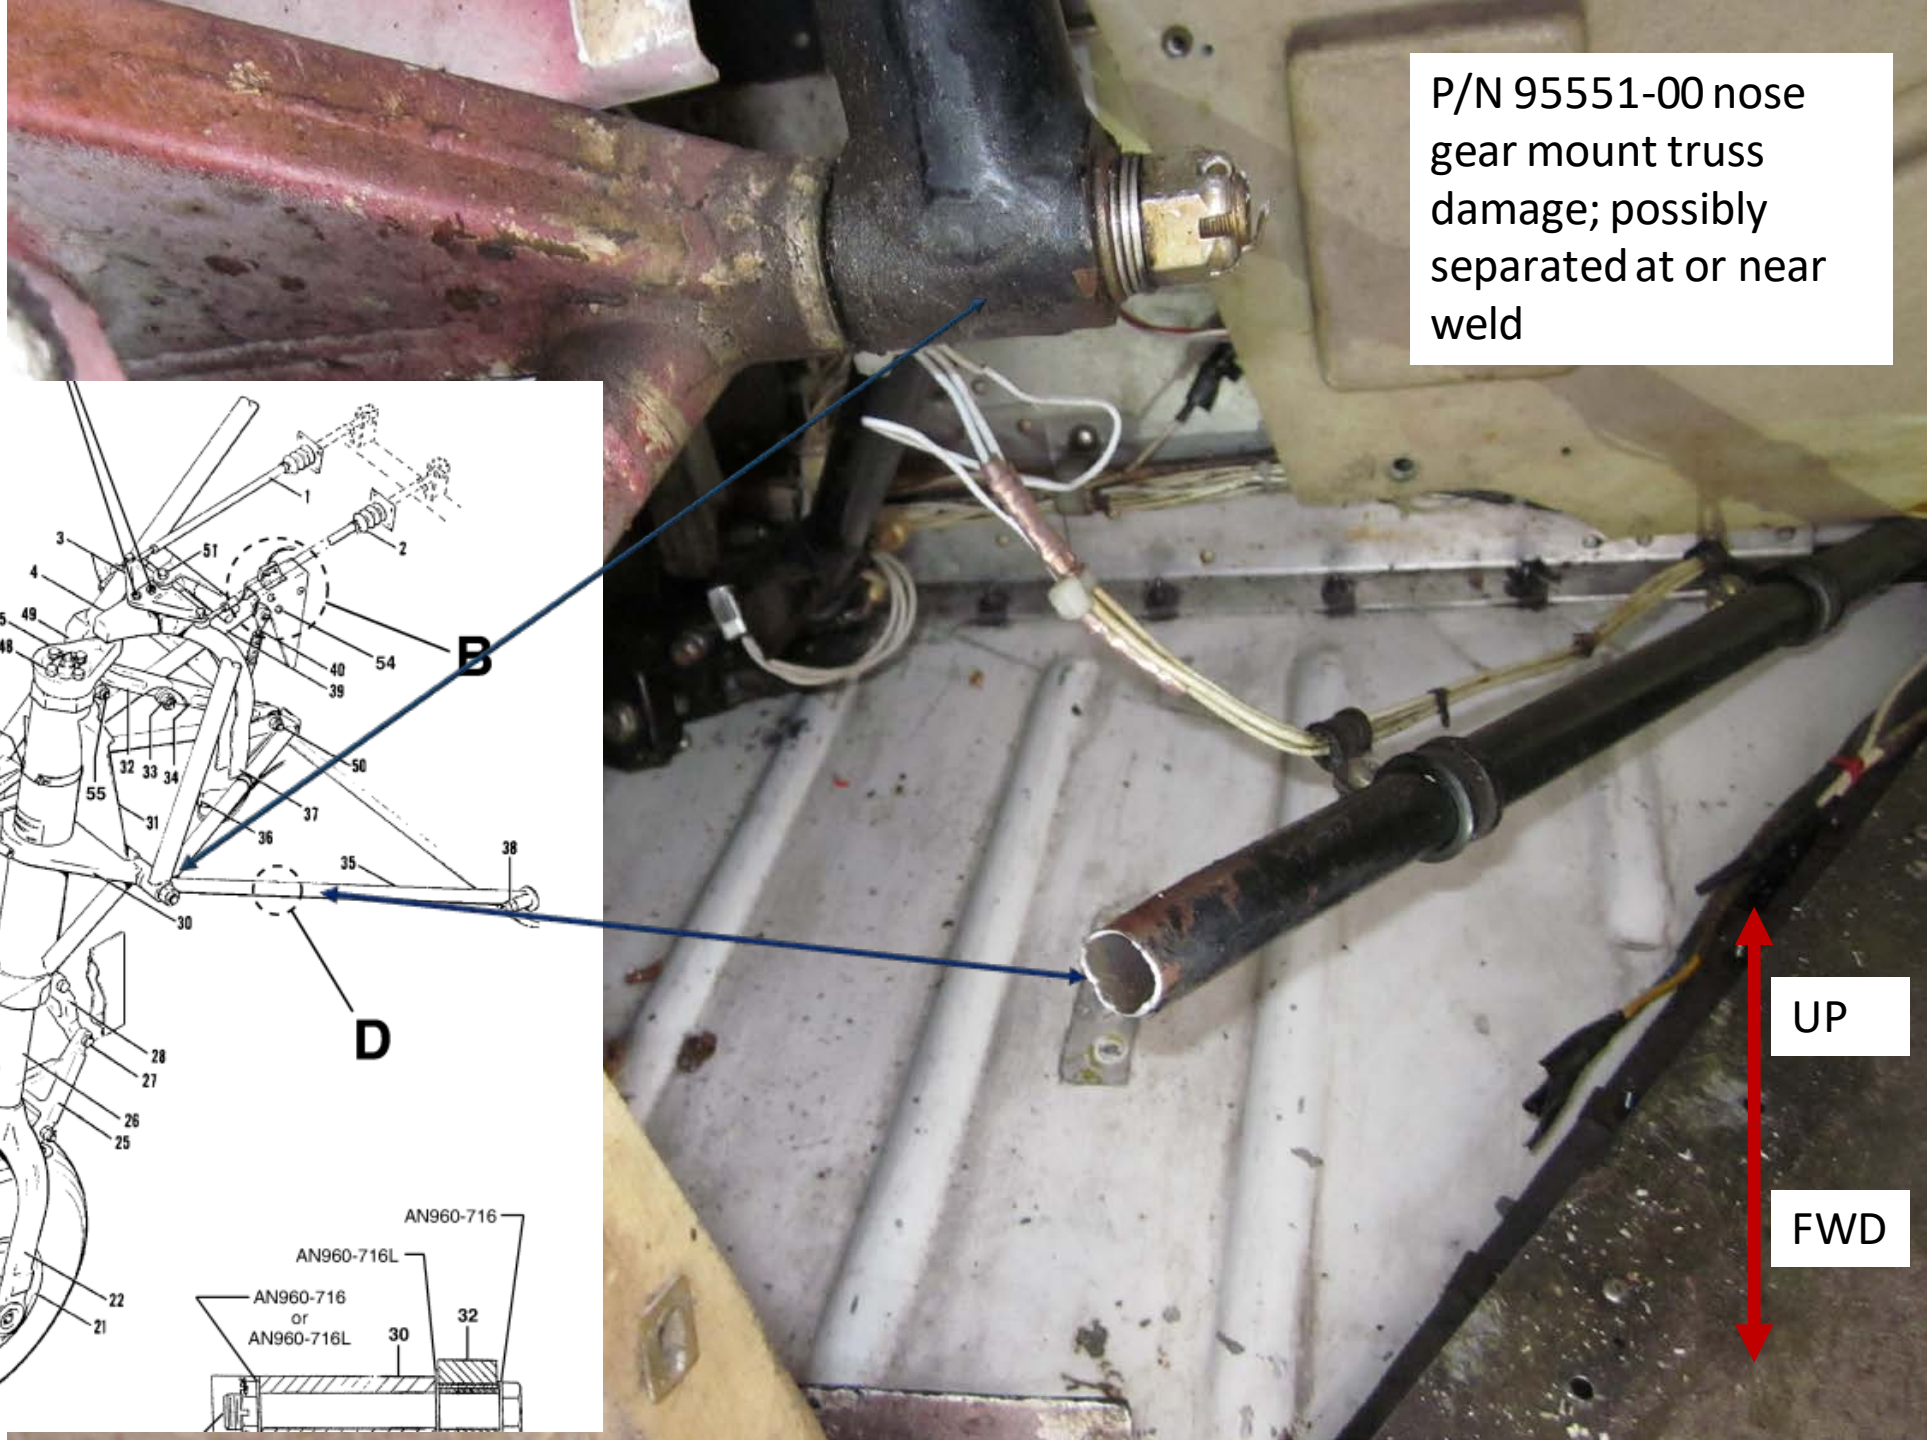
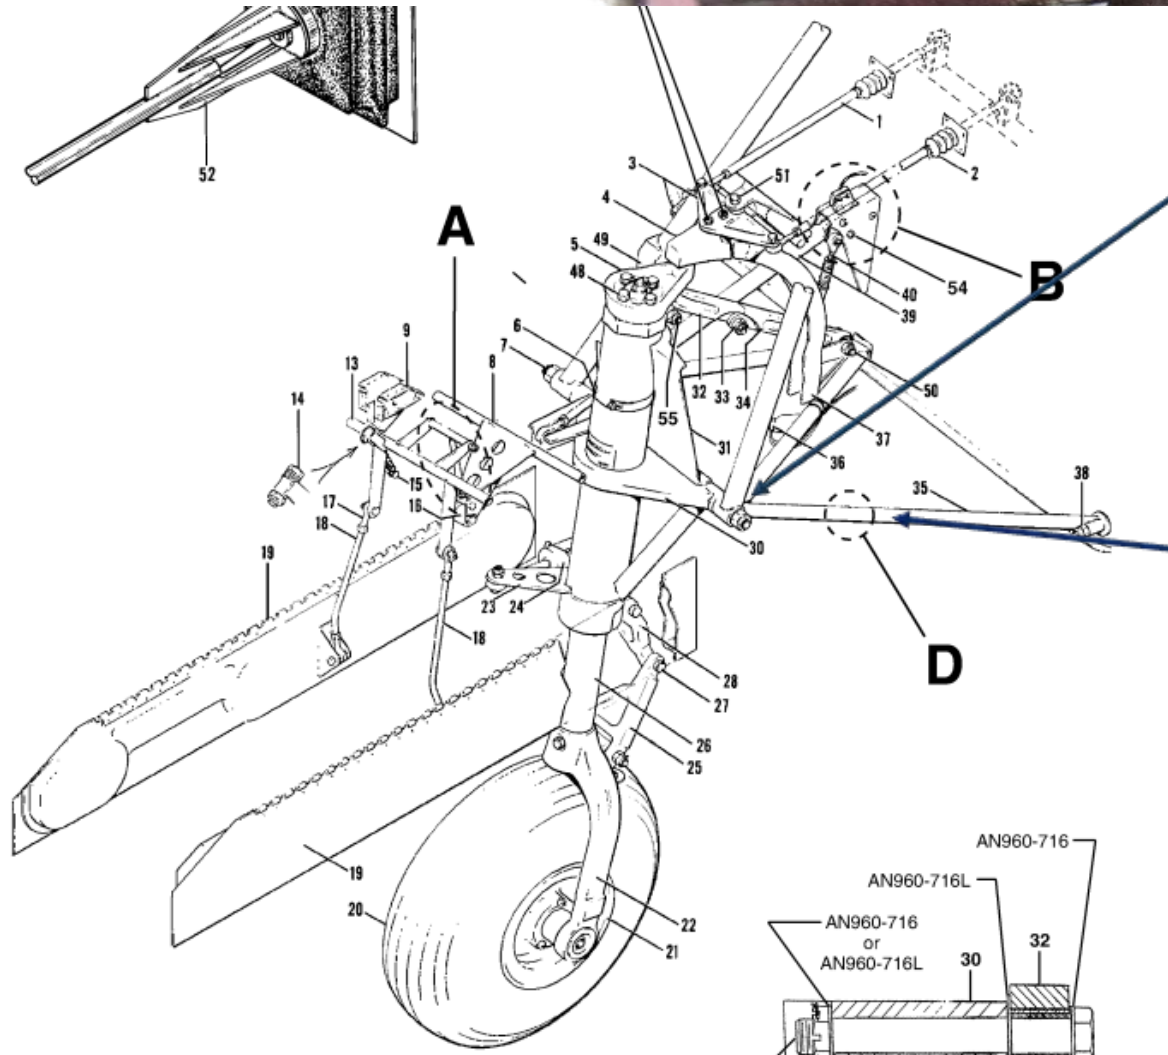
P/N 95551-00 nose gear mount truss damage; possibly separated at or near weld

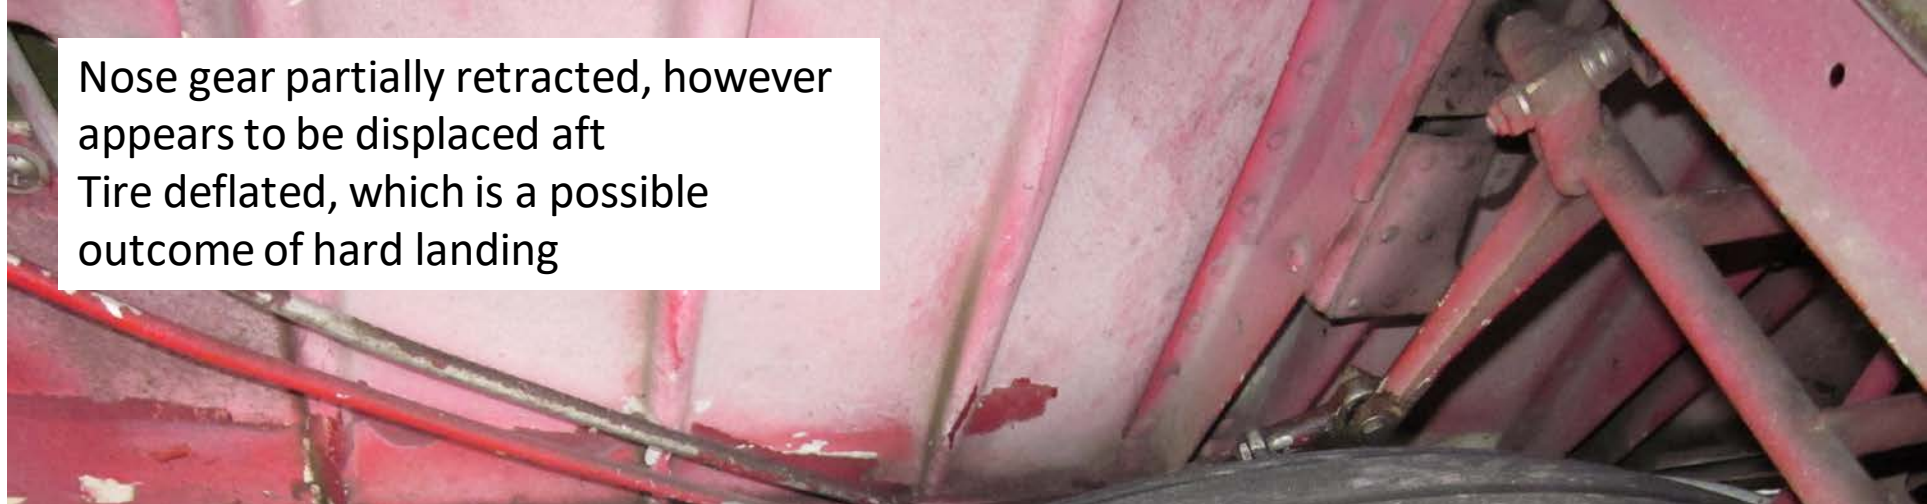
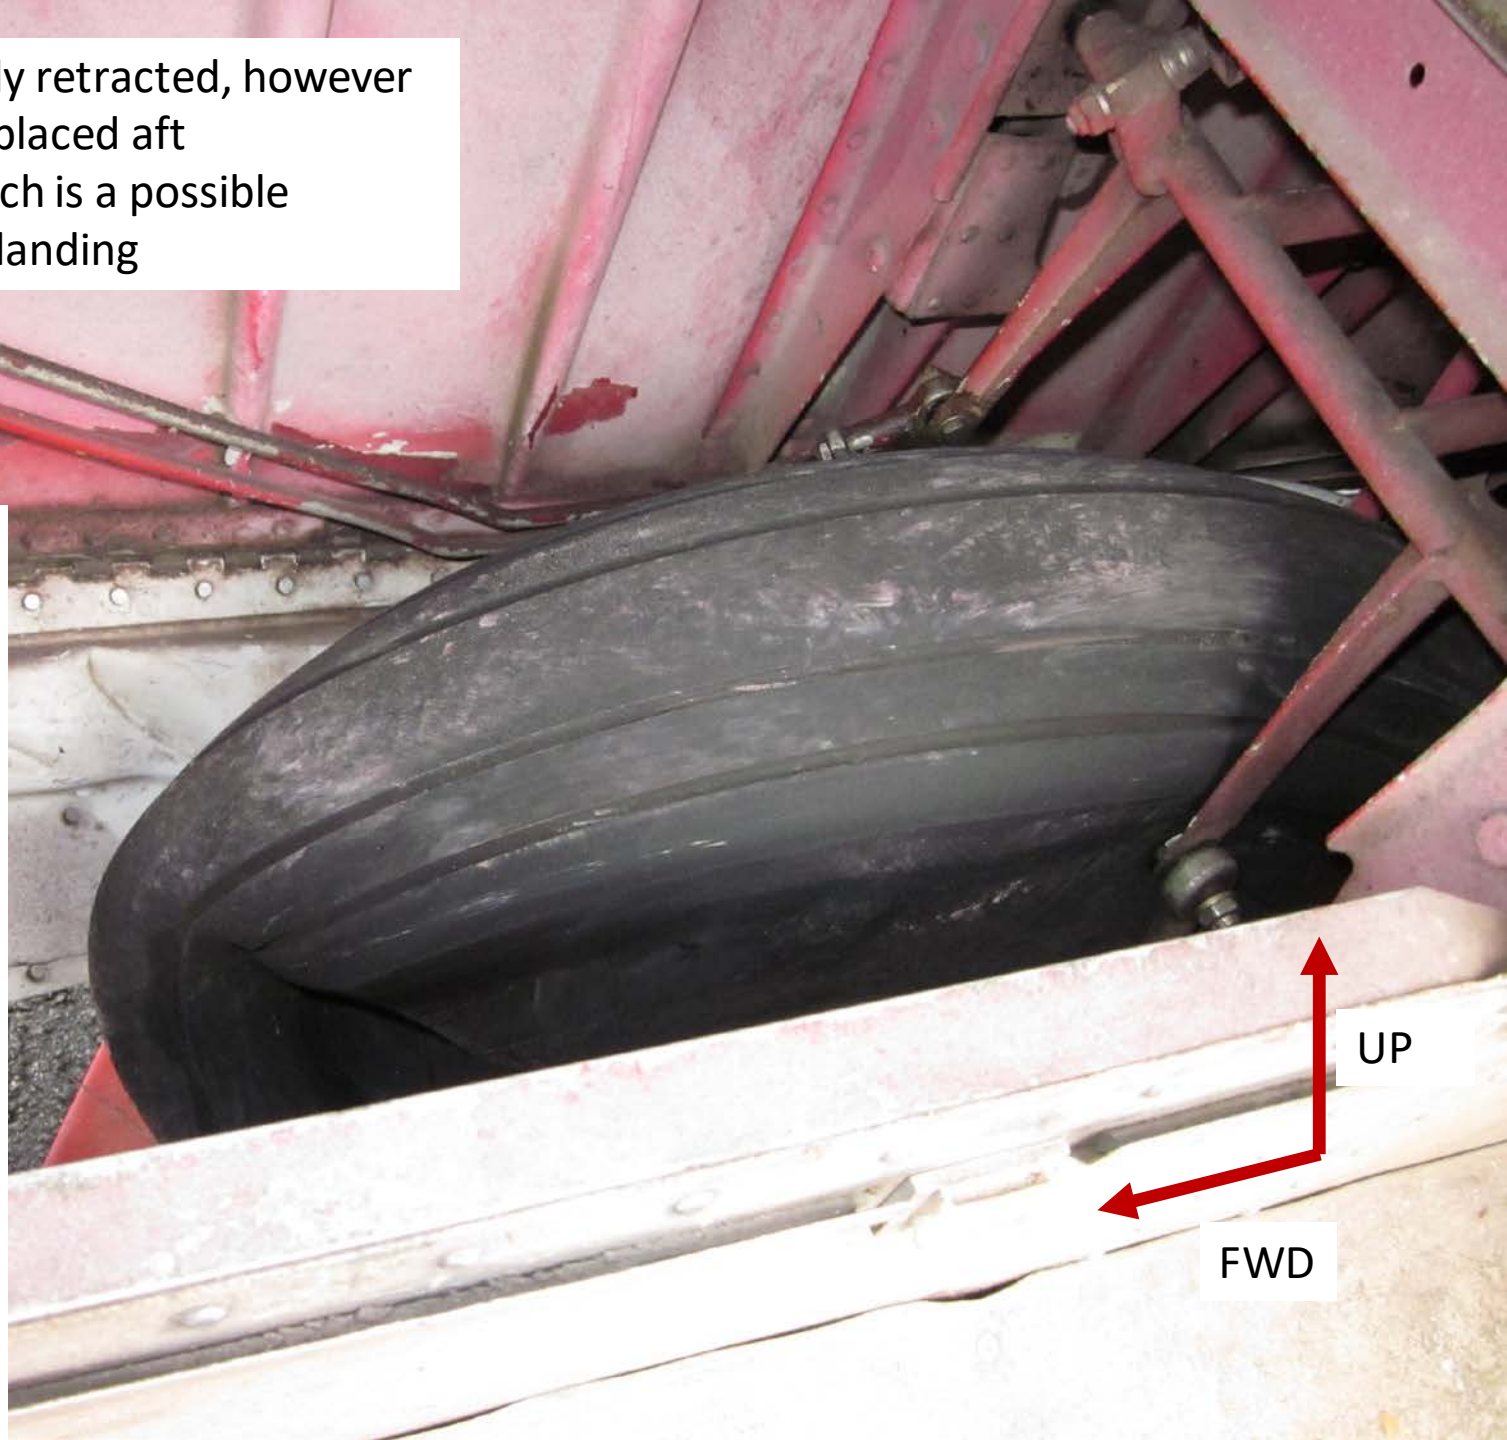
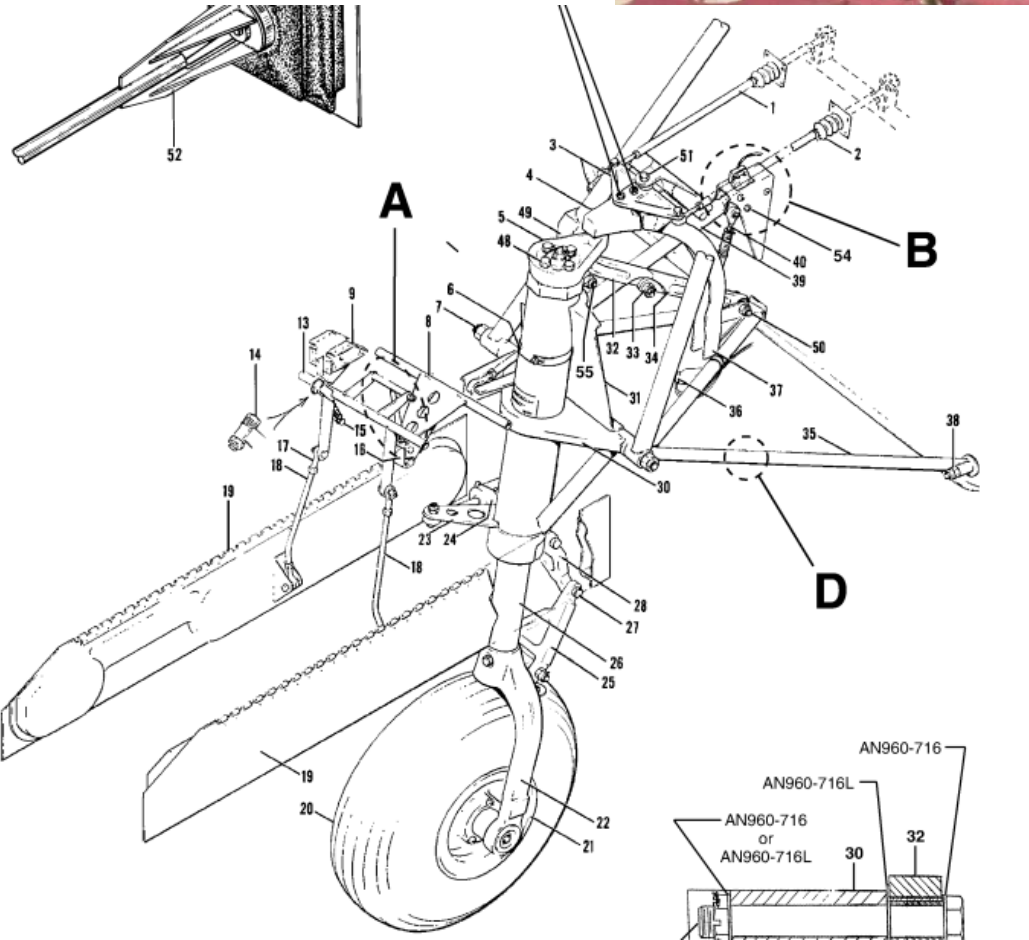
Nose gear partially retracted, however appears to be displaced aft
Tire deflated, which is a possible outcome of hard landing

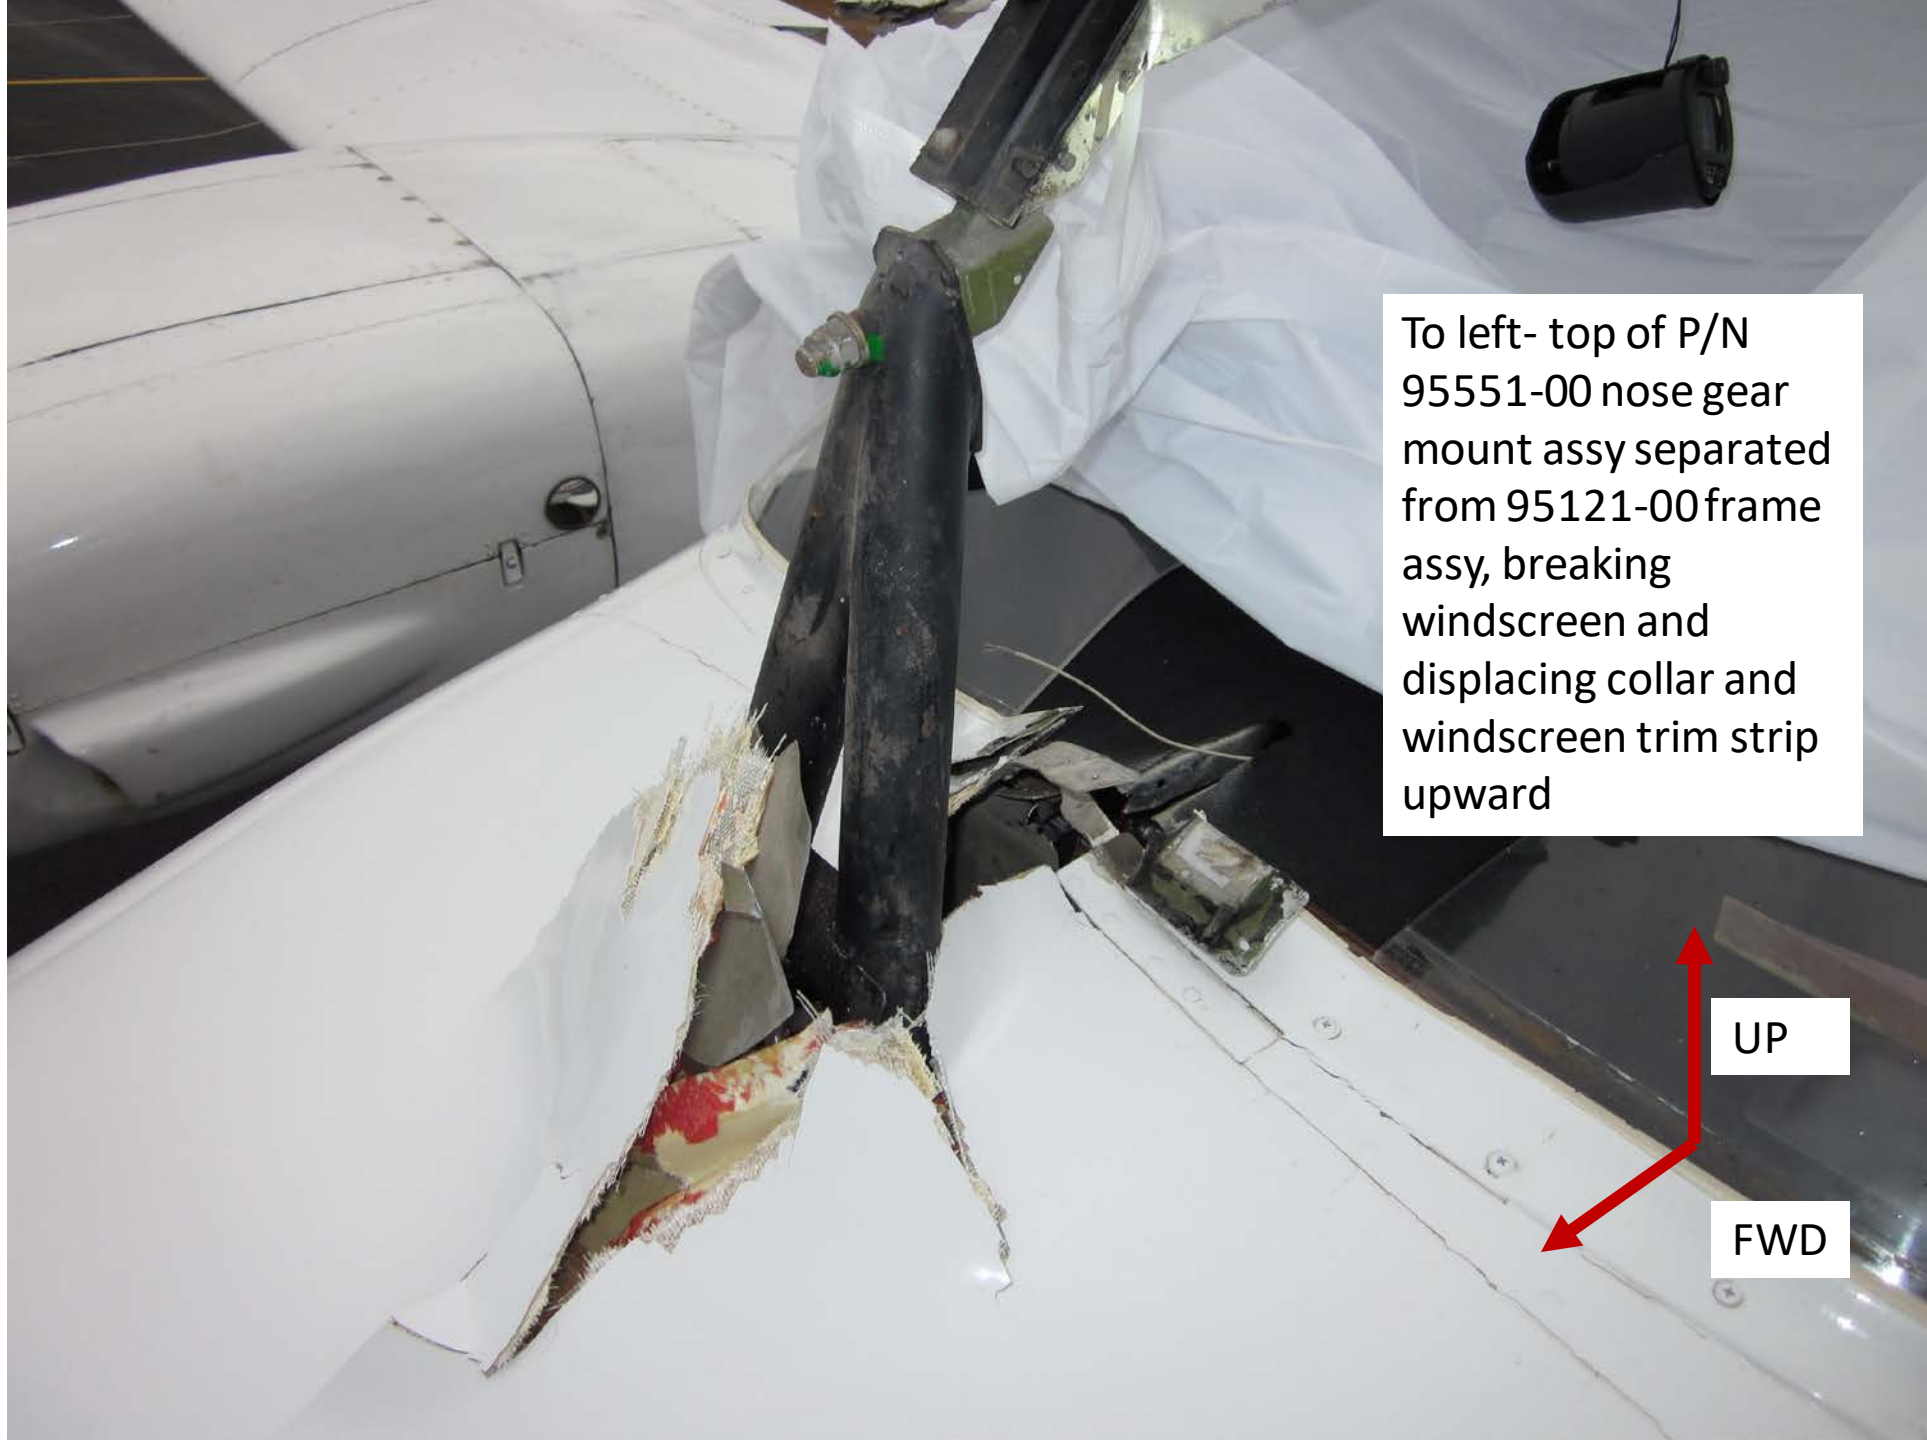
To left- top of P/N
95551-00 nose gear
mount assy separated
from 95121-00 frame
assy, breaking
windscreen and
displacing collar and
windscreen trim strip
upward

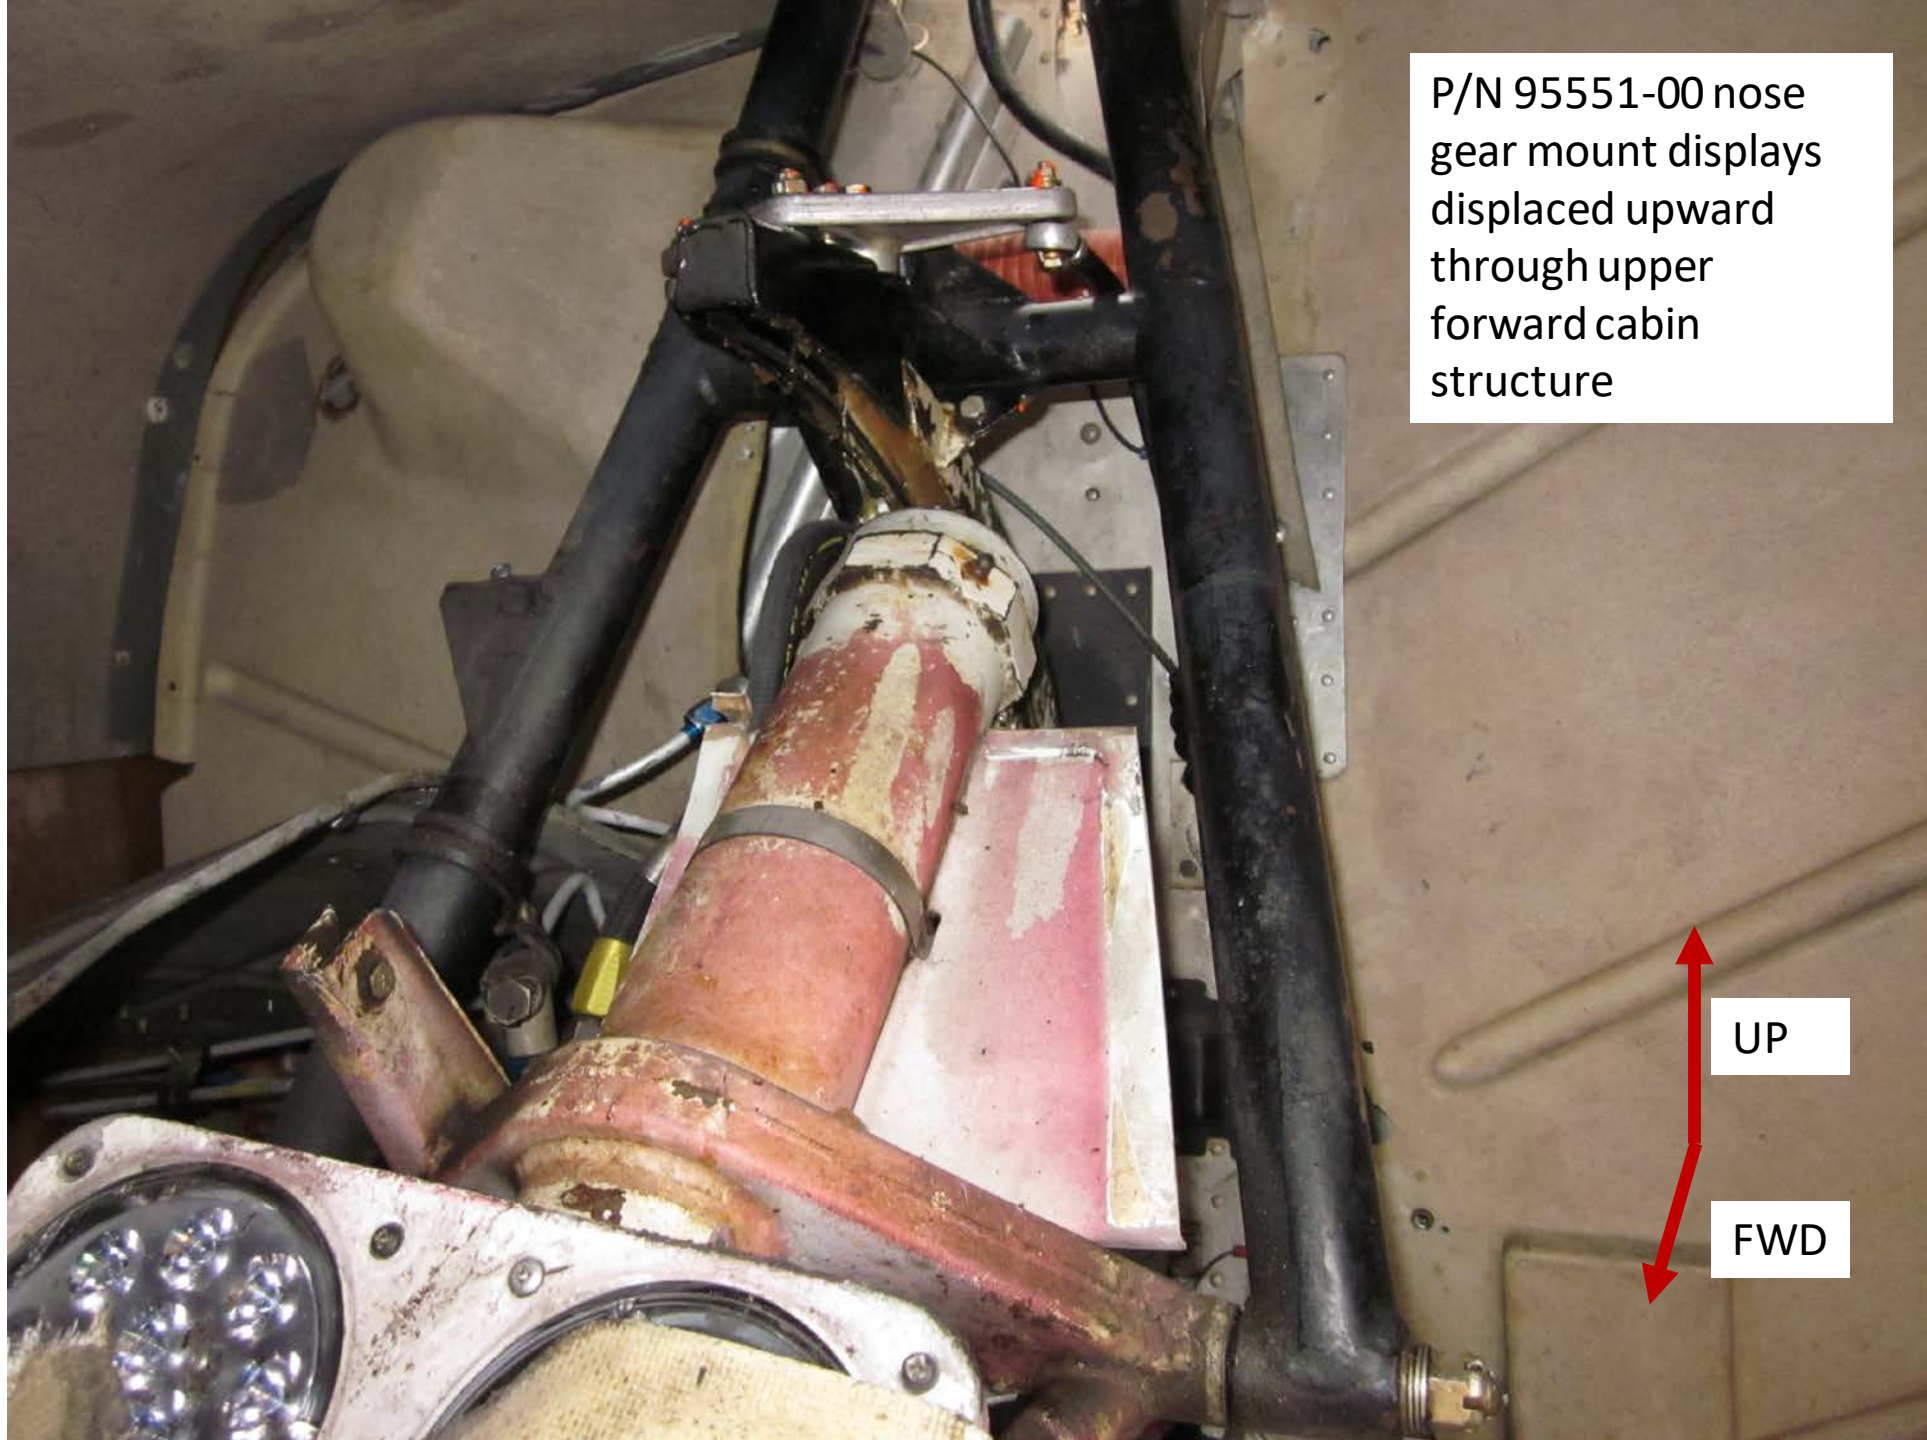
P/N 95551-00 nose gear mount displays displaced upward through upper forward cabin structure
