**Continental Airlines, Inc.**  
**Submission**

**Aircraft Accident**  
**Boeing B-737-524, N18611**  
**Denver International Airport (DEN)**  
**Denver, Colorado**  
**December 20, 2008**

**NTSB ACCIDENT INVESTIGATION**  
**DCA09MA021**

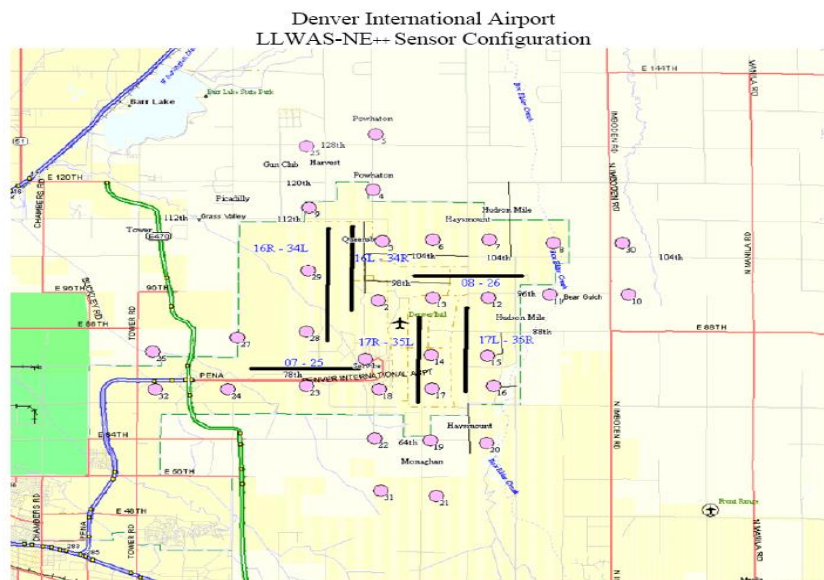
**Figure 1 – Locations of DEN LLWAS sensors.**

LLWAS sensor #2 is located near the approach (south) end of Runway 34R on a 40-foot tower. LLWAS sensor #29 is located just west of Runway 34L, near the mid-point of Runway 34R, on a 40-foot tower. The locations are shown in Figure 1:<sup>25</sup>

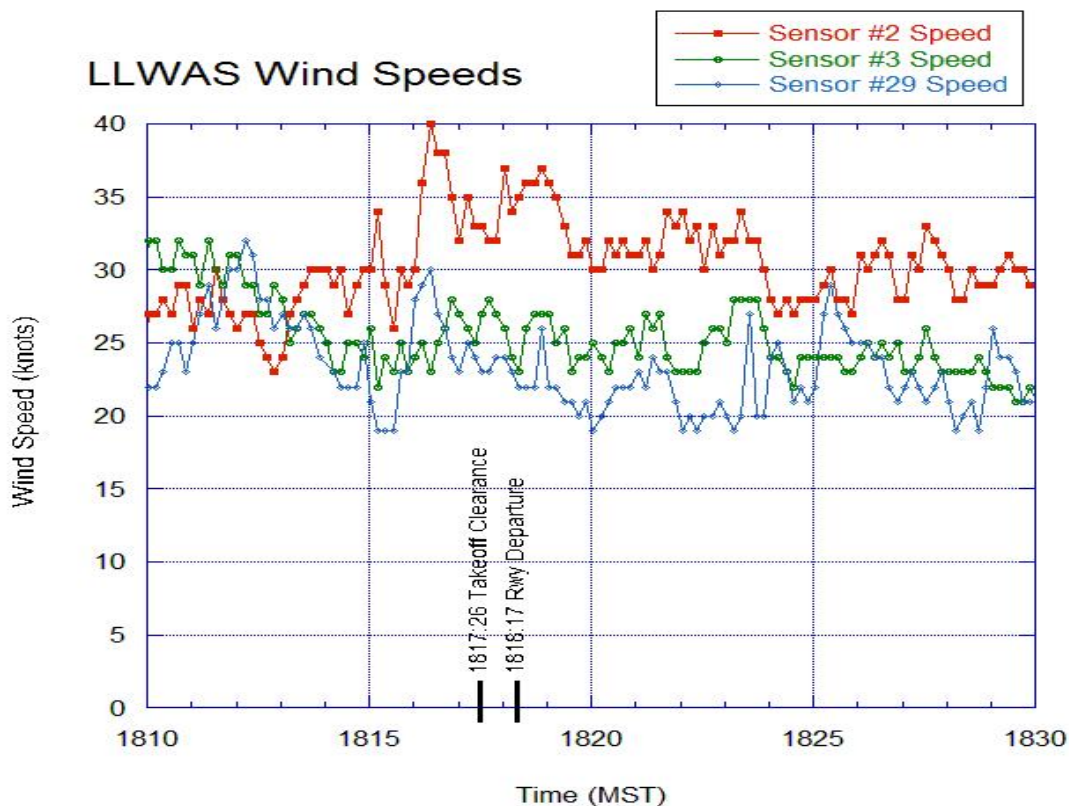
**Figure 2 – Wind speed (knot) time-series for the three LLWAS sensors closest to Runway 34R.**

Figure 2 shows the time series of the 10-second average crosswind speed from the three LLWAS sites closest to Runway 34R.<sup>29</sup> As noted in the previous Tables 1 and 2, the crosswind speed was much stronger at LLWAS sensor #2. The pilots had been provided the 27 knot crosswind speed, and specifically mentioned it in the cockpit at 1817:38,<sup>30</sup> but the crosswind speed measured by LLWAS sensor #2 was as high as **40 knots** before the takeoff clearance, and the crew was not given this information.

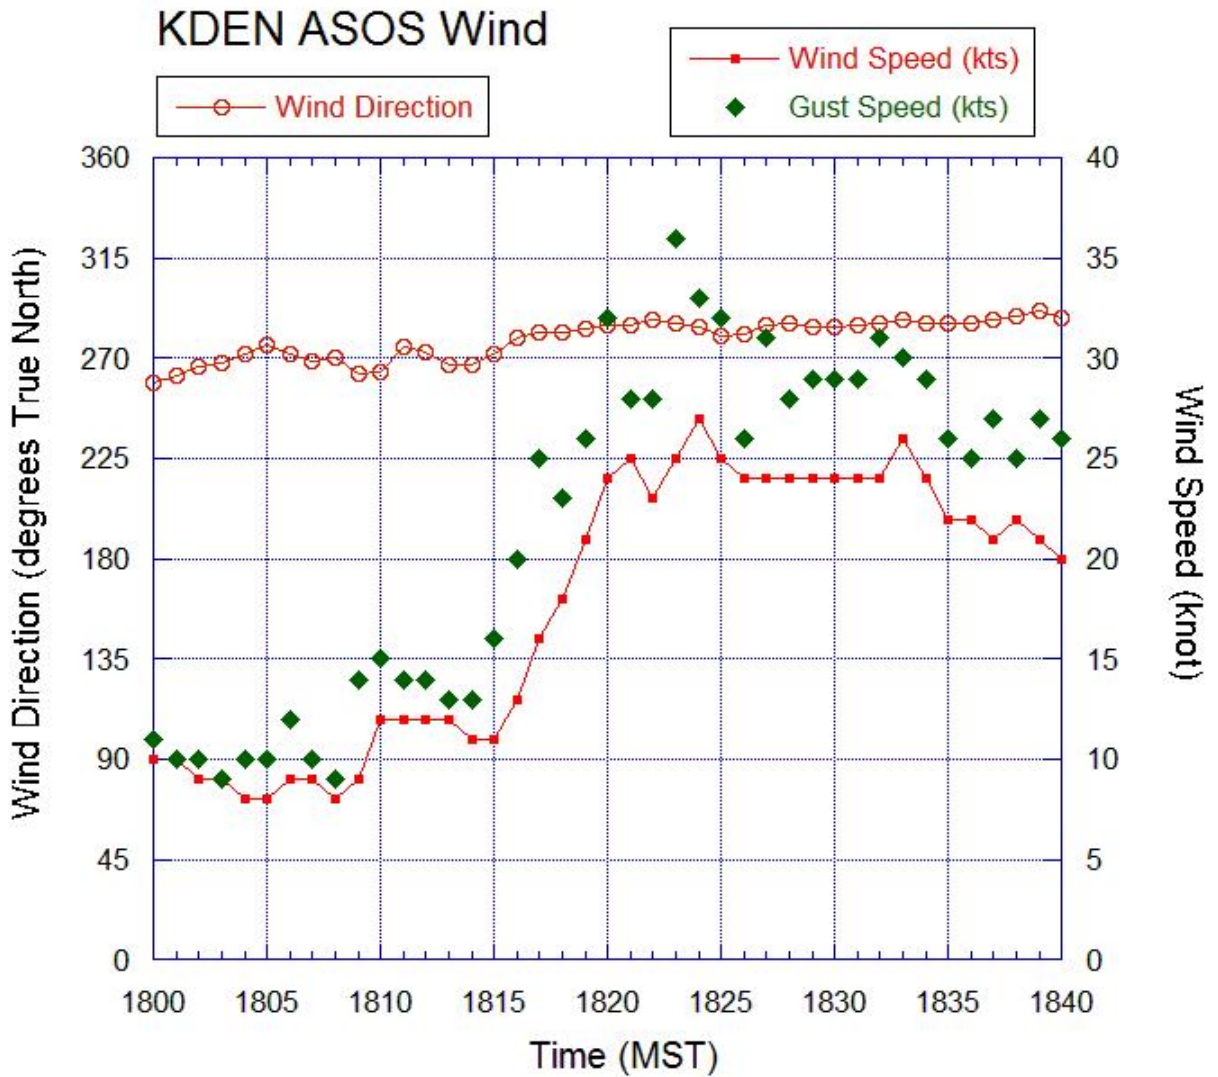
**Figure 3** – 2-minute average wind speed and 5-second max wind time-series from the ASOS station at DEN.

The character of the surface wind around the time of the accident was gusty. This is suggested by the 10-second data and confirmed by the DEN ASOS gust measurements<sup>31</sup> on a 30-foot (10 meters) tower shown in [Figure 3](#).<sup>32</sup>

The time of the maximum gusts recorded by ASOS likely lags those measured at LLWAS sensor #2 because the ASOS site is 14,600 feet (2.4 nautical miles) southeast of the accident site and downstream from any waves propagating from west to east. The METAR report generated by this ASOS site and available to ATC<sup>33</sup> at 1753 indicated a peak wind of 27 knots, but the Special Observation after the accident, at 1834 showed gusts to 32 knots and a peak wind of 36 knots, from 280 degrees true, at 1823.

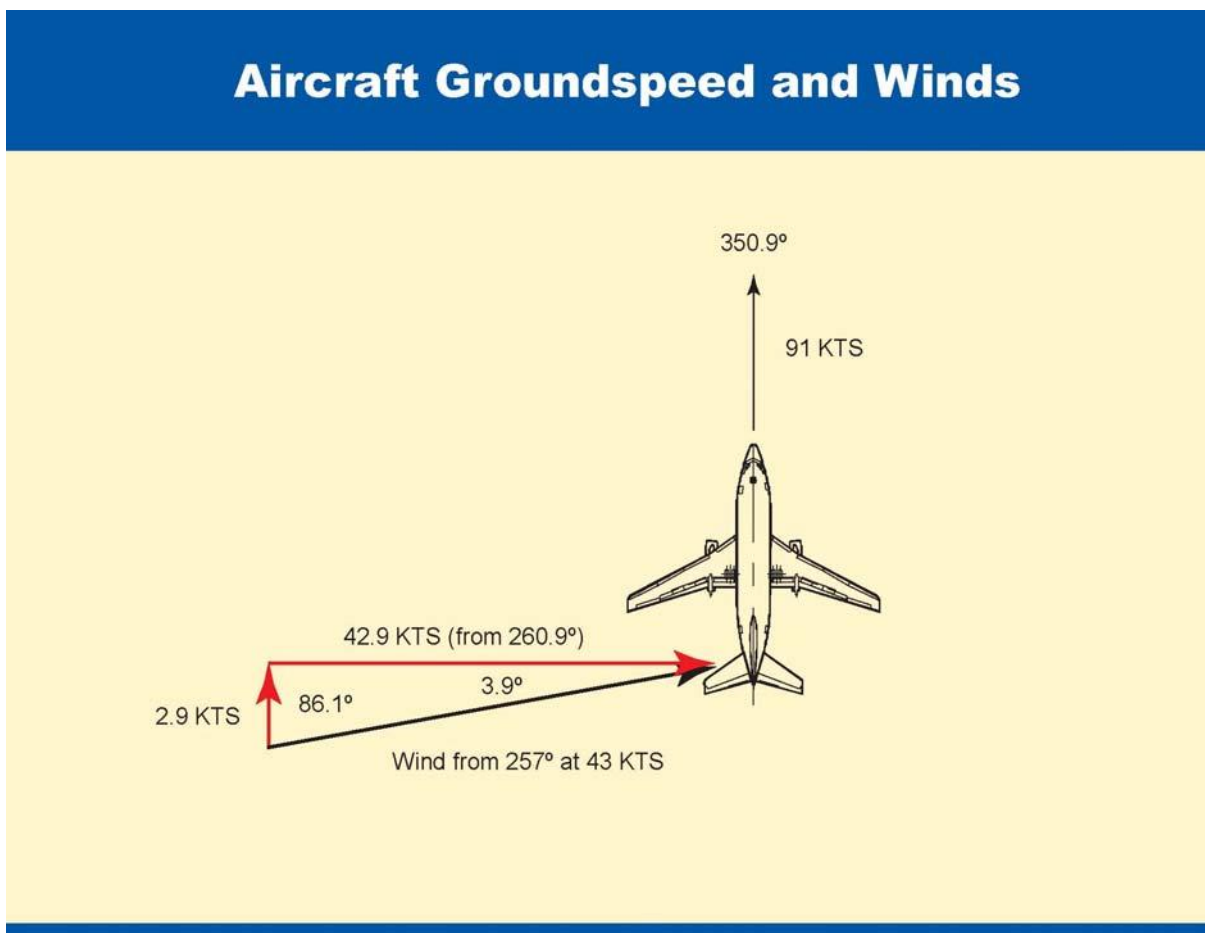
**Figure 8 – Aircraft Groundspeed and Winds.**

The following discussion illustrates the aerodynamic effects on the Boeing 737 during takeoff at the time of the gust event and shows that the unexpected very strong wind gust caused a sideslip angle that was larger than what maximum rudder deflection could counter. At the time of the event,<sup>38</sup> the aircraft was traveling down the runway on a magnetic heading of 350.9 degrees with a ground speed of 91 knots. The assumed gust that was experienced by the aircraft was from 257 degrees at 43 knots; therefore, the angle between the wind direction and aircraft magnetic heading is 93.9 degrees.<sup>39</sup> The NTSB actually extracted wind speeds up to 45 knots from their analysis, so the assumed gust of 43 knots is conservative. The first calculation is to determine the component of the gust that acted as a direct crosswind (i.e., from 260.9 degrees) to the aircraft rolling down the runway. This result is shown in [Figure 8](#).

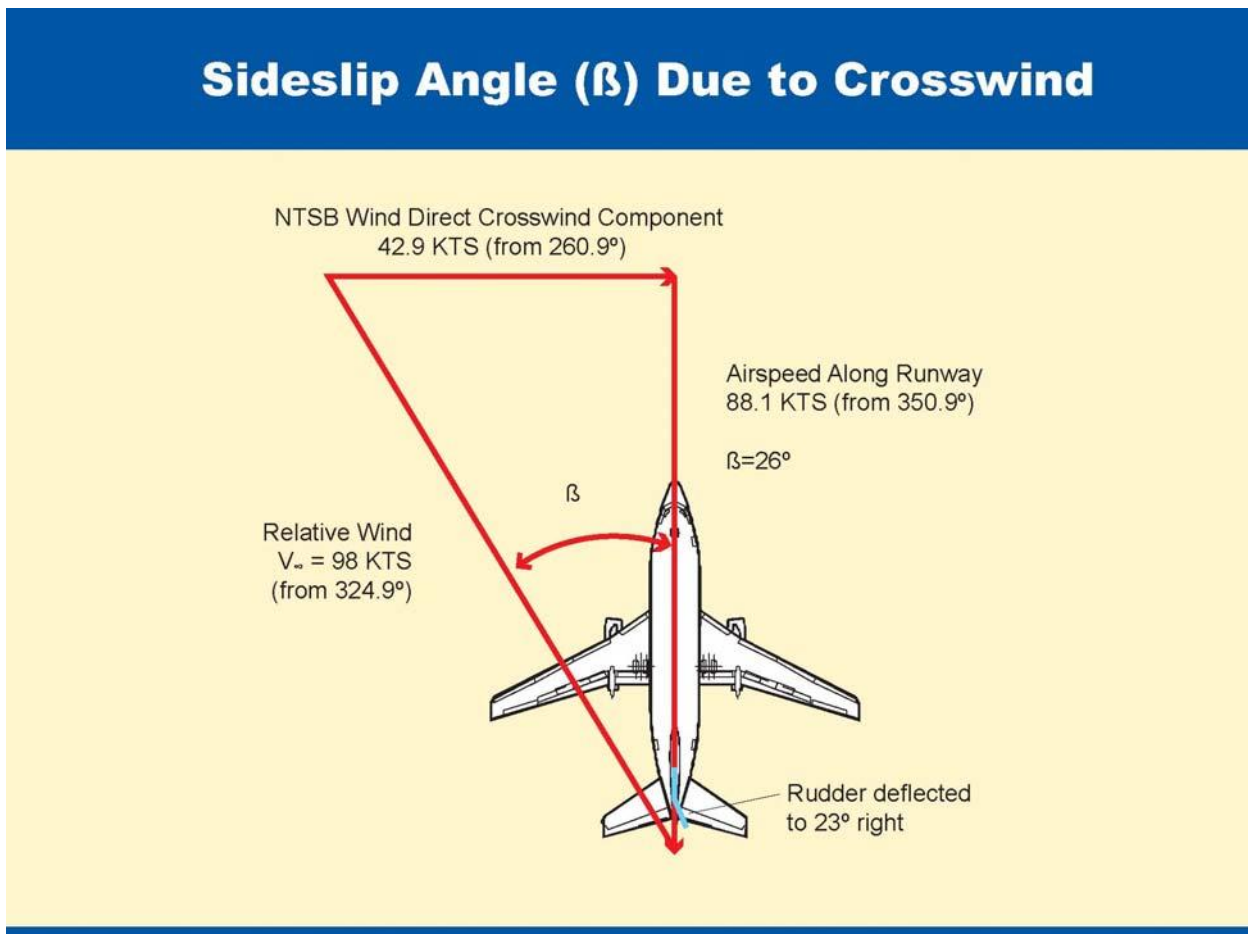
**Figure 9 – Sideslip Angle ( $\beta$ ) Due to Crosswind.**

As a result, the airspeed of the aircraft in the x-direction (heading of 350.9 degrees) is 88.1 knots with a direct crosswind component of 42.9 knots. This is shown in [Figure 9](#):

Based on the airspeed along the runway and the crosswind acting on the aircraft, the sideslip angle,  $\beta$ , and true airspeed,  $V_\infty$ , can be calculated. The true airspeed for these conditions is 98 knots and the magnitude of the sideslip angle is found by the trigonometry in Equation 2 to be 26 degrees:

If the above analysis was performed at an earlier time, such as the second peak rudder deflection of 23 degrees, the aircraft's approximate ground speed was 84 knots and the NTSB extracted wind was from 257 degrees at 45 knots. Based on these conditions, the calculated sideslip angle would have been approximately 29 degrees, making the rudder even less capable of counteracting it.

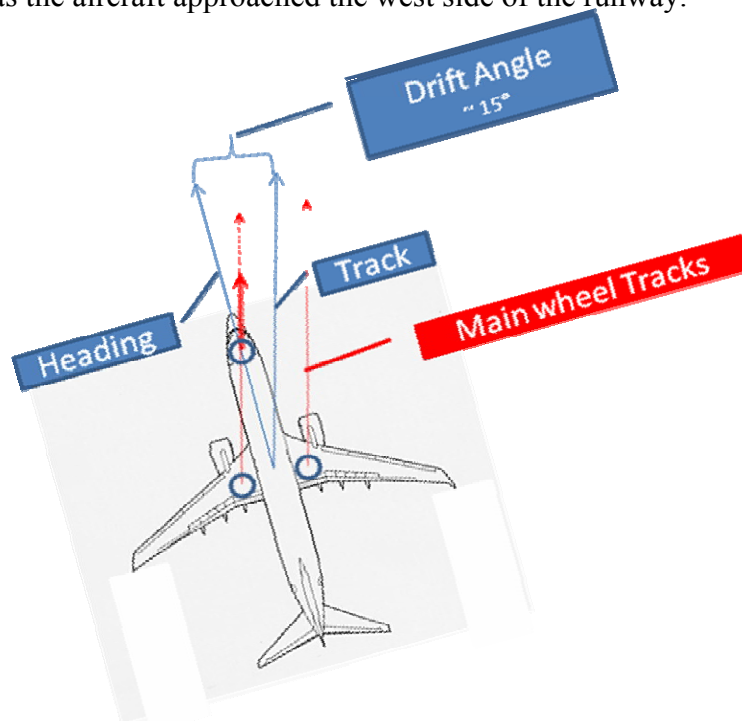
**Figure 10.**

The skid marks left by the nose wheels as they converged with the set of left main landing gear skid marks suggest that the aircraft entered a period of skidding sideways, producing a right drift angle with respect to the aircraft heading.

Figure 10 suggests an approximate drift angle of 15 degrees at the point that the left main landing gear and nose gear skid marks converged. This occurred while the aircraft was still on the paved surface as the aircraft approached the west side of the runway.

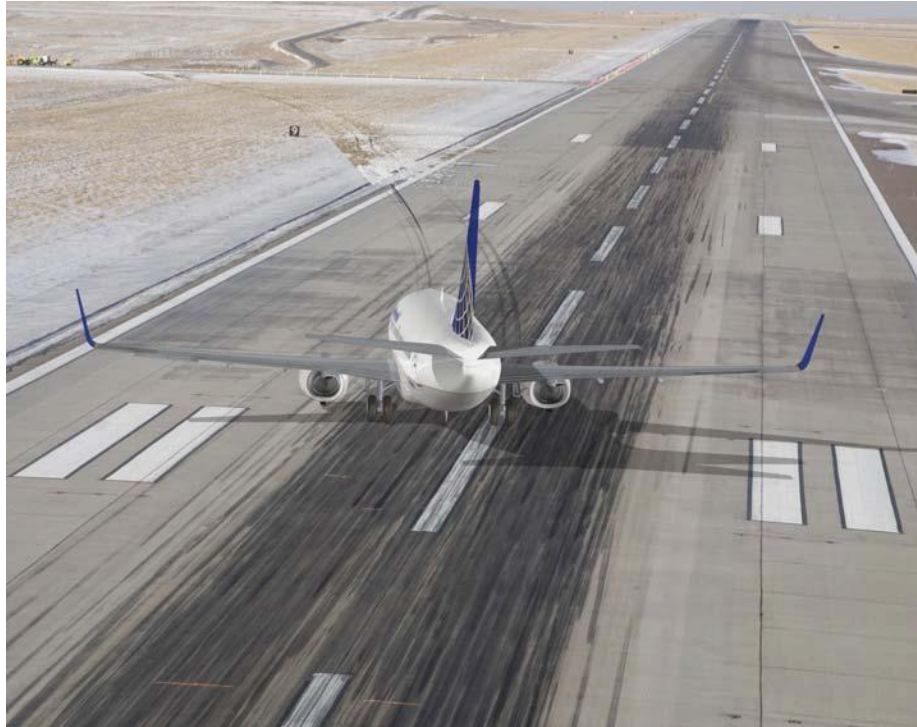
**Figure 13.**

Figure 13 depicts an exemplar 737-500 superimposed on an aerial photograph of the runway. The aircraft's right main gear was still touching the centerline, but the plane had yawed far to the left and was skidding sideways. The Captain undoubtedly quickly realized that the plane was going off the runway even though the main gear was still near the centerline.

Regardless of the proximity of the aircraft's main landing gear to the runway centerline, the pilot's sight picture at night where he could only see the runway edge lights, coupled with the plane's skidding and the failure of the rudder to control the yawing motion, changed his plan of action in an instant. He had no way of knowing why his hard rudder input did not work. He had no way of knowing whether he had encountered an extreme weather condition, hit a patch of ice on the runway, or his rudder was ineffective or even inoperative. The sound of two "snaps" recorded by the CVR may have reinforced the Captain's belief that something was wrong with the rudder. He knew his airplane was not responding as expected and he had to take immediate emergency action. Given the heading of the airplane, a rejected takeoff could not have kept the airplane on the runway at that point.

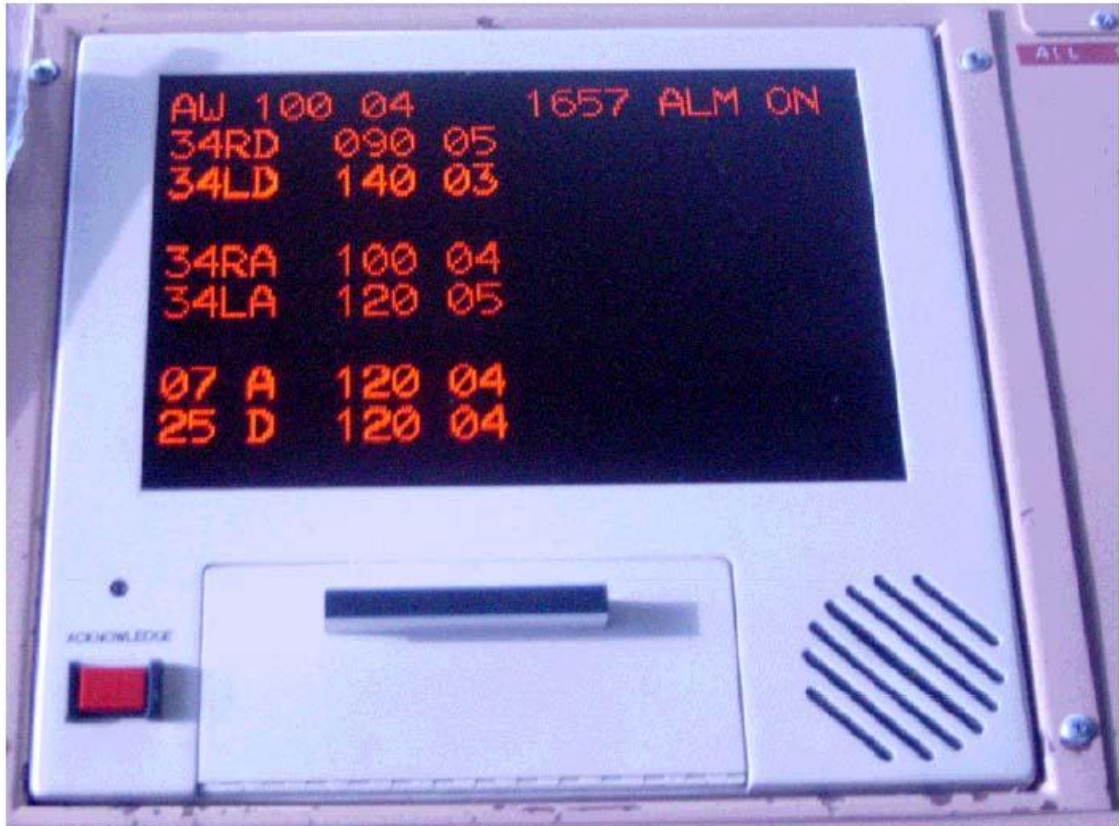
Figure 15<sup>67</sup> depicts the DEN ATCT ribbon display terminal wind display. The wind direction and velocity on this figure were not the ones pertinent to this accident, but those are listed in Table 1 on page 5. The controller's display would have shown the dramatic difference between the wind velocity, at the north and south ends of Runway 34R.
