**Continental Motors, Inc.**

## ENGINE FIELD RUN REPORT

ENGINE MODEL: O-300-A

REGISTRATION: N5781A

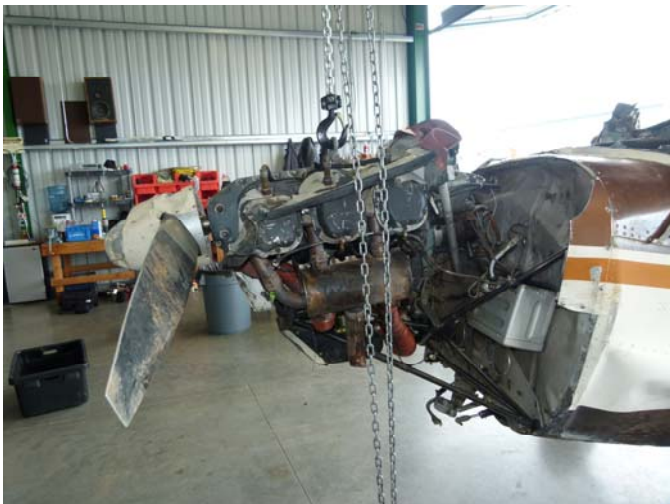
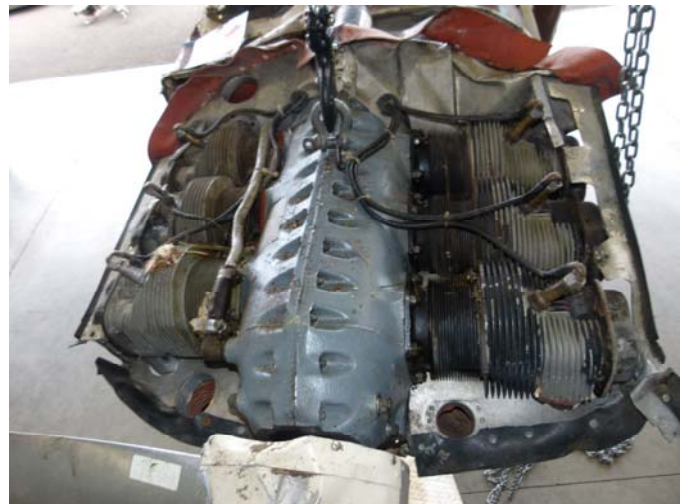
Three of the four engine mount legs were fractured. The upper spark plug leads exhibited damage consistent with impact damage. The carburetor mounting flange was fractured at one corner. One of the carburetor mounting studs was pulled from the induction manifold. The rest of the engine accessories remained attached to the engine and exhibited no visible damage. The top spark plugs were removed and exhibited dark colored combustion deposits. The spark plug electrodes exhibited normal wear when compared with the Champion Check a Plug chart. The cylinder combustion chambers were inspected using a lighted bore scope. The combustion chambers, intake and exhaust valves, cylinder walls and piston faces were unremarkable. The propeller was rotated by hand and continuity to the accessory gears and valve train was established.

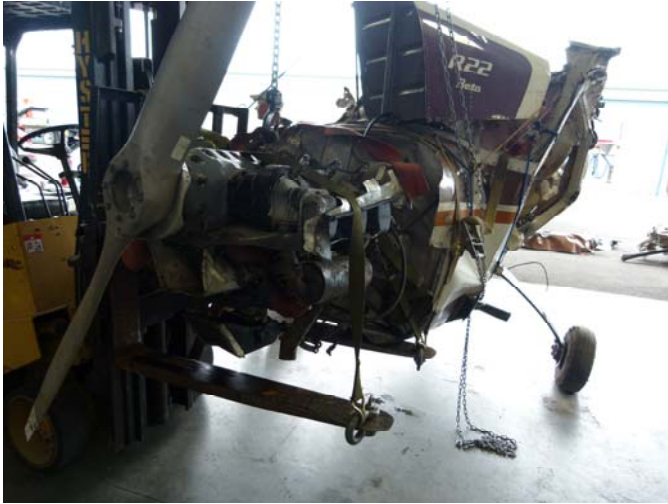
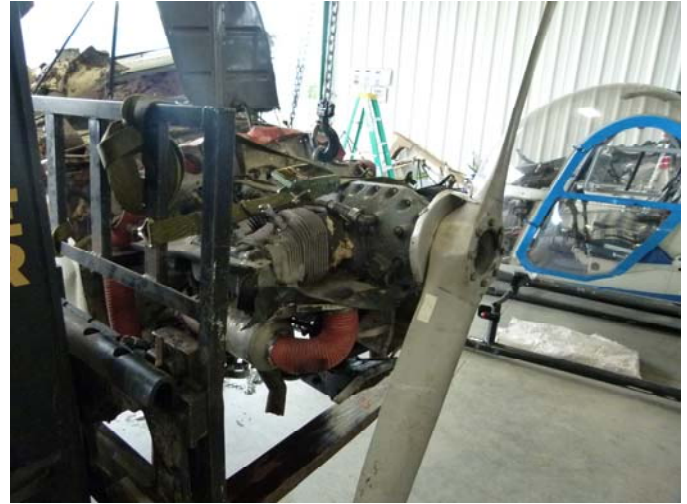
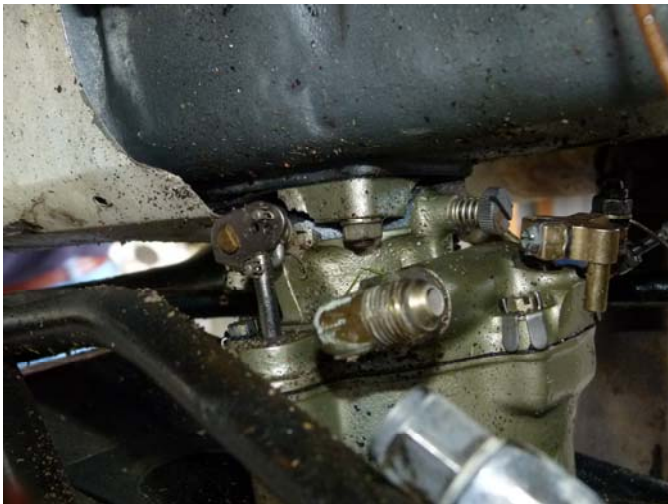
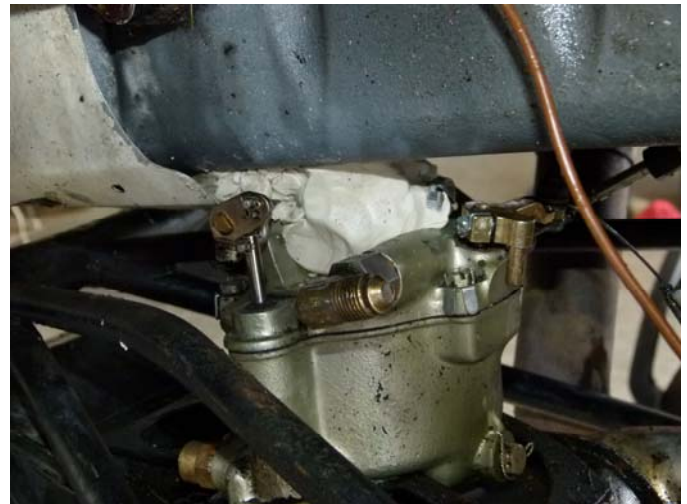
The engine was strapped to a forklift in order to provide stability during the engine run. The carburetor mounting flange was repaired using JB Weld, duct tape and plumbers putty to facilitate the engine run. The carburetor fuel screen and fuel supply line to the carburetor were removed and an external fuel source was connected directly to the carburetor fuel inlet port. The carburetor fuel screen was clear of debris.
