Continental Motors

ENGINE EXAMINATION REPORT

ENGINE MODEL	IO-550-N7B
ENGINE SERIAL NUMBER	685788
AIRCRAFT MAKE & MODEL	Cirrus SR22
AIRCRAFT SERIAL NUMBER	0064
AIRCRAFT REGISTRATION	N451TD
FILE NUMBER	17-508

FILE NUMBER:	17-508	ENGINE S/N:	685788	PAGE 2 of 24
---------------------	--------	--------------------	--------	---------------------

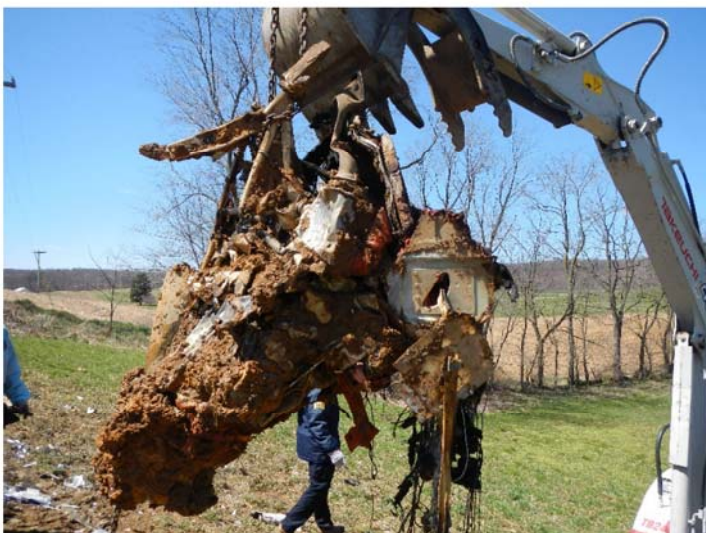
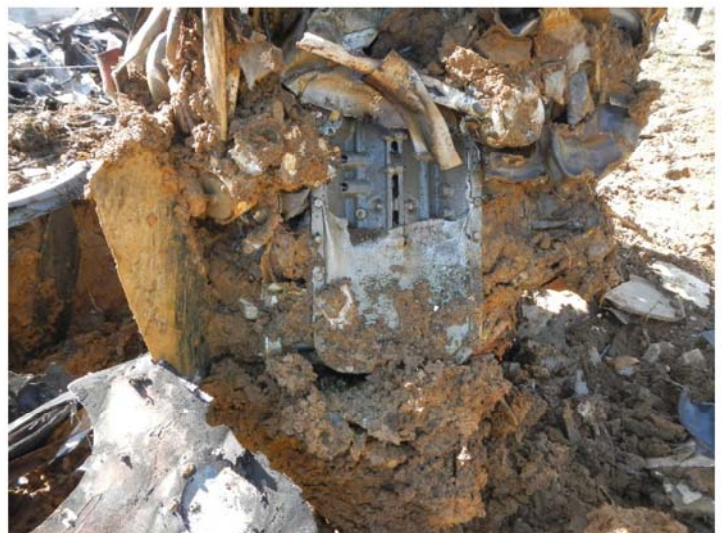
The engine was buried in a crater that was associated with the initial impact area. The engine was pulled from the crater utilizing a backhoe. The airframe mounts and nose landing gear brace remained attached to the engine as did the firewall. The throttle, mixture, and propeller control cables remained attached to their respective control levers. The cables and electrical wires were cut to facilitate the removal of the firewall. The front portion of the oil sump was flattened up against the bottom side of the engine while the aft portion of the oil sump was torn away and displaced aft, exposing the bottom crankcase halves.

The three-blade, constant speed propeller remained attached to the crankshaft, but two of the blades were separated just outboard of the shank. The third blade remained attached to the hub, but it was bent aft around the left side of the engine and twisted toward low pitch with the outboard tip torn from the blade. The leading edge of one of the separated blades displayed heavy gouges. The spinner was crushed aft around the propeller hub.

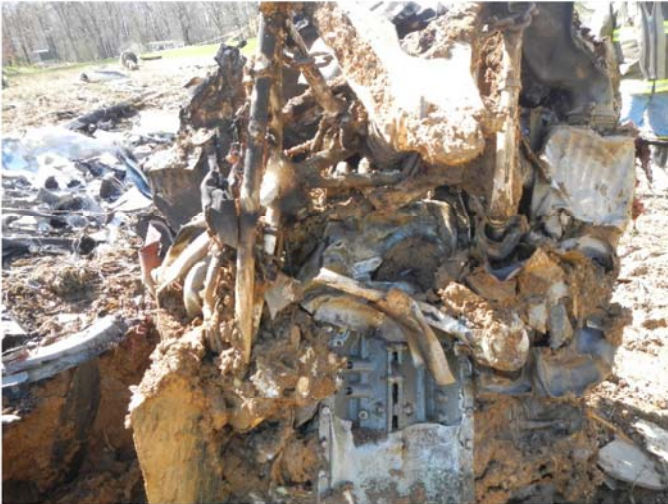
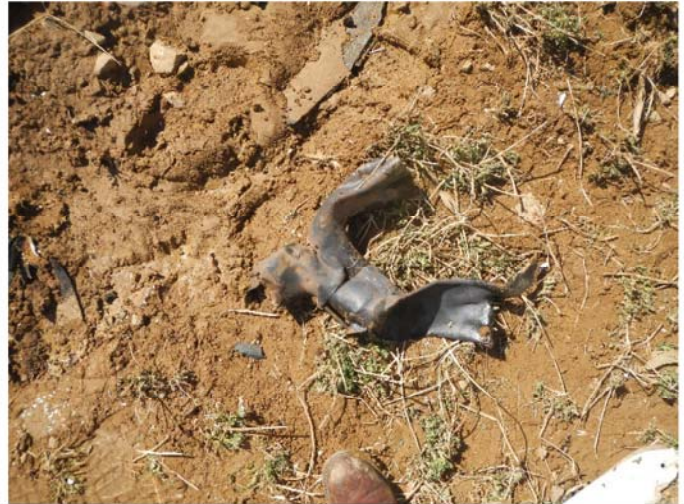
EXHAUST SYSTEM

Condition: The exhaust system was flattened and displaced from its original position.

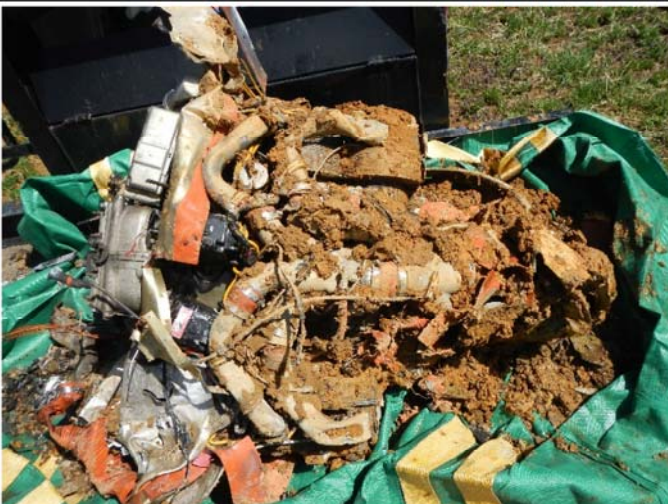
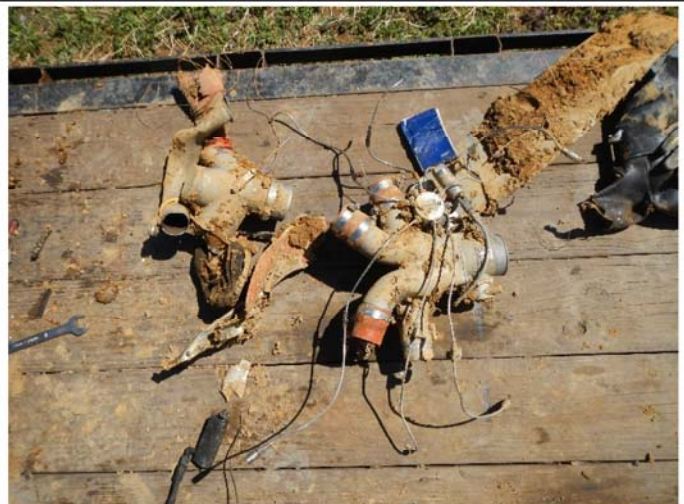
INDUCTION SYSTEM

Condition: The intake tubes were crushed. The intake air filter was deformed but remained attached to the intake tube. The throttle body and intake plenum remained attached to the topside of the engine via the throttle control cable and a hose.

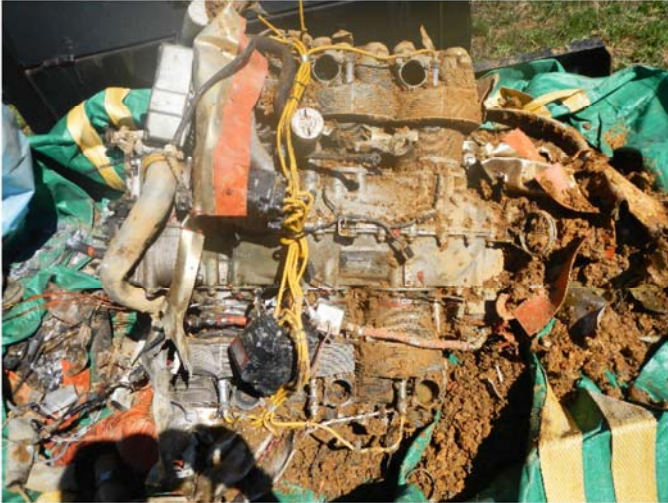
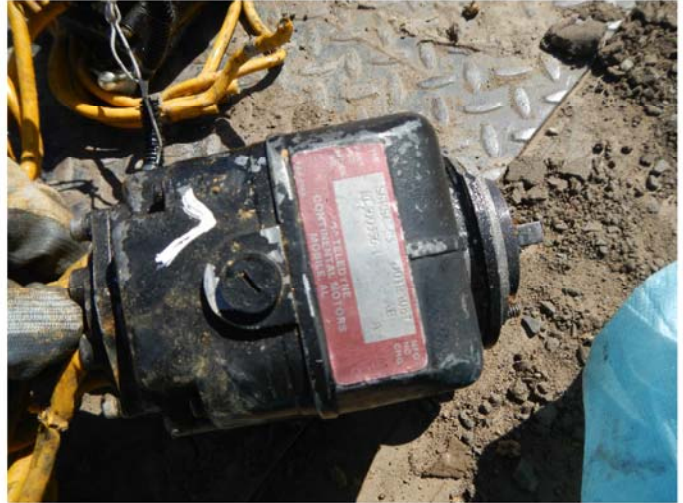
LEFT MAGNETO

The magneto was separated from the mounting pads but remained attached to the engine via the ignition leads. The magneto drive was intact, but dirt and debris was in the impulse coupling area which bound up the rotation of the drive shaft. Rotation of the left drive shaft resulted in a spark from the ignition harness.

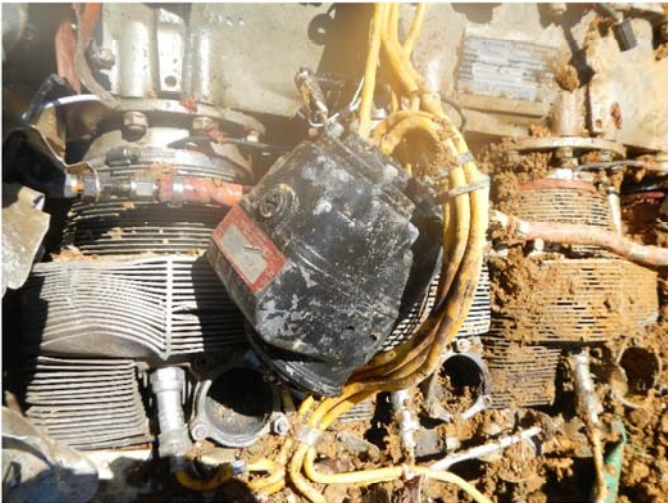
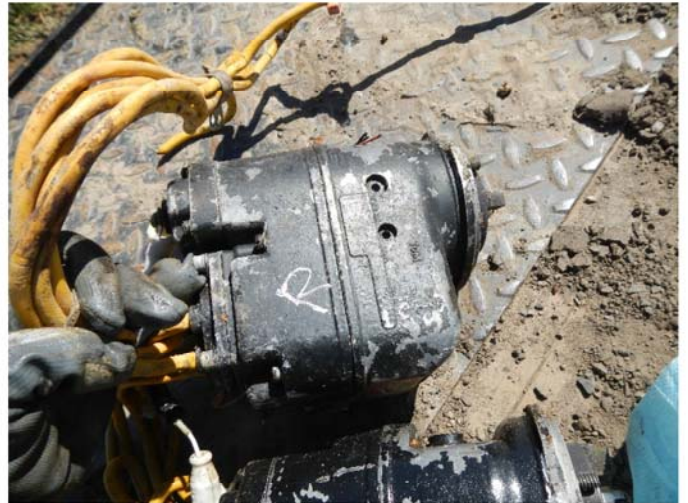
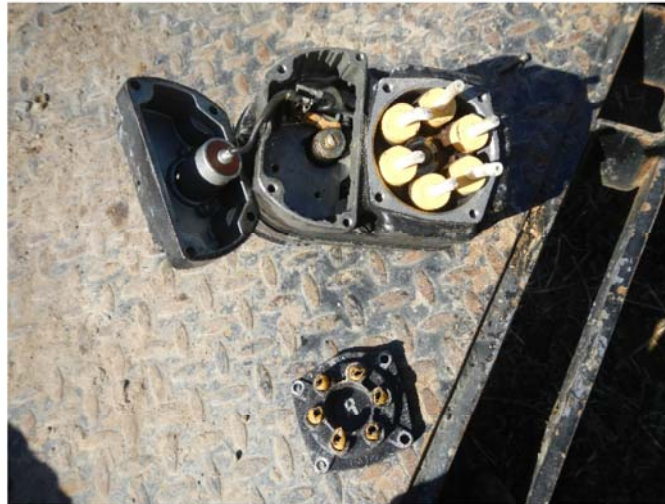
RIGHT MAGNETO

The magneto was separated from the mounting pads but remained attached to the engine via the ignition leads. The magneto drive was intact, but dirt and debris was in the impulse coupling area which bound up the rotation of the drive shaft. The right magneto did not produce a spark on the occasions in which the drive shaft was rotated and the impulse coupling snapped. Removal of the vent plug revealed that the distributor gear teeth were intact. Removal of the damaged capacitor cover revealed the cam follower was intact and the points opened and closed appropriately with drive rotation. No pre-accident anomalies were noted with either magneto.

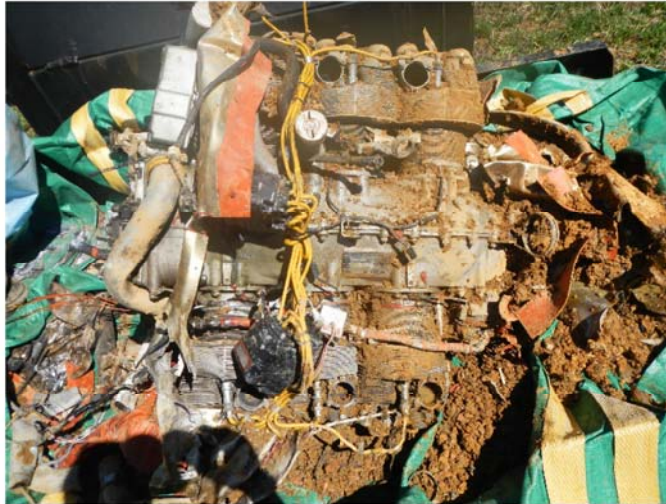
Condition: The ignition harness remained attached to the magnetos, but many of leads displayed pinching damage. The terminal ends remained attached to the sparkplugs.

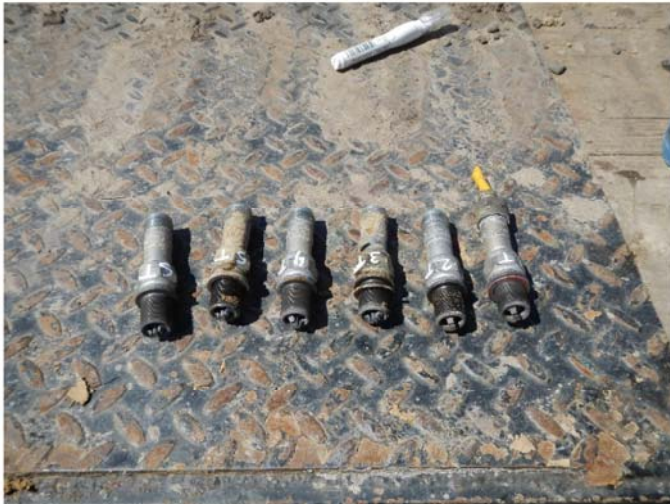
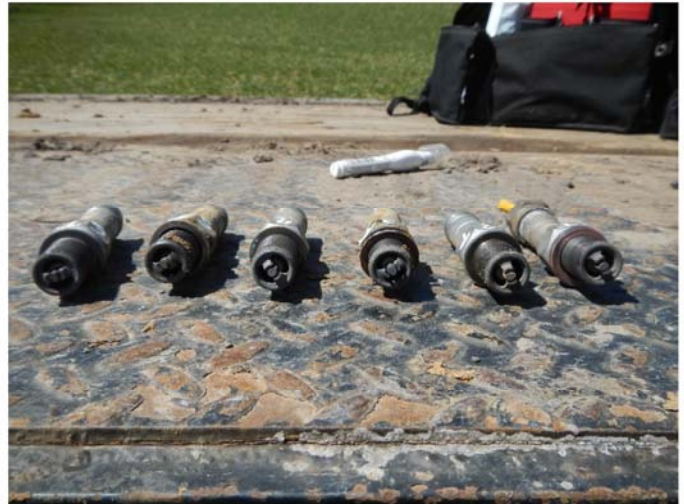
Condition: The top sparkplugs were removed from their respective cylinders. All displayed a normal worn condition with no signs of lead or carbon fouling.

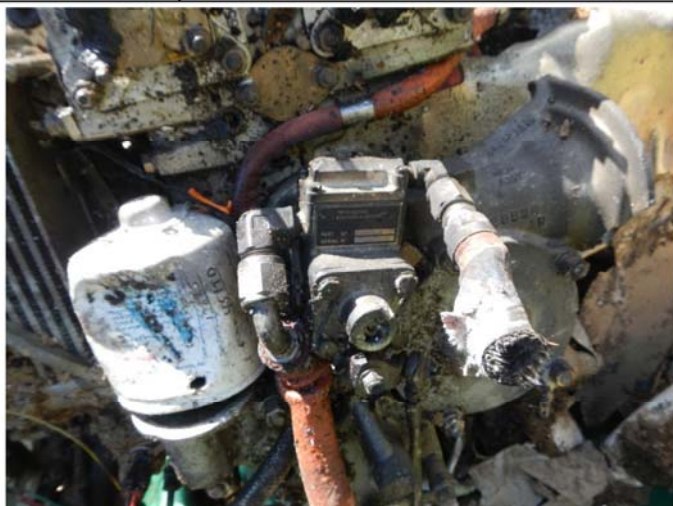
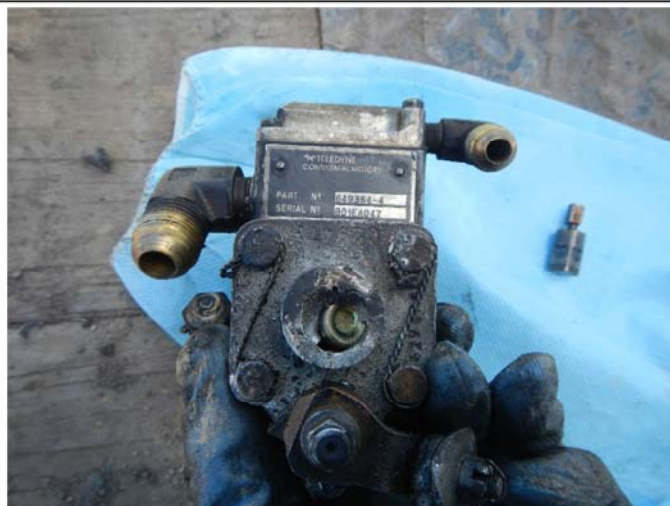
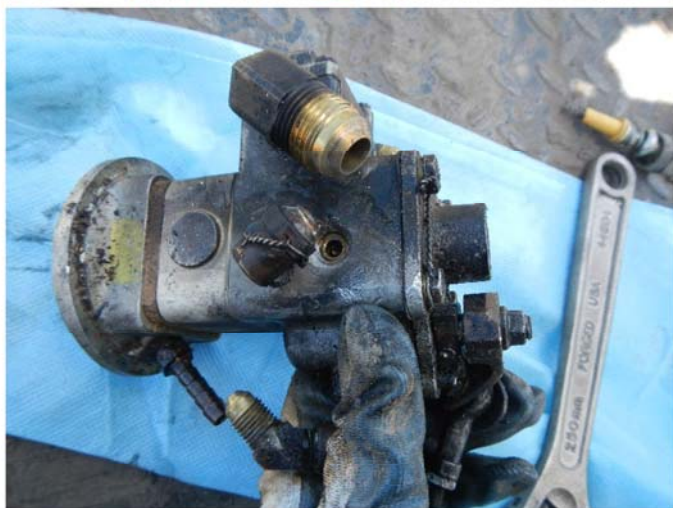
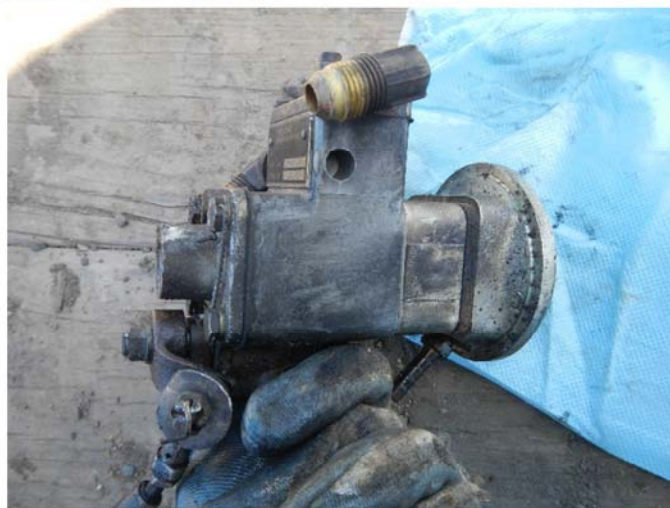
FUEL PUMP

The engine-driven fuel pump remained attached to the backside of the engine and all fuel lines to and from the pump remained attached to their respective fittings. The mixture control cable remained attached to the mixture control lever but the lever was bent. Movement of the lever resulted in a coinciding movement of the shaft with no slipping noted. The low pressure relief valve set screw was displaced into the cap. Removal of the pump from the backside of the engine revealed the drive coupling was intact. Manual rotation of the drive coupling while it was installed in the drive shaft resulted in rotation of the pump with no binding noted. Residual fuel was observed coming from the pump housing.

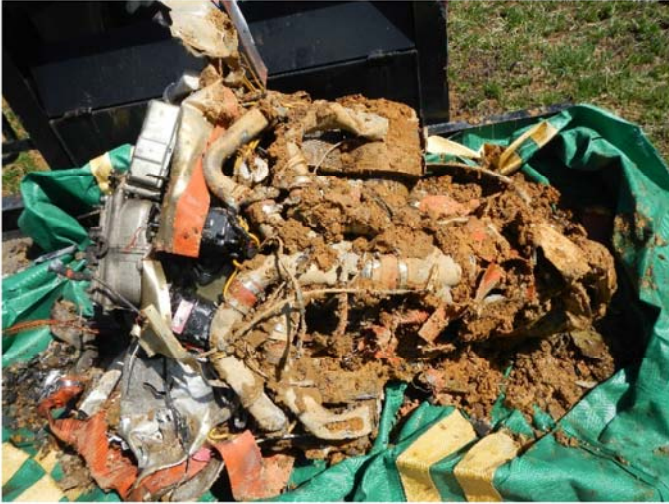
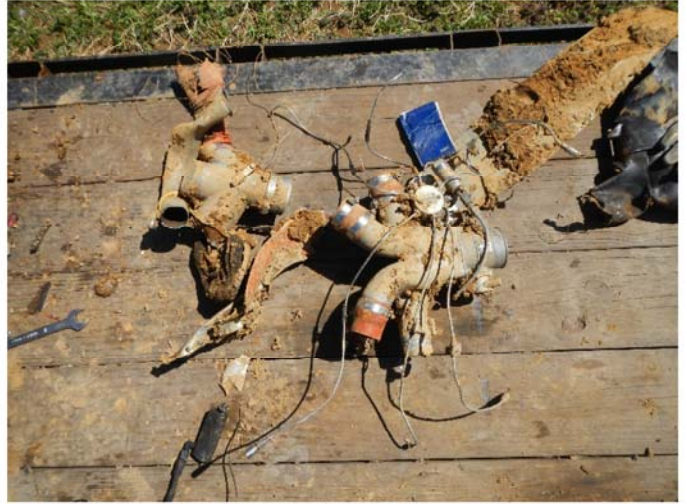
Condition: The throttle body and intake plenum remained attached to the topside of the engine via the control cable and hose. The throttle lever remained attached to the throttle valve shaft. Movement of the throttle lever resulted in a coinciding movement of the throttle valve with no slipping between the shaft and lever and no binding noted.

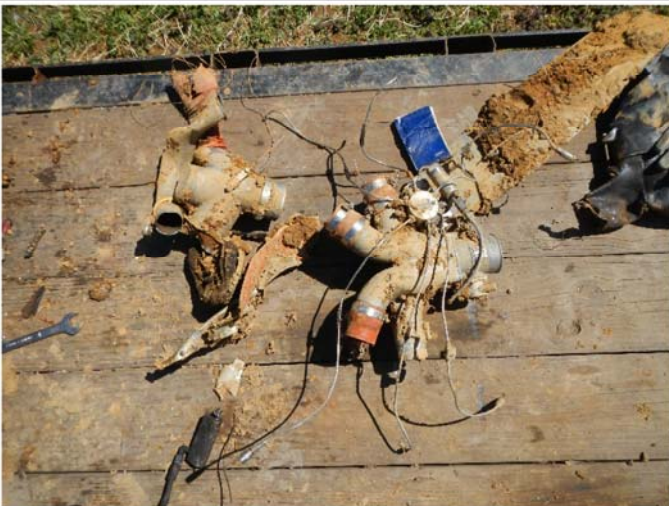
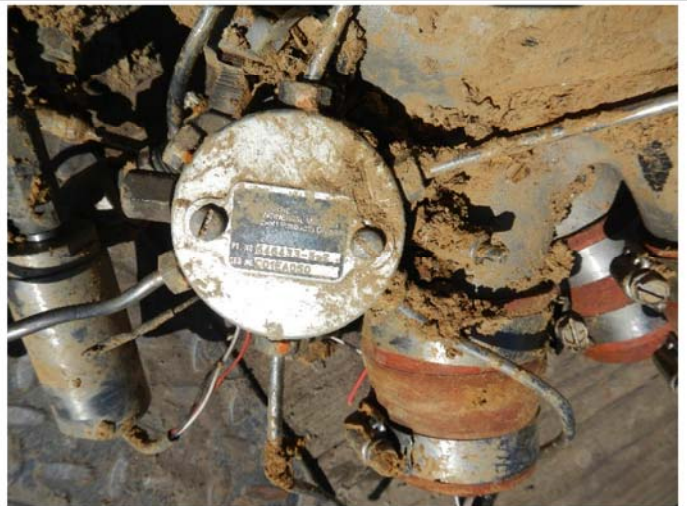
Condition: The fuel manifold valve remained in place on top of the engine and all of the fuel lines remained attached. The manifold valve was removed from the engine and the cap was removed. The diaphragm was intact and the plunger was secured in place. The screen was clear and free from obstructions. Residual fuel was noted in the housing.

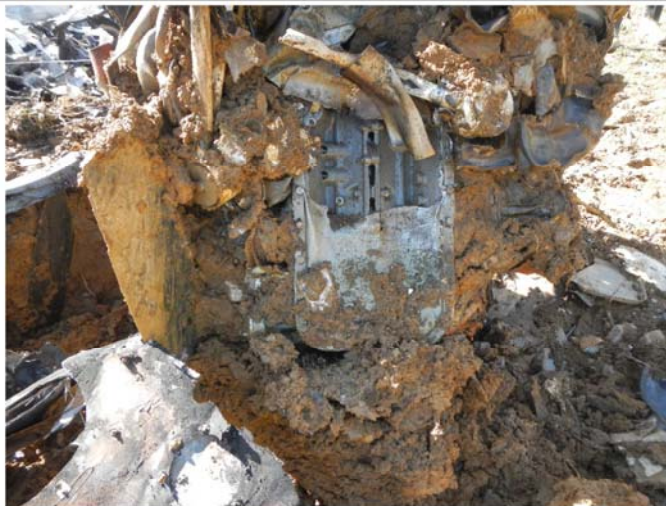
OIL SUMP

Condition: The front portion of the oil sump was flattened up against the bottom side of the engine while the aft portion of the oil sump was torn away and displaced aft, exposing the bottom crankcase portions.

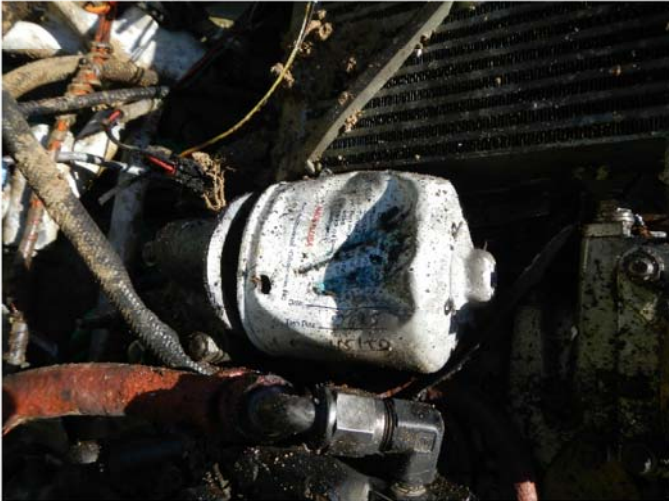
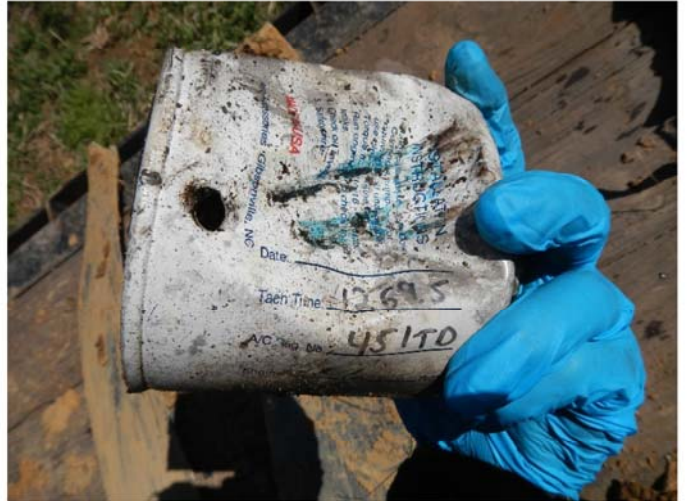
OIL PICKUP TUBE & SCREEN			
Condition:	The oil pickup tube and screen were not observed.		
OIL PUMP			
Condition:	The oil pump housing remained attached to the backside of the engine with no signs of oil leaks noted. Though the oil pump was not disassembled, there was no signs of lubrication distress noted on any of the engine components.		
OIL FILTER	Manufacturer: Tempest	P/N: AA48108-2	
Condition:	The oil filter remained in place on the adapter with the safety-wire intact. It sustained impact-related deformation damage that partially displaced it from the adapter. The tachometer time of 1,269.5 was hand-written on the side of the filter, but the date was not recorded. Removal of the filter revealed residual oil.

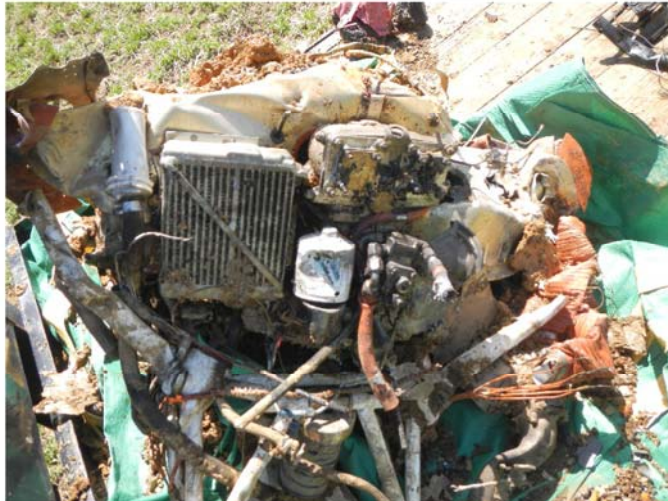
OIL COOLER	Manufacturer: Not Recorded	P/N: Not Recorded	S/N: Not Recorded
Condition:	The oil cooler remained in place, with no signs of pre-accident anomalies noted.

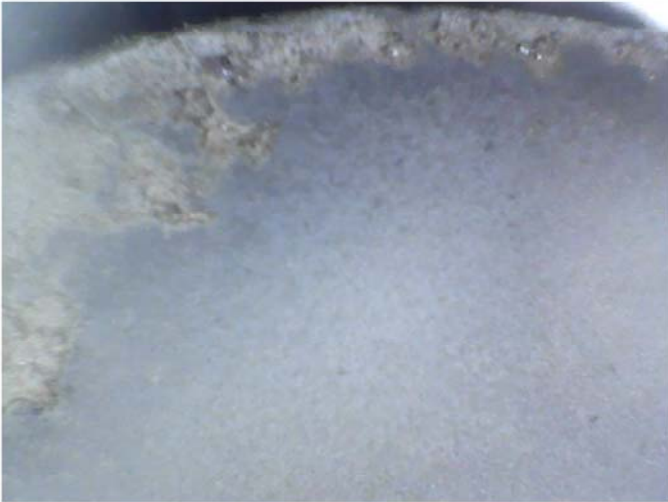
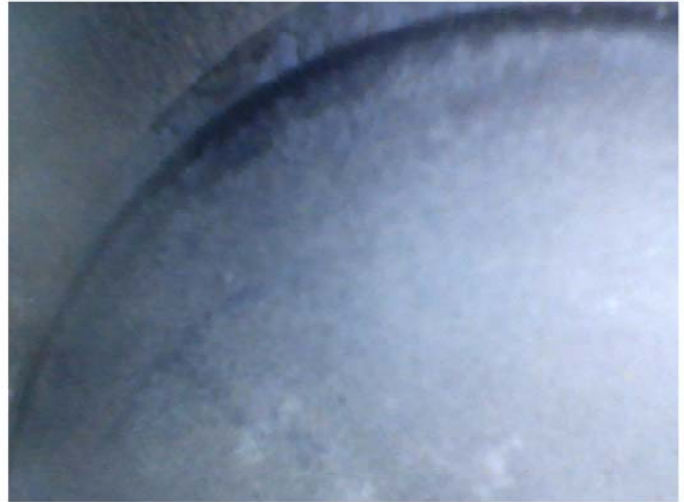
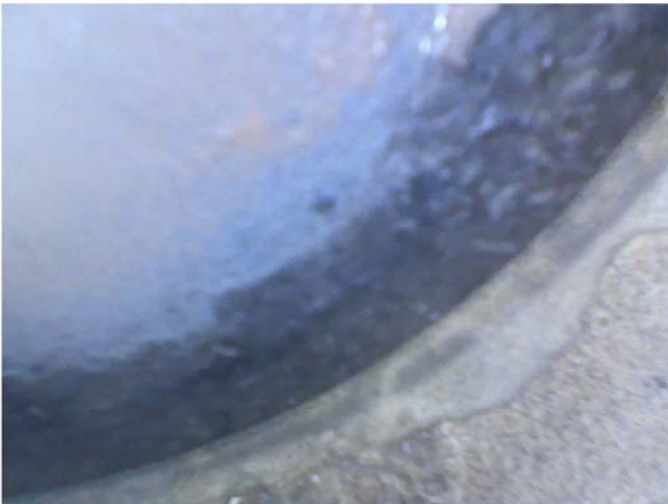
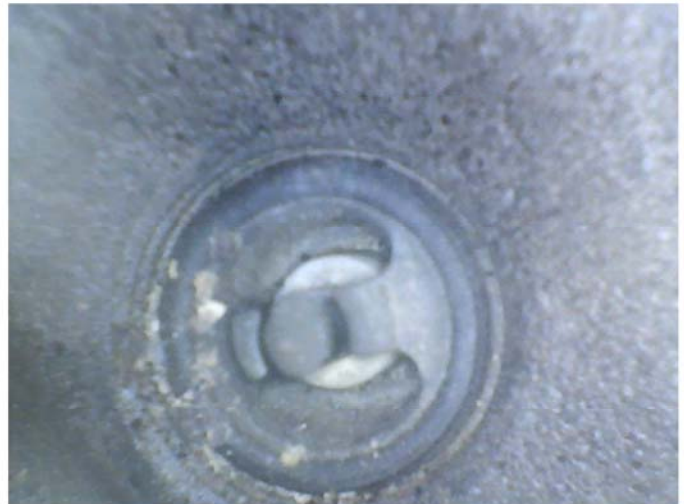
CYLINDER #1

The cylinder remained attached to the crankcase and sustained cooling fin damage. There were no external pre-accident anomalies noted. Borescope examination of the cylinder revealed no pre-accident anomalies with the piston, cylinder barrel, cylinder head, valves, or valve seats.

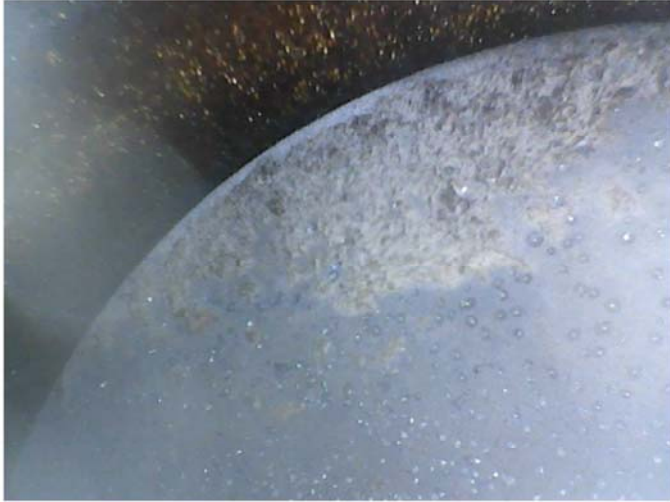
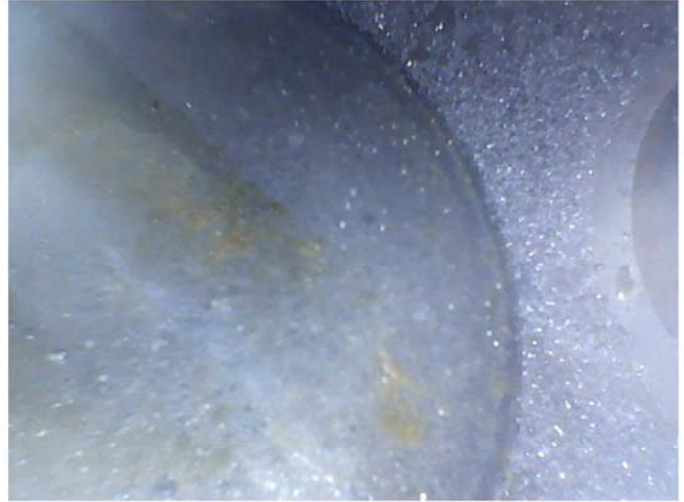
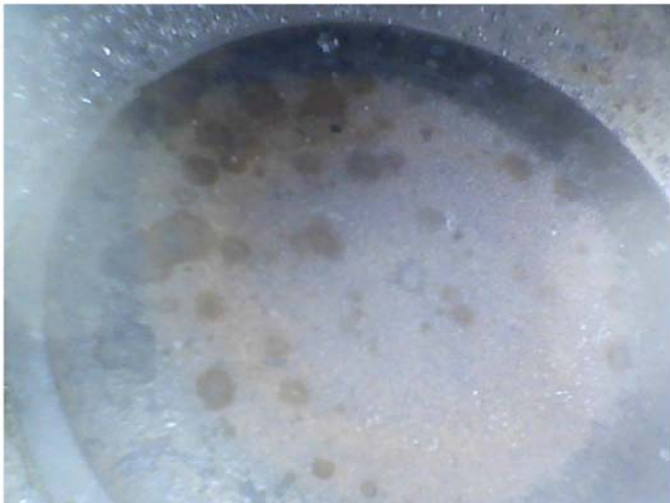
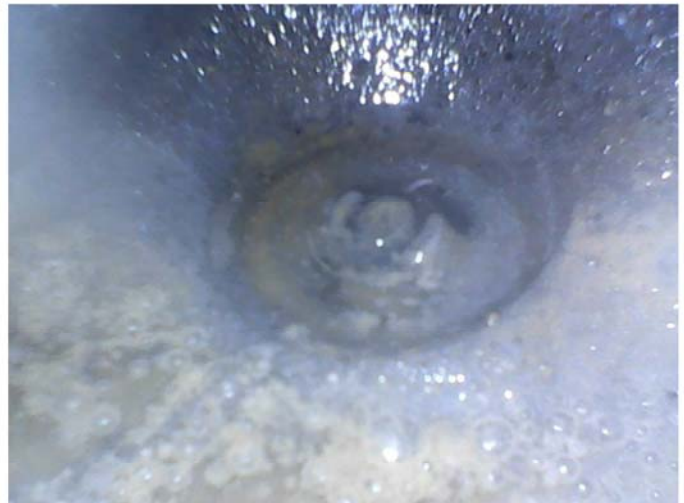
CYLINDER #3

The cylinder remained attached to the crankcase with no external pre-accident anomalies noted. Borescope examination of the cylinder revealed no pre-accident anomalies with the piston, cylinder barrel, cylinder head, valves, or valve seats.

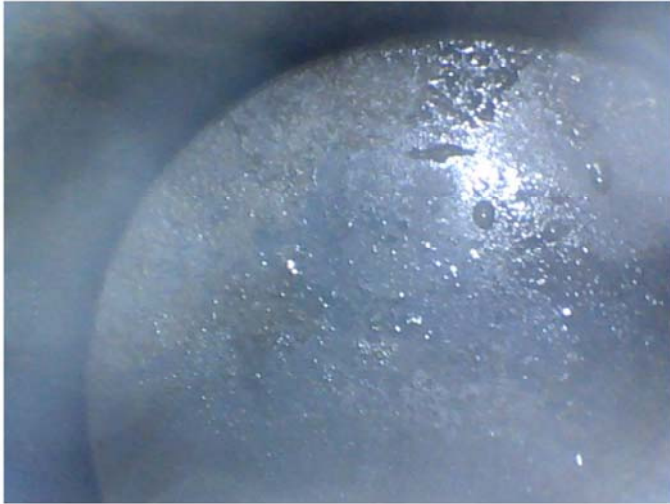
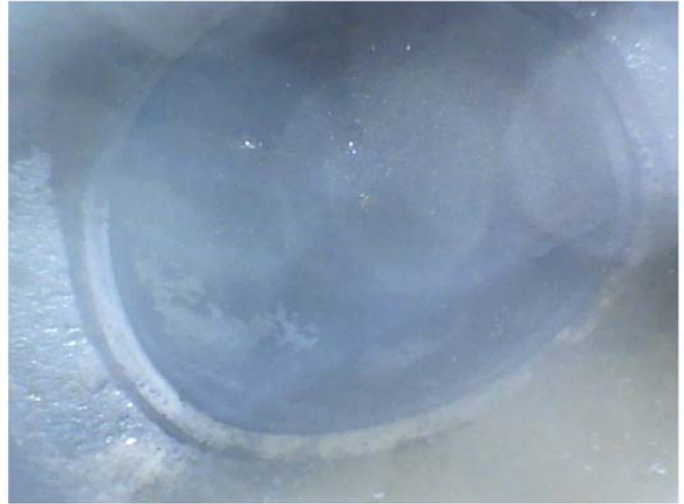
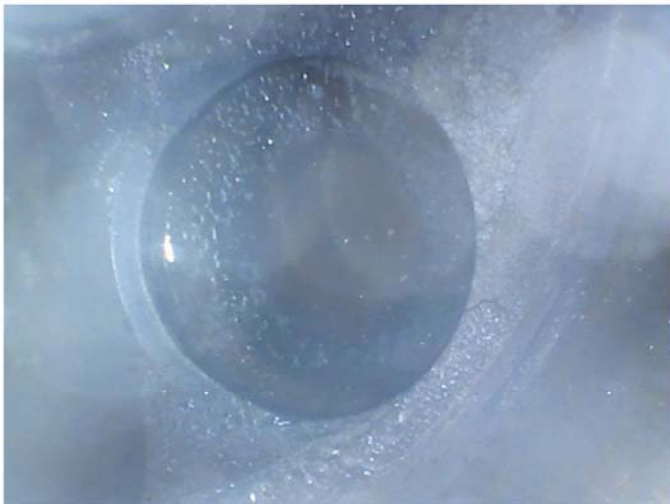
CYLINDER #5

The cylinder remained attached to the crankcase and sustained cooling fin damage. There were no external pre-accident anomalies noted. Water was pooled in the intake port. Borescope examination of the cylinder revealed water was present in the low-lying areas of the cylinder, but no pre-accident anomalies with the piston, cylinder barrel, cylinder head, valves, or valve seats.

Bottom Sparkplug was Not Observed

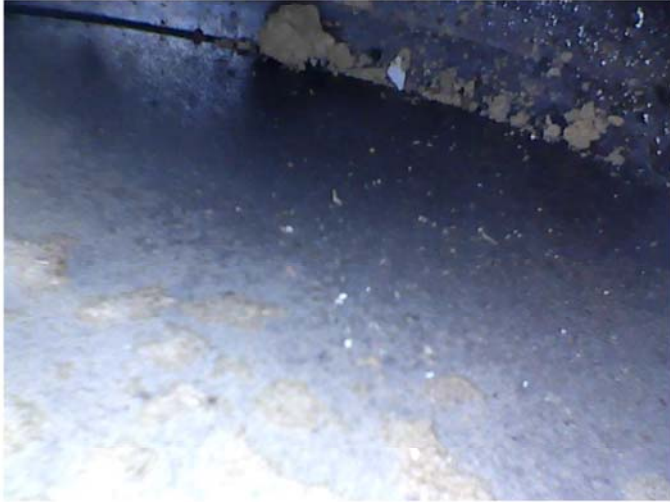
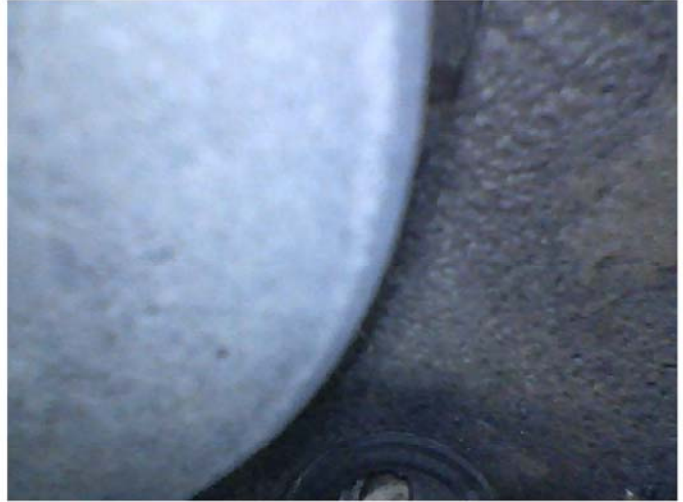
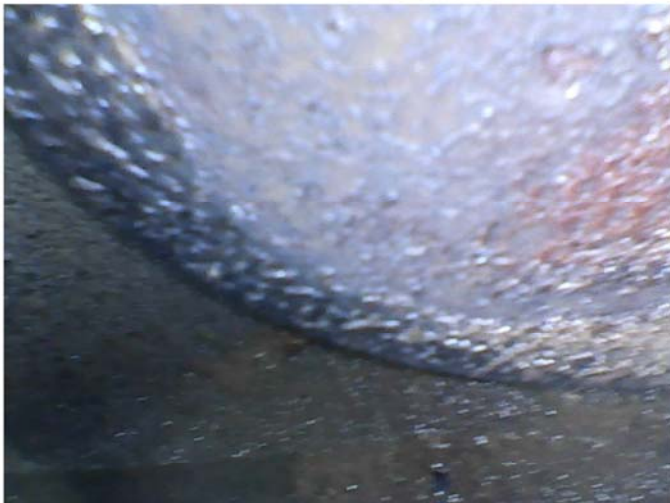
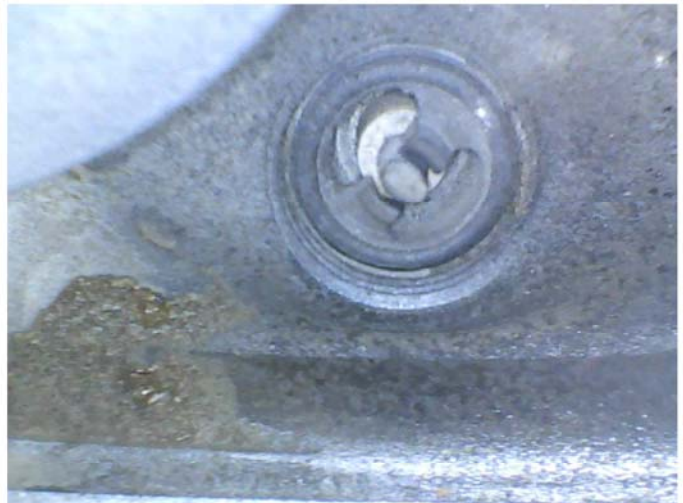
CYLINDER #2

The cylinder remained attached to the crankcase with no external pre-accident anomalies noted. Borescope examination of the cylinder revealed no pre-accident anomalies with the piston, cylinder barrel, cylinder head, valves, or valve seats.

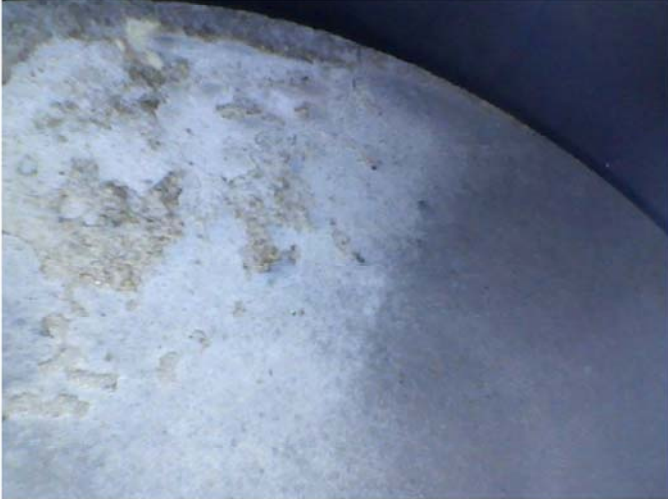
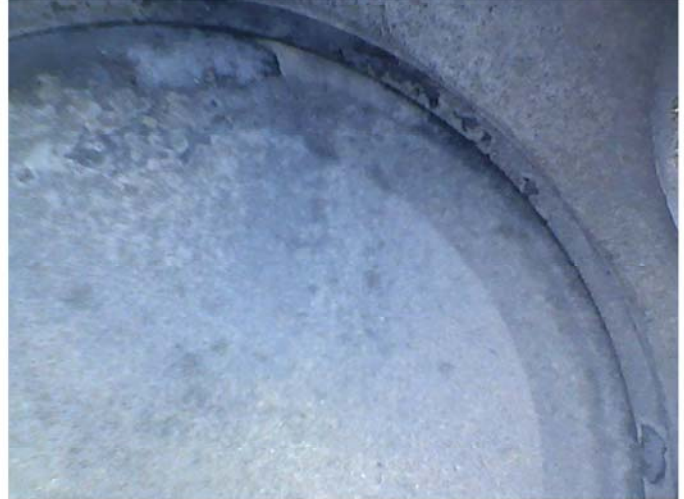
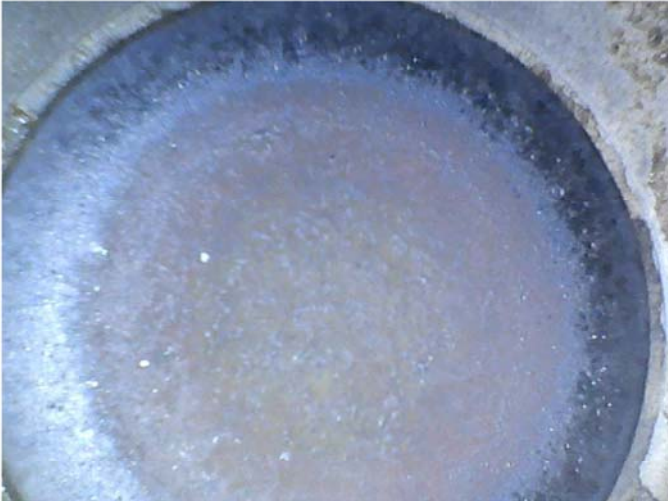
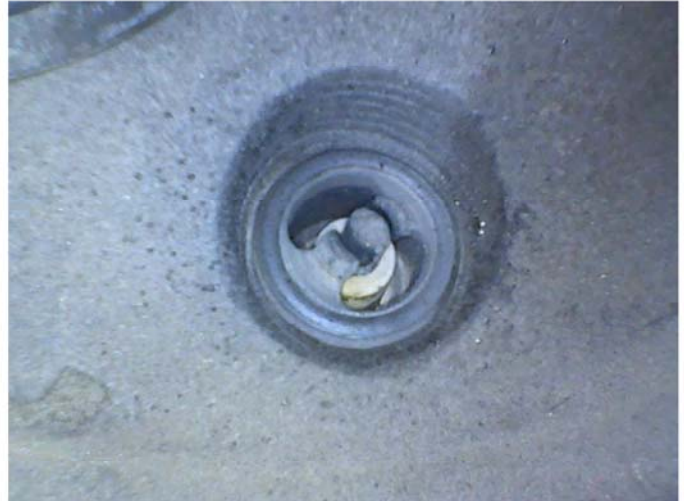
CYLINDER #4

The cylinder remained attached to the crankcase with no external pre-accident anomalies noted. Borescope examination of the cylinder revealed no pre-accident anomalies with the piston, cylinder barrel, cylinder head, valves, or valve seats.

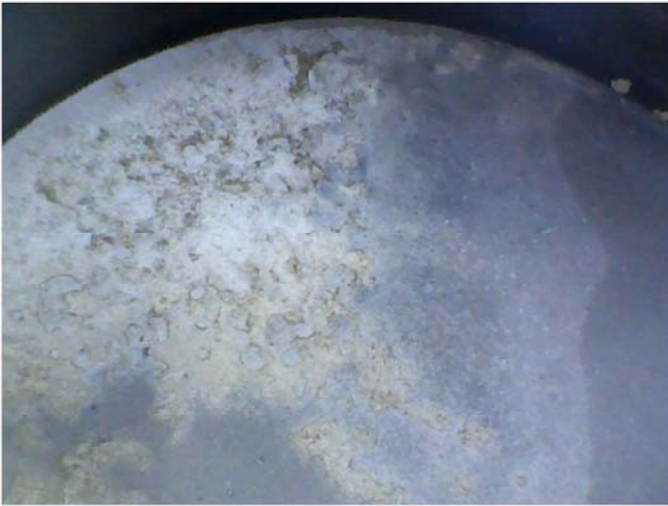
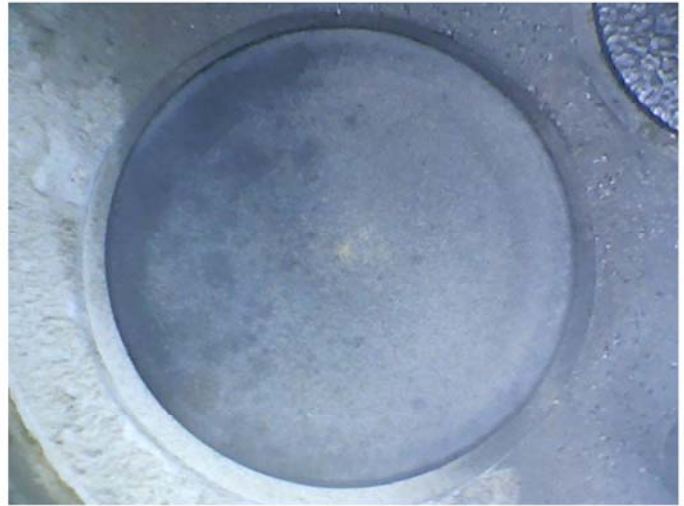
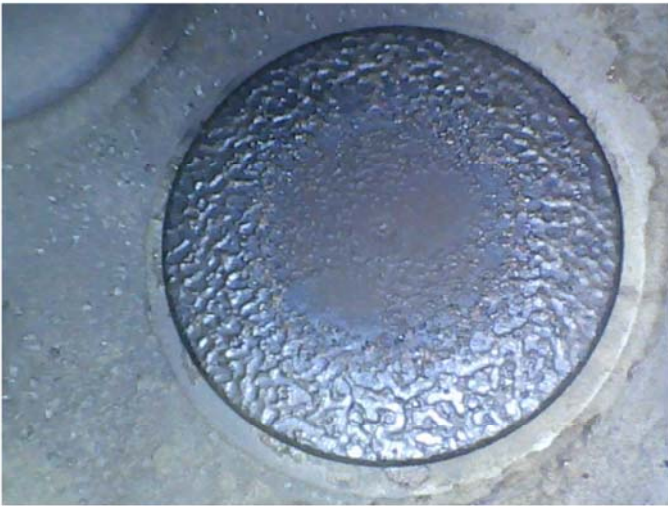
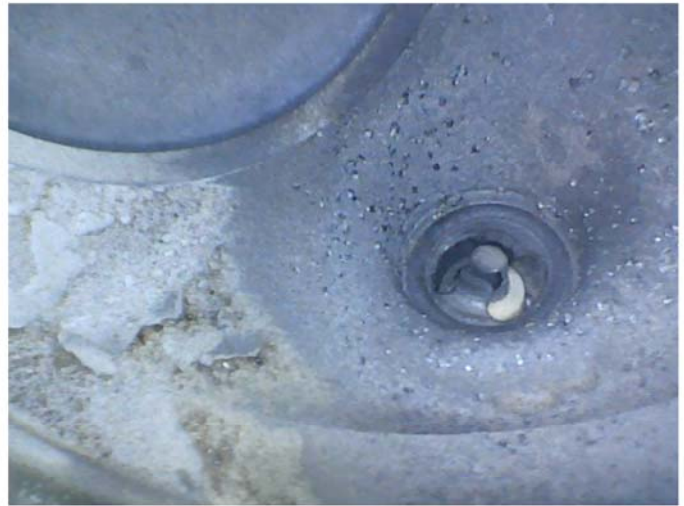
CYLINDER #6

The cylinder remained attached to the crankcase and sustained cooling fin damage. There were no external pre-accident anomalies noted. Borescope examination of the cylinder revealed no pre-accident anomalies with the piston, cylinder barrel, cylinder head, valves, or valve seats.

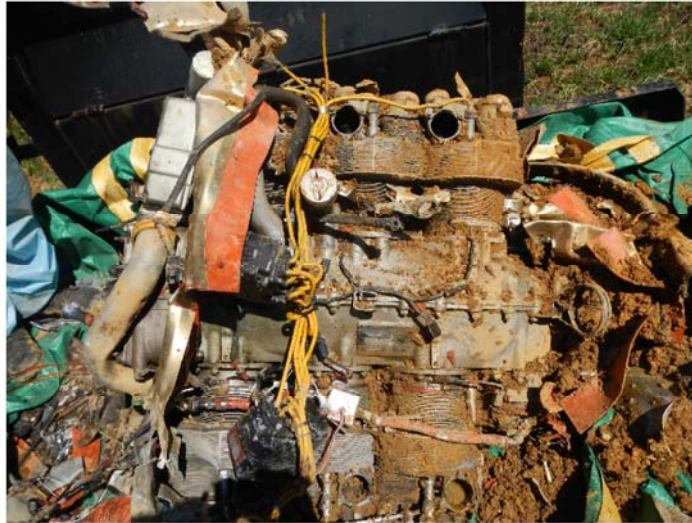
CRANKCASE	Casting Number:	1-3-5: Not Recorded	2-4-6: Not Recorded	S/N: Not Recorded
Condition:	The crankcase halves remained intact with no pre-accident anomalies noted. There was no external sign of operational distress with the internal components.

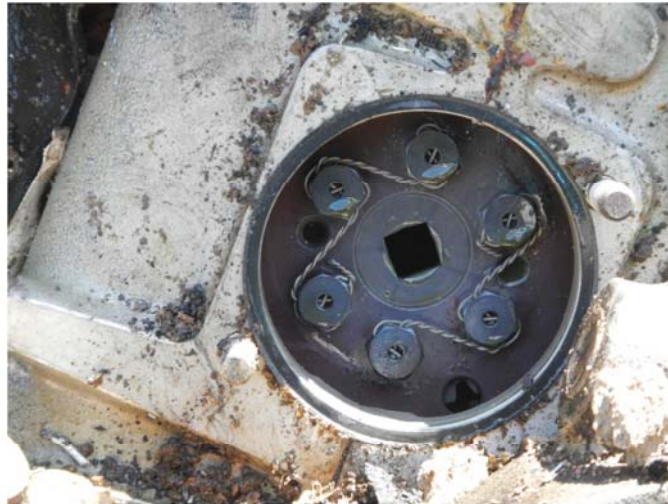
CRANKSHAFT	Forging Number: Not Observed	S/N: Not Observed	Heat code: Not Observed
Condition:	The crankshaft was not observed in its entirety. The propeller remained attached but one of the blades was bent aft around the side of the engine, prohibiting rotation of the crankshaft. Though it could not be rotated completely, crankshaft continuity to the crankshaft gear was confirmed with miniscule rotations of the propeller flange. The crankshaft gear bolts remained in place and the safety-wire was intact.

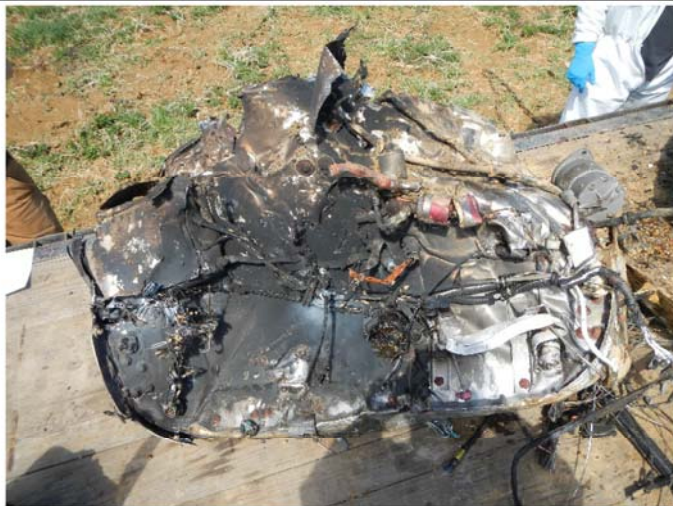
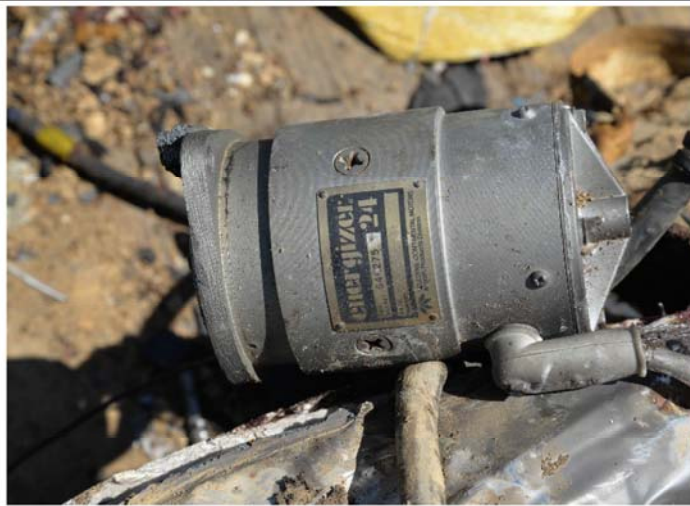
STARTER

Condition: The starter motor was separated from the adapter but remained attached to the firewall via the electrical connections.

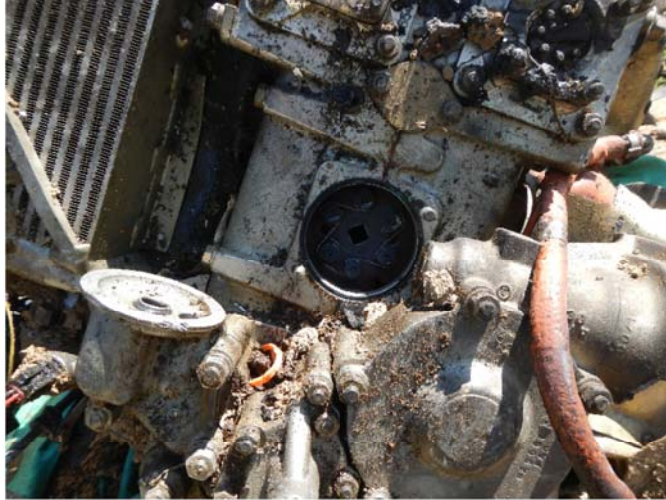
STARTER ADAPTER

Condition: The starter adapter remained attached to the backside of the engine. The motor mounting flange was fractured. No pre-accident anomalies were noted externally.

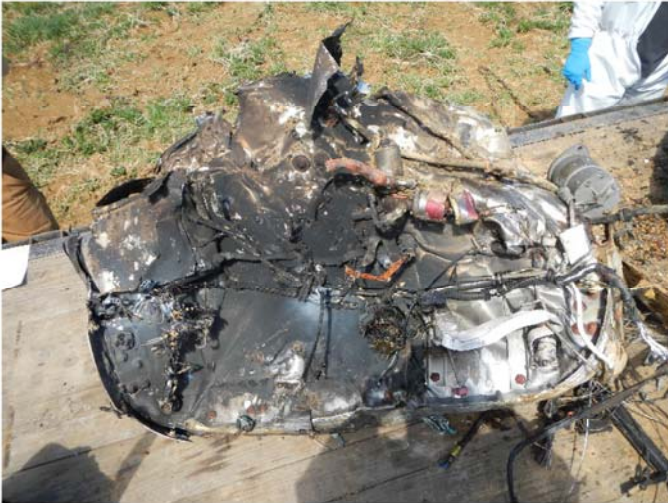
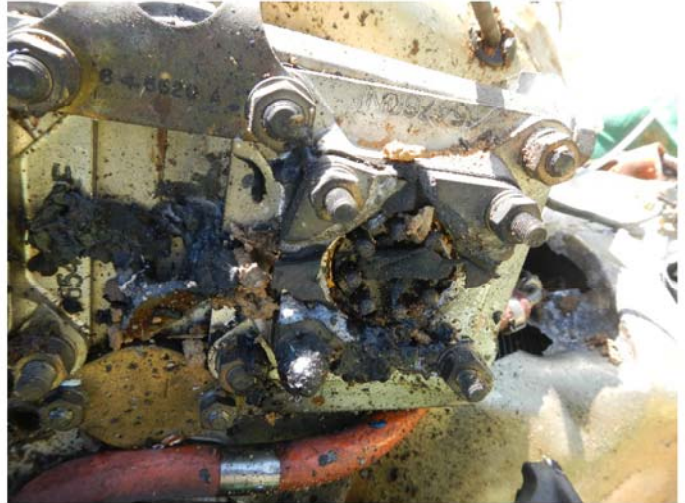
Condition: The engine-driven alternator remained attached to the front right side of the engine, but it sustained impact damage. It was not examined in detail at the accident site.

Condition: The accessory-gear-driven alternator was separated from the accessory end of the engine, but remained attached to the firewall via its electrical connections. It was not examined in detail at the accident site.

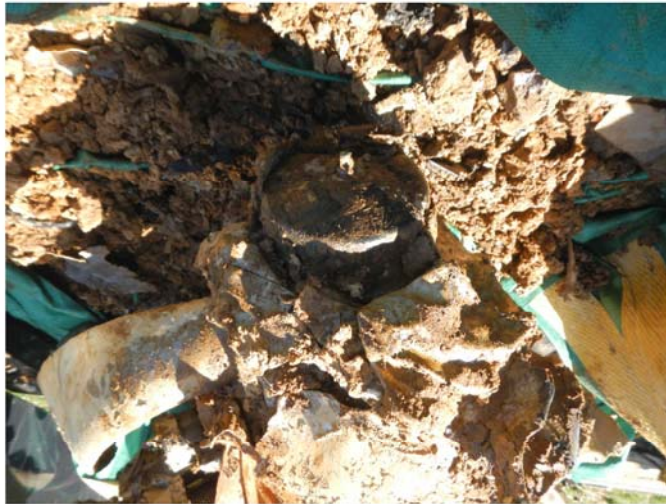
PROPELLER	Manufacturer: Hartzell	P/N: Unknown	S/N: Unknown
Condition:	The three-blade, variable pitch propeller remained attached to the engine crankshaft. Two of the three blades were fractured just outboard of the spinner area. The third propeller blade was bent aft along the left side of the engine. One of the separated blades was bent forward slightly and displayed a heavy leading edge gouge near the tip. The blade that remained attached to the hub was bent aft, twisted toward low pitch, displayed heavy leading edge gouges, and the outboard tip was missing.
