Joint Submission to

**The National Transportation Safety Board**

Chalk's Ocean Airlines  
Miami, Florida  
December 19, 2005

NTSB No. : DCA06MA010

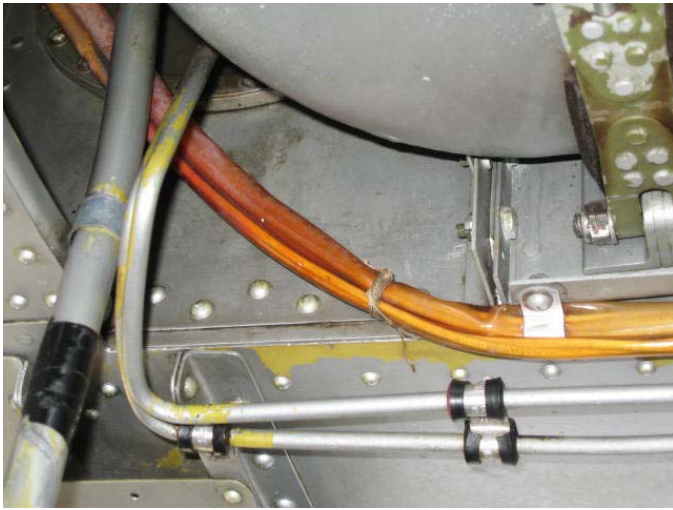
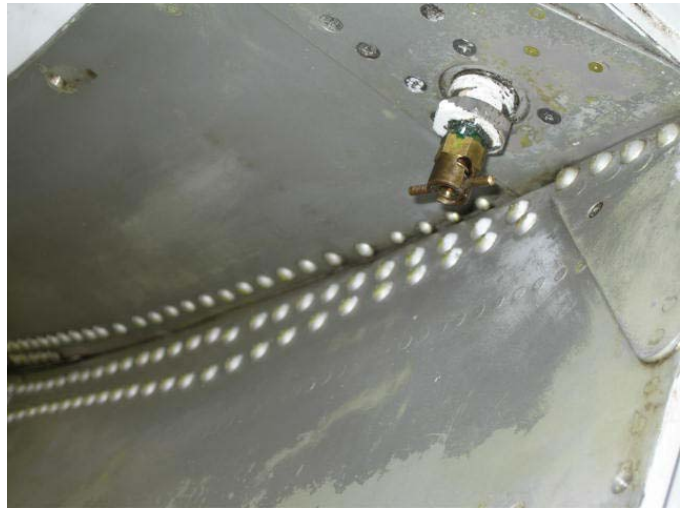
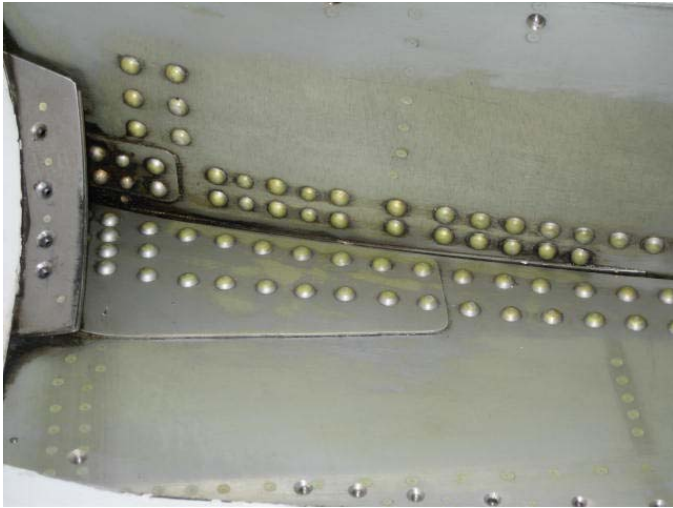
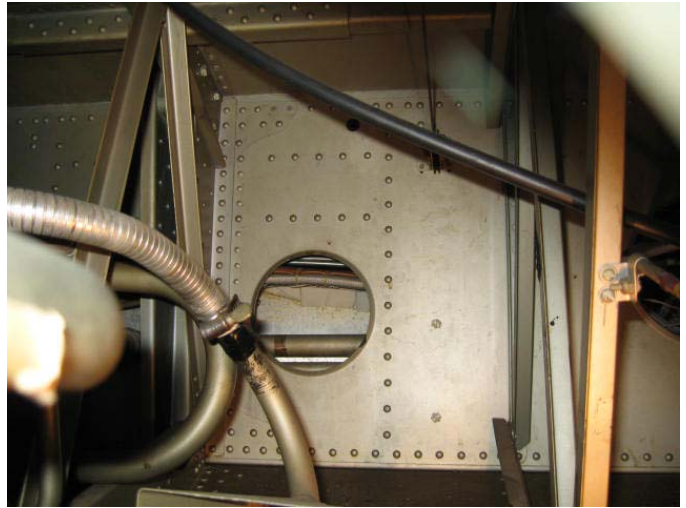
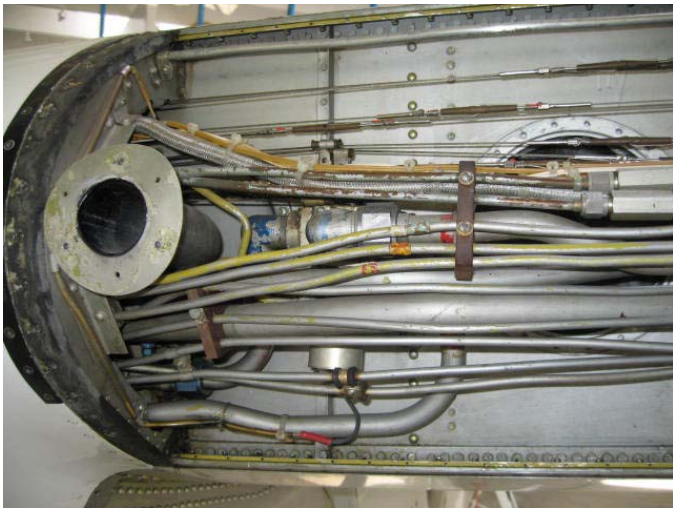
Grumman G73 Mallard Serial # J57.

Built 1951 Aircraft Total time: 11,655.4 hours

Zero corrosion or structural deterioration--.  
Typical of private/corporate Mallards operated  
within certified limits.
