**G550 Outfitting Check Flight Accident
Gulfstream Party Submission**

CEN11FA193

MARCH 25th, 2013

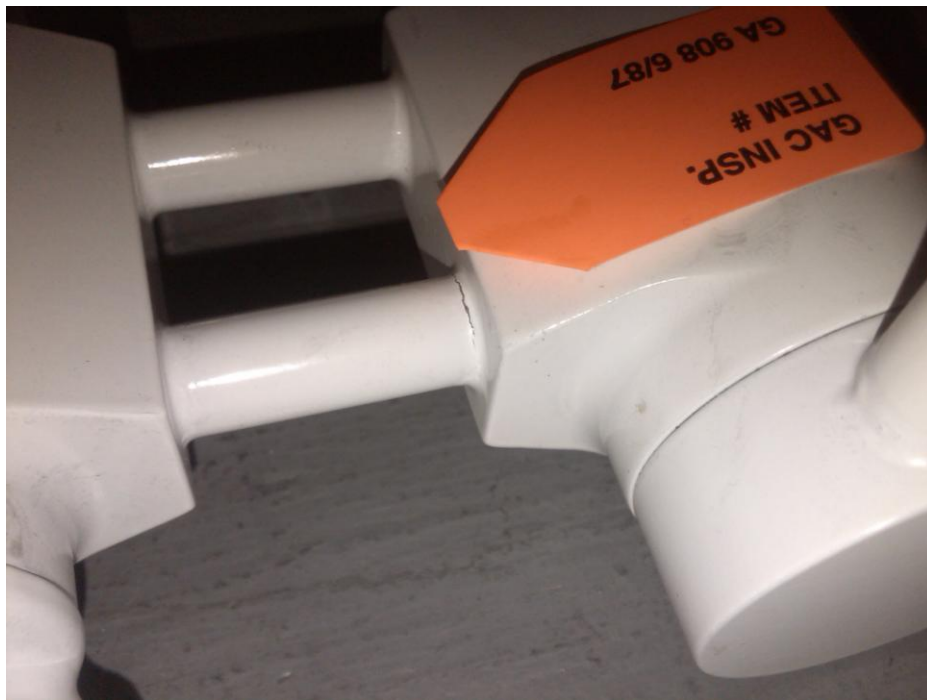
5.4.3 Failure Data: S/N 0689 Failure During Production Test (Gear Swings)

On 07 April 2010 S/N 0689 was removed from a production GIV-X. The technicians had completed an initial gear swing clearance check, and were in the process of a 60 cycle required operational gear cycling checkout following initial installation on the production line, using full pressure supplied by an external hydraulic cart. The specific number of completed cycles prior to the failure is unknown, however, the failure did not occur during the initial gear swing. The Aft Left Connecting Rod failed on the bottom side of the tube just aft of the Center housing body joint. The Center housing and spool were documented to be “seized”. No movement of this joint could be accomplished. In a failed attempt to rotate the center member, the GAC investigation team sheared the Connecting Rod and its adjacent Rod at the opposite end of the original failure zone. The unit was sent to PDI for investigation. While PDI reported that the failure was due to an external load, the matter was not investigated further and the unit was scrapped. This failure scenario is most consistent with the accident failure, and Gulfstream now believes that the root cause was likely the same as the accident swivel.

FIGURE 1 FAILED SWIVEL S/N 0689

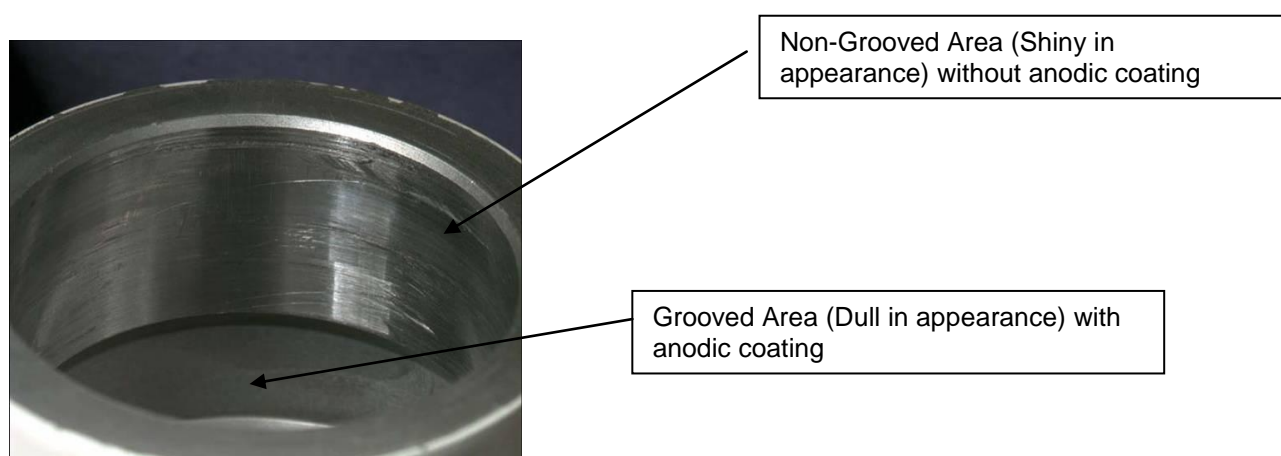
Evidence of contact between the housing and spool was observed for all seven units sent to ATS. There was no evidence of the required anodic coating identified for the non-grooved surface of the housing inside diameter as required by the type design drawing

(PDI drawing # 7438-4). There was evidence of the required anodic coating identified in the grooved surfaces of the housing inside diameter. The spools exhibited the required anodic coating for all internal surfaces grooved and non-grooved. The inspected units ranged in aircraft time from 54 to 235 aircraft landing cycles (pursuant to Gulfstream Computerized Maintenance Program records). No dimensional abnormalities of significance were noted, but there was evidence of galling found on all units inspected by ATS. Two units, S/N 0747 and 0749 were noted to exhibit "severe galling" on matching surfaces of the spool and housing inner-diameter.

FIGURE 2 ANODIC COATING MISSING FROM NON-GROOVED SURFACE OF HOUSING INSIDE DIAMETER

Gulfstream has determined that the NWS swivel failed because of a manufacturing defect. The defect was a lack of the specified anodic coating most likely resulting from an undocumented rework process which removed the original anodic coating from the housing ID. The anodic coating provides corrosion protection and wear protection on the surfaces in the event of contact between the spool and housing ID. In the accident NWS swivel, the required anodic coating on the inside diameter of the center swivel housing was missing.⁴ The absence of anodic coating allowed galling to occur during incidental contact during normal G550 NWS swivel operation. The galling which occurred in the accident NWS swivel eventually resulted in the swivel housing and spool seizing upon gear extension during the accident landing. The NWS swivel housing and spool seizing caused the left aft fluid transfer tube in the swivel to crack open upon nose landing gear extension. The crack in the left aft fluid transfer tube allowed all of the hydraulic fluid in the Left System Reservoir, to fully deplete within 40 seconds of the transfer tube cracking upon landing gear extension. The Aux System Hydraulic Reservoir was also depleted through the crack at the transfer tube at some point prior to touchdown.

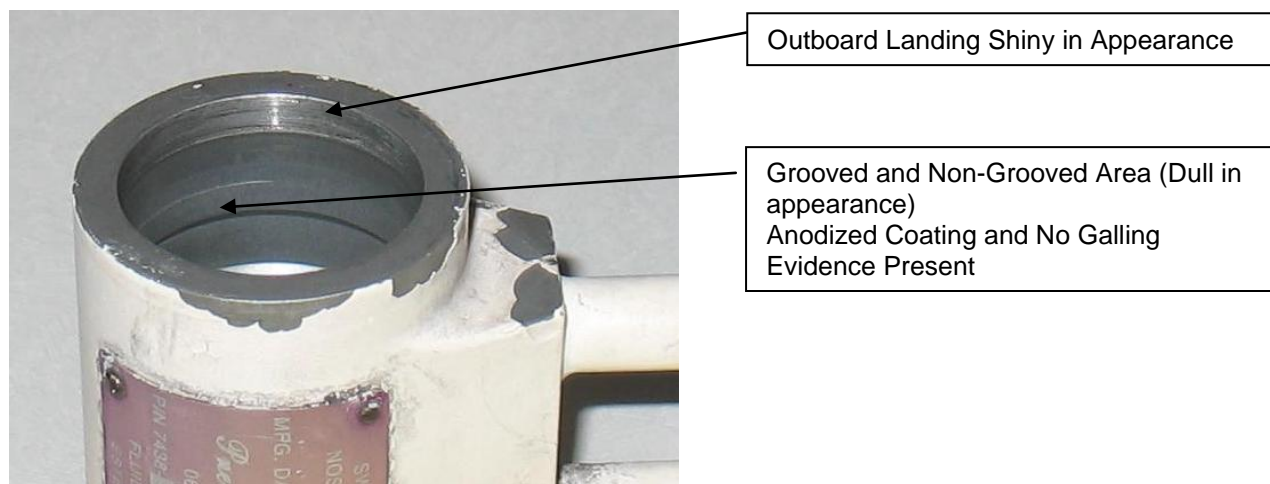
5.6.1 Inspection Swivel S/N 0163

The high flight time/cycle unit swivel S/N 0163 had over 4,000 aircraft landing cycles completed before it was removed from a fleet aircraft. Upon disassembly, GAC discovered that unlike the units sent to ATS; the anodic coating was still intact for the housing ID (grooved and non-grooved surfaces). There was also evidence of spool to housing contact at the outboard landings. The contact pattern was similar to that identified on the seven units sent to ATS.

FIGURE 3 ANODIC COATING CAN BE SEEN ON HOUSING INSIDE DIAMETER (S/N 0163)
