Date of Accident: April 28, 2017

NTSB File No.: CEN17FA168

Aircraft: PC-12 (Modified to /45 Configuration)

Written by: Les Doud
Hartzell Propeller Air Safety Investigator

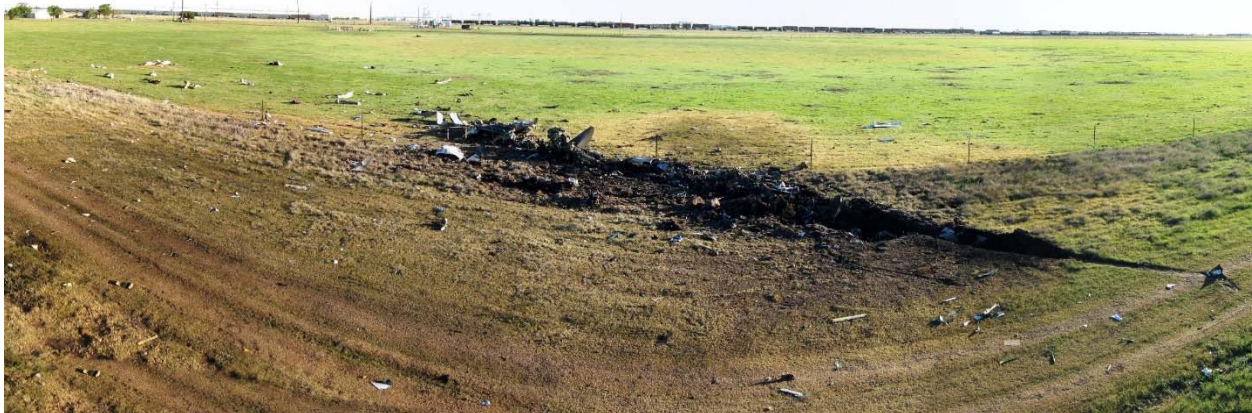
The airplane impacted a pasture (Photo #1) adjacent to several stationary train cars about 1 nautical mile south of AMA and a post impact fire ensued. The wreckage debris path was generally oriented southwest. All major structural components of the airplane were located within the wreckage.

Photo #1 – Accident Site Viewed from the south (NTSB Photo)

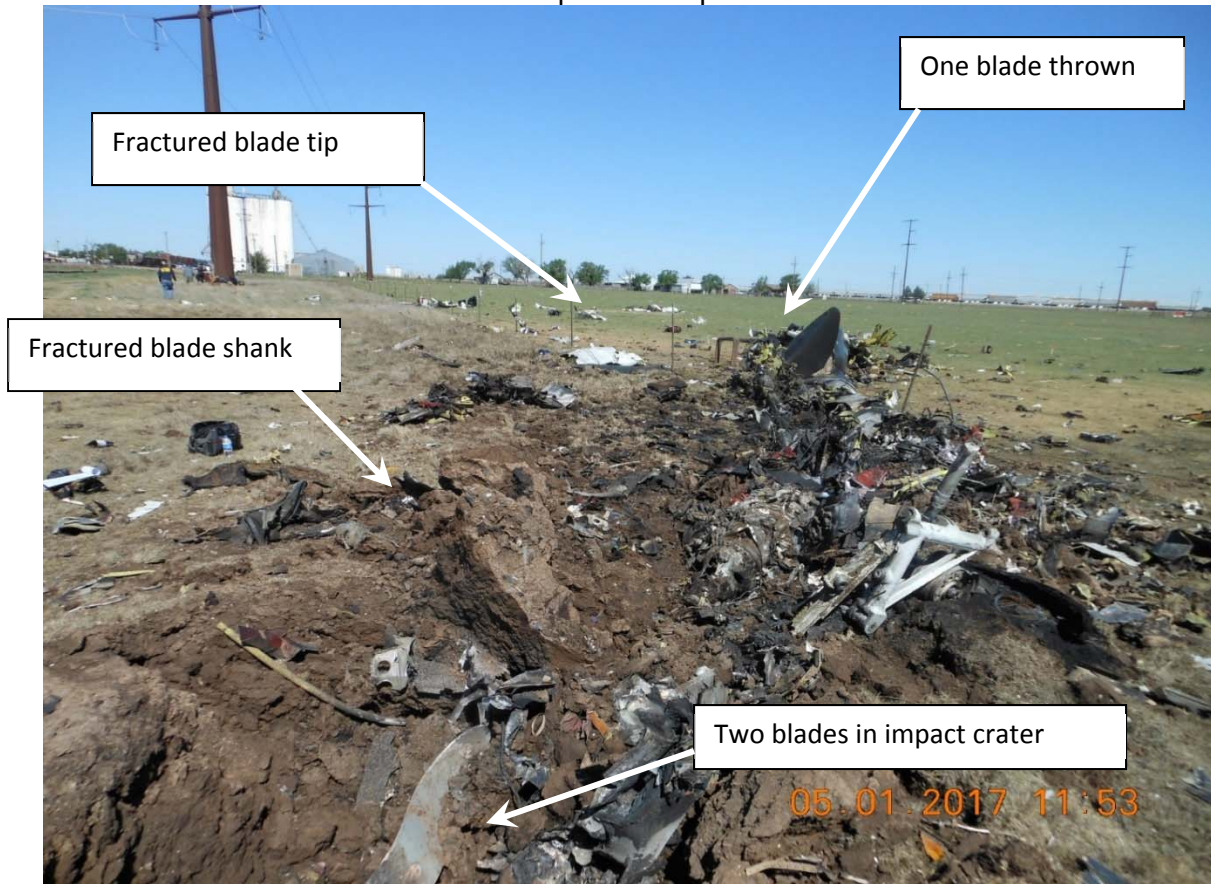
As Received: The propeller assembly fragmented during the impact sequence. All four blades separated and were found at the crash site; two in the impact crater, one blade shank just forward of the impact crater and its corresponding tip section approximately 100 yards forward and to the right of the flight path, and another blade approximately 50 yards to the right of the flight path (see Photo #2). Approximately 90% of the hub fragments were recovered; either still attached to a blade shank or in the impact crater. The aft wall/mounting flange of the propeller hub fractured and remained attached to the engine propeller shaft. The cylinder, piston and feathering spring fractured from the propeller assembly as a unit and was found in the impact crater. The pitch change rod aft of the piston and pitch change fork were not found. All four counterweights fractured; two were found near the impact crater and two were not recovered. Other fragments such as bearing races, ball bearings, preload plate fragments, spinner bulkhead and de-ice slip ring fragments were found in the impact crater.

Photo #2 – Propeller Components In-Situ

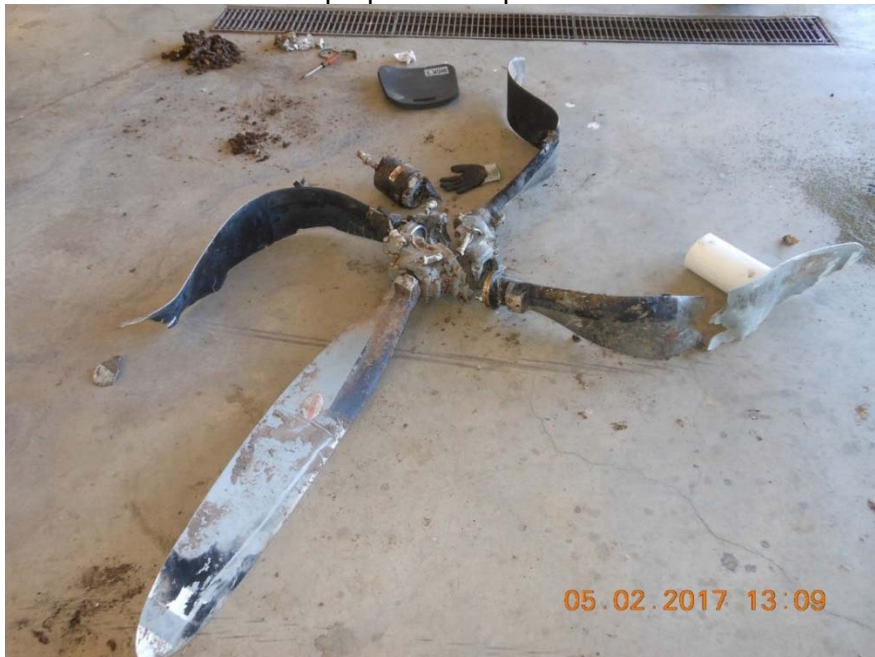
The propeller components were recovered to a hangar at Amarillo International Airport for further examination. The blades and hub fragments were loosely assembled as shown in Photo #3. Three blades exhibited S-bending and one blade had forward/thrust direction bending.

Photo #3 – Main propeller components as-recovered

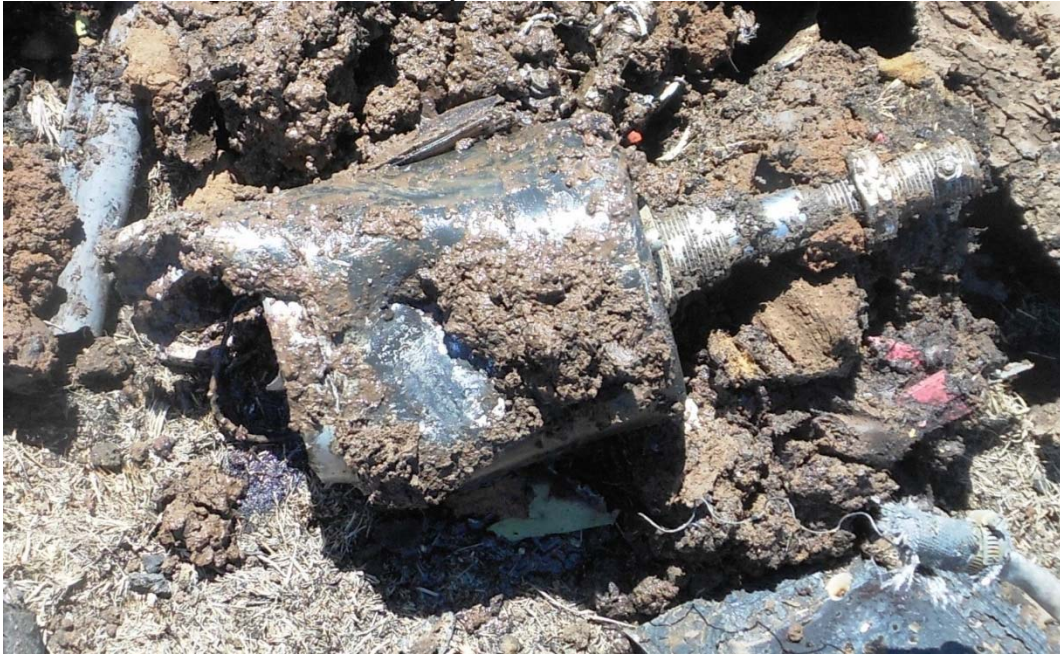
Hydraulic Unit & Pitch Change Mechanisms: The hydraulic unit (cylinder, piston, feathering spring and pitch change rod) fractured from the propeller assembly and was found in the impact crater in the condition shown in Photo #4. The remaining portion of the pitch change rod appeared to be in the extended position with approximately 2.44" between the reverse stop sleeve and feather stop nuts.

Photo #4 – Hydraulic Unit as recovered

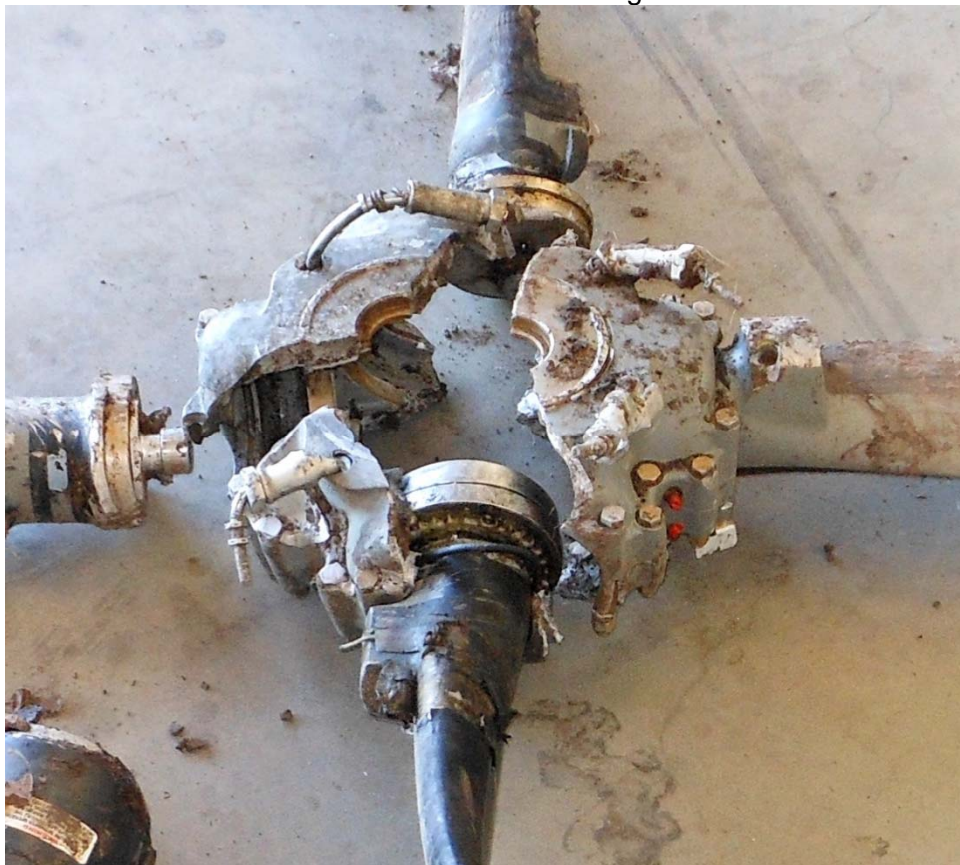
Hub Assembly: See Photo #5. The hub assembly fragmented into three main pieces; a forward and aft portion around blade #1 that was found at the deepest level of the impact crater, a forward and aft portion around blade #2 found approximately 100 yards to the right of the flight path, and forward and aft portions between blades #3 and #4 found in the impact crater and

was not attached to any blades. The aft/mounting wall of the propeller hub remained attached to the propeller shaft flange. The cylinder attachment boss threads were fractured from the hub.

Photo #5 – Fractured hub fragments

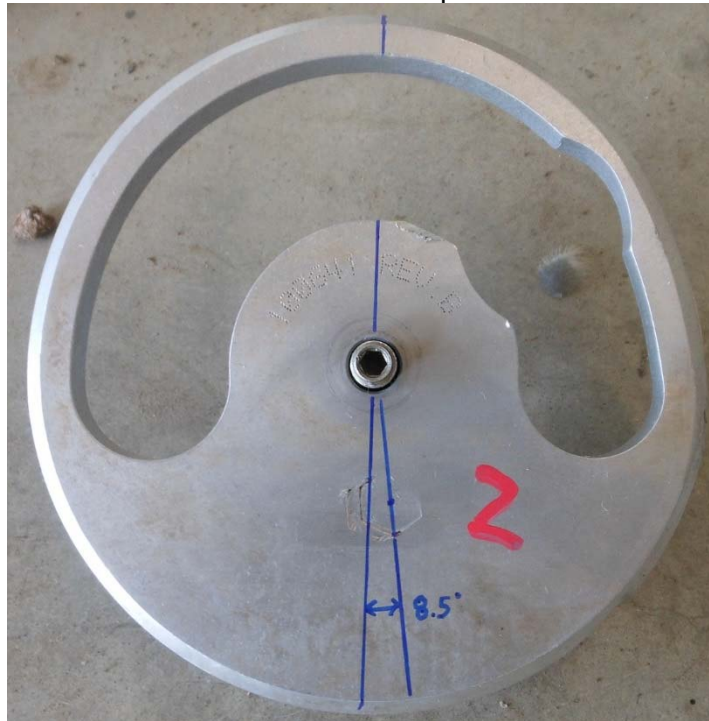
Preload Plates: Preload plates #1 and #2 were still retained in their respective hub fragments and were mostly intact. Only fragments of preload plates #3 and #4 were found. All had lip damage/deformation consistent with impact forces and the corresponding hub pocket damage. Preload plate #2 had two discernable fork bumper impact marks near the hub split line corresponding to a blade angle range of 28-34° (see Photo #6). Preload plate #2 knob slot also had a knob bracket impact mark at the high pitch end of travel.

NOTE: For this propeller model, when the blade knob is aligned with the hub parting line, the blade angle at the reference station is approximately 33° (knob -3° + 36° - difference between blade Set-up Station and the 42" reference radius = 33°).

Preload Plate	Condition
1	Stain marks at ~20.5° and ~40.5° forward of parting line, lip sheared/damaged, trail edge sidewall dented
2	Hex shape bumper dents at and 8.5° aft of parting line. Lip damaged and sheared, trail edge sidewall fracture. Knob dent at high pitch end of slot
3	Fractured/fragmented, center plug remained in shank
4	Fractured/fragmented, pieces recovered in impact crater

Photo #6 – Preload plate #2

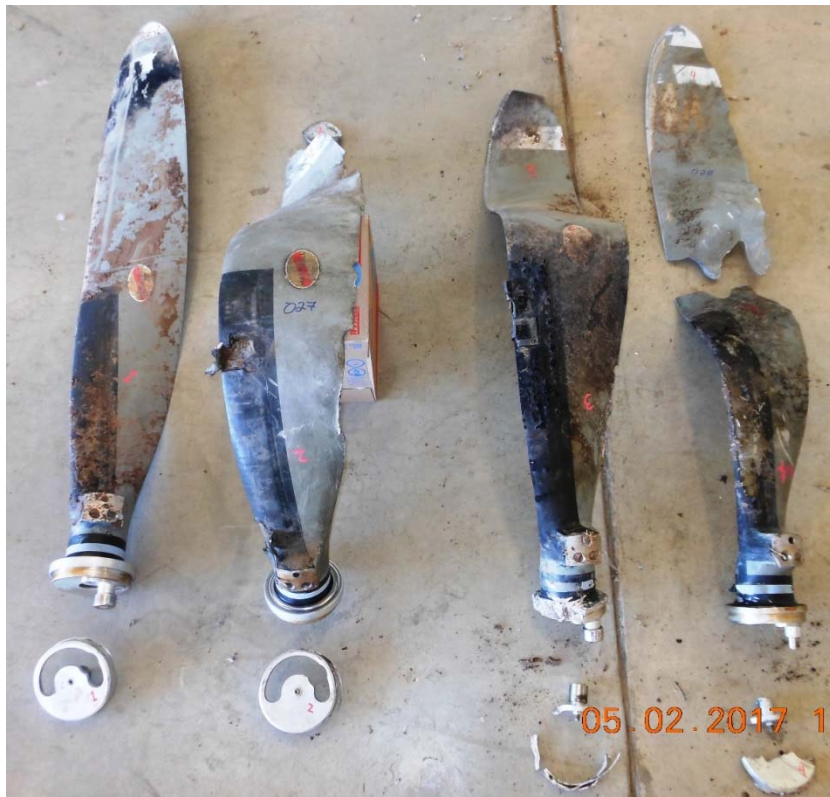
Photo #7 – Blades camber side shank view

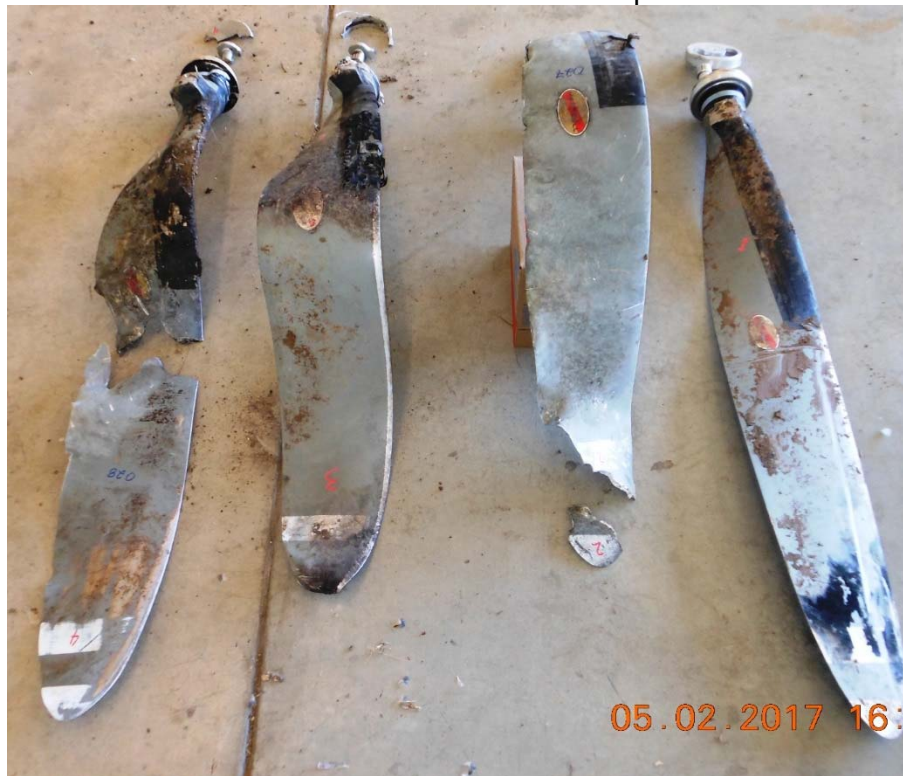
Photo #8 – Blades camber side tip view

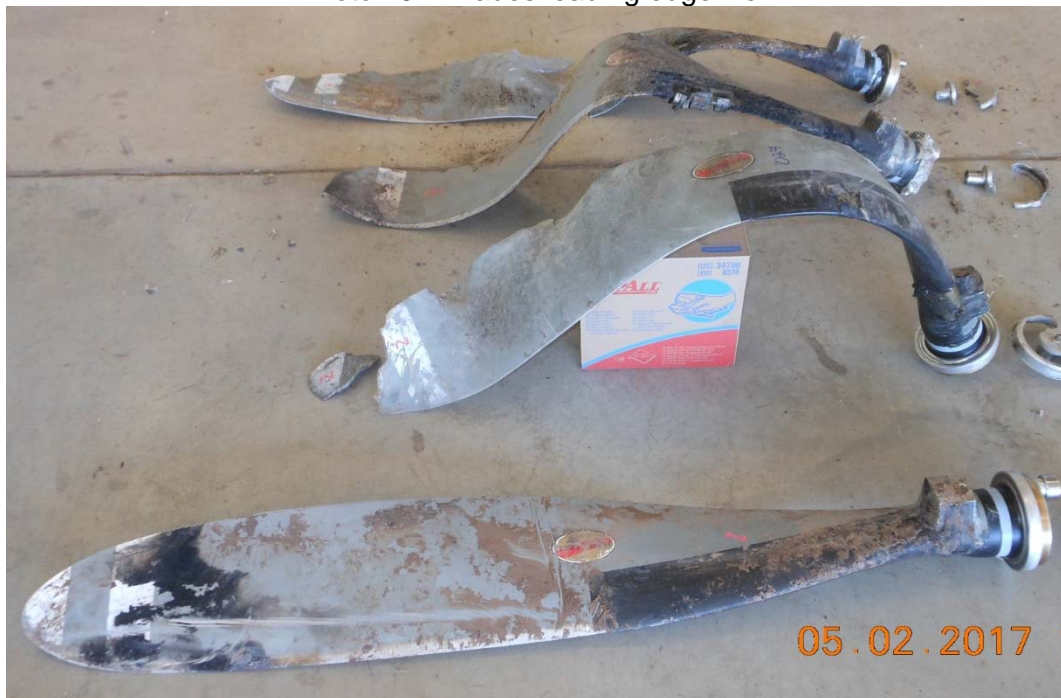
Photo #9 – Blades leading edge view

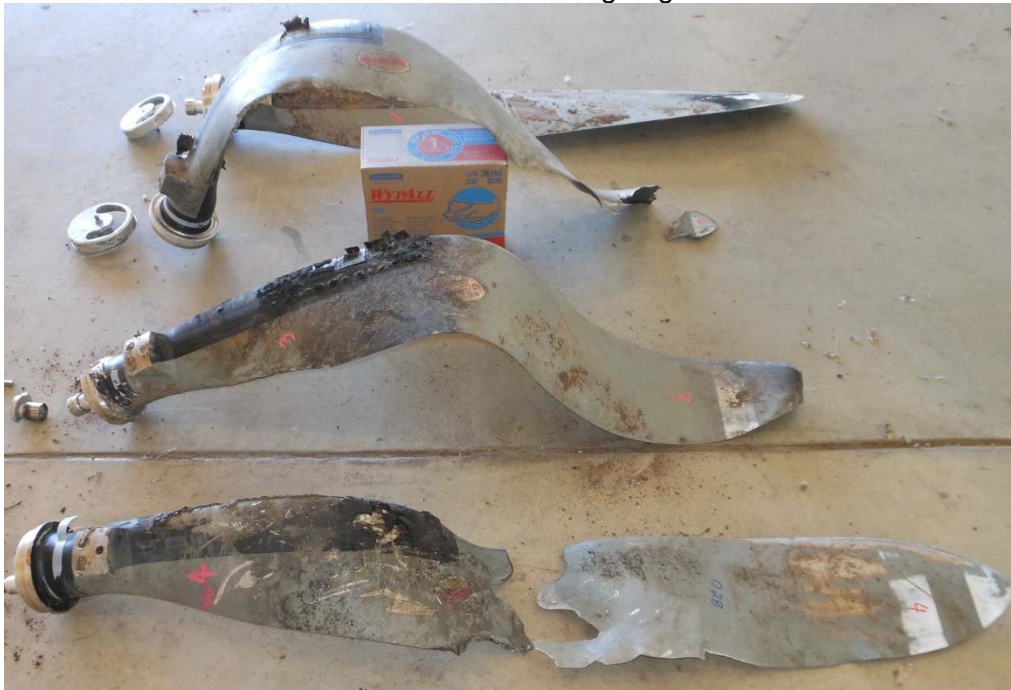
Photo #10 – Blades trailing edge view

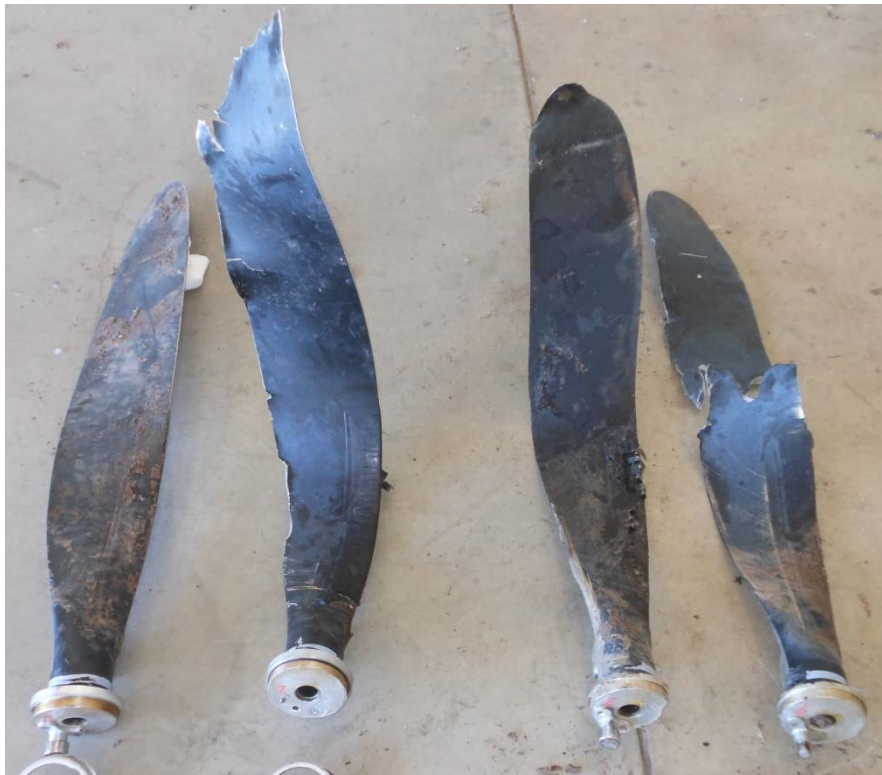
Photo #11 – Blades face side

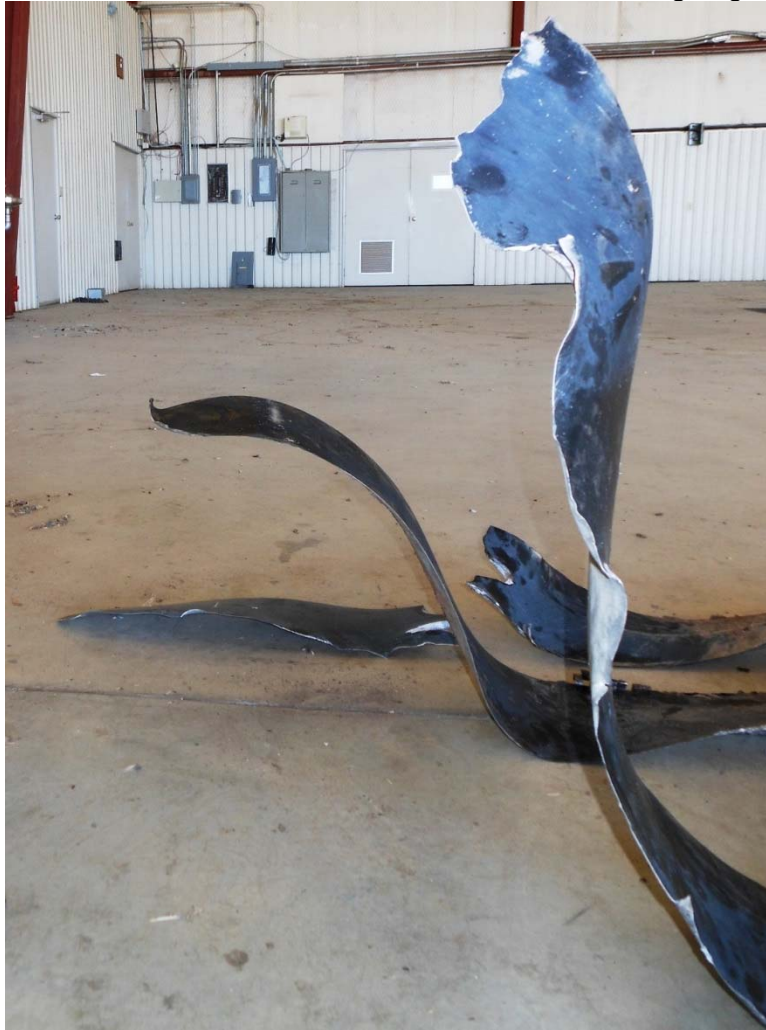
Two blades were fractured suggesting rotation under power; blade #2 tip and blade #4 was fractured at mid-blade. Damage suggesting a positive angle of attack at initial impact included blade #2 forcible rotation to high pitch, blade S-bending and twisting towards high pitch.

Photo #12 – Blades #2-#4 S-bend characteristics trailing edge view

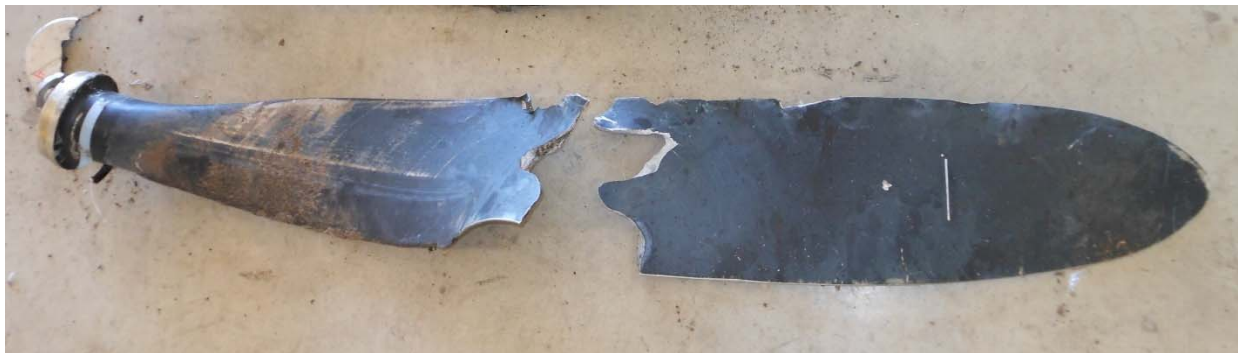
Blade #4 – Jagged fracture 22-26” from tip, fracture surface appears to show forward/thrust direction bending. Shank found just outside and beyond impact crater. Tip section found approximately 100 yards forward and to the right of the impact crater.

Photo #13 – Blade #4 fracture

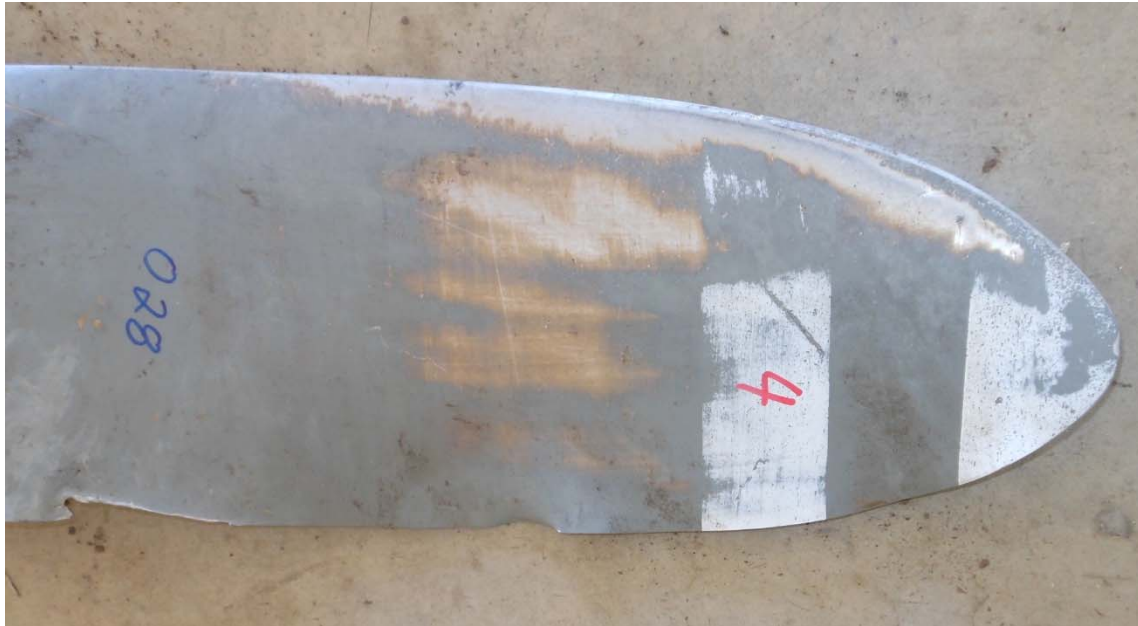
Camber side	Chordwise/rotational abrasion last 14”, random gouges near shank, sooted near tip
Face side	Chordwise/rotational scoring/abrasion near shank
Bend	S-bend
Twist	Leading edge up/untwisted
Lead edge damage	Dents outboard of de-ice boot
Trail edge damage	Torn and gouged, wavy bends
Knob/Bracket condition	The cam follower bearing was fractured and not recovered. The bracket was attached with both screws but lifted/bent off blade surface.
Counterweight	Fractured, holes damaged opposite rotation
Blade bearings	All bearing races missing/not recovered, retention ring missing.
Butt/shank impact marks	Compression/deformation on the leading edge side in the shape of the preload plate slot
De-Ice boot	Torn, chunked and heat damaged.

Photo #14 – Blade #4 chordwise/rotational scoring on camber side
