Re: Proposed Findings, Probable Causes, and Safety Recommendations  
Collision between Bulk Carrier *Conti Peridot* and the chemical tanker *Carla Maersk*, on March 9, 2015 in the Houston Ship Channel, Texas  
**DCA15MM017**

**Proposed Findings:**

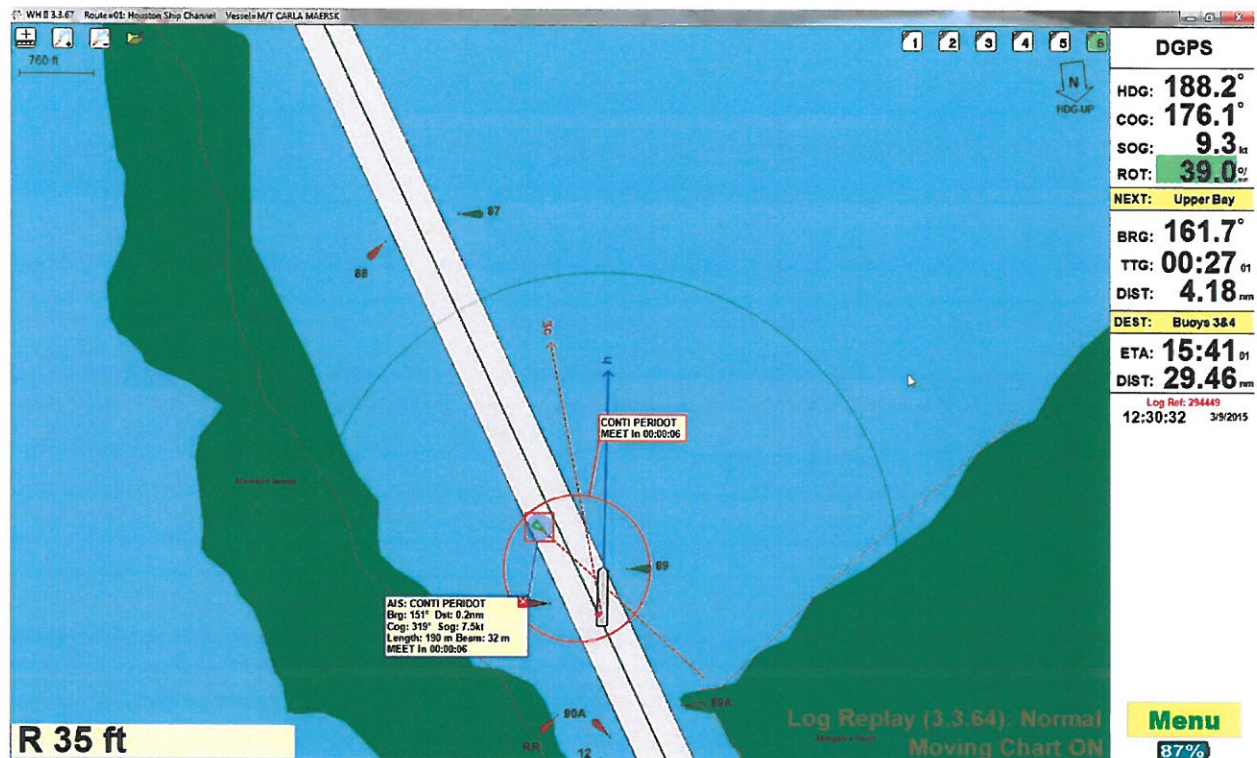
14. If the *Conti Peridot* had properly come right, her rate of approach to the *Carla Maersk* would have slowed. Considering the evasive maneuvers of the *Carla Maersk* to her right and her speed of 9.2 knots in the opposite direction, the relative motion of the two ships would likely have resulted in them clearing one another rather than colliding. This is best

demonstrated by the relative positions of the two vessels at the time of the collision. The following is a screenshot from the PPU of the pilot aboard the *Carla Maersk*:
