PARTY SUBMISSION OF BOMBARDIER LEARJET

Global Exec Aviation's Learjet N999LJ

Columbia, South Carolina 19 September 2008

DCA-08-MA-098

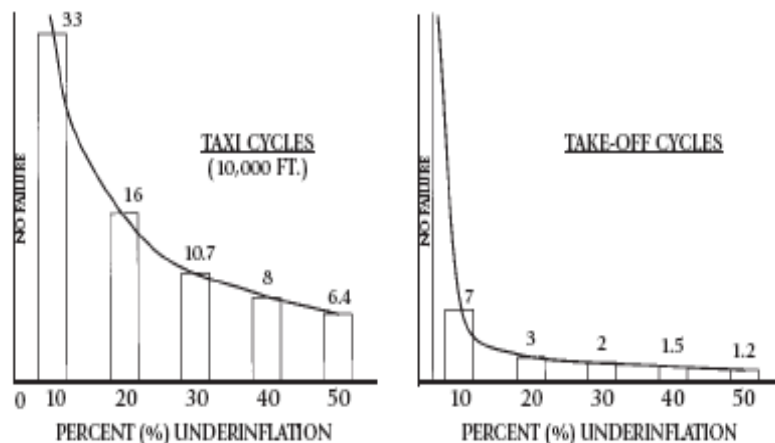
CYCLES TO FAILURE VERSUS UNDERINFLATION

The above data from the Goodyear Aircraft Tire Care and Maintenance document illustrates the significant impact of under inflation on tire life. The data also shows that the life impact of the tire is more sensitive to under-inflation during Take-Off cycles than with Taxi cycles.

Based on the fact that the aircraft completed three full flights and one additional taxi with severely under inflated tires, there can be no expectation for a successful fourth flight. The failure of each tire was directly related to the lack of proper tire inflation. The data illustrates that each tire exceeded its expected useful life, under the given conditions, and that tire failure was imminent.

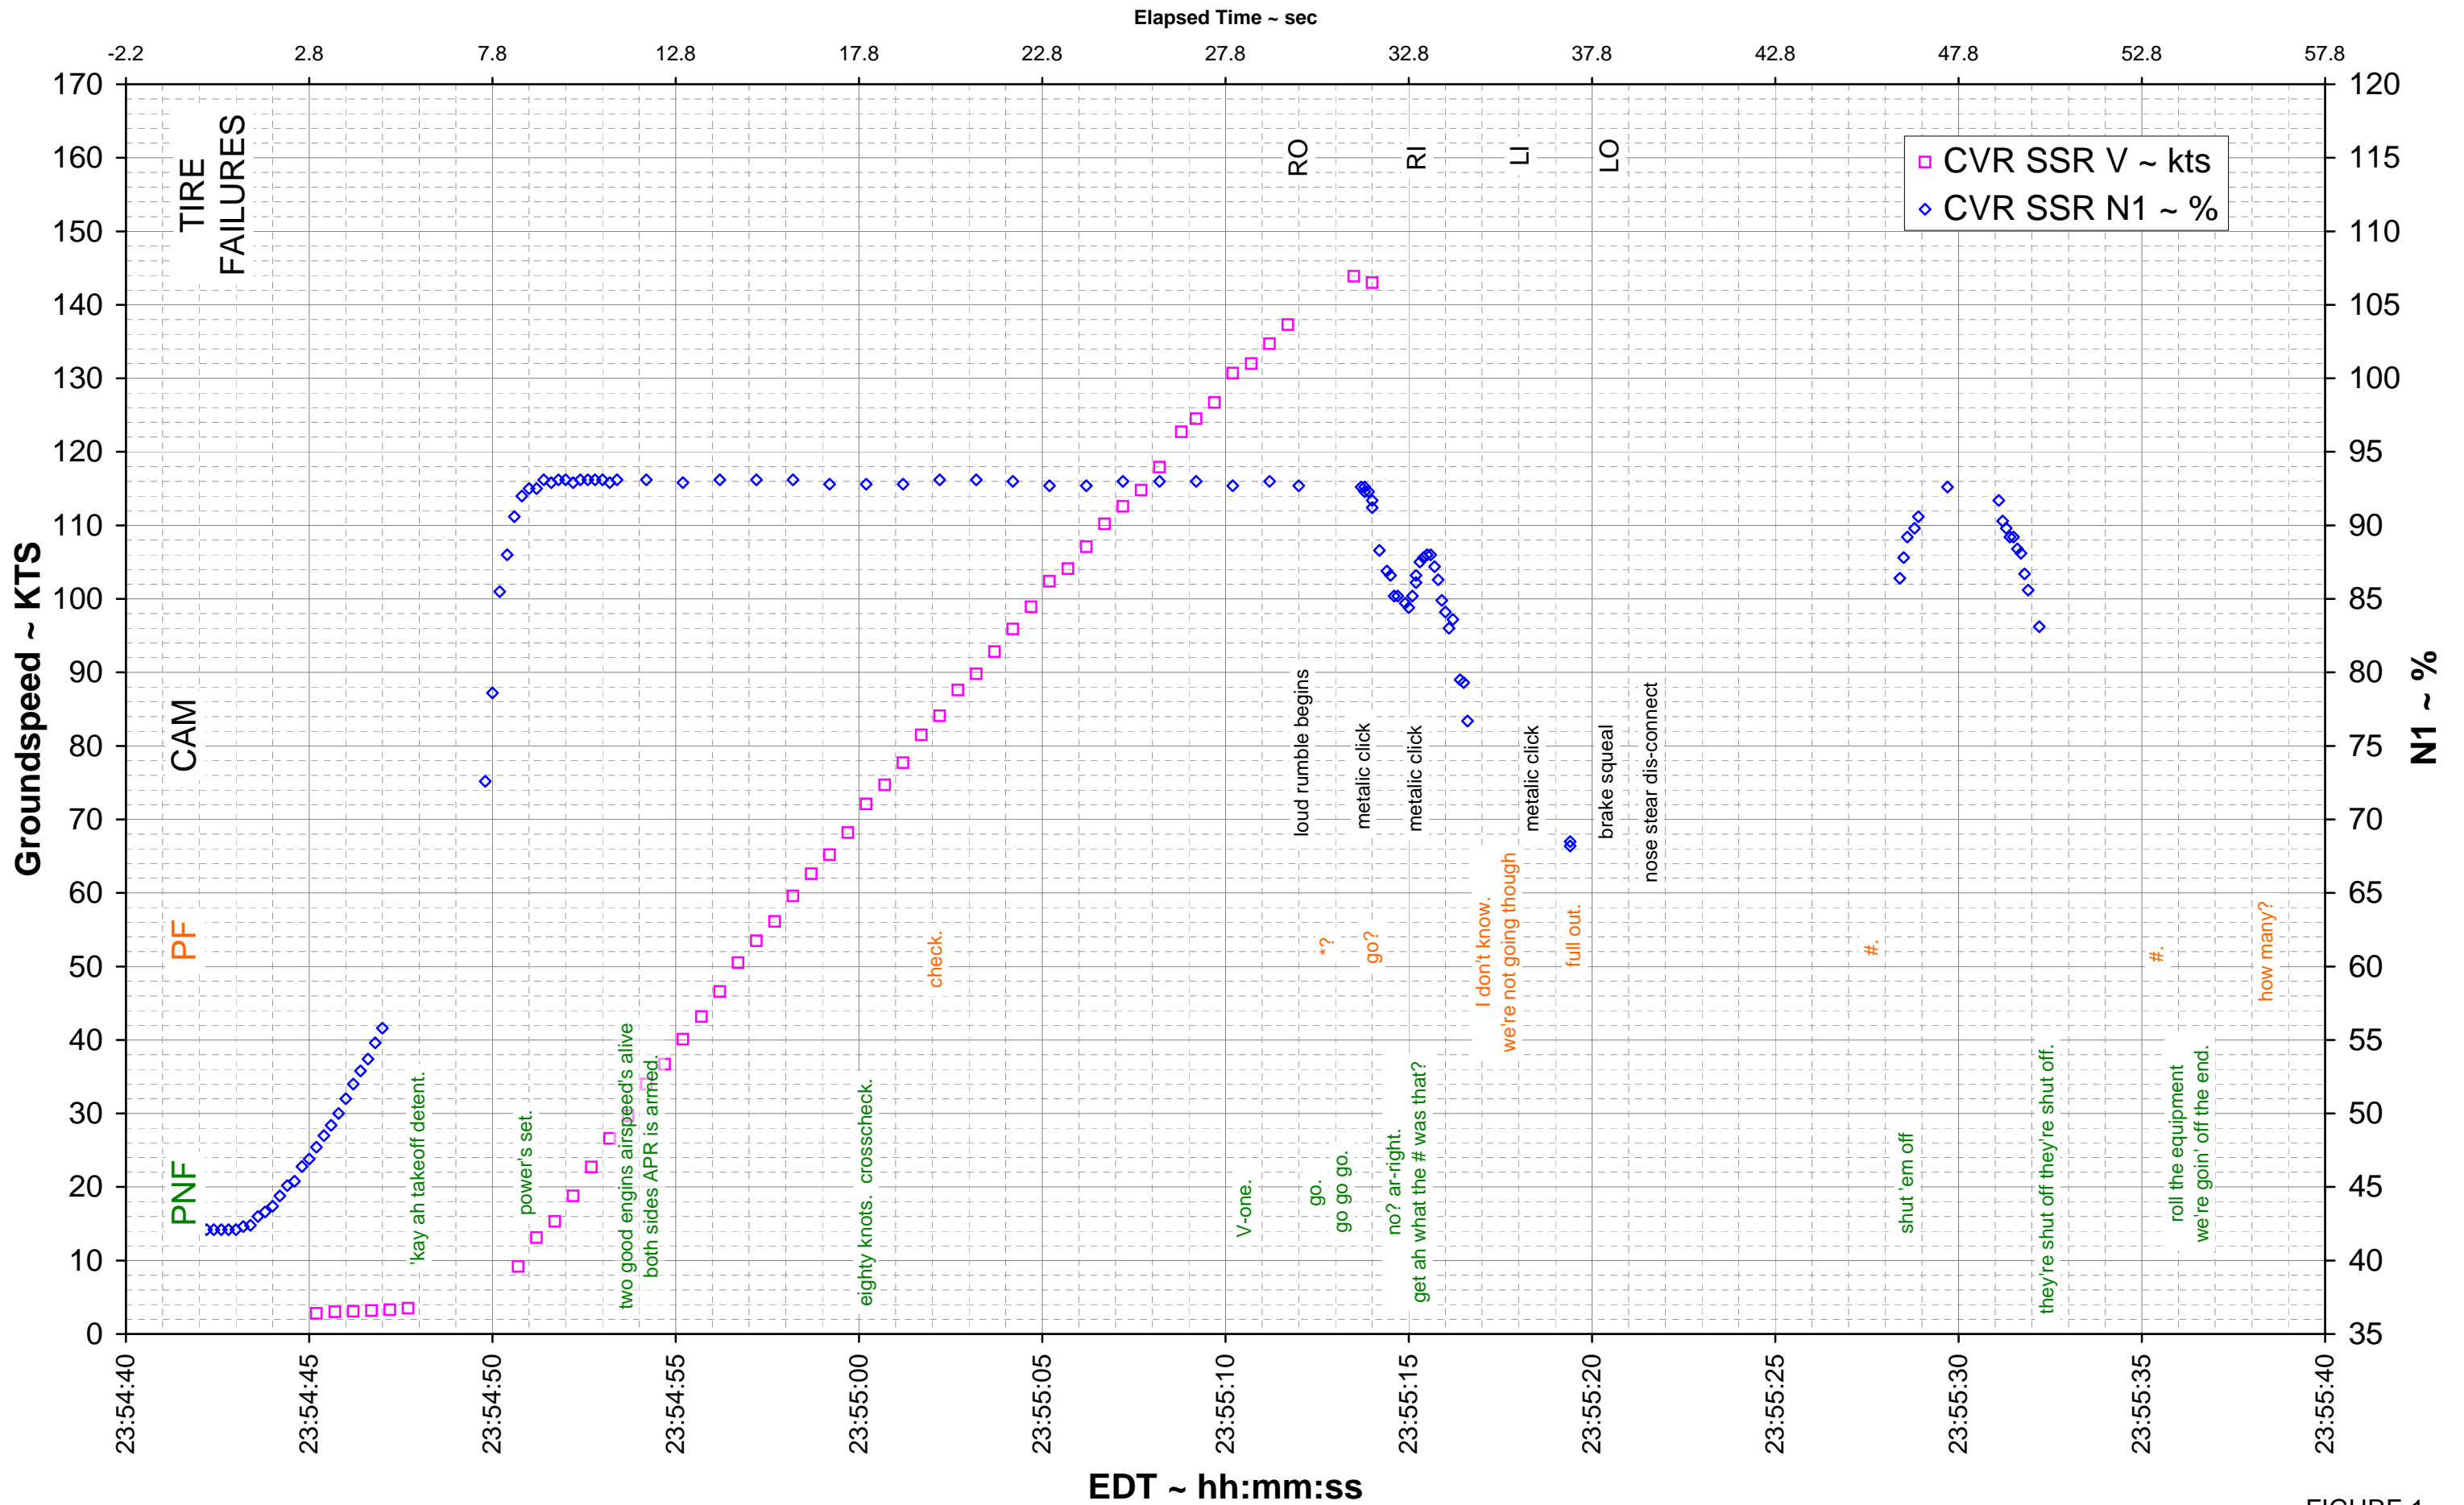
FIGURE 1

Time history data for groundspeed and N1 were available from the CVR Sound Spectrum Report (including additions per Addendum I), which were combined with the crew statements and relevant CAM sounds from the CVR Factual Report, and the approximate tire failure events as described in Factual Addendum and Study for Tires and Landing Gear. These data are shown in graphical form on Figure 1, Section VIII of this Submission. Note that the elapsed time presented in the CVR Sound Spectrum Report was synced with Eastern Daylight Time (EDT) at time zero equal to 23:54:42.2 per that document's October 6, 2009 errata publication. For reference, the corresponding elapsed time is shown on the upper x-axis of Figure 1, Section VIII of this Submission.

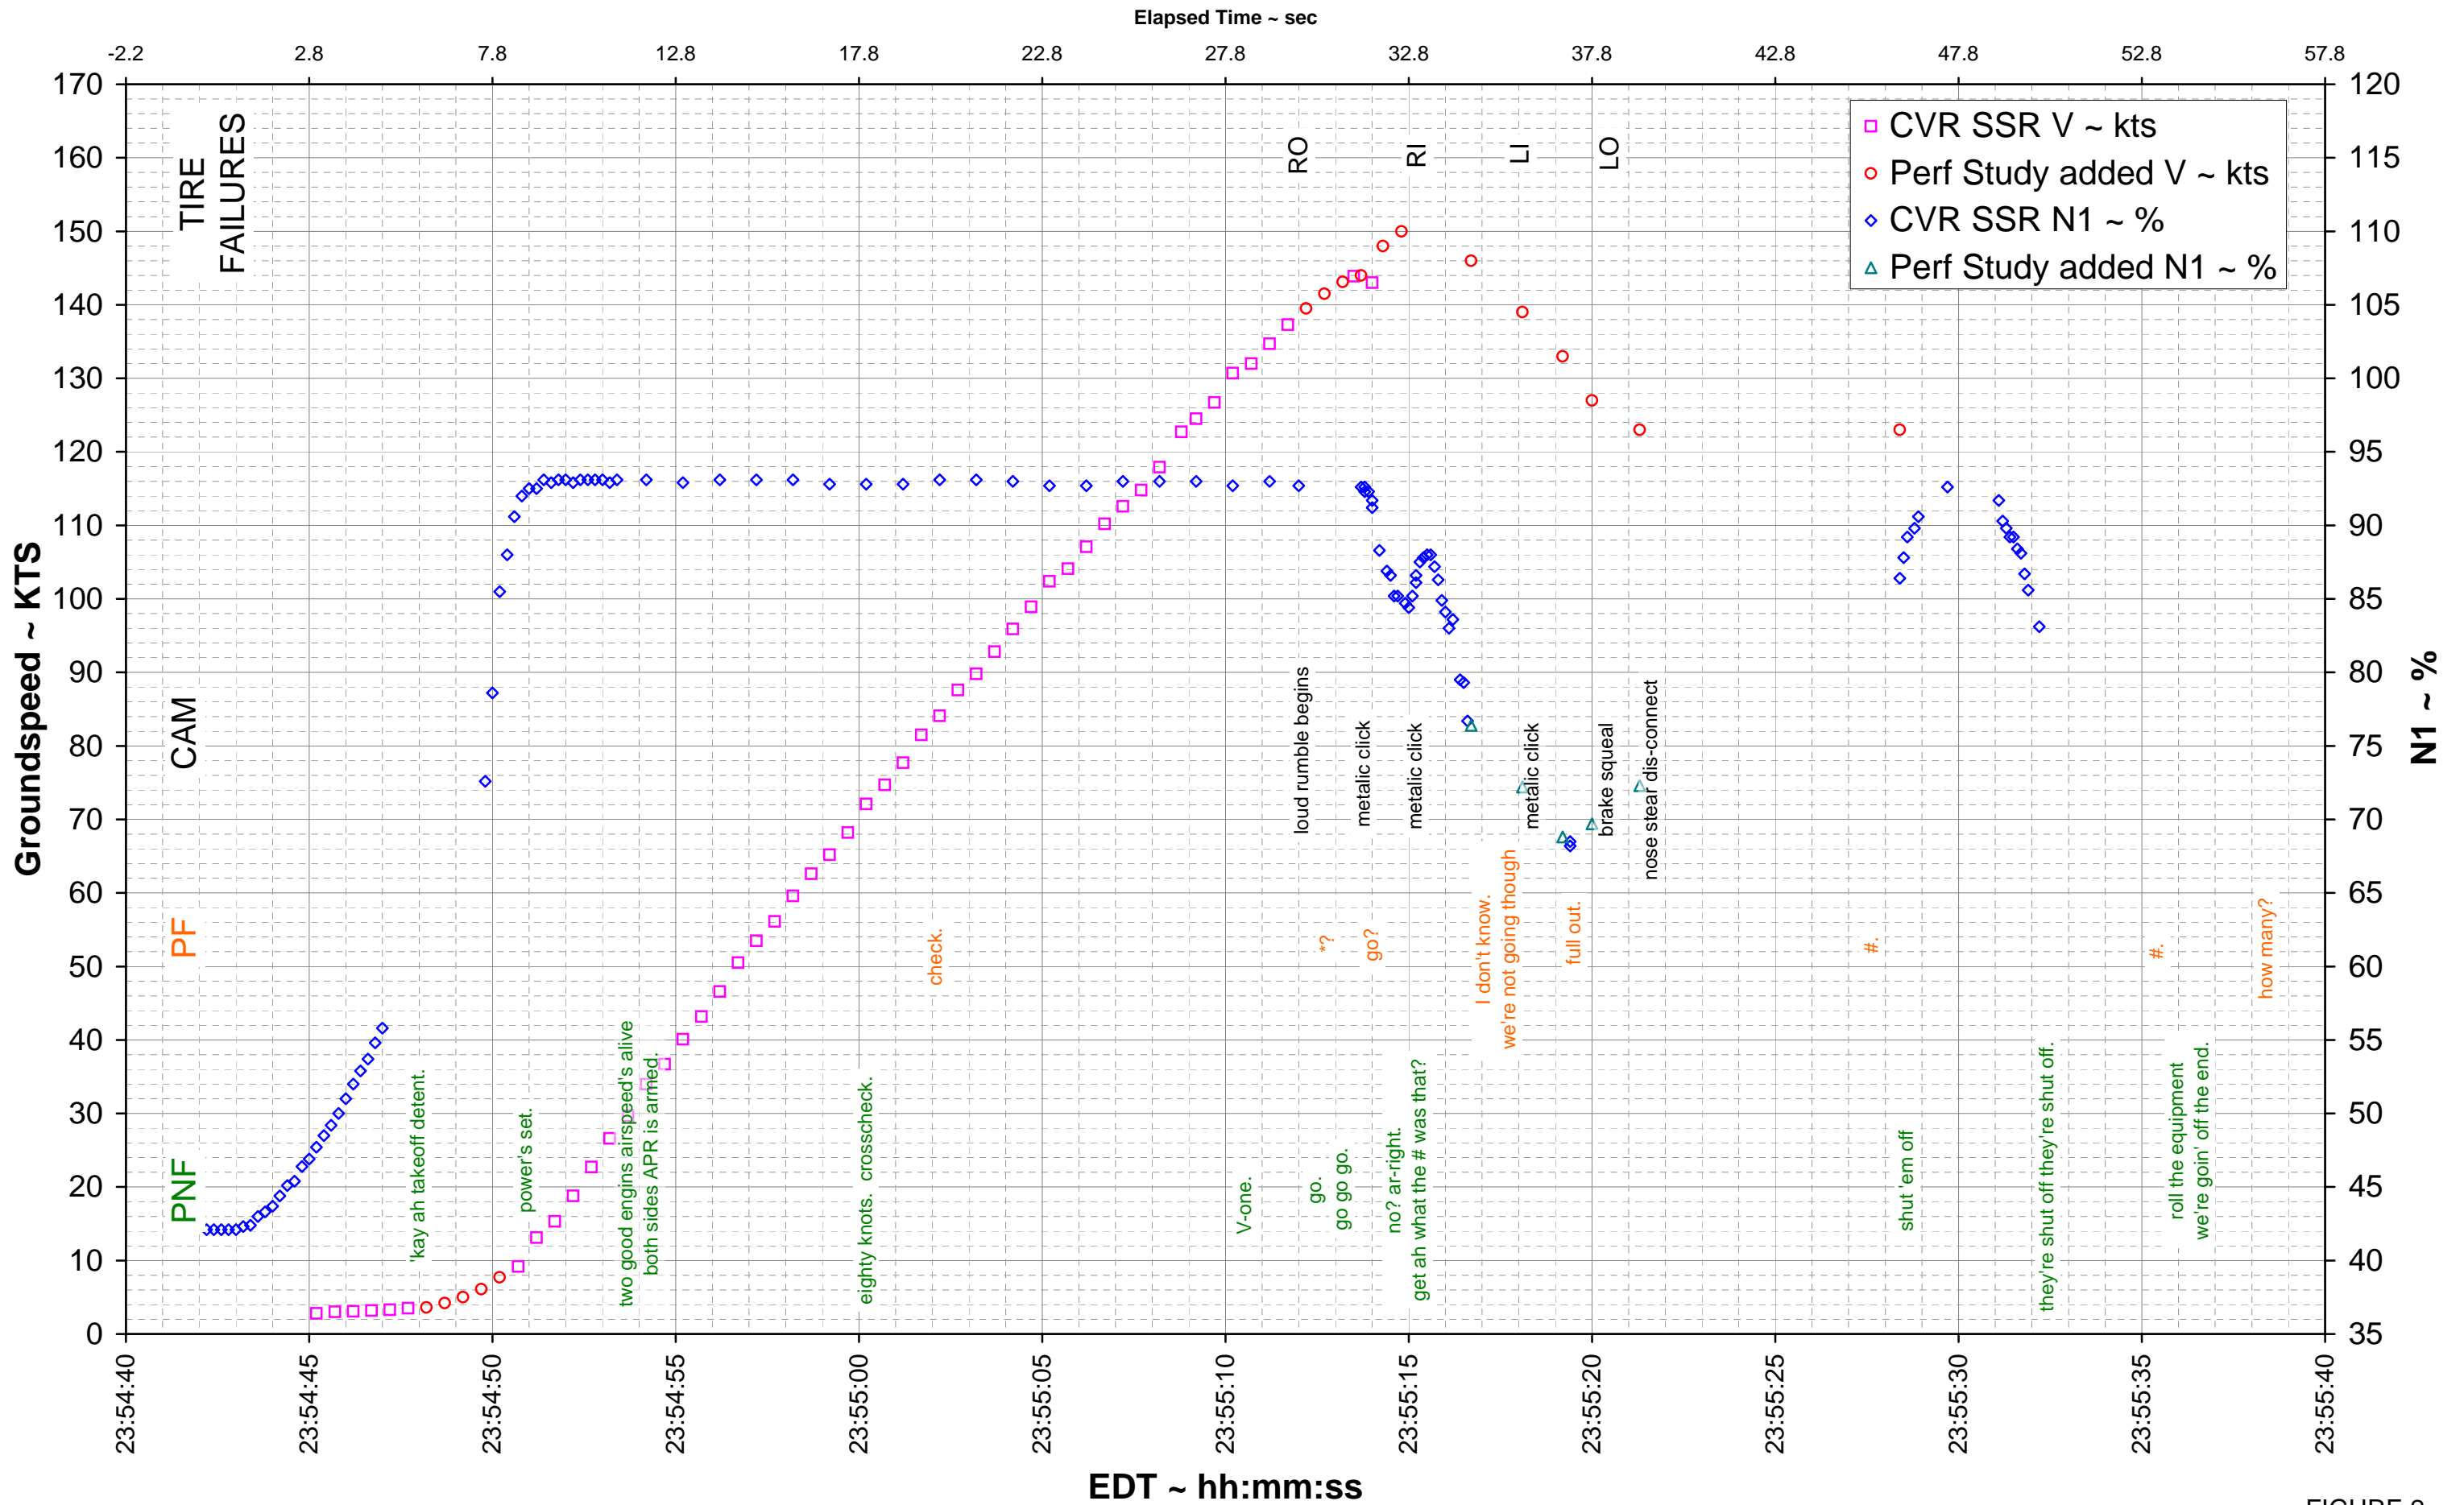
FIGURE 2

therefore shown on Figure 2, Section VIII of this Submission, shifted -0.3 seconds from their presented EDT to be consistent with the data in Figure 1, Section VIII of this Submission. A final observation is noted that the END OF RECORDING time shown on Attachment 1 from this report is 23:56:40.1 EDT. This is one second earlier than that presented in the CVR transcript, and is assumed in error.

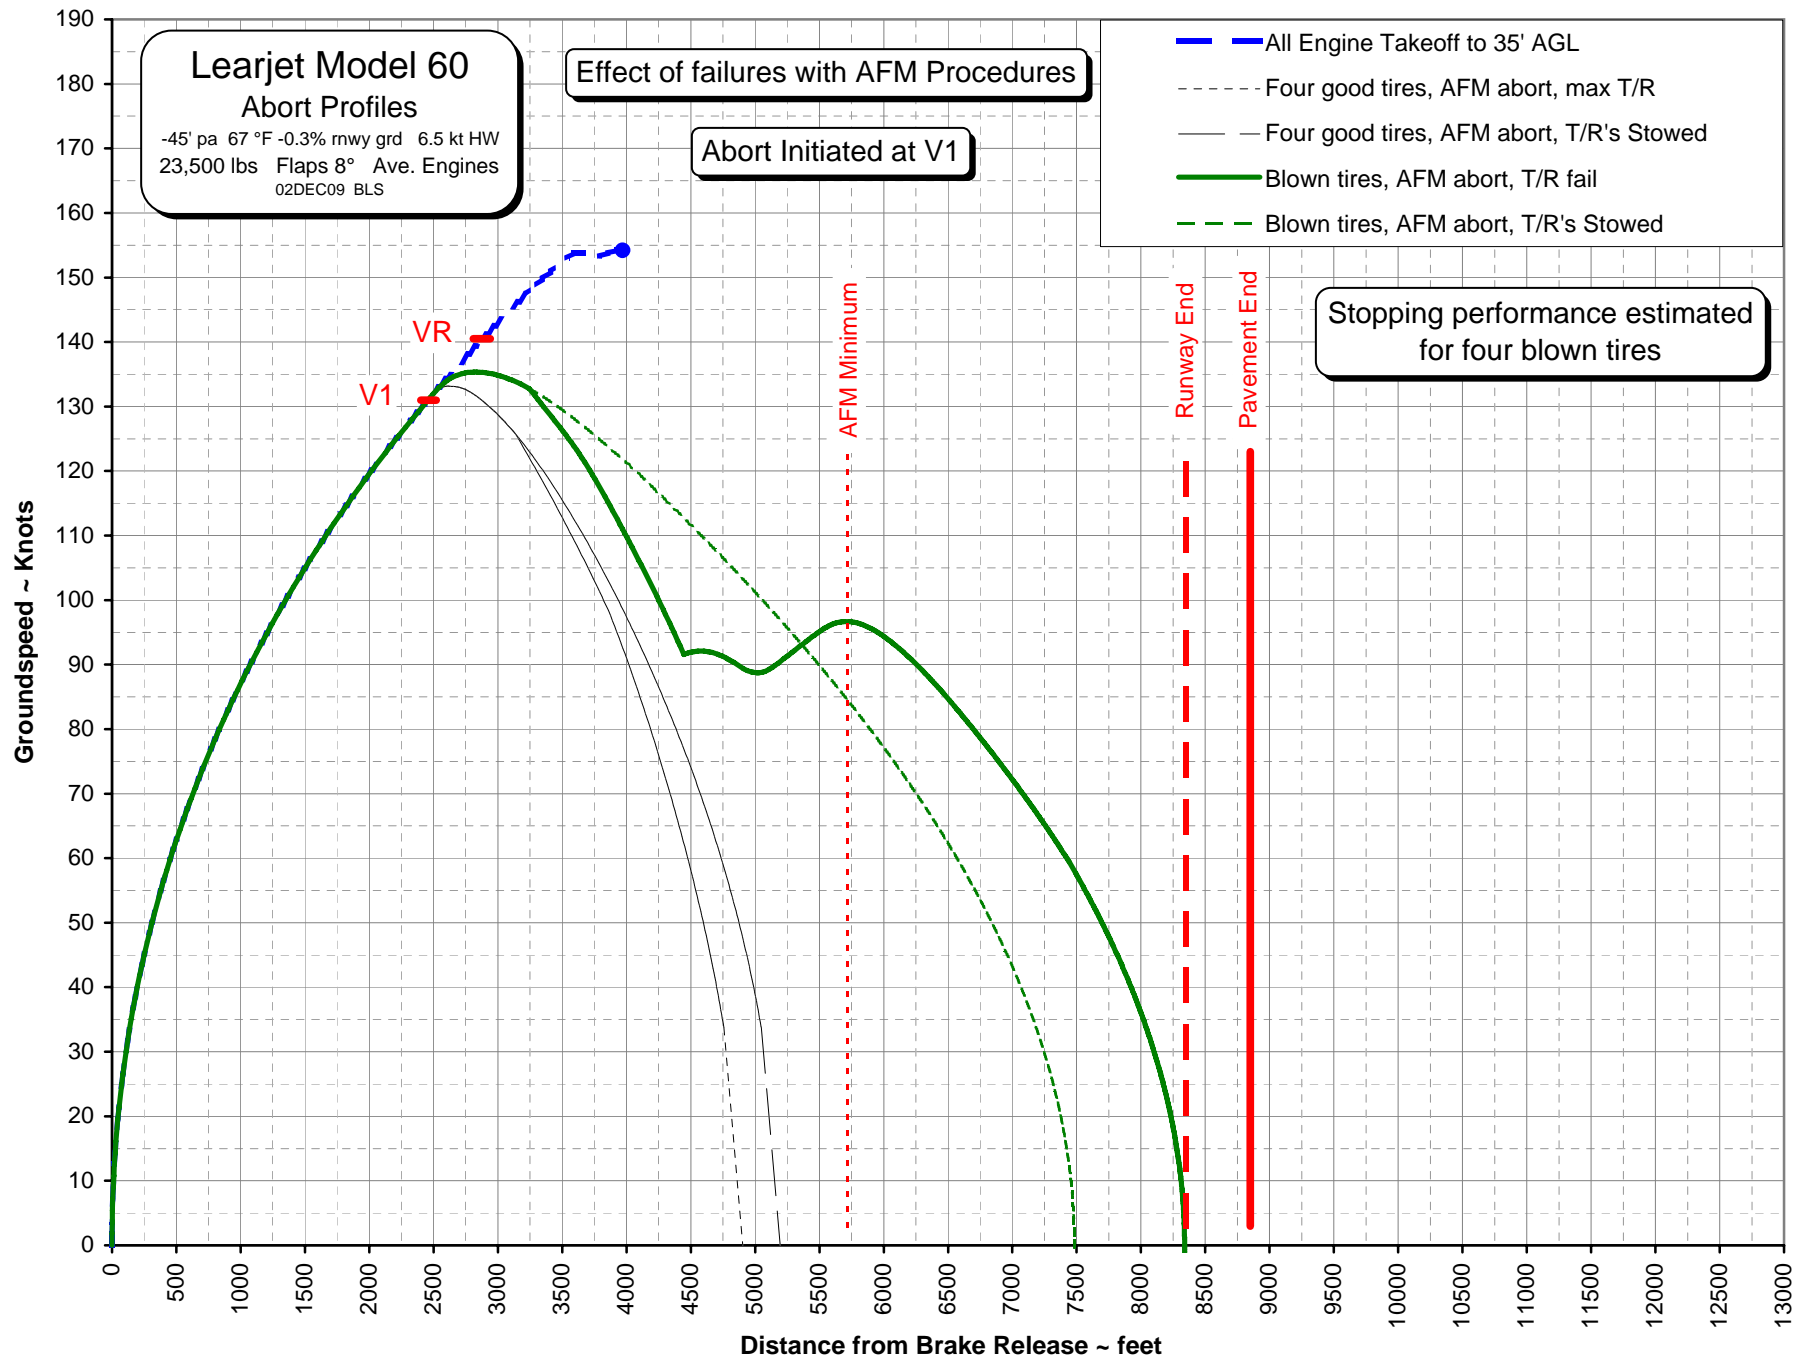
FIGURE 8

Figures 8, 9 & 10, Section VIII of this Submission, present a series of analytical groundspeed profiles for various scenarios. Profiles shown on Figure 8, Section VIII of this Submission, illustrate AFM procedures in combination with the failures encountered by 60-314. Profiles are shown for aborts from V1 with good wheels / tires / brakes both with and without thrust reversers, as well as the continuation of the takeoff with all engines to a height of 35' AGL. Failure profiles are shown with four blown tires using estimated braking performance as derived above. One profile is shown for a stop without thrust reversers and a second is shown assuming thrust reversers initially deployed, then stowed uncommanded with crew reaction similar to that derived above for 60-314. Figure 9 illustrates the effect of the nonstandard procedures employed by the crew of 60-314. All profiles on Figure 9 assume four good wheels / tires / brakes and employ the "double abort" thrust profile as documented above. One set of profiles assumes maximum effort braking applied and sustained from the "first abort" event 3.2 seconds after V1. The second set of profiles assumes a delay in sustained braking until 9.8 seconds after V1. Each set contains a trace for T/R's stowed and maximum reverse thrust. Note that three of these four profiles would result in an exceedance of the maximum demonstrated brake energy of 5.5 Mft-lbs per brake. Figure 10 then combines the effects of the nonstandard procedures and the failures encountered on 60-314. Note that this plot contains the probable profile as derived above, along with a hypothetical profile assuming T/R's stowed. The three AFM profiles (good brakes with and without T/Rs and all engine takeoff to 35') from Figure 8 are also shown for reference on Figure 10 in Section VIII of this submission. Reference lines are shown on all three figures for the approximate runway end and pavement end for CAE Runway 11 as well as AFM published required field length for the ambient conditions.
