Aircraft Accident/Incident Report No.: 100807

NTSB File No.: ERA10FA404

Aircraft: Beech 58 Baron

Aircraft Accident/Incident Report No.: 100807**Propeller Teardown Report****Date of Investigation:** May 13, 2011**Location:** Hartzell Propeller Inc.**Propeller Model:** HC-C4YF-2E with FC7063Q blades

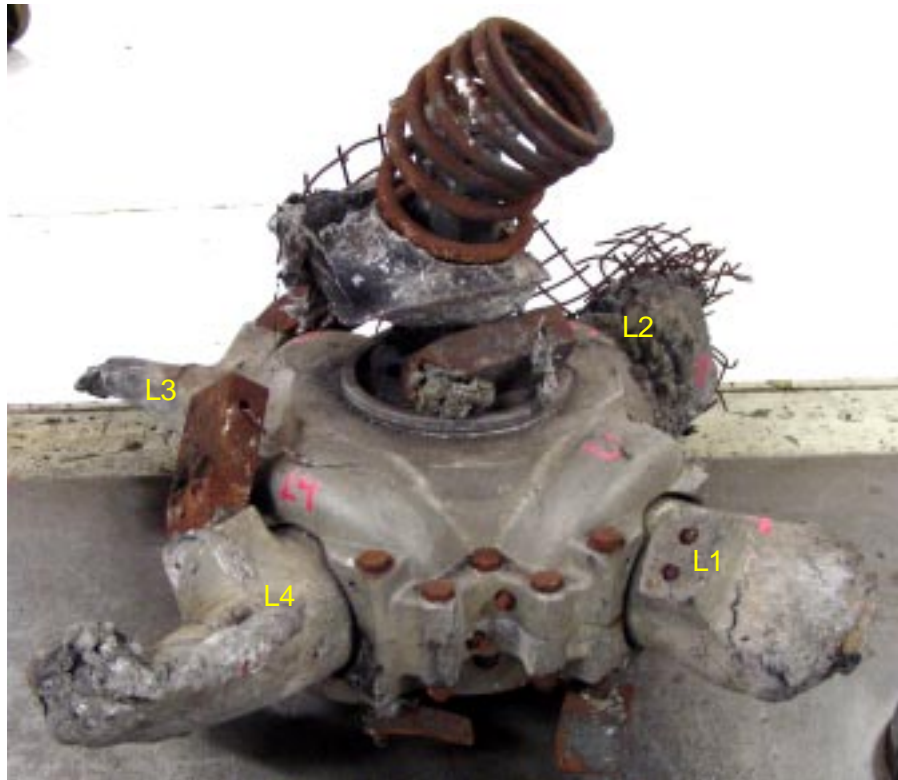
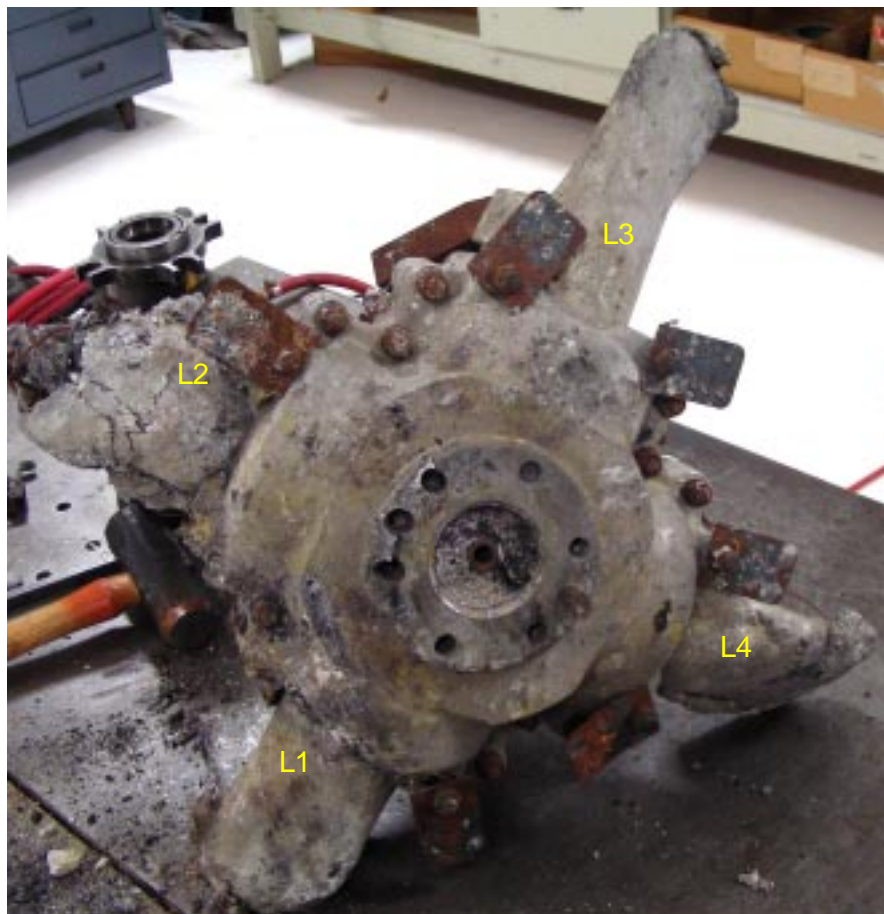
See photos on Page 5.

The propeller had severe thermal damage. All four blades had been melted outboard of the blade counterweights. The outboard portions of the blades were missing. The spinner assembly was missing. The cylinder assembly was melted and mostly missing. The low pitch stop, air valve, feather stop, start lock mechanism, and feather spring guides were also missing. The mounting studs were missing. Two of the four blade counterweights had separated from the blades; the blades were melted in the area of the counterweight boss.

All four blades and the piston were at a low pitch position.

A coarse screen mesh was imbedded into melted aluminum in the area of the piston/cylinder.

All six mounting studs were missing. One of the two mounting flange dowel pins was missing. The mounting flange was cracked and partially deformed.

The cylinder was largely missing. A fragment of the cylinder was crushed and torn and remained attached to the feather spring.

The piston was largely melted/missing.

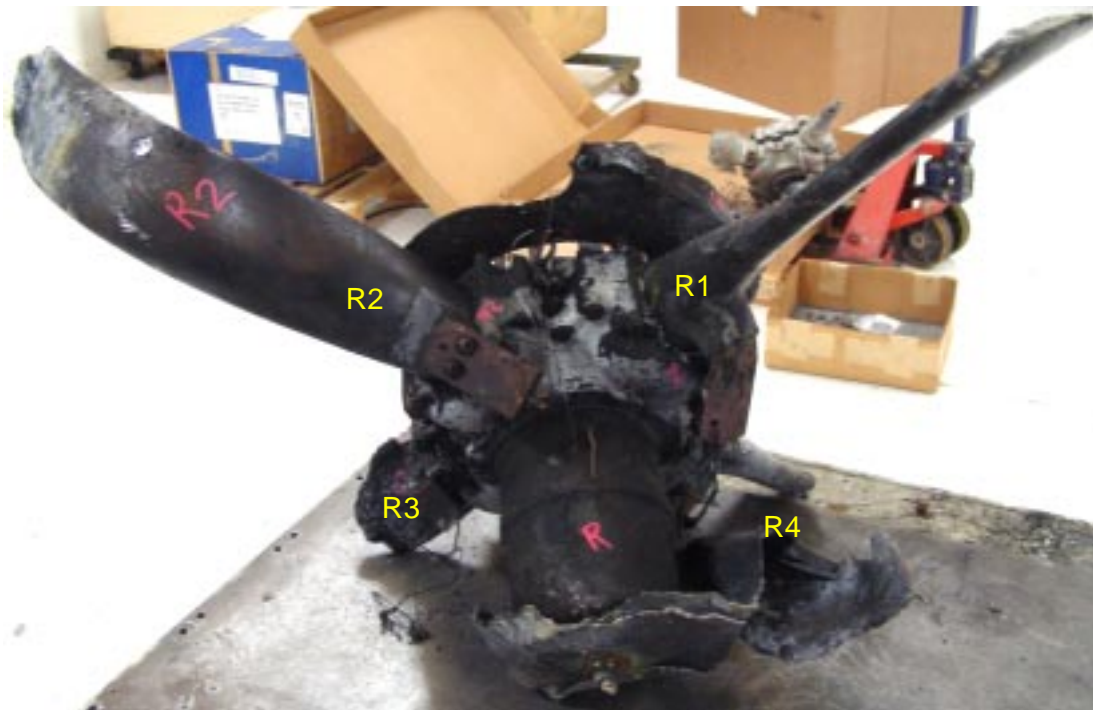
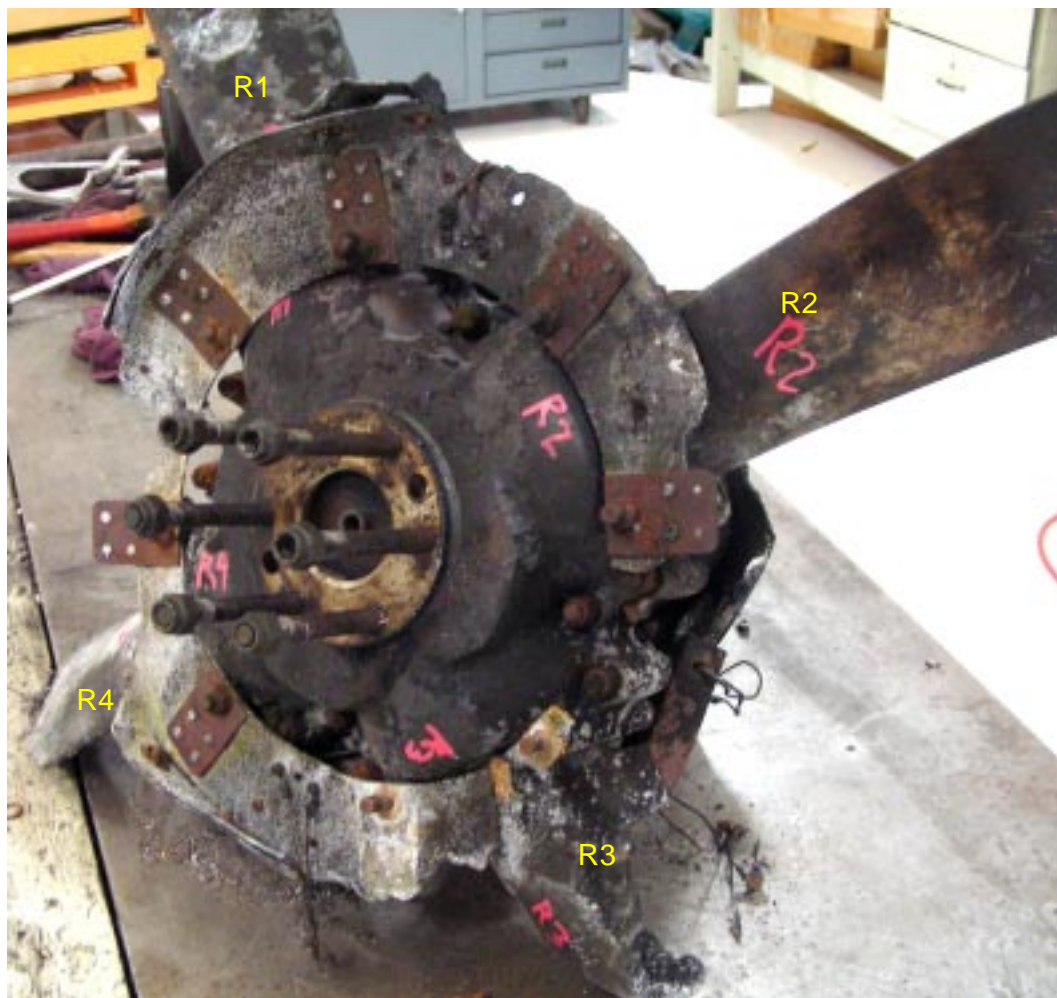
See photos on Page 8.

The propeller was blackened and had extensive thermal damage. The spinner dome was mostly missing. All four blades were at a low pitch position.

The spinner dome was missing except for a small portion attached to the front of the cylinder. The spinner bulkhead was fragmented and partially melted with portions missing.

The air valve was broken and did not retain an air charge.

The pitch change rod was intact. It could not be removed from the front hub half. It was blackened except in the area that was masked by the front hub half. This discoloration indicated that the rod was at a low pitch position during the fire.

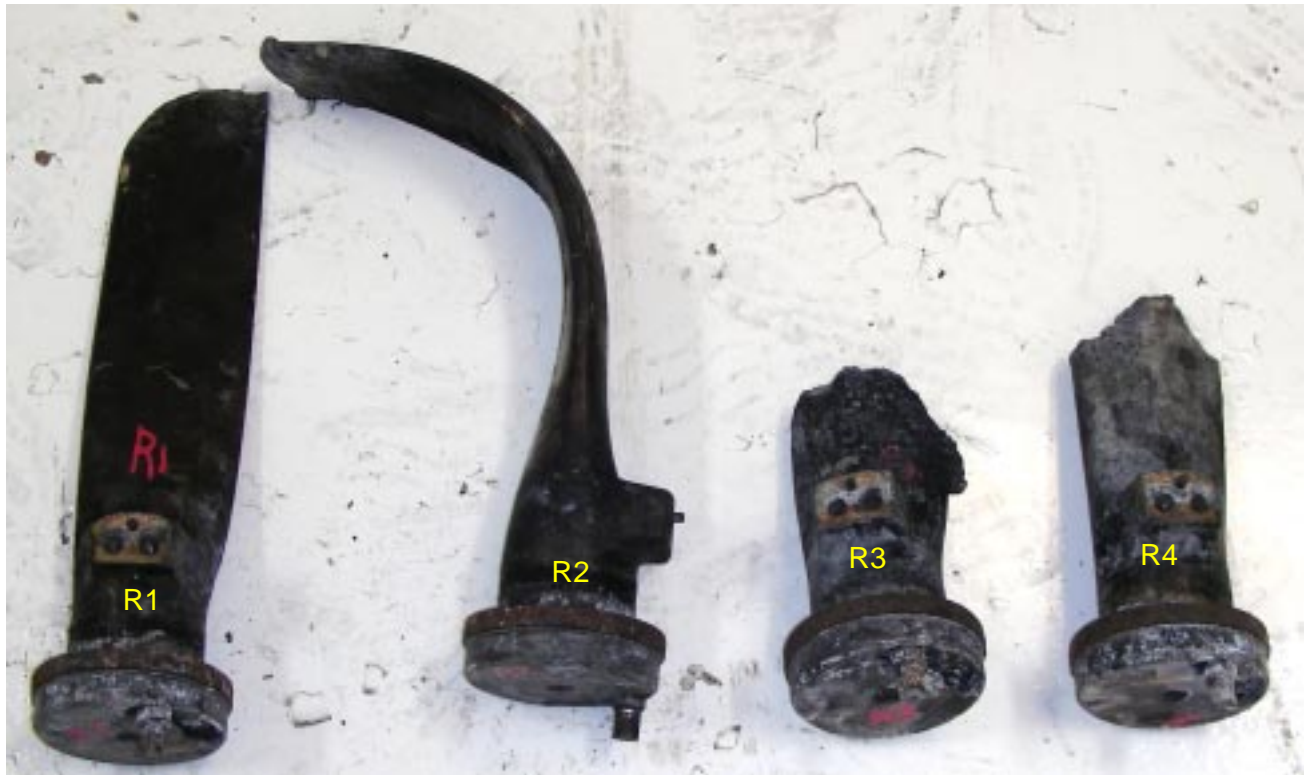
See photos on Page 10.

R1 blade was straight. The outer 1/2 of the blade was melted/missing.

R2 blade was bent aft approximately 90° degrees and was not twisted.

R3 and R4 blades were melted/missing outboard of the blade counterweights.

All four blade pitch change knobs were intact and all four blade counterweights were intact.
