Technical Report

Evaluation of Crankshaft and Other Selected Components from

TIO-540-AF1B Engine (S/N L-9457-61E)

In Support of NTSB Accident Investigation ERA16FA023

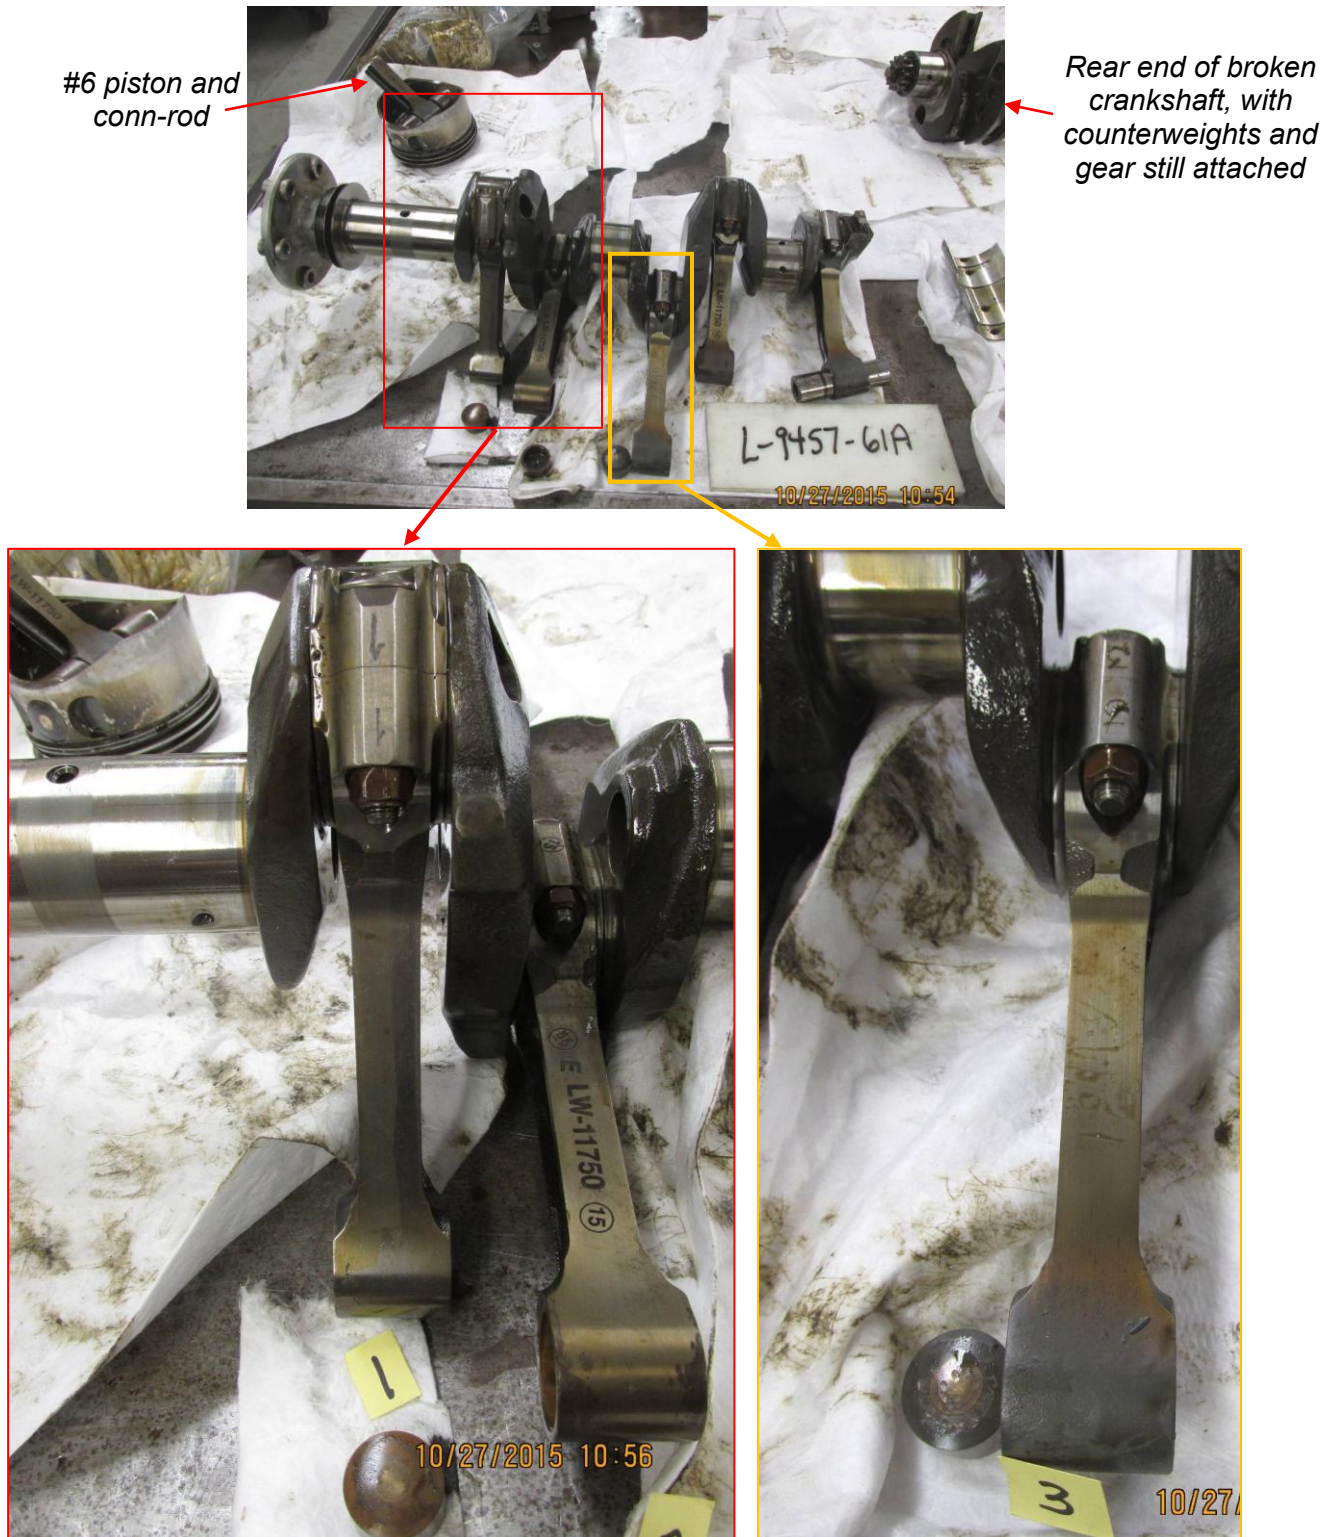
Figure 1. Broken crankshaft as removed from the engine, with closer views of the #1 - #3 connecting rods, still attached. Broken #6 connecting rod with piston still attached also visible in top photo. Also note, clean, undamaged surface of the main journals. See Figure 2 for closer views of the #4 and #5 connecting rods and adjacent areas.

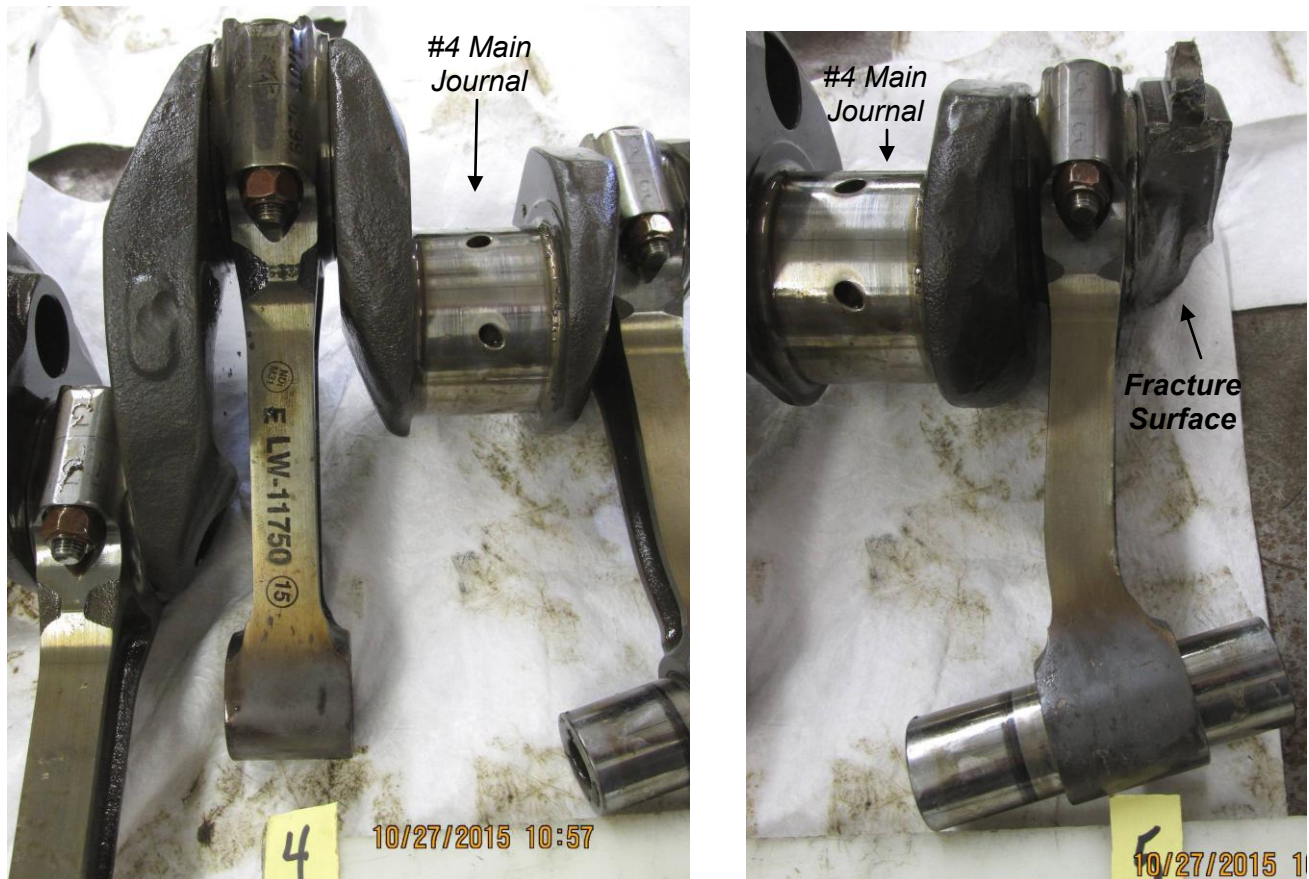
Figure 2. Closer views of the #4 and #5 connecting rods, still attached to the broken crankshaft, as removed from the engine. Note #5 rod is twisted, and both connecting rods have darkened appearance at the piston end. Note clean, undamaged surface of the #4 main journal. Fracture surface visible in right photo.

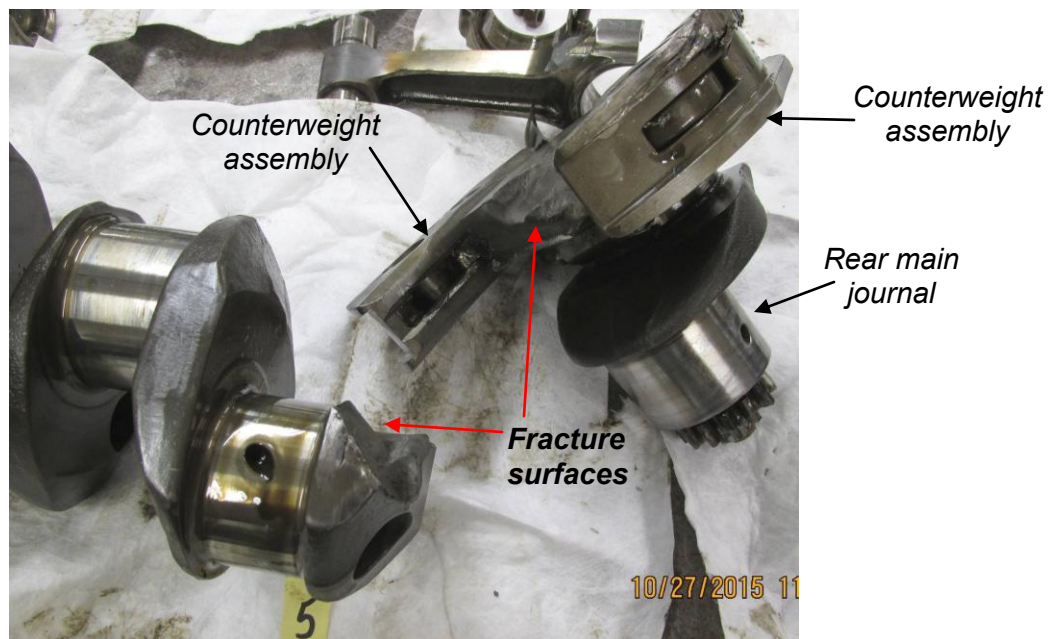
Figure 3. Rear section of the broken crankshaft, after removal of the #5 connecting rod, with the mating piece placed alongside (counterweights still attached). Note generally clean, undamaged, and lubricated surface of the #5 crankpin journal adjacent to the fracture surface.

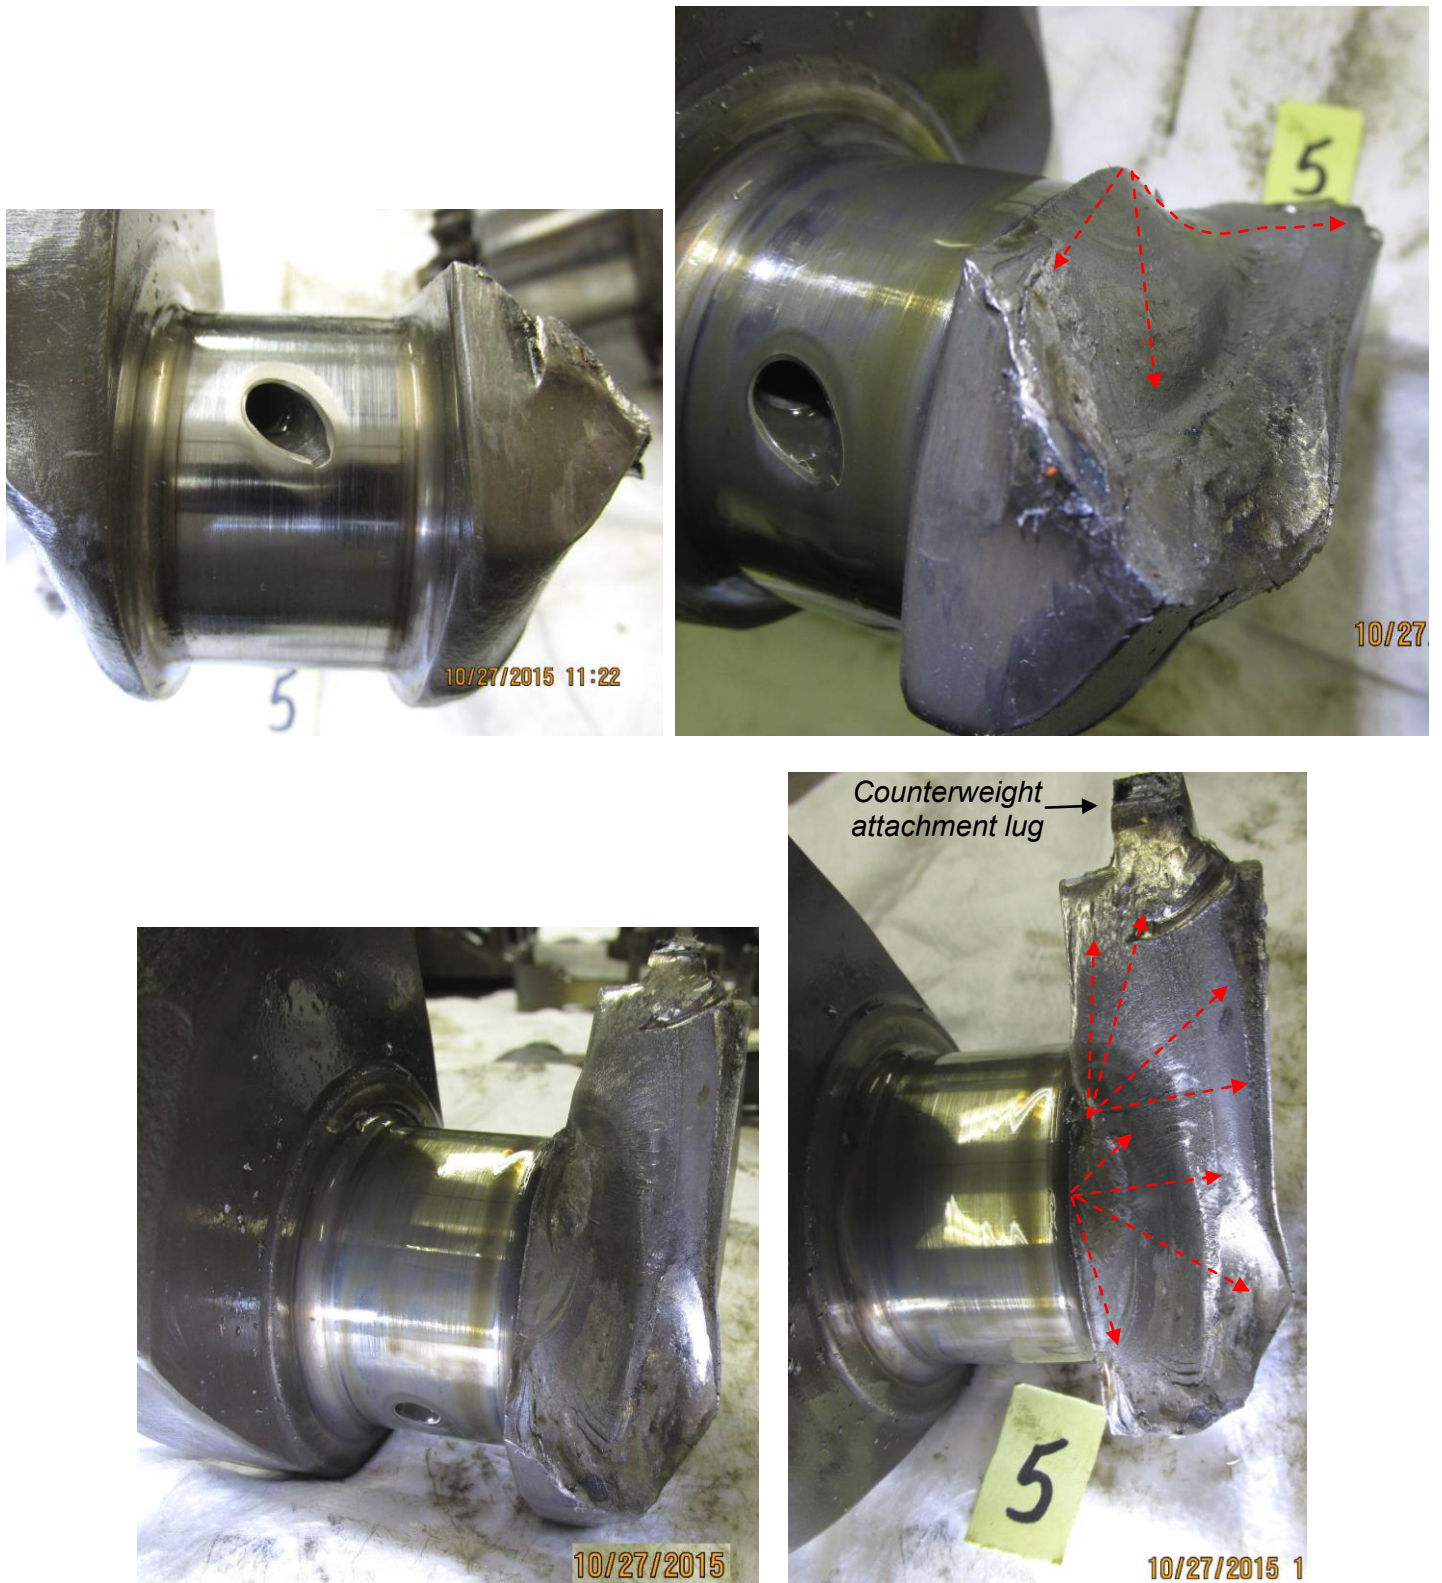
Figure 4. Fracture surface of the crankshaft adjacent to the #5 crankpin journal, viewed from four different perspectives. Journal surface was in good condition, and clearly had not experienced bearing seizure. Beach marks visible in top/right and bottom two photos, indicate fatigue crack initiation from the rear fillet radius of the #5 crankpin journal, followed by stable fatigue crack growth through nearly the entire section thickness of the #8 cheek, in directions as indicated by the dashed arrows.

Summary and Conclusions. The crankshaft failed in fatigue, with crack initiation from the rear fillet radius of the #5 crankpin journal, followed by stable fatigue crack growth through nearly the entire section thickness of the #8 cheek. Fracture surface markings indicate a likelihood of multiple fatigue crack initiation sites. Multiple origins indicate high stress conditions; however, the majority of crack growth through the #8 cheek occurred under high cycle fatigue loading, consistent with relatively lower nominal stress conditions. This cracking pattern suggests overstress conditions of relatively short duration acted to initiate the fatigue cracks. The root cause for this overstress was not determined, but it was not related to any material non-conformance. The crankshaft conformed to engineering drawing requirements for alloy chemistry, case hardness, case depth, case and core microstructure. It was slightly below the core hardness specification, but within the Lycoming MRB limits, and the slightly low core hardness is not considered relevant for this fracture. Charpy impact test bars cut from the undamaged regions of the #8 cheek were free of any honeycomb or microcrack features, indicating the steel had not been exposed to excessively high temperatures during billet forging or crankshaft forging. The crankshaft journal diameters conformed to engineering specifications. The crankshaft journals also conformed for roundness, except for the #1 and #3 crankpin journals -- these exceeded the specification tolerance for out-of-round; however, these crankpin journals were undamaged.

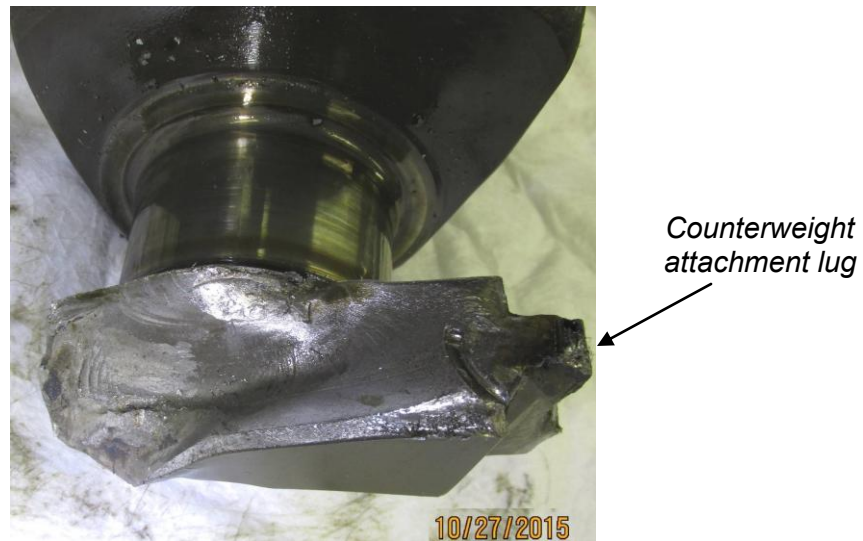
Figure 5. Additional view of the fracture surface of the crankshaft adjacent to the #5 crankpin journal, better showing the crack path from the rear journal fillet radius, through the cheek and into the counterweight attachment lug.

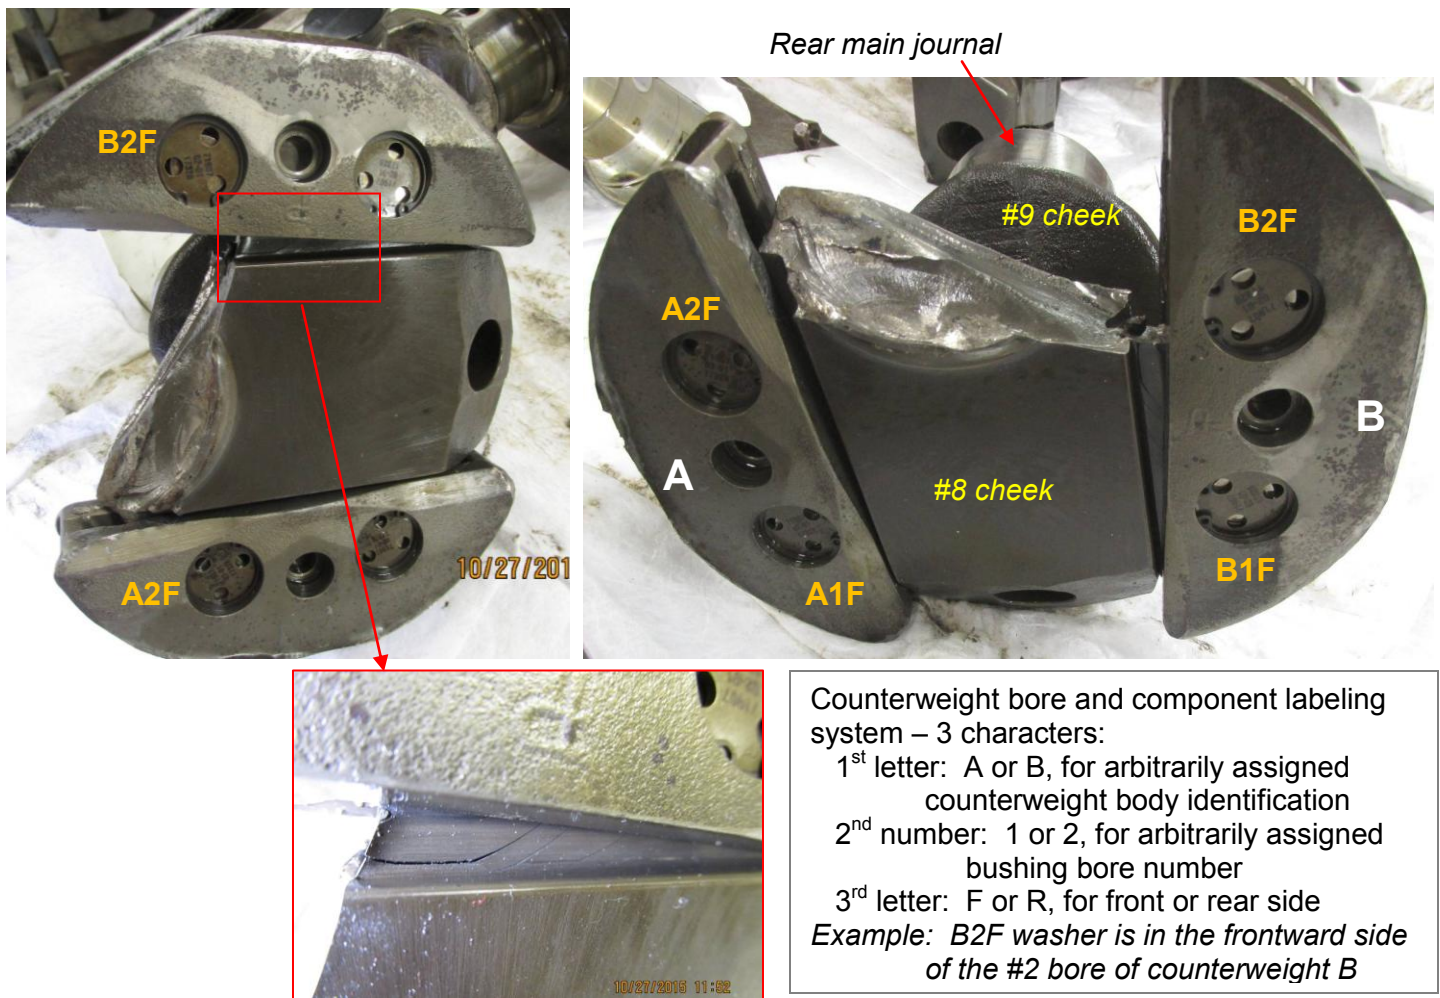
Figure 6. Mating (rear) piece of the broken crankshaft. Fracture proceeded through the #8 cheek, and out into both counterweight attachment lugs, but both counterweight assemblies and their subcomponents remained attached to the shaft. At bottom, a closer view of some secondary cracking in the counterweight attachment zone, adjacent to the main fracture surface.

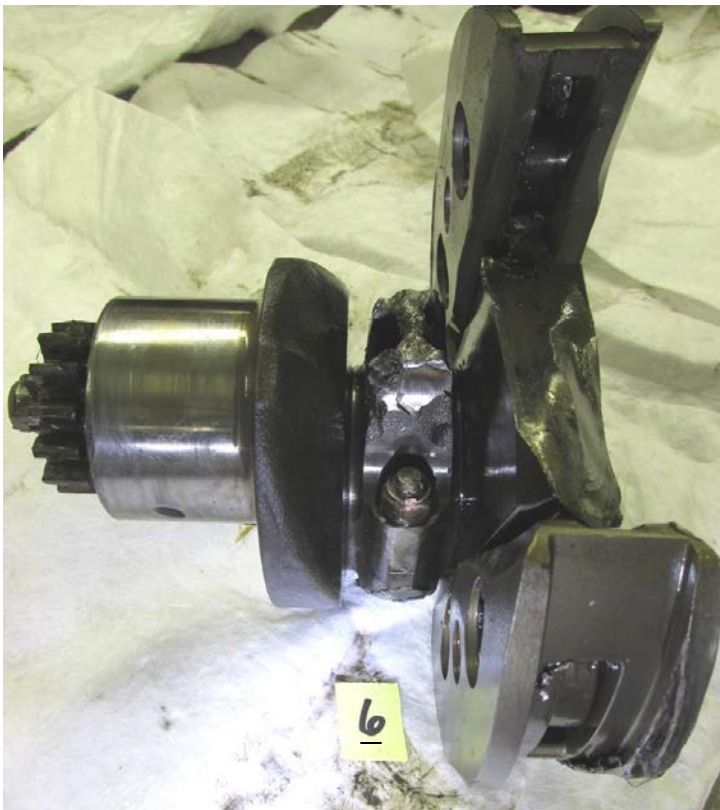
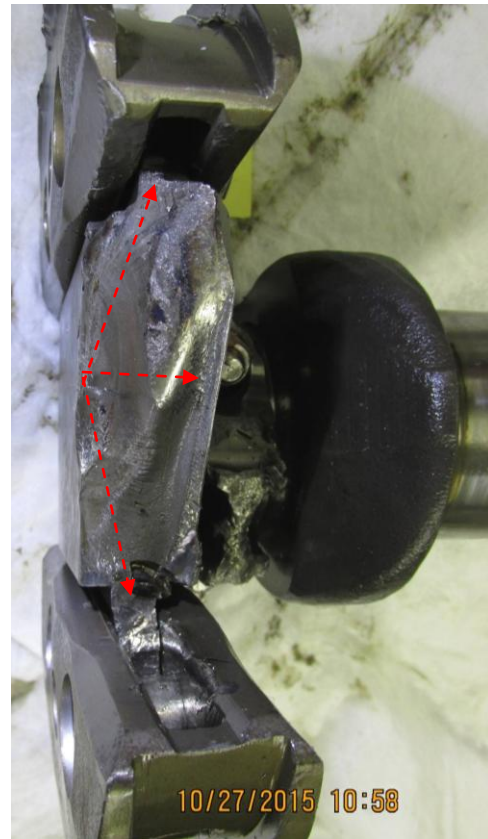
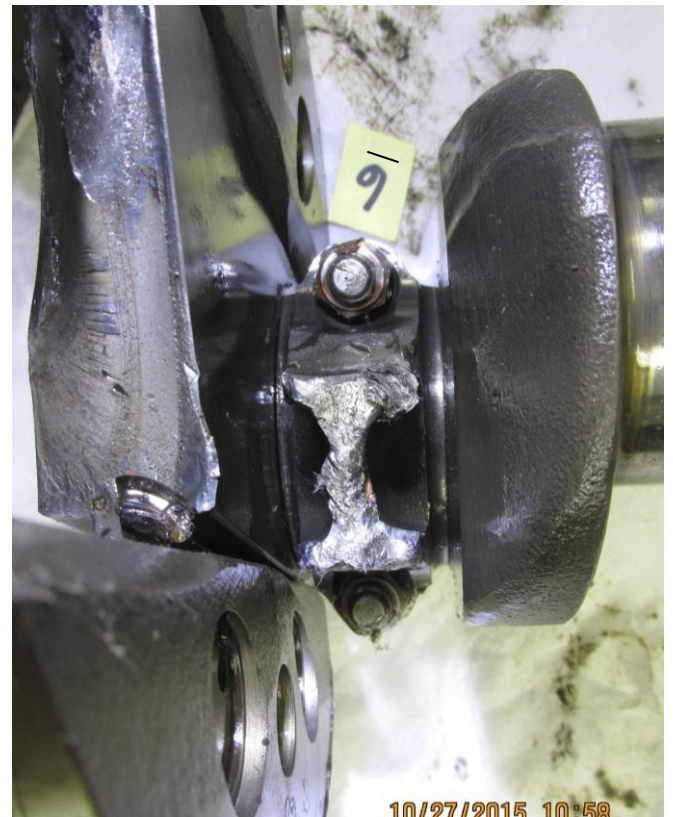
Figure 7. Mating (rear) fracture section of crankshaft, shown from three more perspectives. Top left, with #6 conn-rod cap visible, still attached. Top & Bottom/right, with #6 conn-rod's broken web section visible (and badly smashed by secondary impacts). Direction of crack growth indicated by dashed arrows.

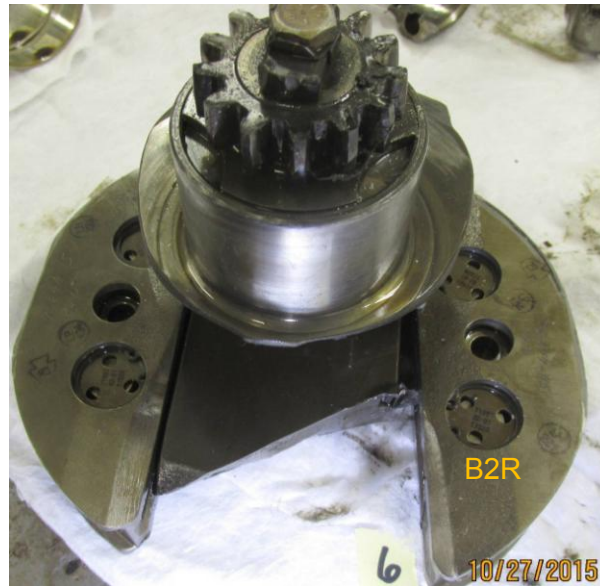
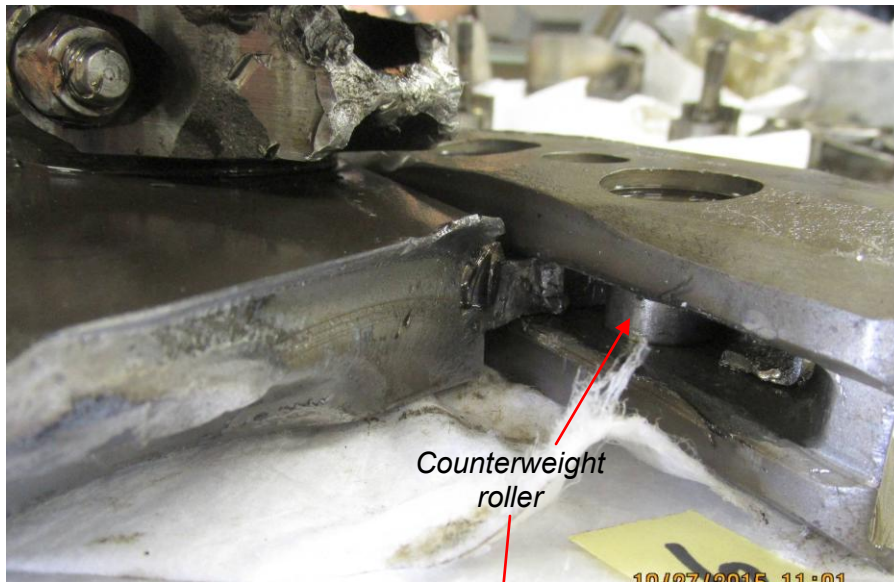
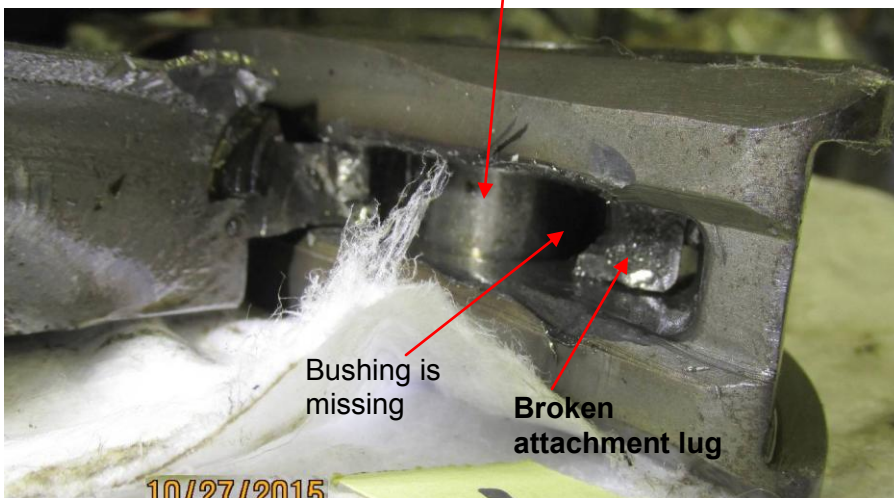
7. Counterweight Bushings (installed in crankshaft). Three of the four were still installed, and were in good condition. The fourth was missing from the broken counterweight lug (apparently released during crankshaft fracture), and not recovered. Bushings were not evaluated further.

Figure 8. Additional views of the broken rear section. At middle and bottom, two views into the counterweight attachment lug area, showing roller in place, but bushing missing from the crankshaft's lug (apparently ejected after fracture of the attachment lug).

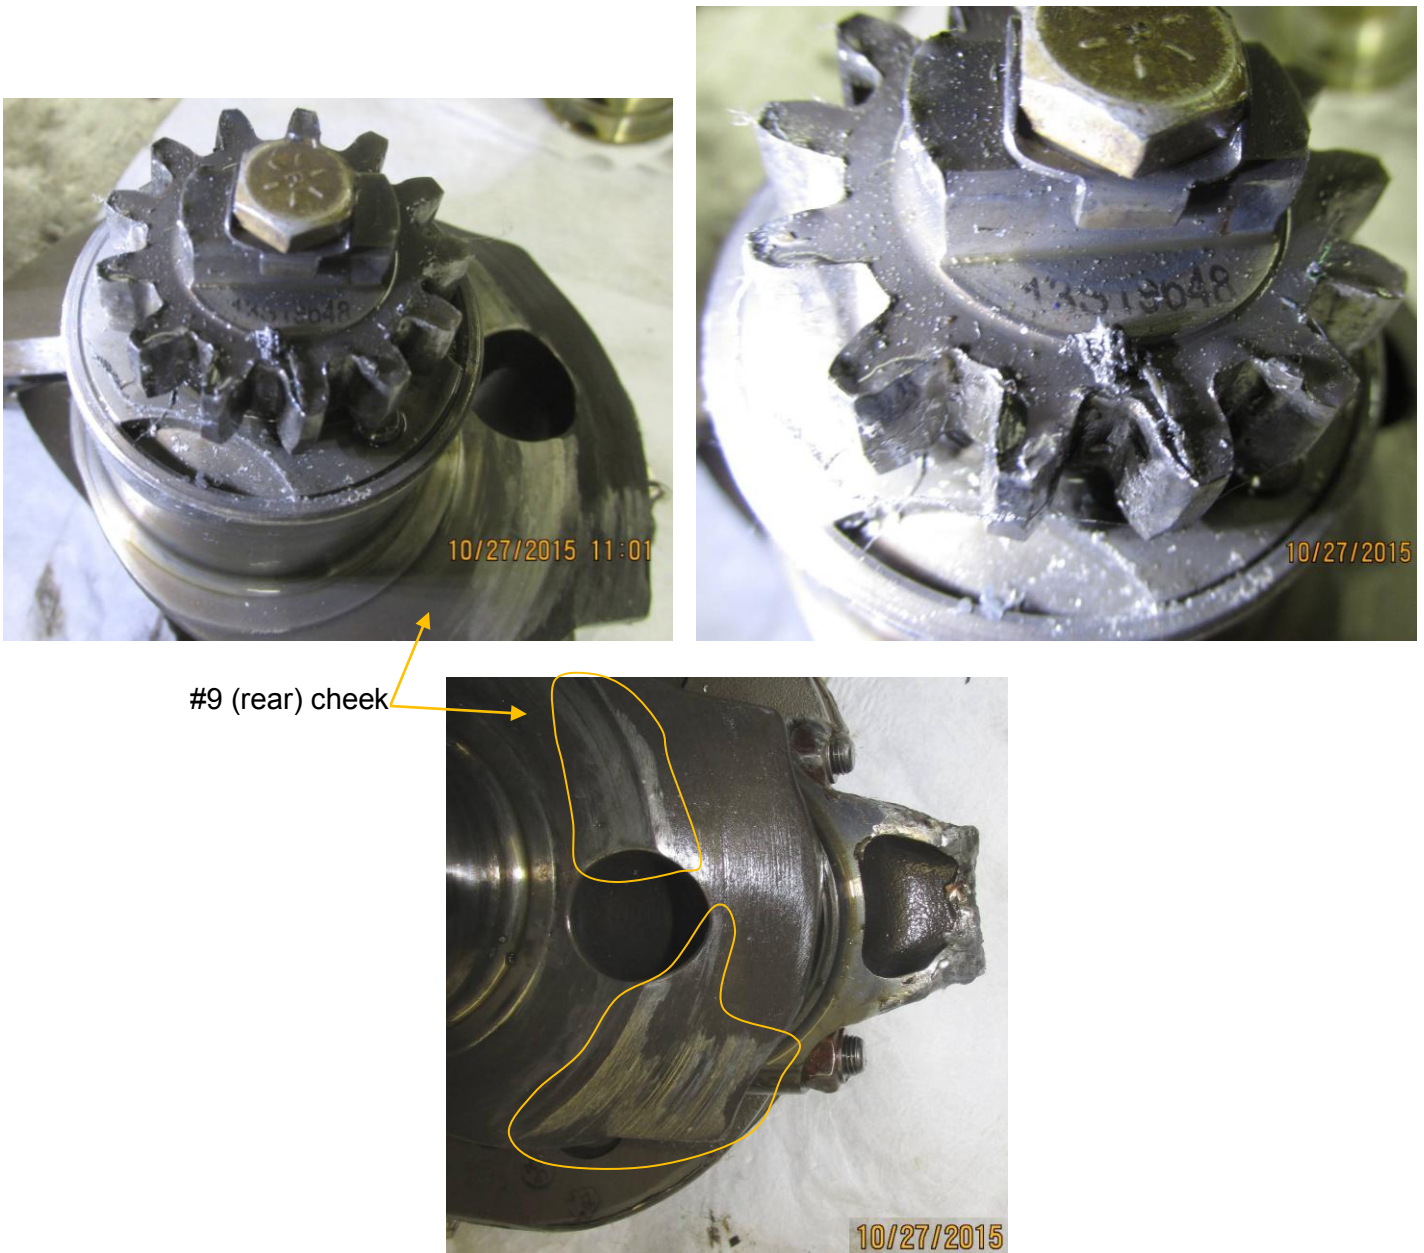
Figure 9. The rear end of the crankshaft, with gear still installed (top photos). Note severely damaged gear teeth, most likely caused by the impact with the ground. Also note, gear bolt and bolt locking plate both still installed and undamaged. Also note, in left and bottom photos, the rear side of the #9 cheek exhibits wear and scoring marks (circled), from contacting the crankcase saddle during final fracture. Broken #6 connecting rod also visible in bottom photo, with connecting rod bolts and nuts still attached tightly.

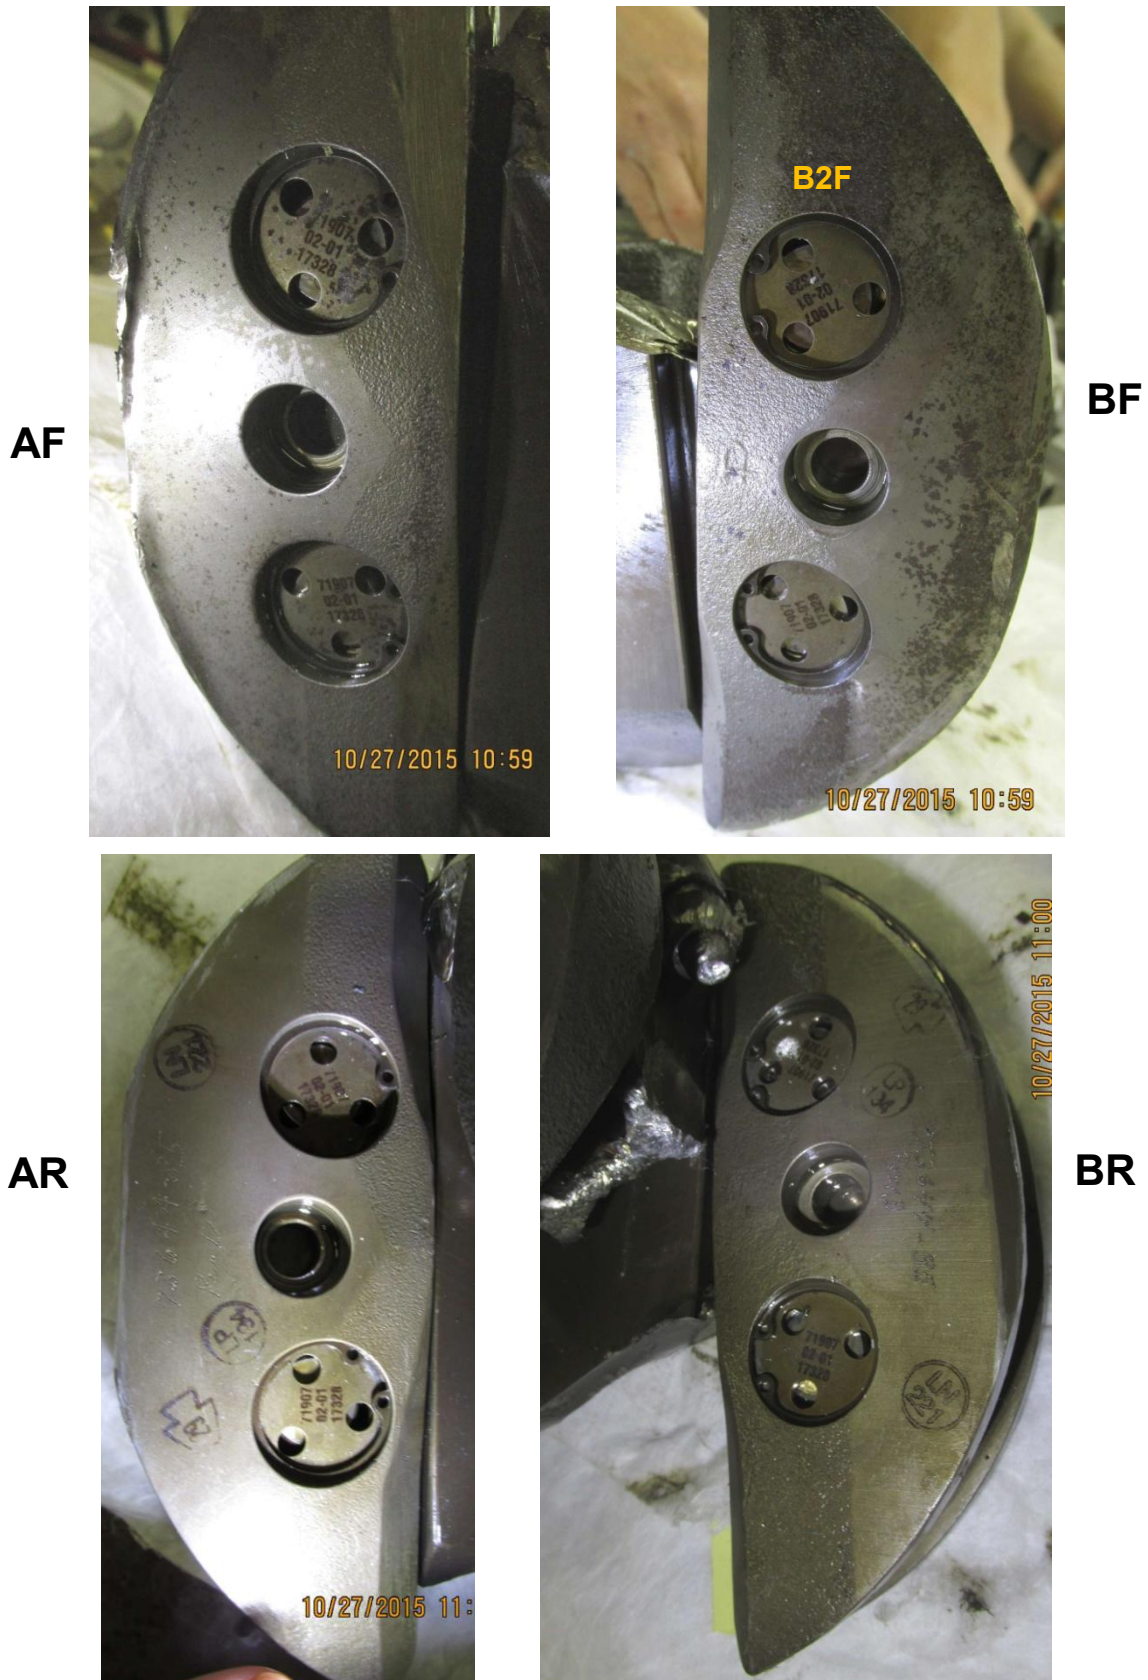
2. **Counterweight Bodies.** Both counterweight bodies were marked with part number 73644-85, Rev. D, and had ink stamps of LP194, LN-221, a keystone with a 29 inside. The counterweight bodies were intact, but had numerous impact dents and dings. The counterweight bushings, rollers, washers, and snaprings were all still in their installed positions. See Fig. 6 for explanation for the labeling system used in this report, for identifying the locations of the counterweight bushing bores and their subcomponents.

Figure 10. The front and rear sides of the two counterweight assemblies, still attached to the crankshaft. Front sides – top photos. Rear sides – bottom photos. Left photos – counterweight A. Right photos – counterweight B. Note all washers, snaprings, and rollers still attached.

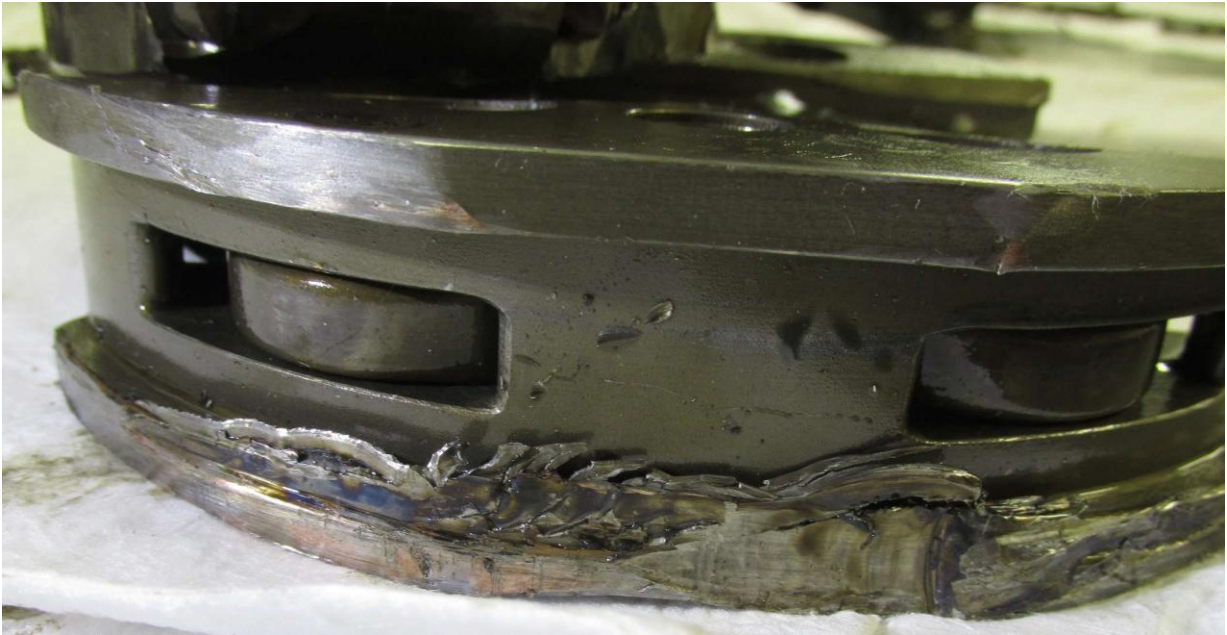
Figure 11. The outer surfaces of the A counterweight body, still attached to crankshaft. Note severe damage from contact with other engine components during final stages of fracture and/or impact with the ground.

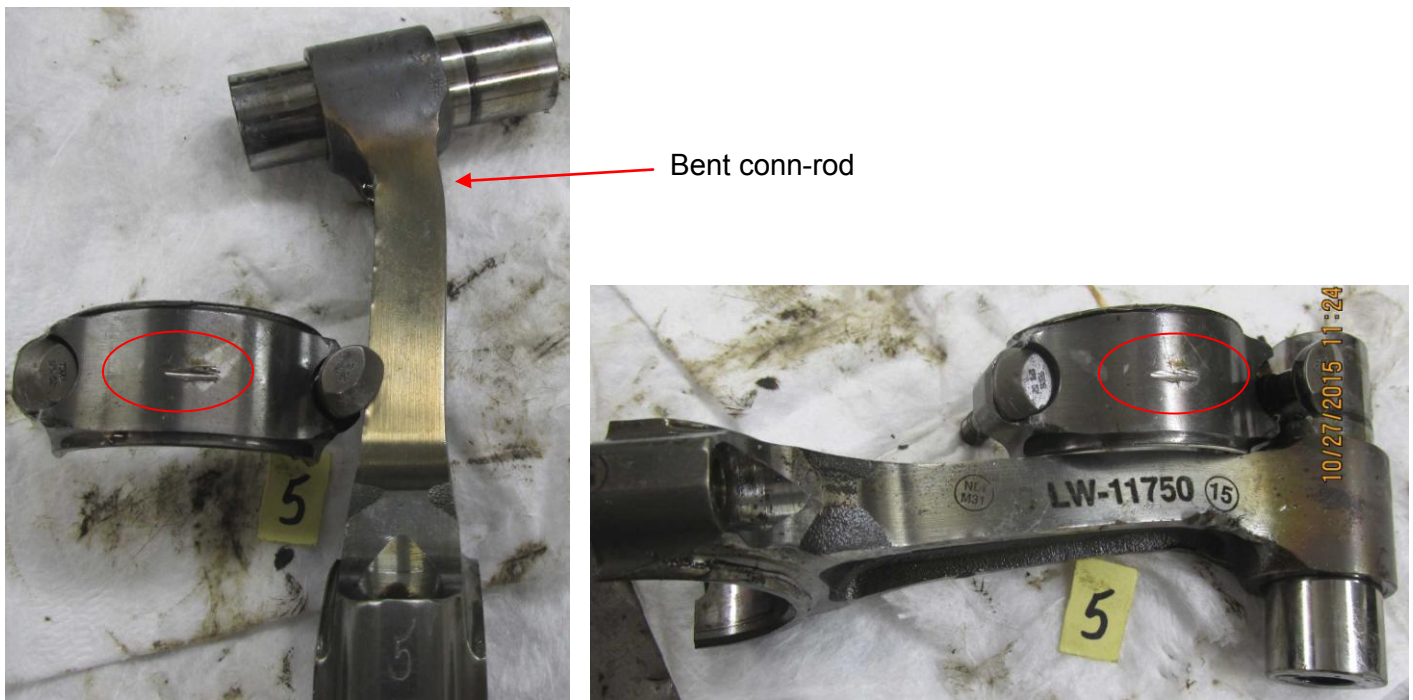
8. Connecting Rods. All were p/n LW-11750 (some were S, some were E). The #1-#4 rods were in good condition. The #5 rod was bent, and the #6 rod was broken through the web section near the crankpin bore end. That fracture surface was severely damaged from post-fracture contacts, but generally presented a rough fracture surface with pronounced shear lips, indicating it was most likely caused by sudden overload. The #5 and #6 connecting rods were most likely damaged by the fracture of the crankshaft and subsequent events. The connecting rods were not investigated further.

Figure 12. The #5 connecting rod was bent near the piston pin end, and the #5 connecting rod cap experienced a hard impact on its outer top surface (circled).

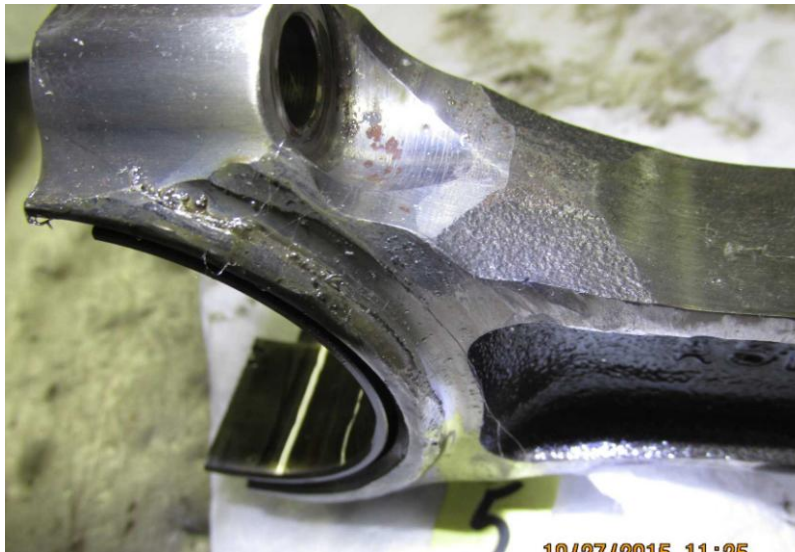
Figure 13. The #5 connecting rod's side faces were worn from contact with the crankshaft's #8 cheek thrust face, adjacent to the #5 crankpin journal. This most likely occurred during fracture, as the crankshaft's fatigue crack opening displacement grew progressively larger.

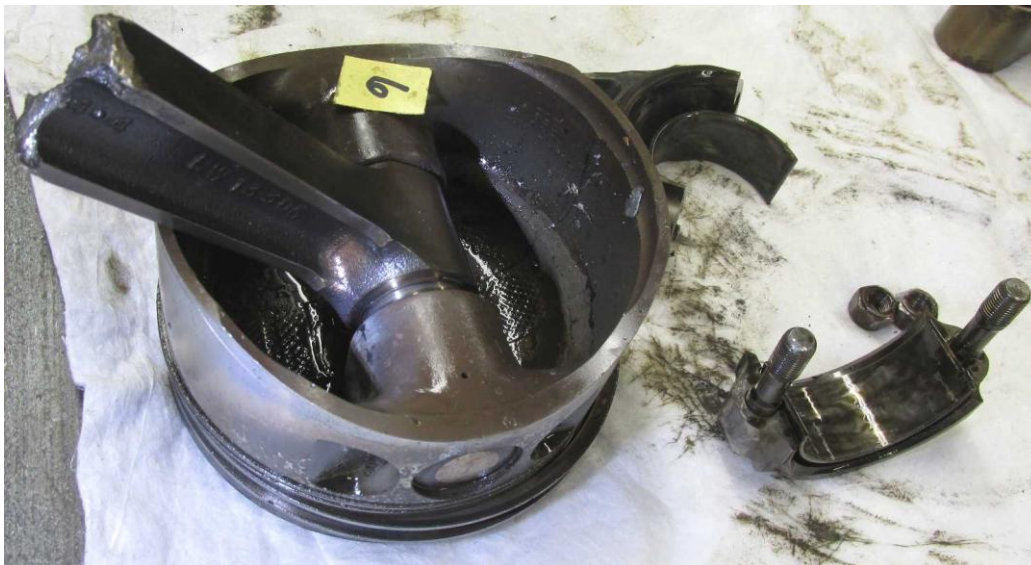
Figure 14. The #6 connecting rod was fractured through the web section, near the crankpin bore end. This fracture surface was very badly damaged from post-fracture contacts.

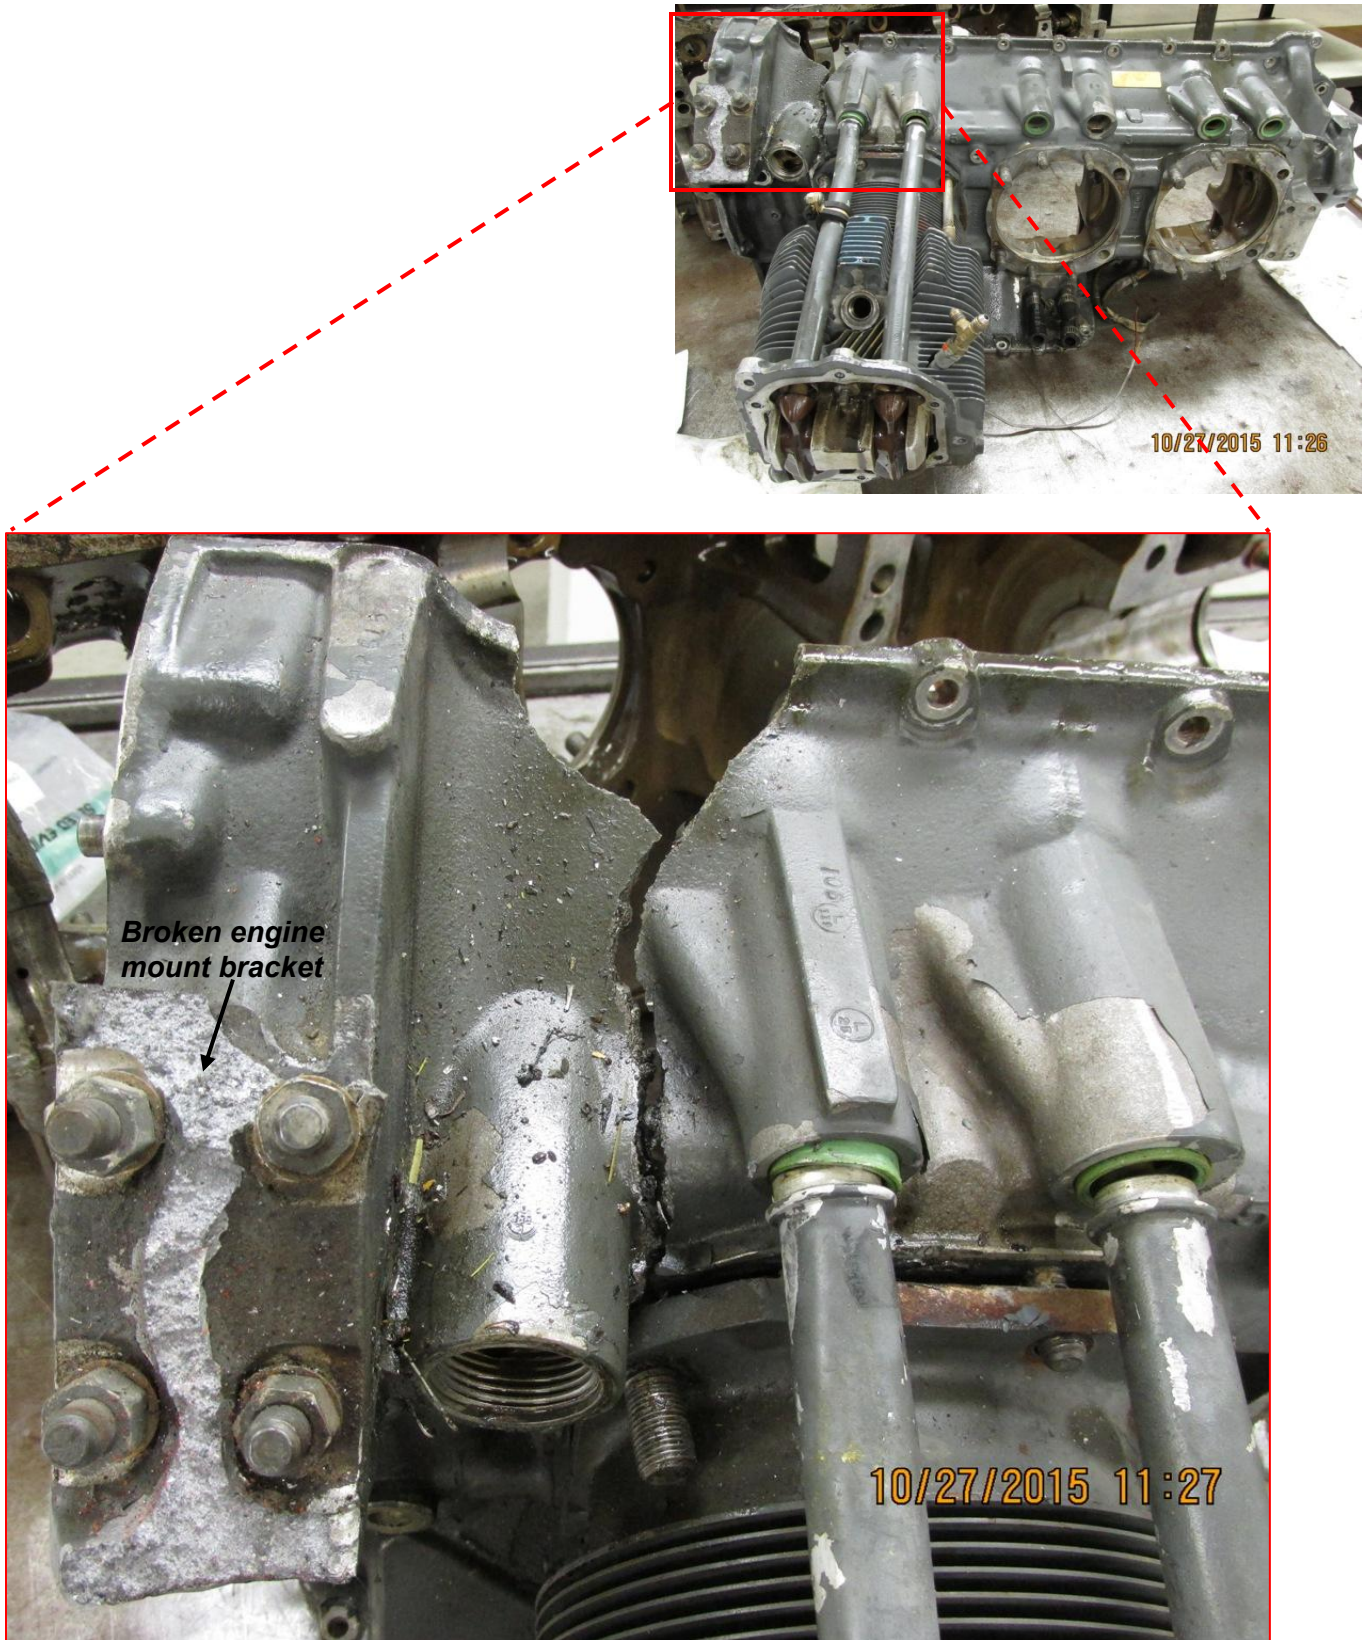
Figure 15. The right crankcase half. At bottom, closer view of the severe damage in the rear section. Note broken engine mount bracket and large cracks in the crankcase adjacent to the #5 cylinder.

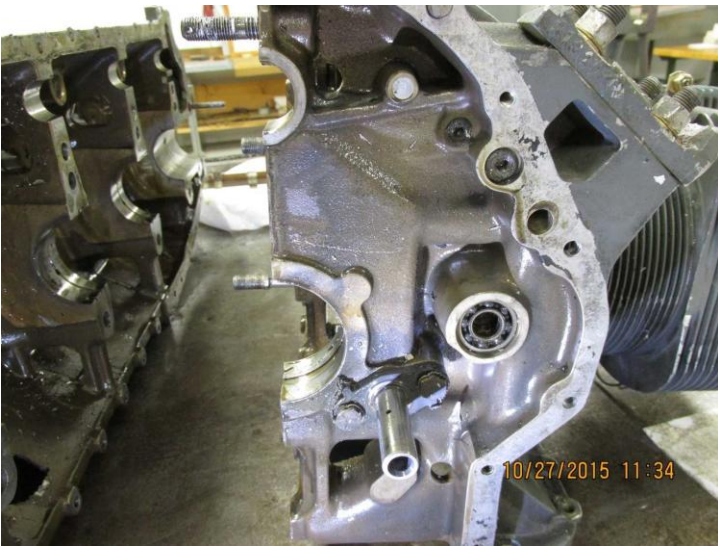
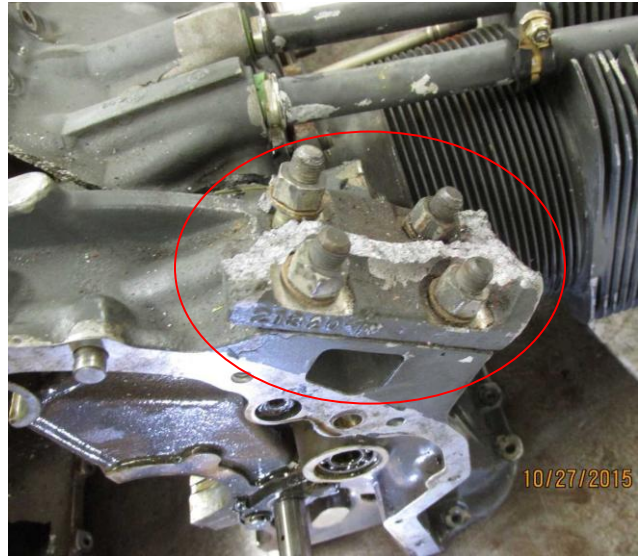
Figure 16. Rear view of the right crankcase half, and a view from different perspective, showing the broken engine mount bracket (*right, circled*).
