Technical Report

Evaluation of Crankshaft and Other Selected Components from

TIO-540-AF1B Engine (S/N L-9457-61E)

In Support of NTSB Accident Investigation ERA16FA023

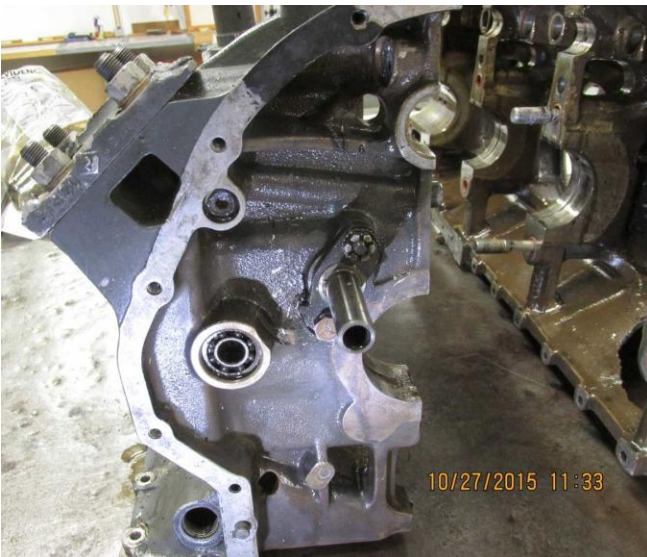
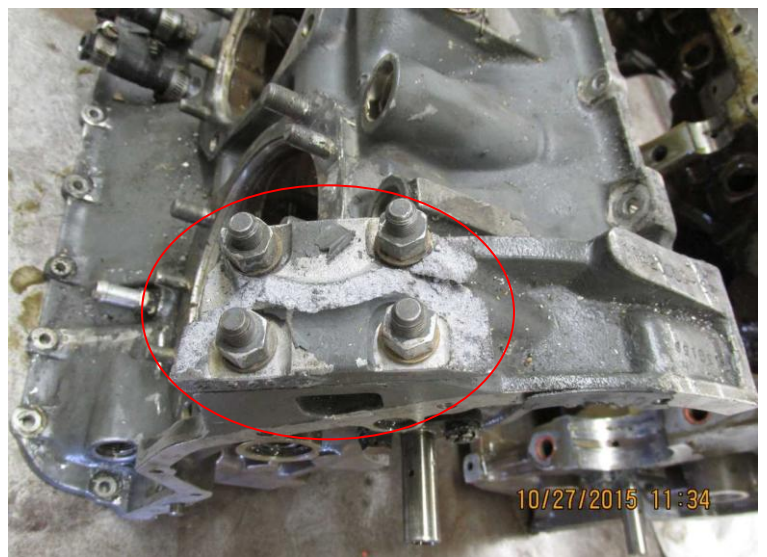
Figure 17. Rear view of the left crankcase half (left). At right, a view showing the engine mount bracket on this side was also broken (*right, circled*).

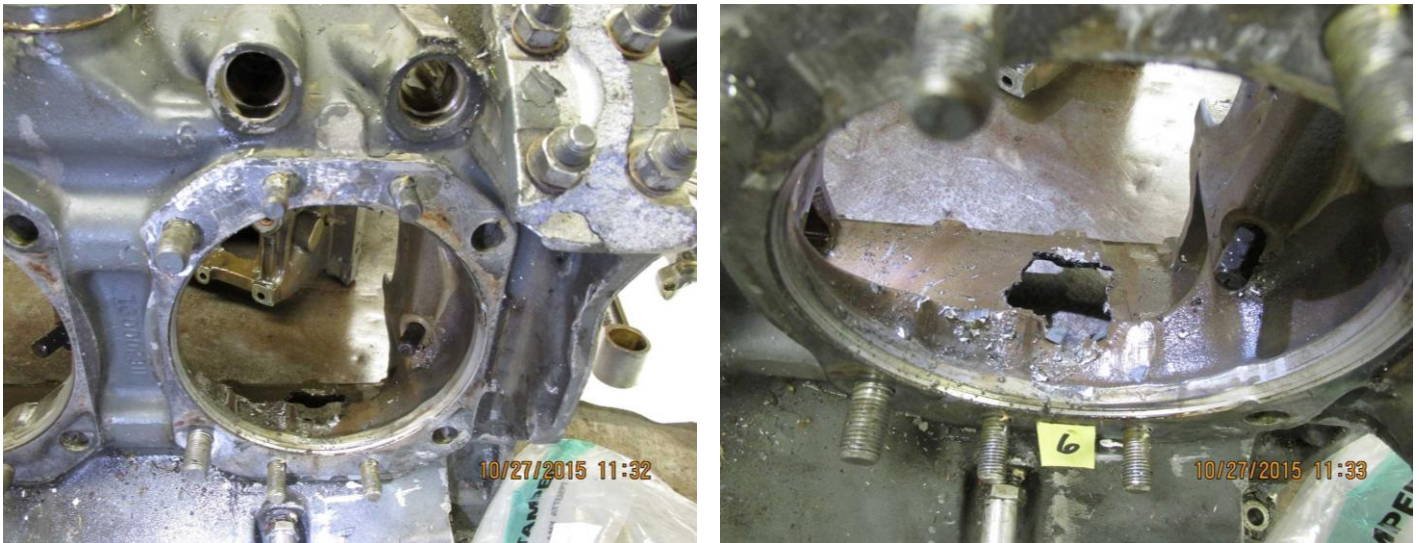
Figure 18. Two views of the #6 cylinder mounting area of the left crankcase half (note: damage visible on deck mounting surface was caused during disassembly). At right, large hole punched through the inside wall of the crankcase, by hard impact from the #6 connecting rod or other broken component.

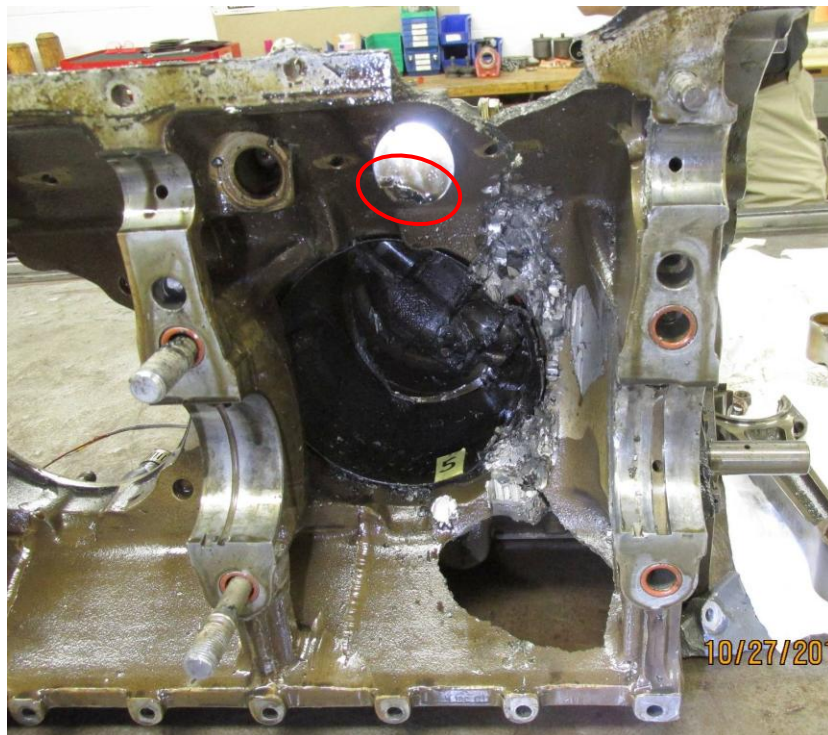
Figure 19. Inside view of the right crankcase, showing extensive damage to the crankcase walls. Also note the #5 cylinder still has the upper section of the piston stuck inside, and one of the #5 tappets has a piece broken off from its head (*circled*). See Figure 20 for additional views.

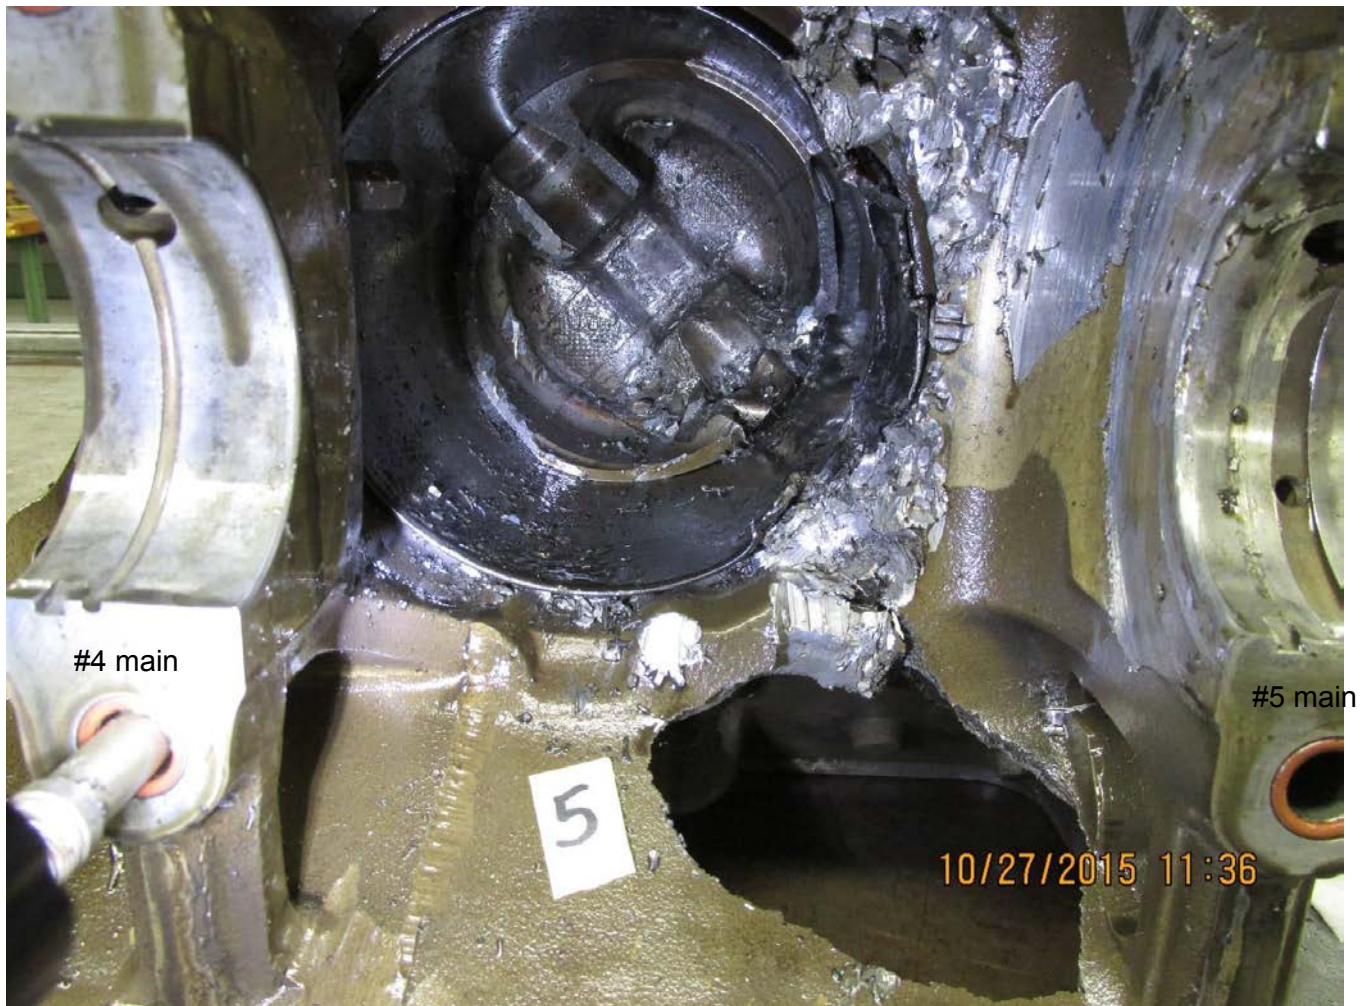
Figure 20. Severely damaged crankcase walls in the vicinity of the #5 cylinder barrel. Note damage to the #5 rear main journal support saddle (right side of photo), caused by hard contact with the crankshaft's #9 cheek. Also note the #5 piston stuck inside the cylinder, twisted from its normal installed orientation, and with several chunks ripped free by the connecting rod and piston pin (the #5 connecting rod was bent, but not broken, and still had the piston attached – see Figures 1, 2, and 12).

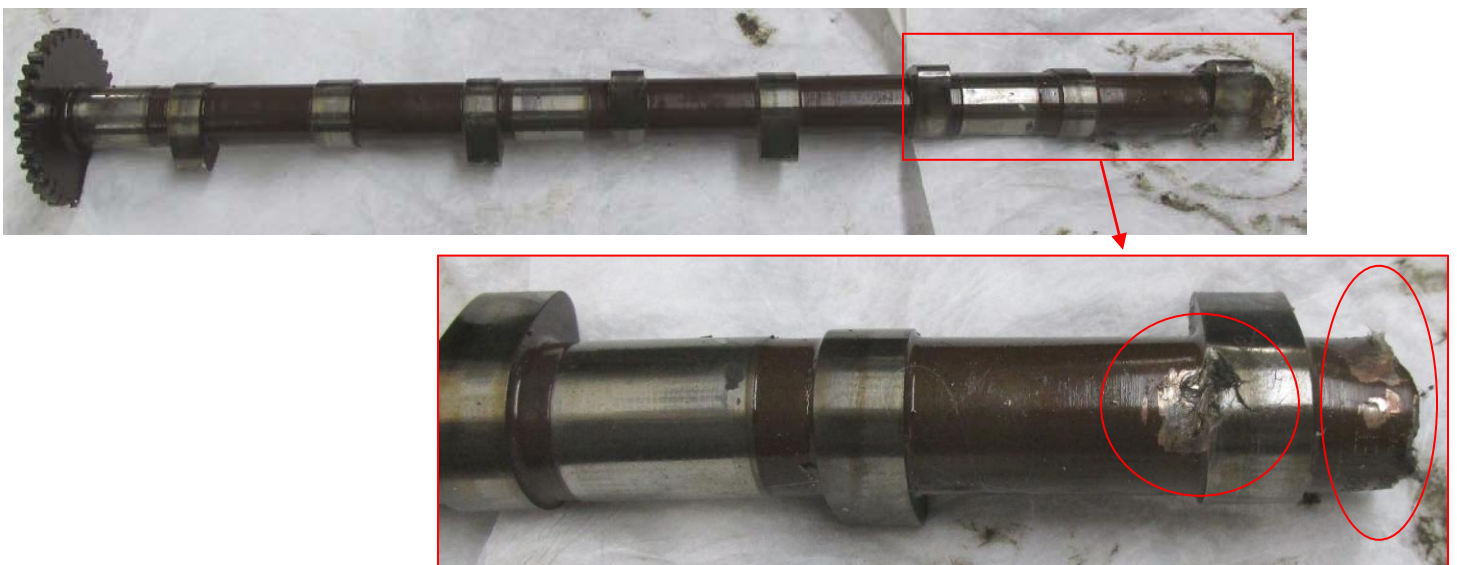
Figure 21. Broken camshaft, with hard impacts visible in several locations (circled).

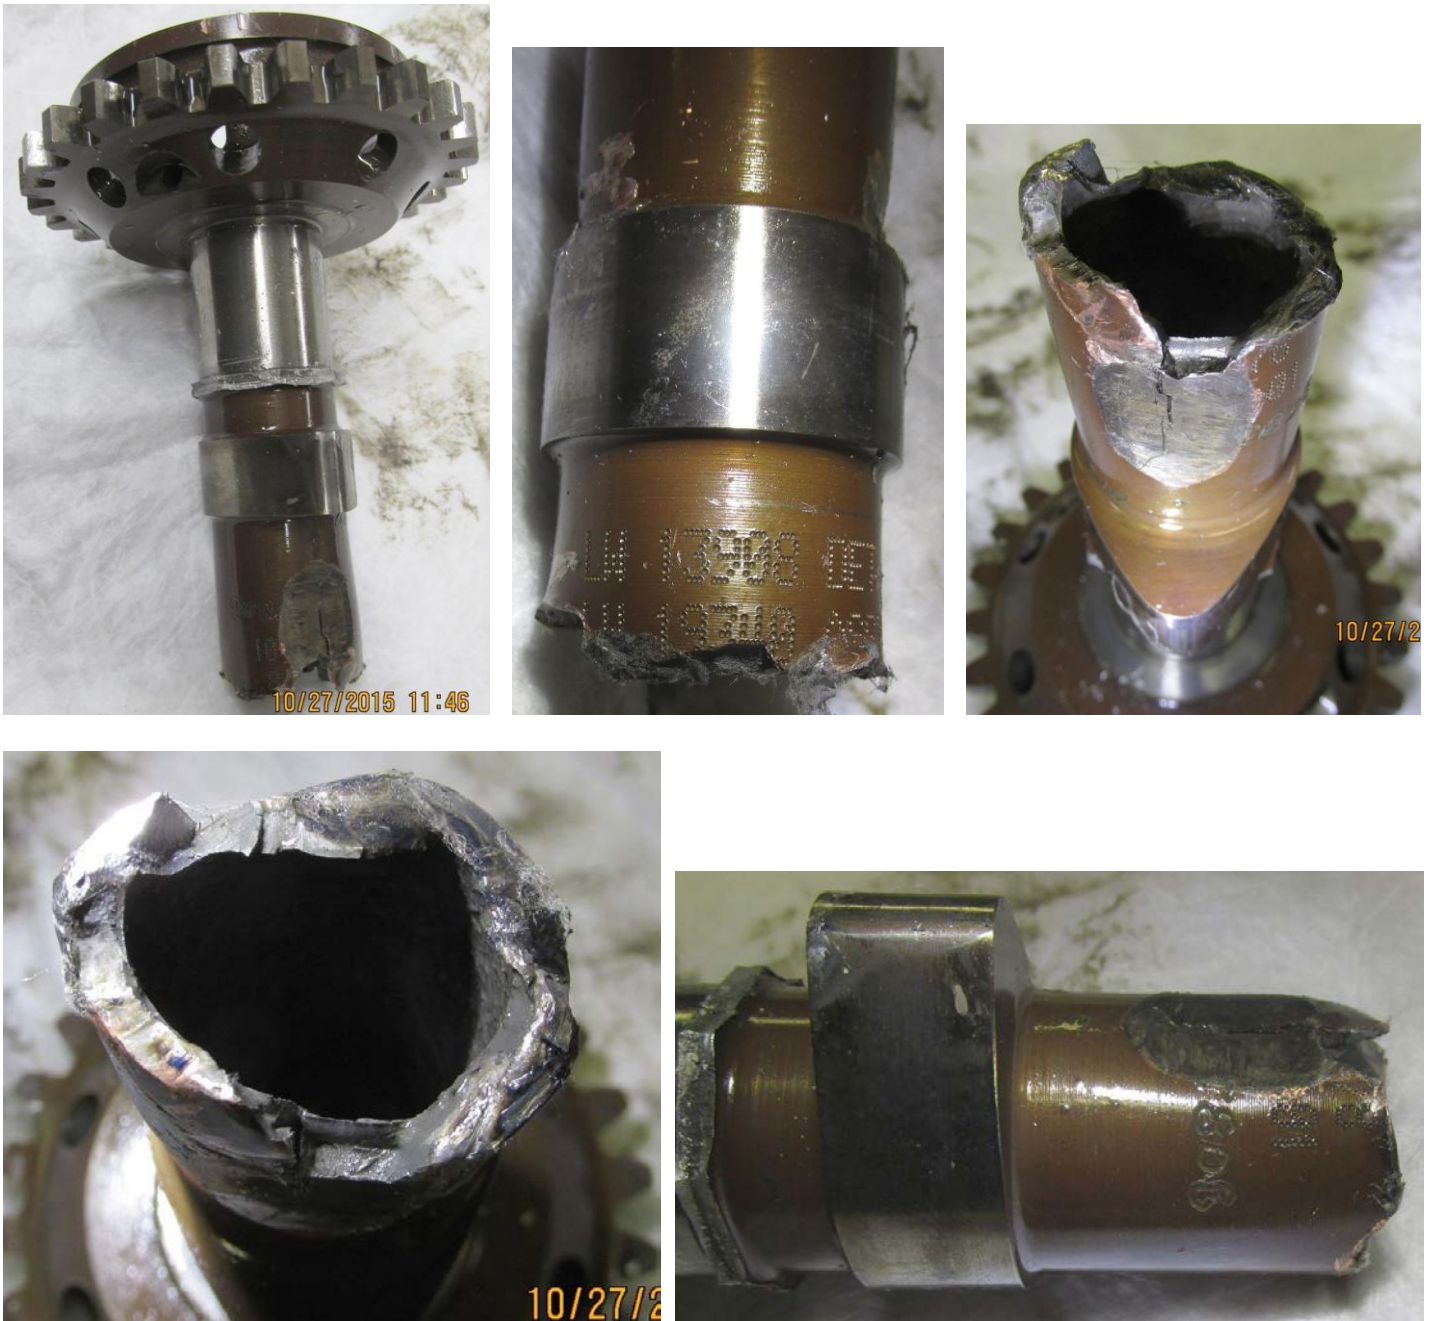
Figure 22. Mating piece of the broken camshaft, also exhibited several hard contact marks. Shaft was broken through the non-carburized region between the #5/#6 intake and the #6 exhaust camlobes. Fracture surface was completely smashed and could not be evaluated, but evidence indicates fracture was most likely caused by hard impacts from other engine components.

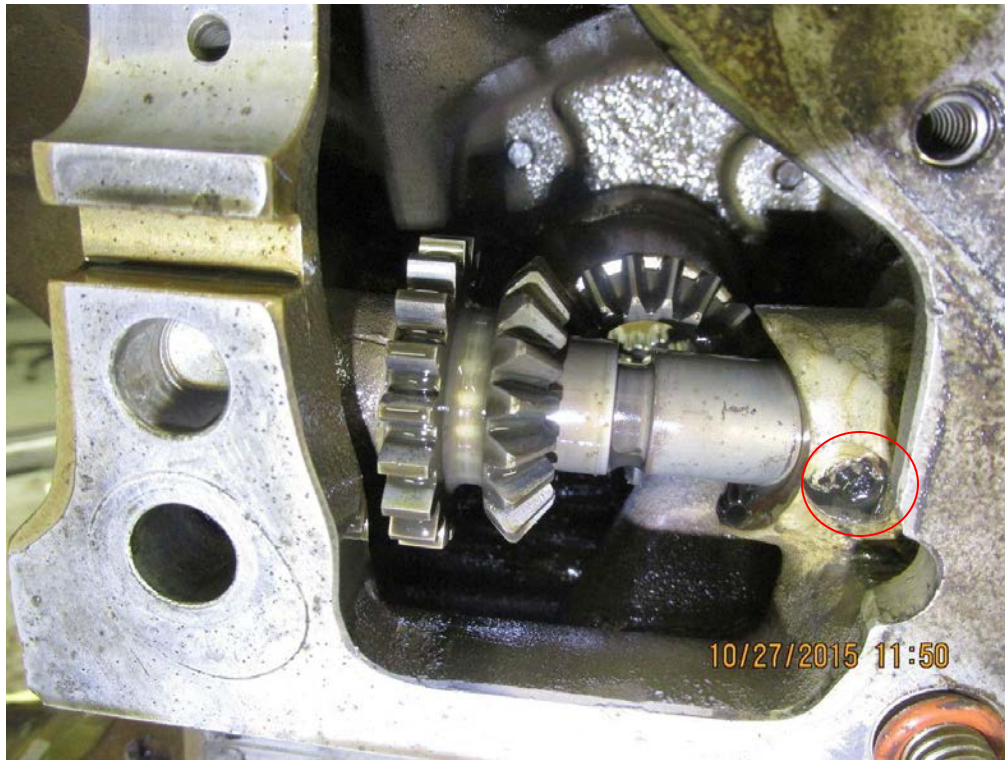
Figure 23. Propeller governor gears and shaft were in good condition, and the set screw was present (circled, with peening marks visible surrounding it, for retention).

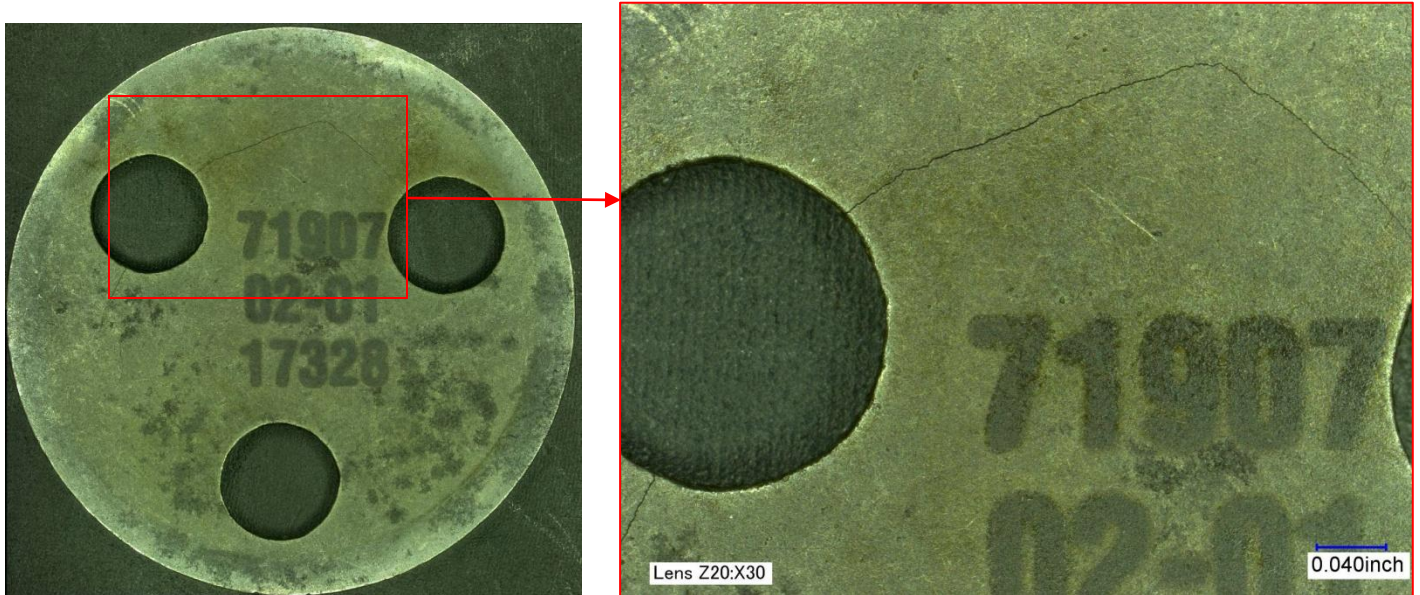
3. **Counterweight Washers.** The eight counterweight washers were all marked with part number 71907, 02-01 date code, and 17328 vendor code. All eight were cracked on their outward faces, but no pieces were broken off. Cracking appears consistent with sudden impact loading. Washers were not evaluated any further, except one was checked for case hardness, and it conformed (91 HR15N).

Figure 24. Counterweight washer AF1 (from counterweight body A, bore F1, see Fig. 6 for explanation of labeling system), displayed cracking on its outward face.

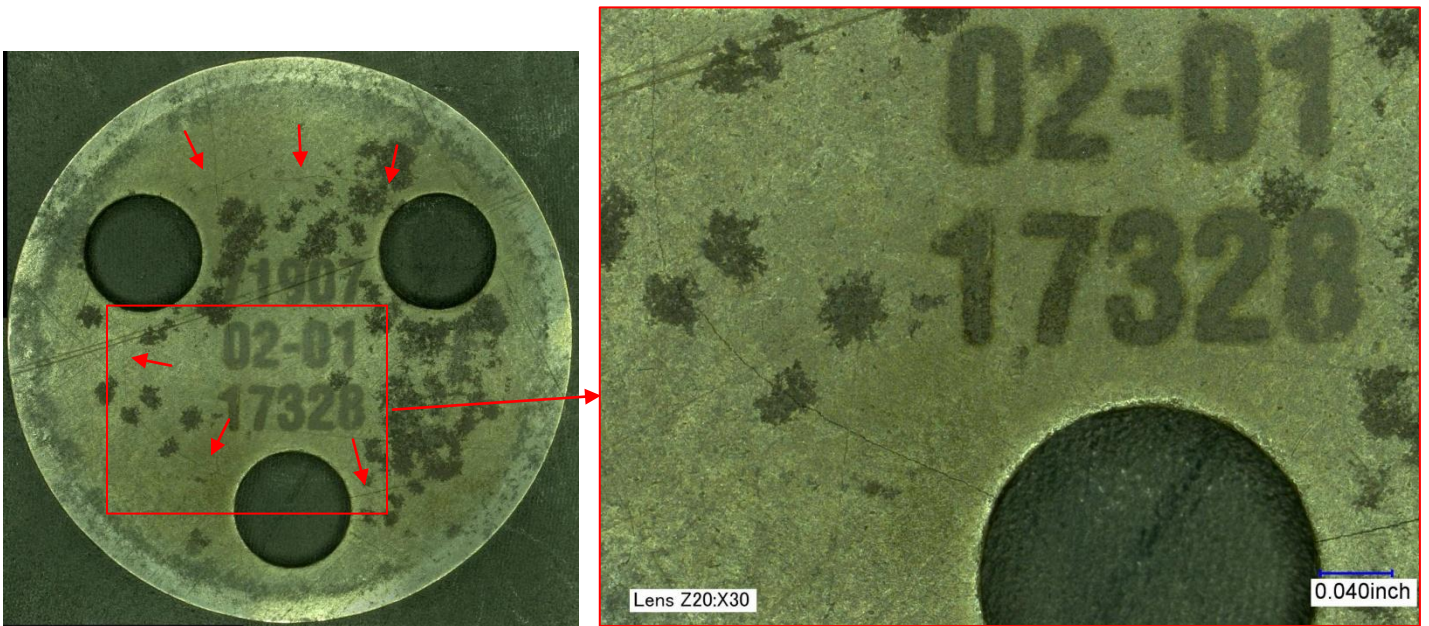
Figure 25. Counterweight washer AF2 (from counterweight body A, bore F2, see Fig. 6 for explanation of labeling system), displayed cracking on its outward face (arrows).

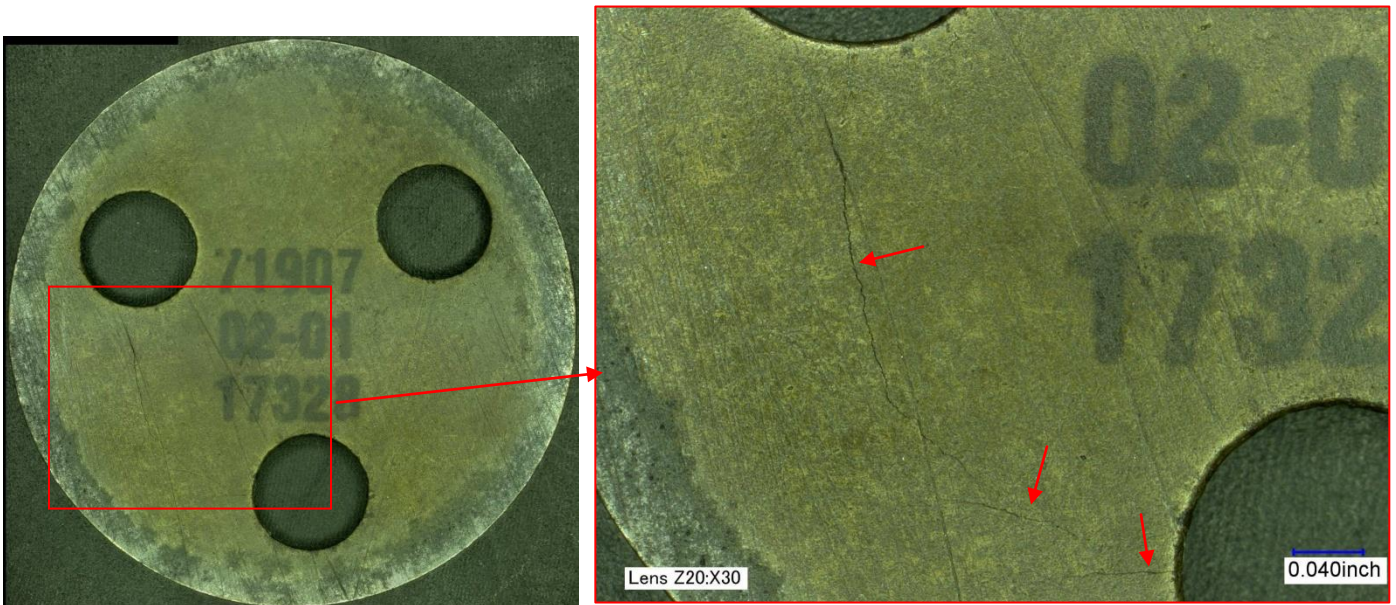
Figure 26. Counterweight washer AR1 (see Fig. 6 for explanation of labeling system), displayed cracking on its outward face (arrows).

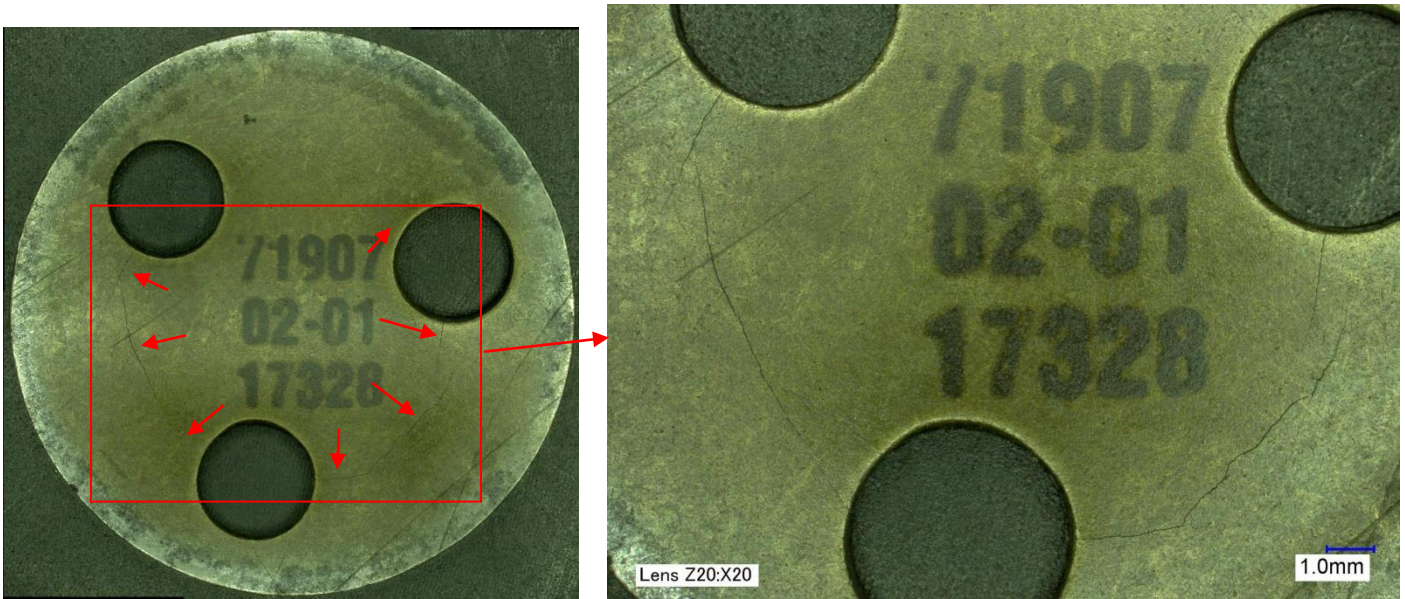
Figure 27. Counterweight washer AR2 (see Fig. 6 for explanation of labeling system), displayed cracking on its outward face (arrows).

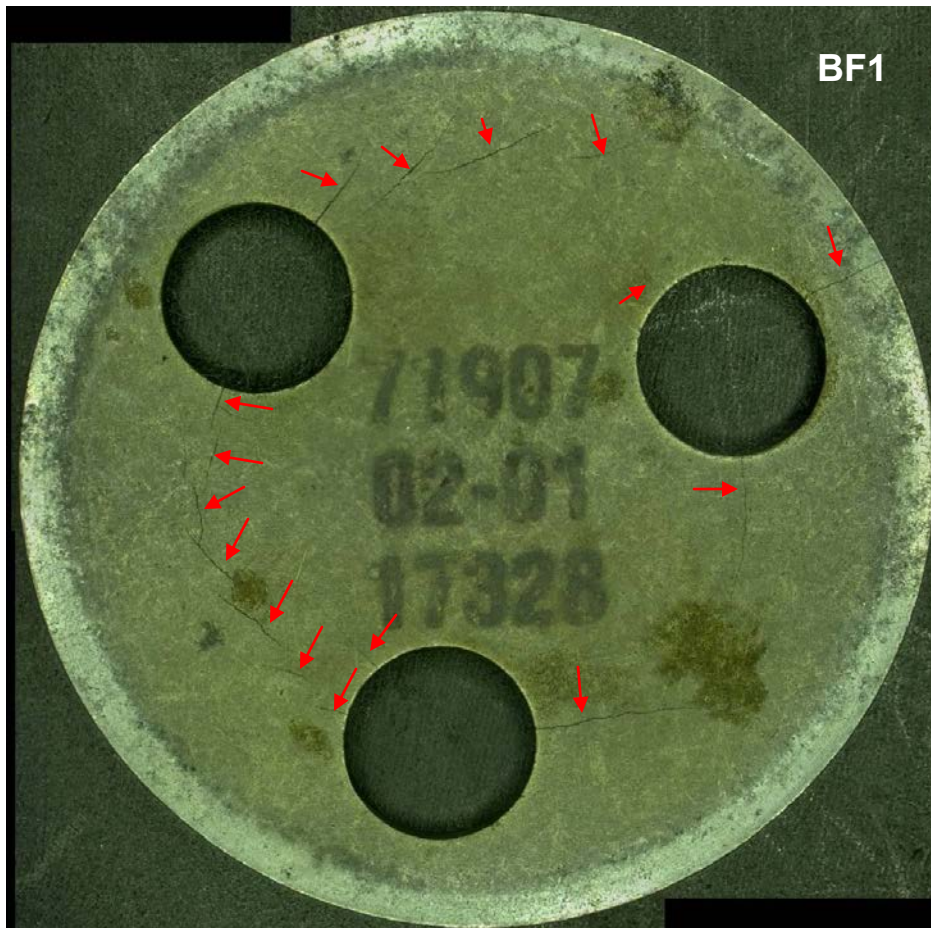
Figure 28. Counterweight washer BF1 (see Fig. 6 for explanation of labeling system), displayed cracking on its outward face (arrows).

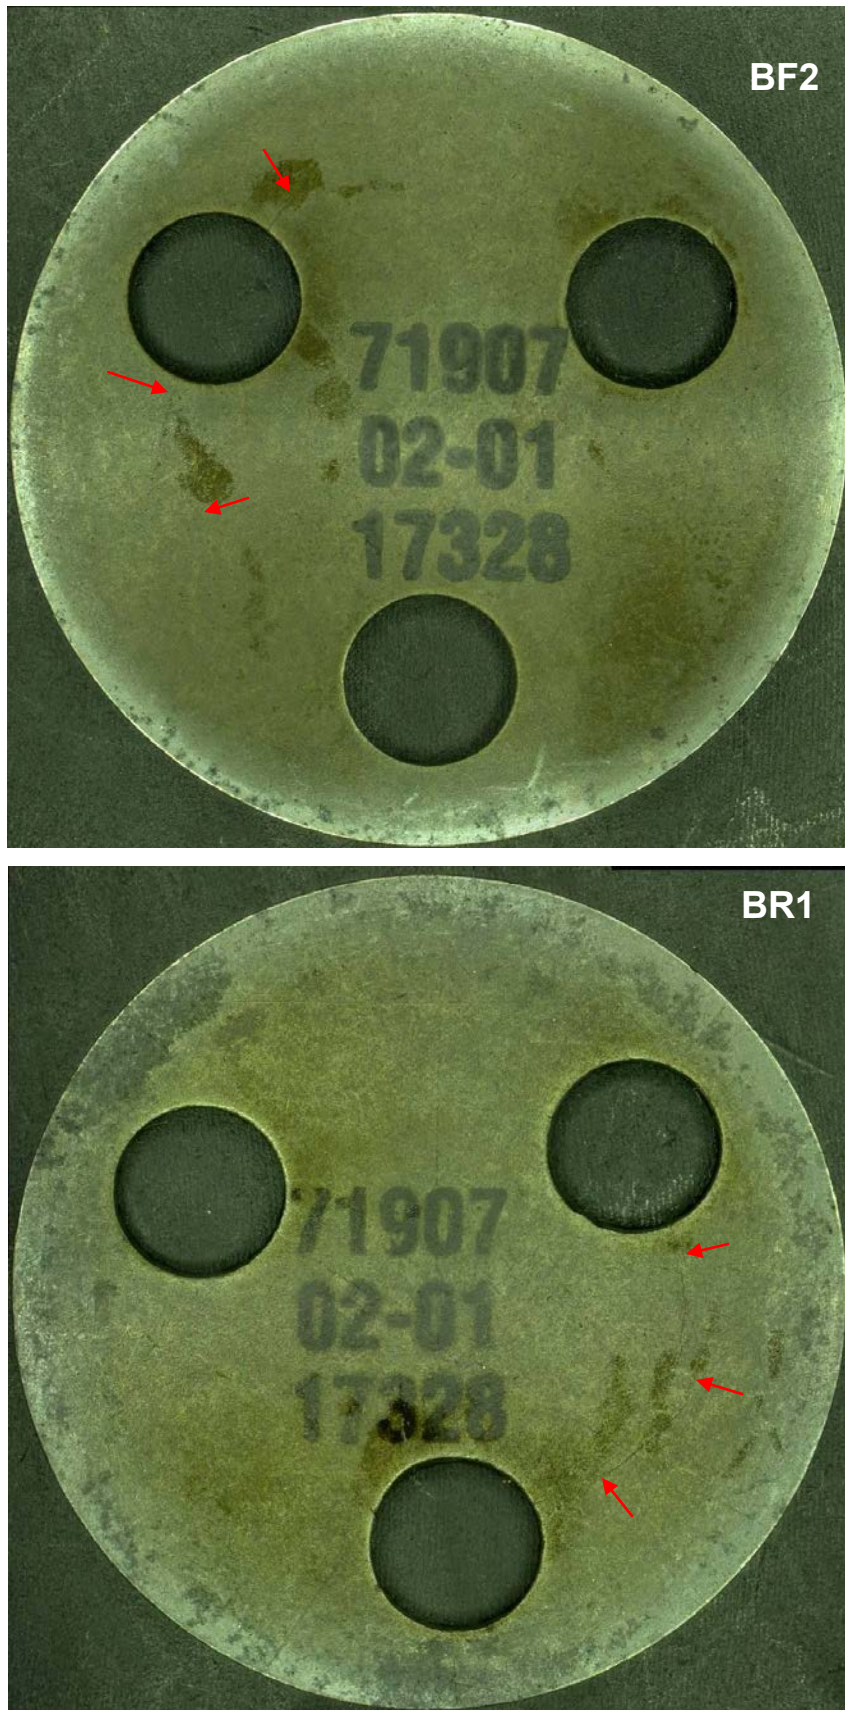
Figure 29. Counterweight washers BF2 and BR1 displayed cracking on their outward faces (arrows).

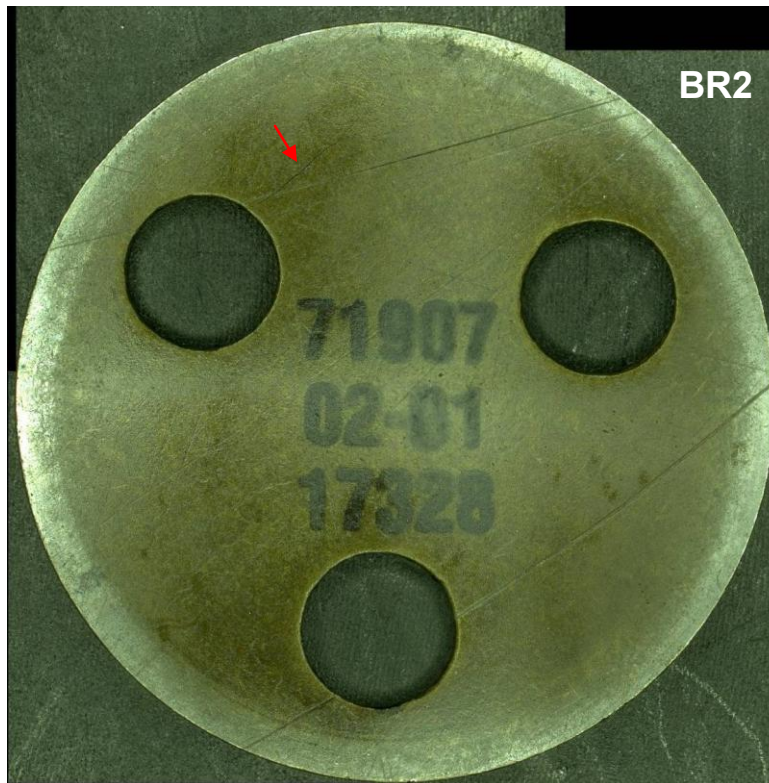
Figure 30. Counterweight washer BR2 displayed cracking on its outward face (arrows).

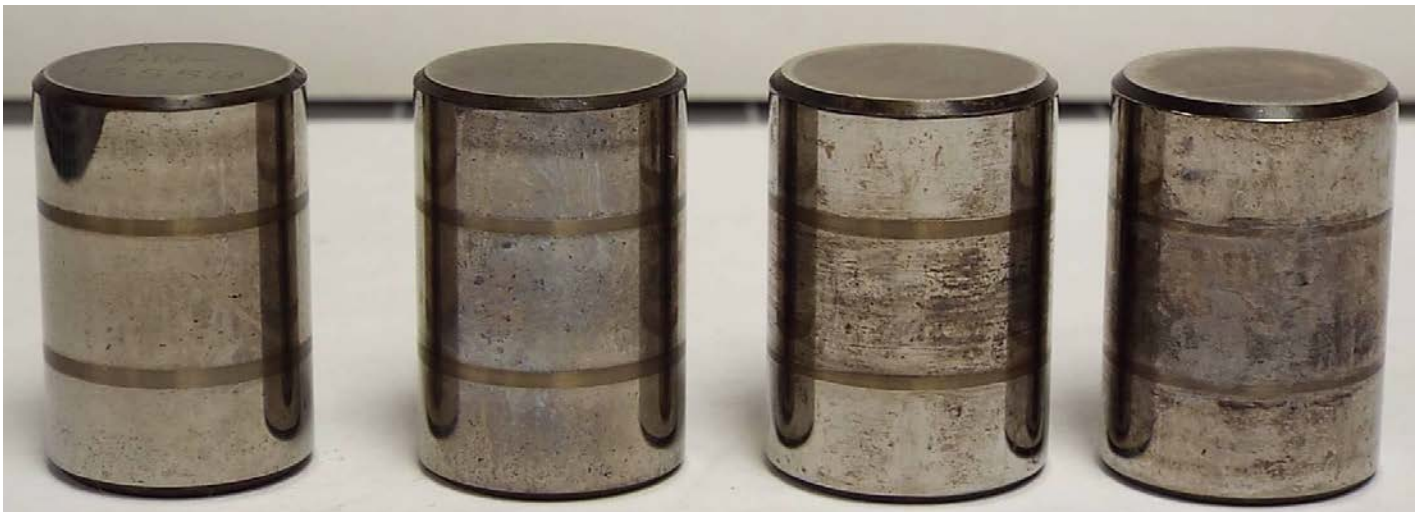
5. **Counterweight Rollers.** One counterweight had two P/N LW-15558 rollers (both marked with vendor code 79960 and date code 13-01), and the other had two P/N 76788 rollers (both marked with vendor code 7207 and date code 27-01). The rollers were all in good condition, except for moderate damage on the OD surfaces of the P/N 76788 roller that was installed where the crankshaft lug fractured and lost its bushing. Rollers all conformed for length and diameter, and were not evaluated further.

Figure 31. Counterweight rollers that were installed in bores A1, A2, B1, and B2 (left to right). Note, the crack grew into the B2 lug, releasing the crankshaft's bushing, and causing some wear on the B2 and the B1 rollers. Otherwise, all four rollers were in good condition.

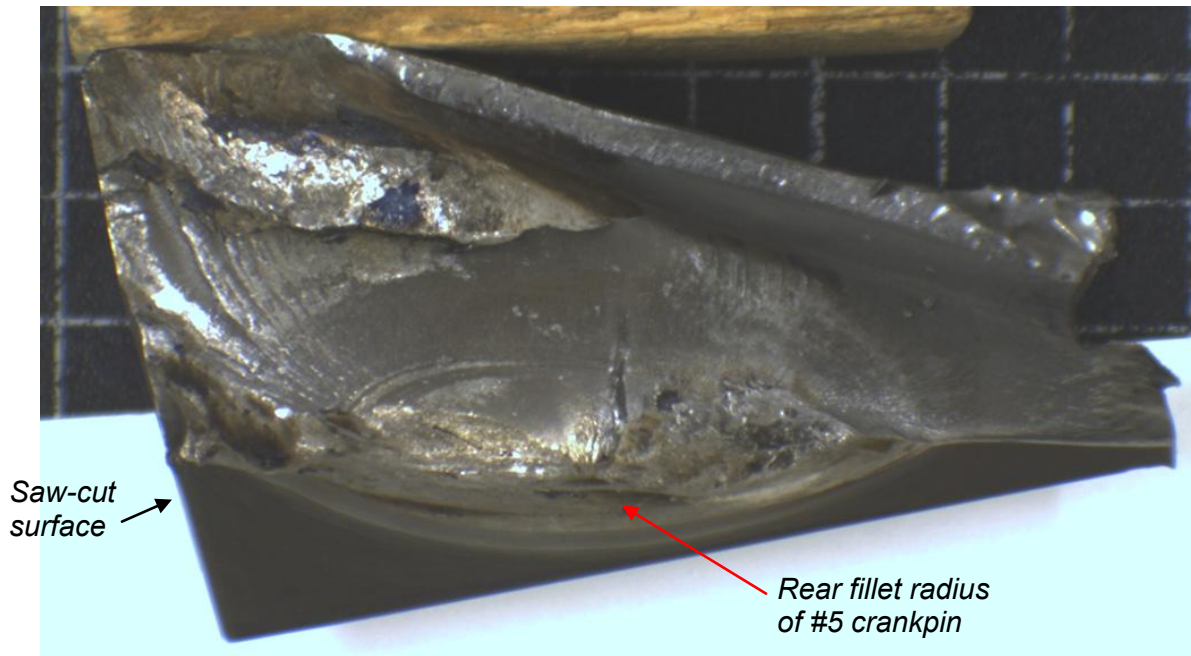
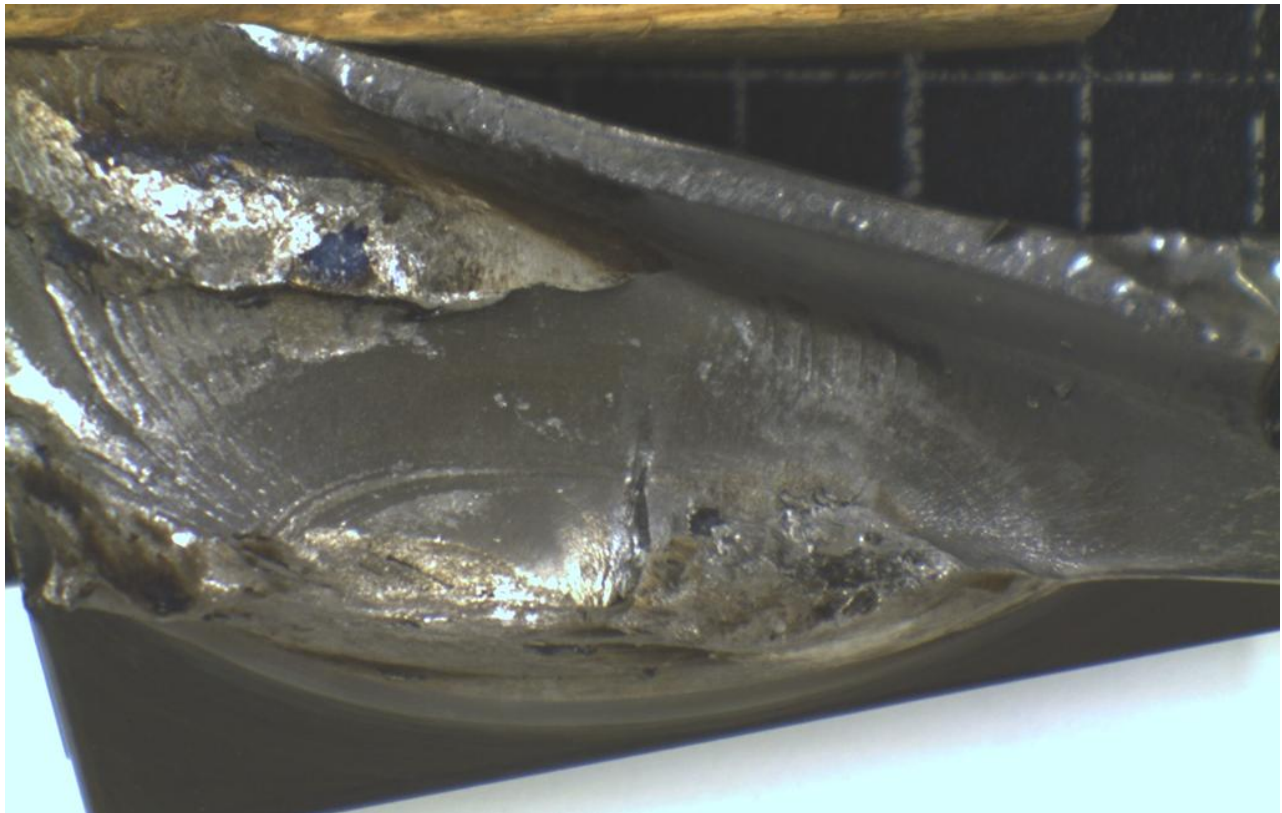
Crankshaft Fracture Surface Examination. The rear piece of the crankshaft was sectioned with a bandsaw, then an abrasive cutoff saw, to remove the fracture surface for easier examination under stereo-optical microscope. Fracture surface displayed beach marks, indicating fatigue crack initiation from at least one origin (and possibly 2-3) on or near the rear fillet radius of the #5 crankpin journal. The crack then propagated under fatigue loading conditions, through nearly the entire section of the #8 cheek and outward to the counterweight attachment lugs. The fracture surface and nearby thrust face were badly damaged by post-fracture contacts, in the immediate vicinity of the crack origin(s). See Figures 32-36. Examination of fracture surface in SEM did not reveal any additional information.

Figure 32. Crankshaft fracture surface, displaying beach marks indicating fatigue crack initiation near the rear crankpin journal fillet radius, from at least one and possibly two or three origin sites. See Figure 33 for closer views of the origin area. *White gridlines = 1 cm.*

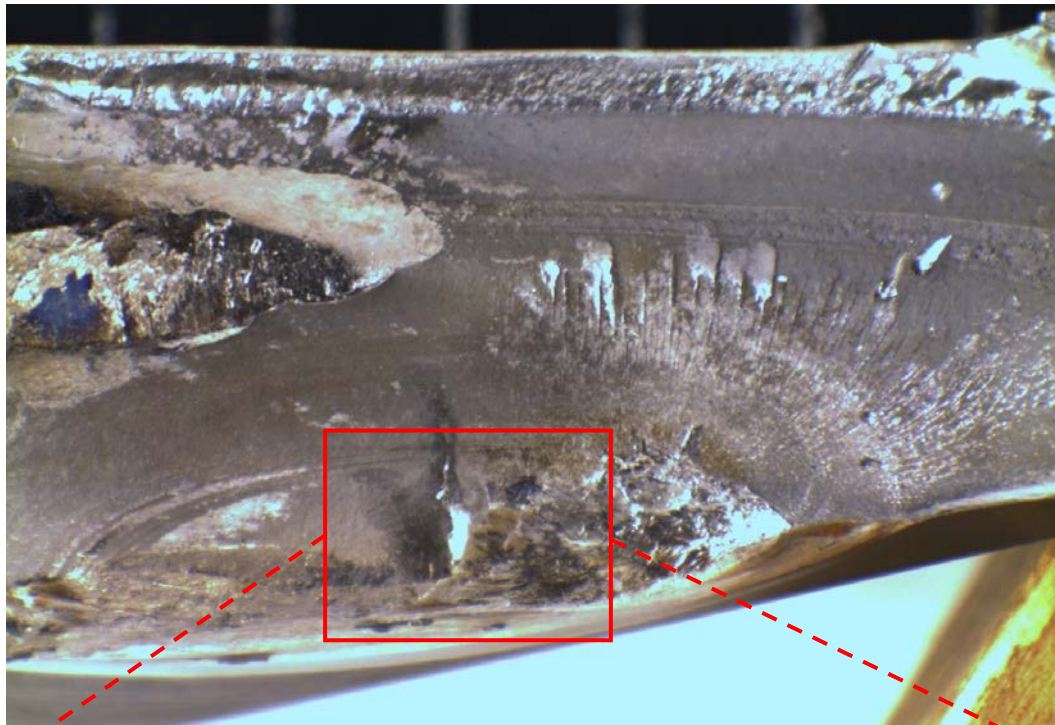
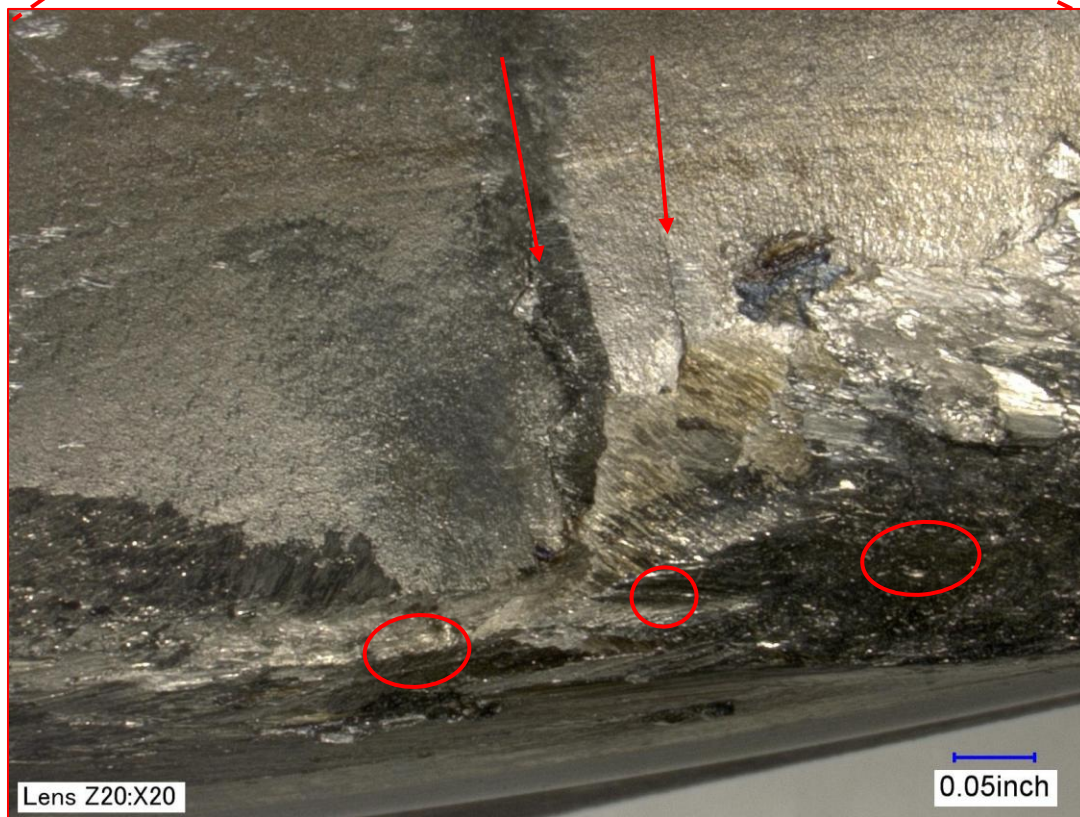
Figure 33. Closer views of the crankshaft's fatigue crack origin area. The badly damaged surfaces prevent determination of the exact crack initiation site(s), but the curvature of the beach marks and presence of two possible ratchet marks (*arrows*), indicate the possibility of three separately initiated fatigue cracks, all near each other, at or just below the crankpin journal fillet radius, at approximate locations circled. Three origins would indicate crack initiation under conditions of high local stress or short-time high stress excursions; and the generally flat, smooth macroscopic appearance of the fatigue crack surface indicates propagation under relatively low nominal stress (low stress, high cycle fatigue).

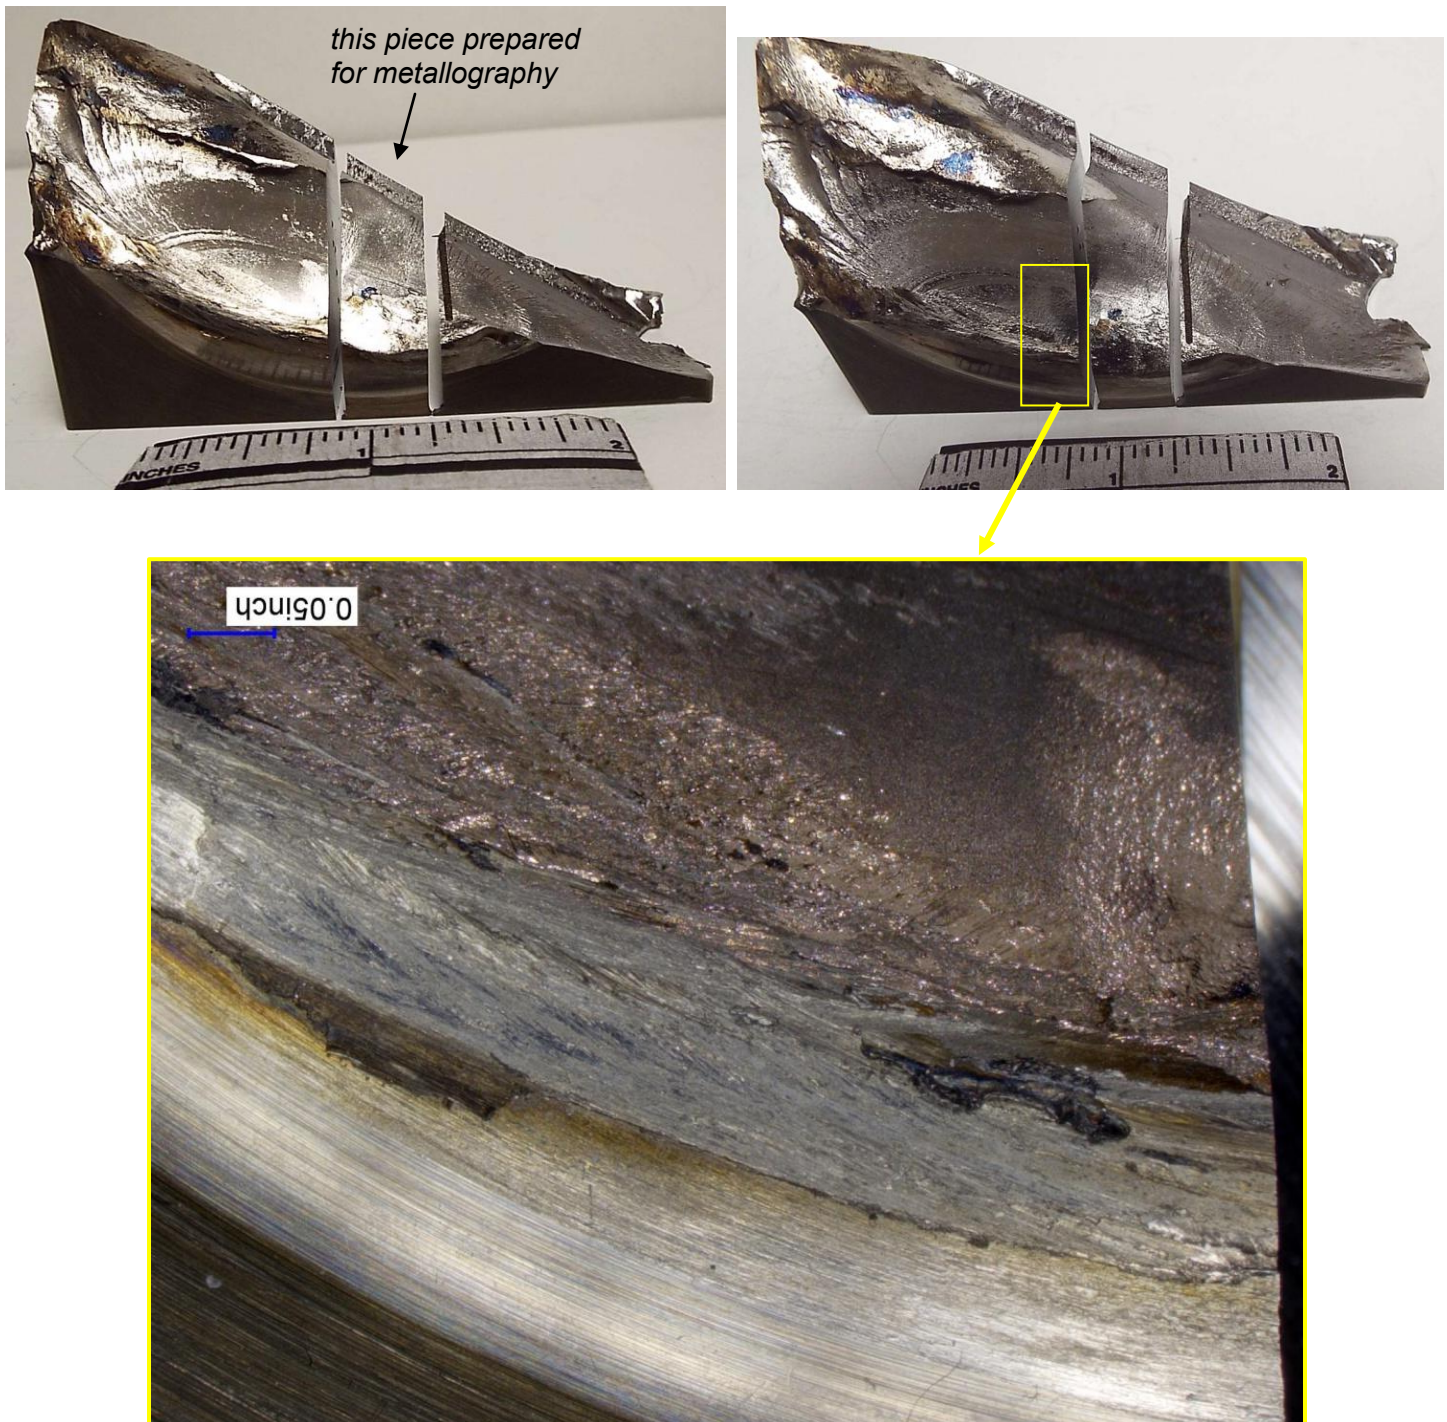
Figure 34. Sections cut by abrasive cutoff saw, through the fatigue crack origin area, fracture surface, thrust face and rear journal fillet radius of the #5 crankpin journal and #8 cheek. Top photos show same view, but different lighting conditions. The thin, center slice was sectioned further to remove the far side of the fracture surface (away from crack origin area), then mounted and polished (left side surface was polished, for metallographic evaluation). Bottom photo is magnified image of larger, left-most piece, after rotating to present a better view of the severely damaged fillet radius, thrust face, and fracture surface, in the immediate neighborhood of the crack origin area. See Figure 35, for view of at the cut section surface of this same piece.
