Technical Report

Evaluation of Crankshaft and Other Selected Components from

TIO-540-AF1B Engine (S/N L-9457-61E)

In Support of NTSB Accident Investigation ERA16FA023

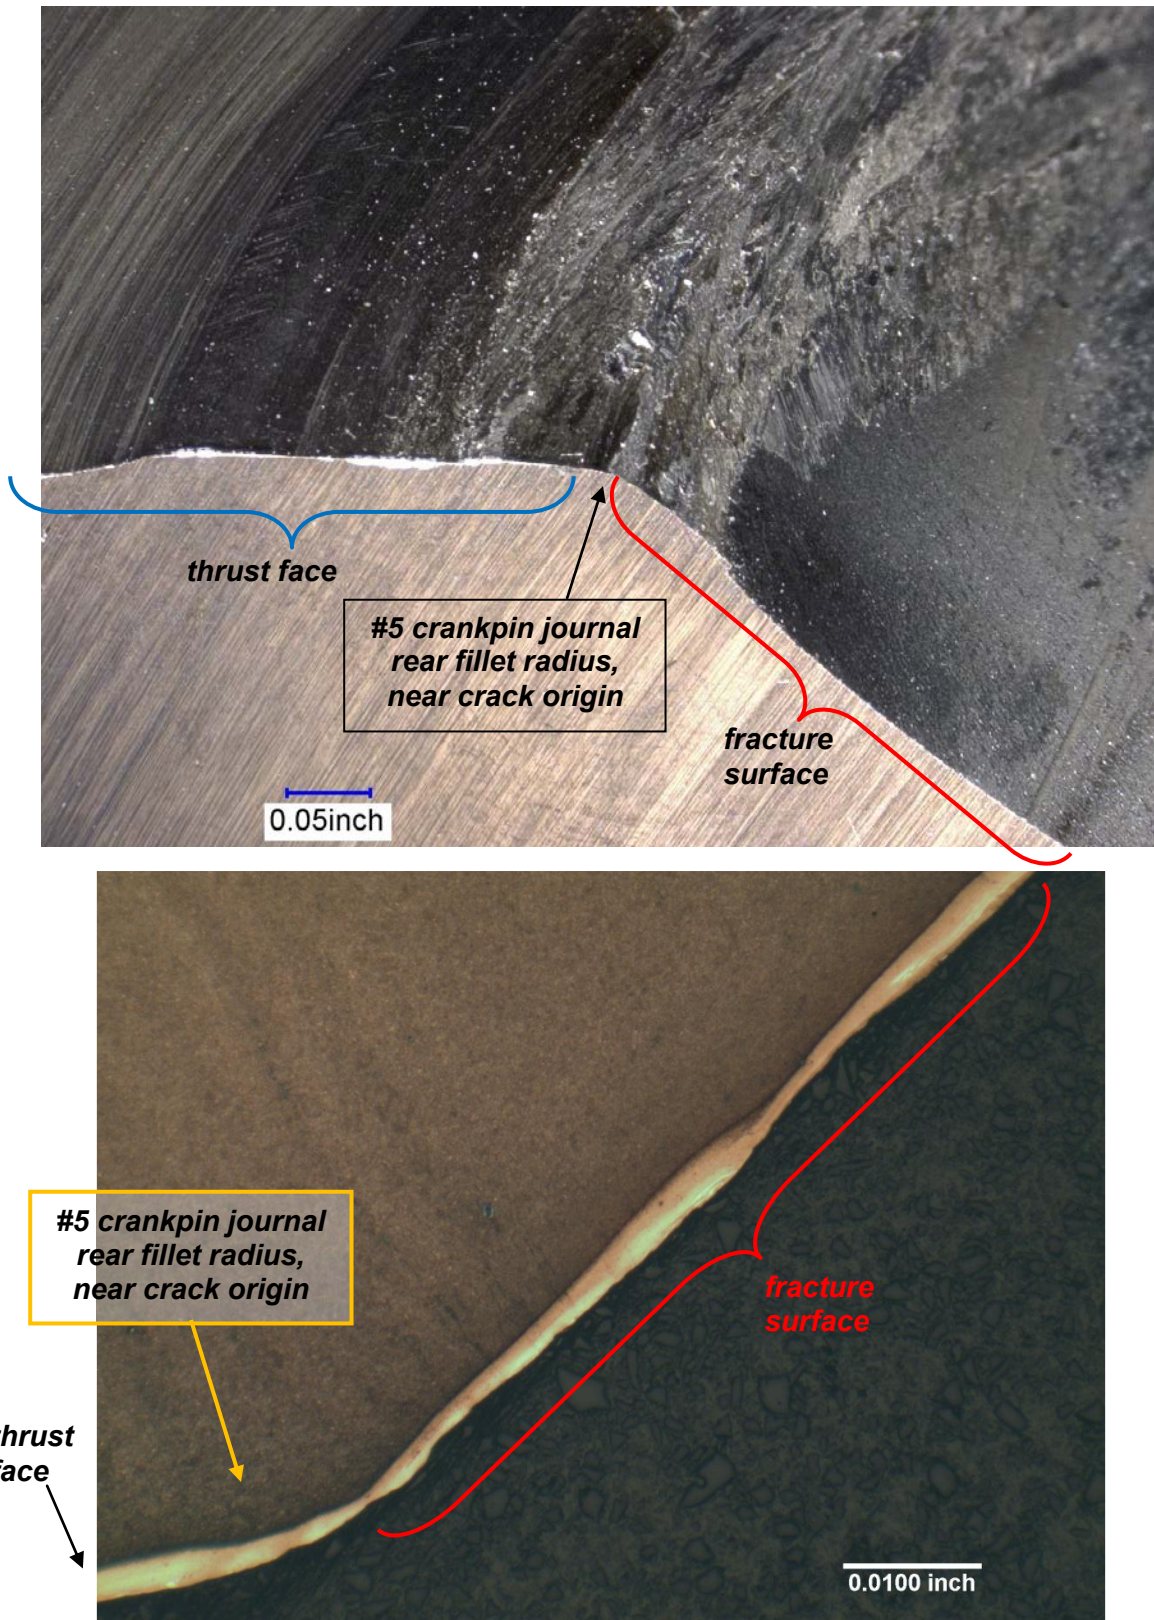
Figure 35. *Top* – angled view of the cut-section surface of same piece as shown at bottom of Fig. 34. Note severe contact damage at and near the rear fillet radius. *Bottom* – polished, nital etched cross-section of mating surface, showing severe contact damage and surface deformation, along the fracture surface, and adjacent thrust face. This region has been hammered by post-fracture contact events. White-etching zones along the surfaces have been re-hardened by intense frictional heat, from metal-to-metal contact.

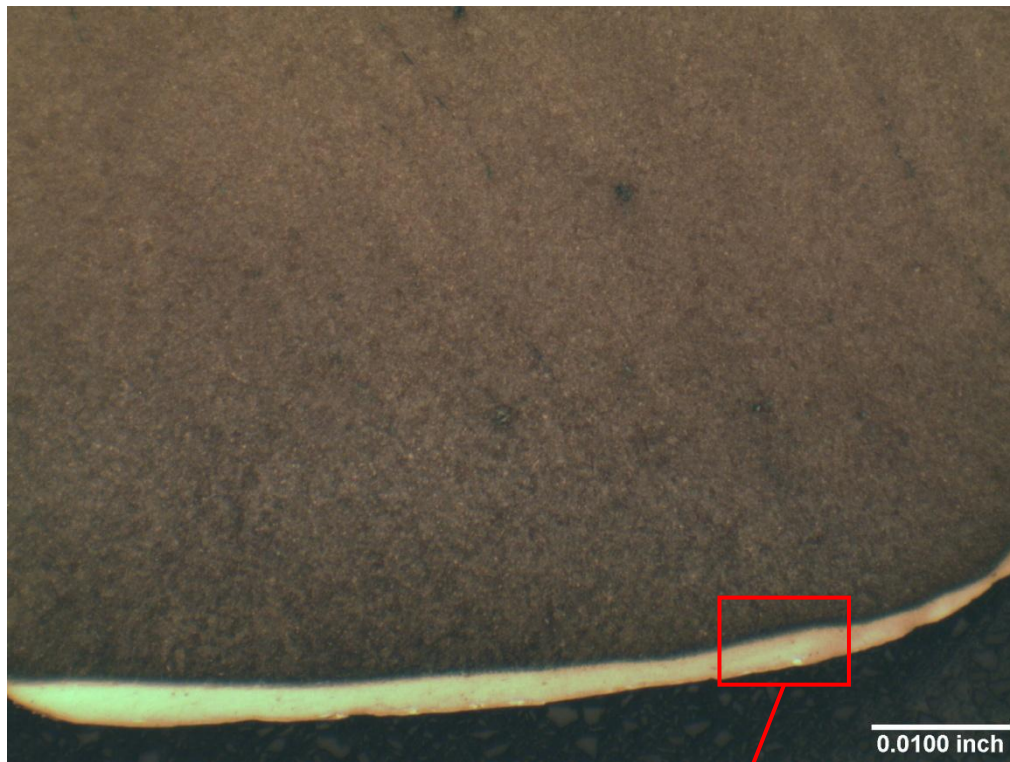
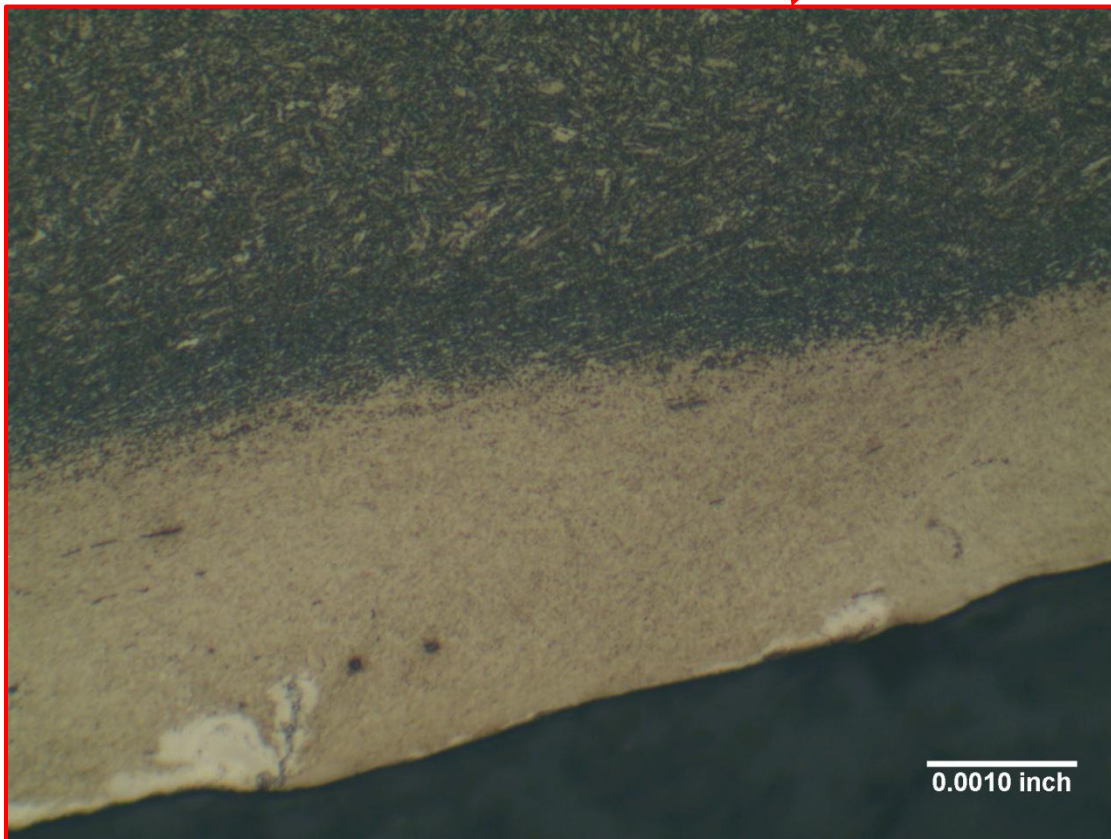
Figure 36. Severe rehardening contact damage on the thrust face, adjacent to the #5 crankpin journal rear fillet radius. Region shown is just to the left of the field of view shown in bottom photo of Figure 35. *Nital-etched*.

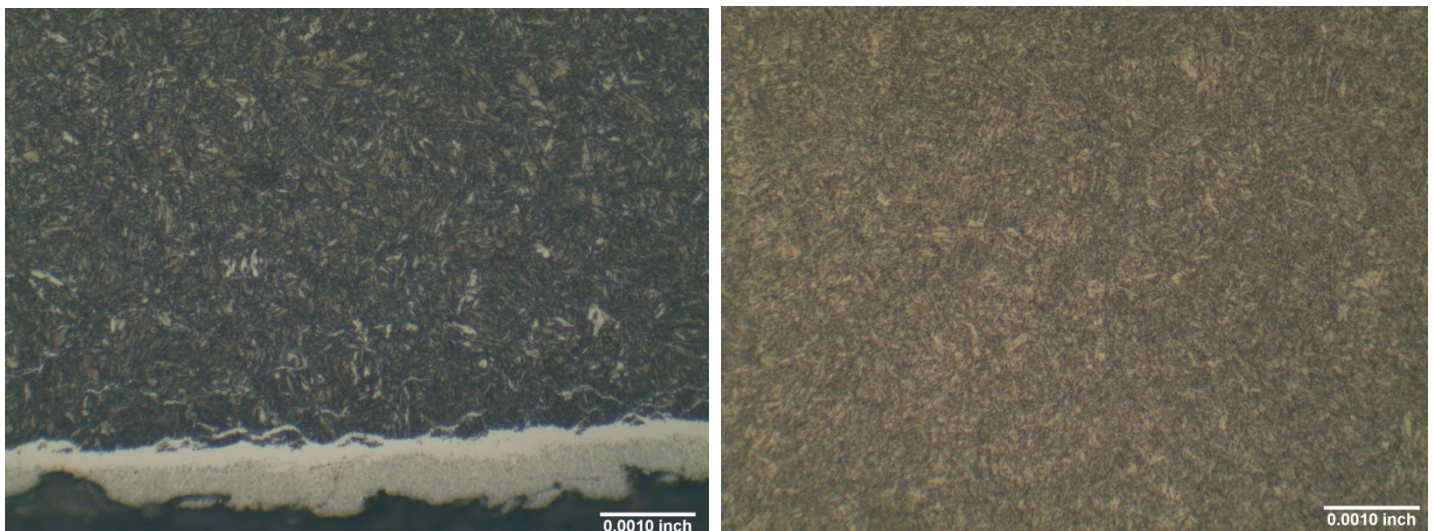
Crankshaft Material Conformance. The case hardness was 68.3 HR30N (average of six measurements, ranging from 67.2 – 69.1 HR30N, measured on the broken counterweight attachment lug of the #8 cheek, after sectioning). Core hardness was 31.3 HRC (average of 11 measurements, on Charpy test bars cut from the #8 cheek), which is slightly below the [REDACTED] HRC range specified on the engineering drawing. Alloy chemistry was analyzed by Optical Emission Spectroscopy (see appended analysis report), and conformed to AMS-[REDACTED] (air-melted 4340 steel). The vanadium level was 0.0089%, indicating it was not vanadium-modified steel. Total case depth was 0.0197 inch, measured by Vickers microhardness traverse, on the polished cross-section through the fatigue crack origin (i.e., measured on the nearby #5 crankpin journal's rear thrust face, on the #8 cheek, adjacent to the fracture surface). Microstructure was tempered martensite in the core, and tempered martensite plus dispersed nitrides in the case (Figure 37). The as-nitrided region of the #8 cheek just above the thrust face had a white layer thickness of 0.00067 inch, while the thrust face itself had no remaining white layer. There was also a zone of intense surface damage, indicative of rehardening and retempering, consistent with frictional heating caused by metal-to-metal contact (see Figures 35-36). This zone of re-hardening damage extended for approximately 0.17 inch along the thrust face and journal radius, and extended along the fracture surface for approximately 0.19 inch. Most likely, this damage was produced during final rupture, as the crack-opening displacement was increasing rapidly; and the damage on the fracture surface was caused by post-separation secondary contact events. Three Charpy impact bars were machined from the #8 cheek, and tested in accordance with ASTM [REDACTED]. Impact energies ranged from 39.9 – 40.1 ft-lbs, which is typical for AMS-[REDACTED] steel tempered to this hardness. Charpy bar fracture surfaces were examined by Scanning Electron Microscope, and no honeycomb or microcrack features were found. All metallurgical characteristics conformed to the engineering drawing requirements, except the slightly low core hardness.

Figure 37. Case and core microstructures from the broken #8 cheek. **Left** – tempered martensite with dispersed nitrides, and white layer of approximately 0.00067 inch thickness, on the as-nitrided surface just above the thrust face, not far from the fracture origin. **Right** – core microstructure from same section. *Nital etched.*
