Dry Air / Vacuum Pump Examination Notes from May 16, 2013

N5714W

NTSB Case # ERA13FA088

Parkton, North Carolina

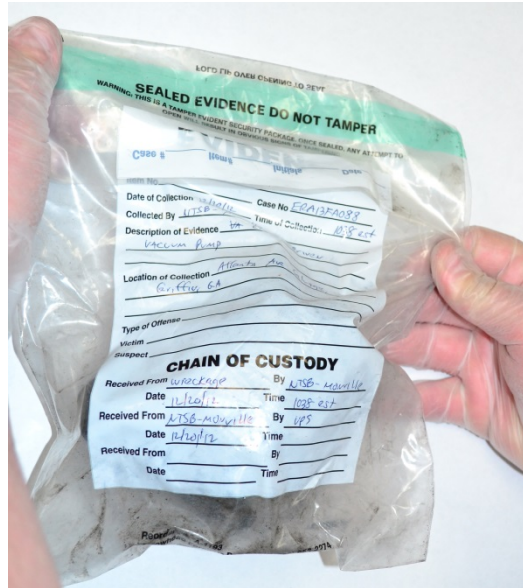
- Removed subject article from open box as delivered by the FAA representatives.
- Pump was in plastic evidence bag which was sealed.

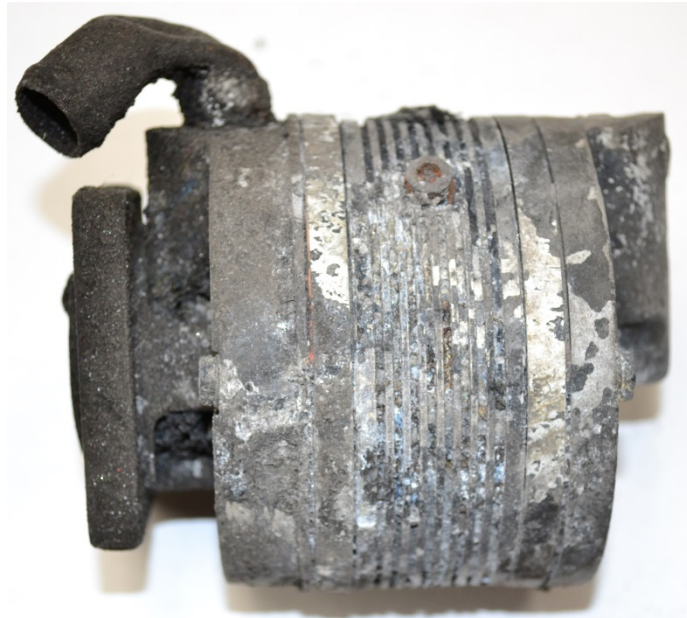
- Visual inspection of article shows significant heat damage.
- No data plates or labels were able to be identified.

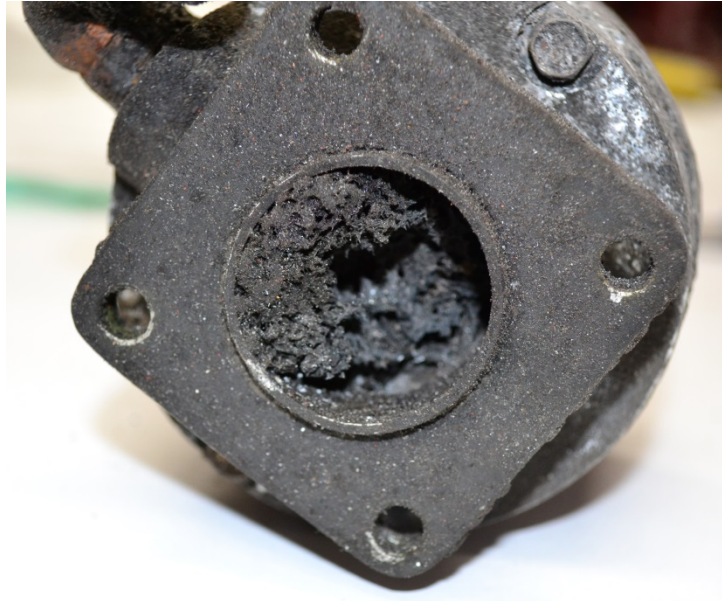
- Visual inspection of the article drive end showed that the external drive gear and shear coupler are damaged beyond recognitions due to heat damage.

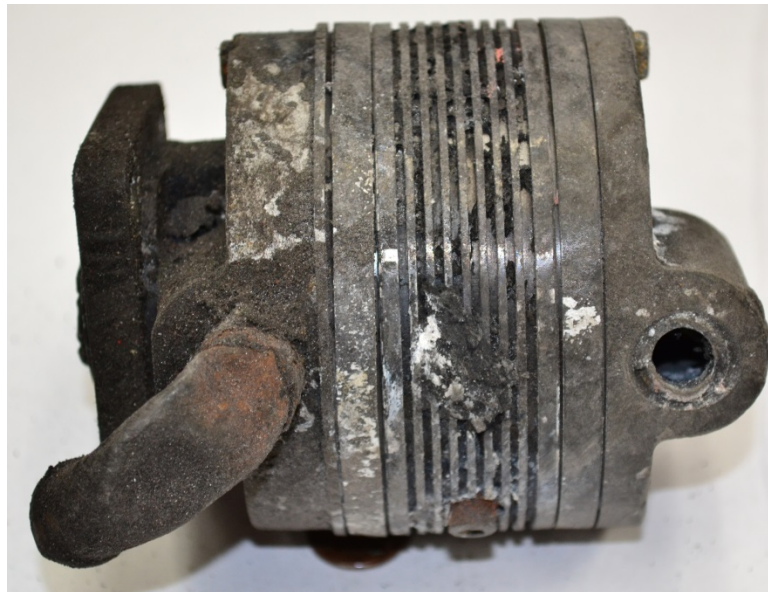
- Inlet fitting of vacuum pump was damaged.
- Outlet fitting was sheared at the attach flange.

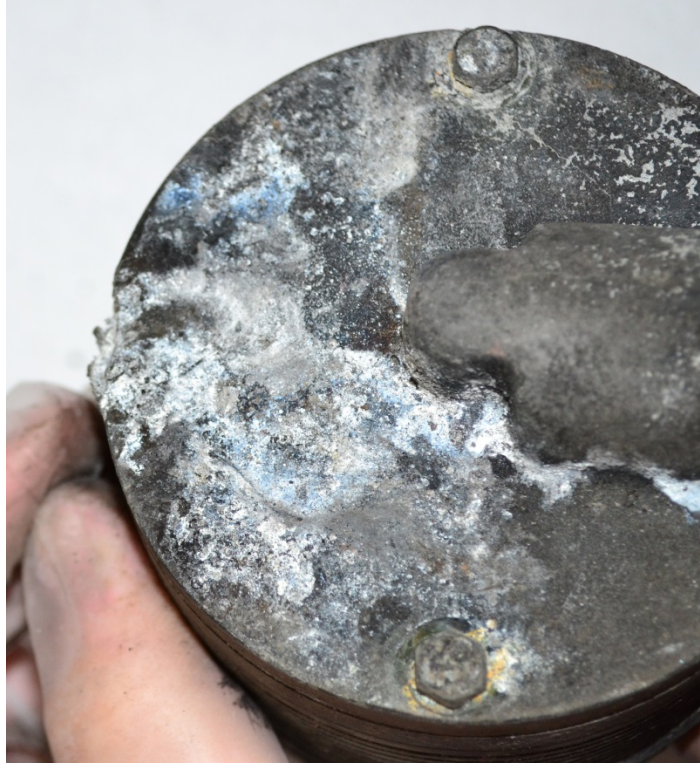
- Rear end of vacuum pump shows signs of corrosion, heat, and impact damage.
- Rear end bolts were found to be tight.
- No torque seal was noted on rear end bolt heads. (Bolt heads are marked with blue torque seal when manufactured as new FAA PMA approved from Rapco)

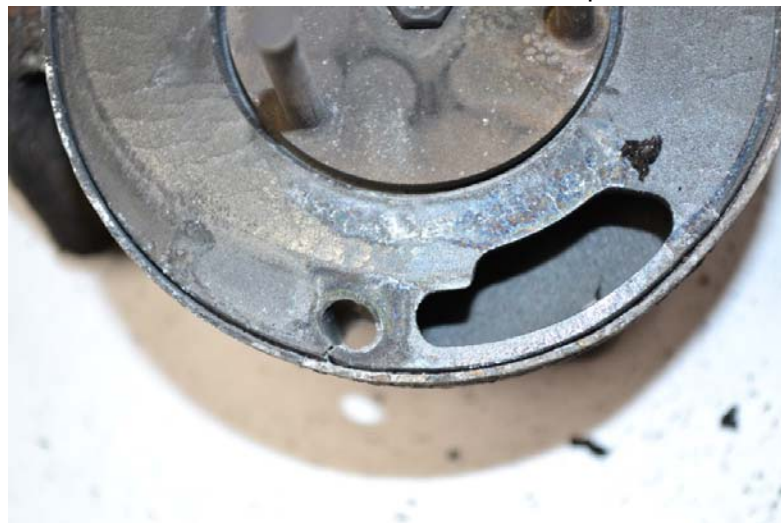
- Visual inspection of front end shows deformation due to impact.

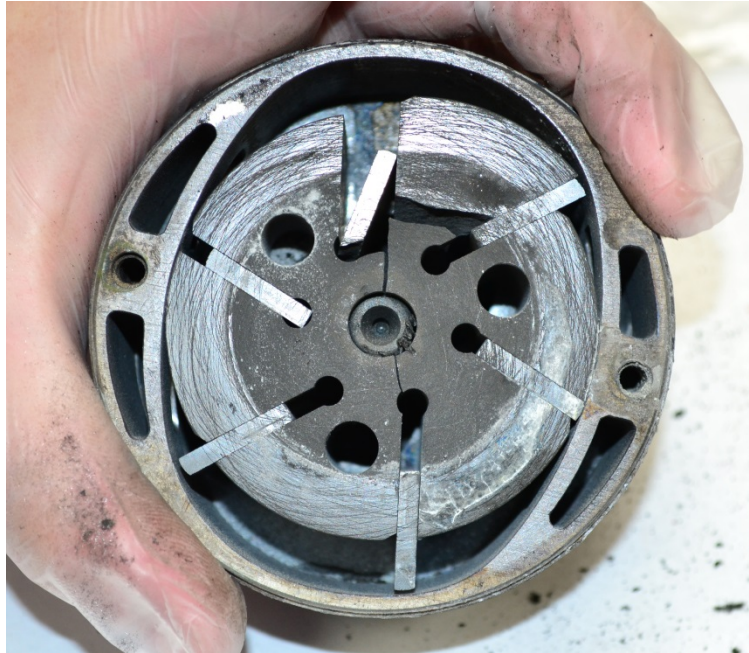
- Visual inspection of vacuum pump shows rotor cracked and one vane chipped (Vane later identified as Vane 5 was chipped).

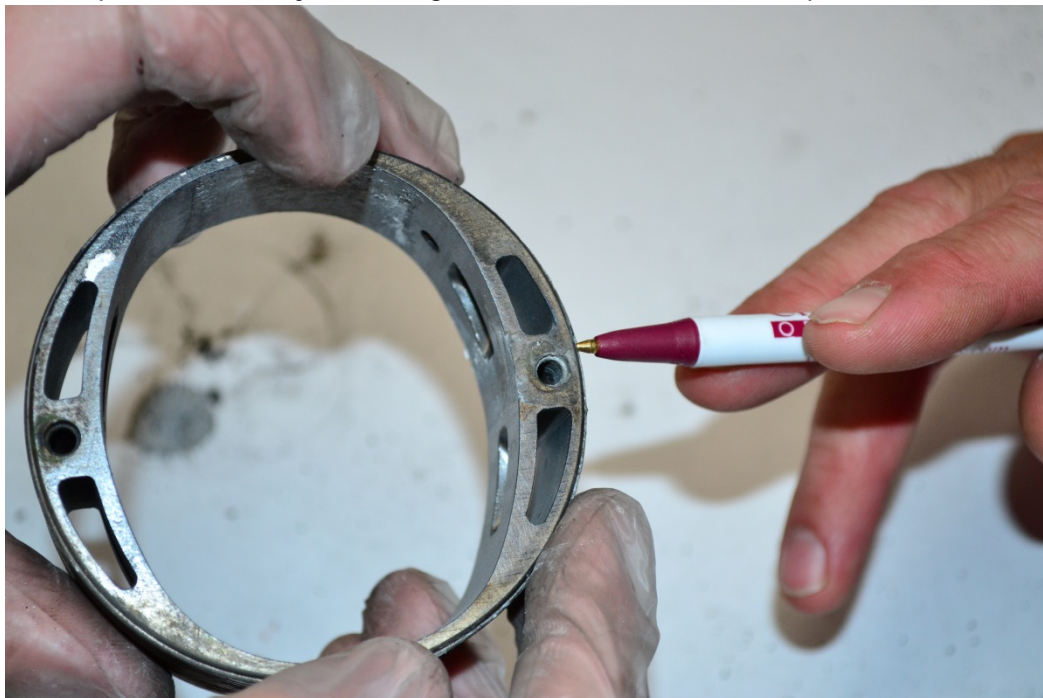
- Visual inspection of cavity shows signs of deformation due to impact.

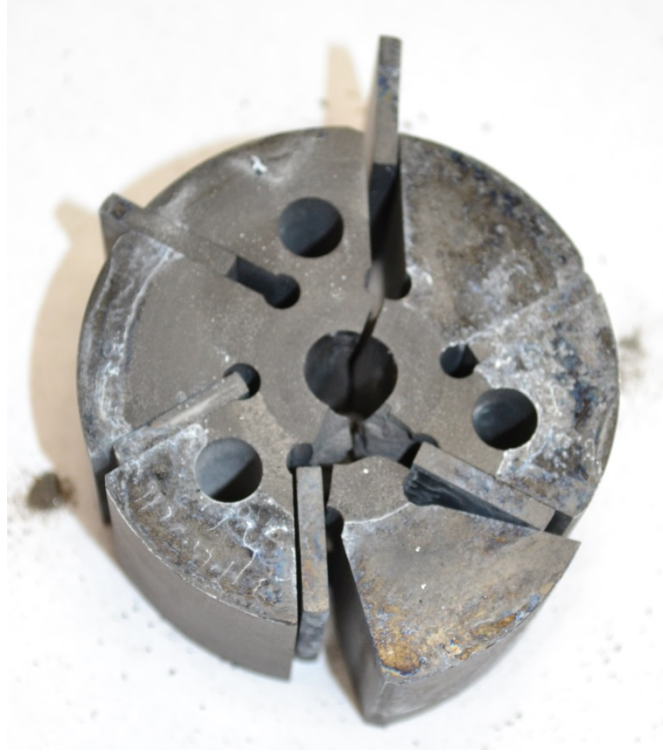
- Visual inspection of rotor and vanes after removal showed a single crack through the center hole of the rotor, which resulted in a segment separating from the rotor.
- Visual inspection of the rear face of the rotor and vane assembly showed heat damage.

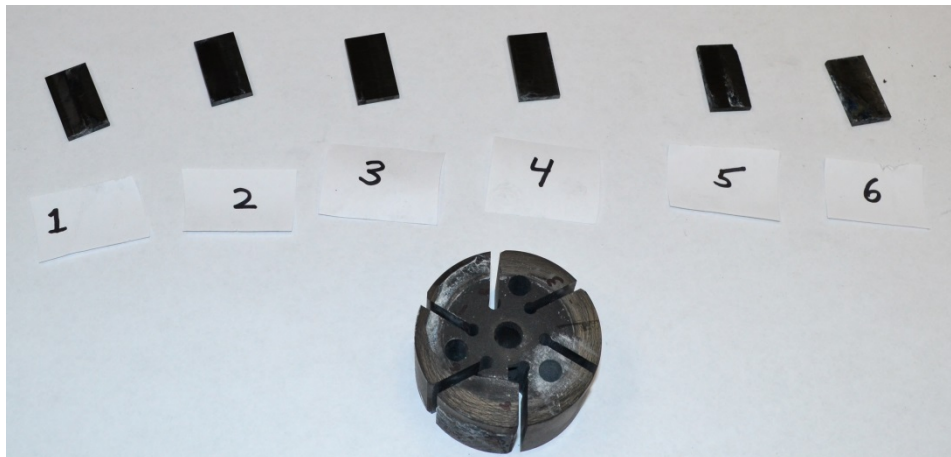
- Each vane and vane slot were marked with a permanent ink marker to identify where it was matted.
- Vanes were removed from rotor.

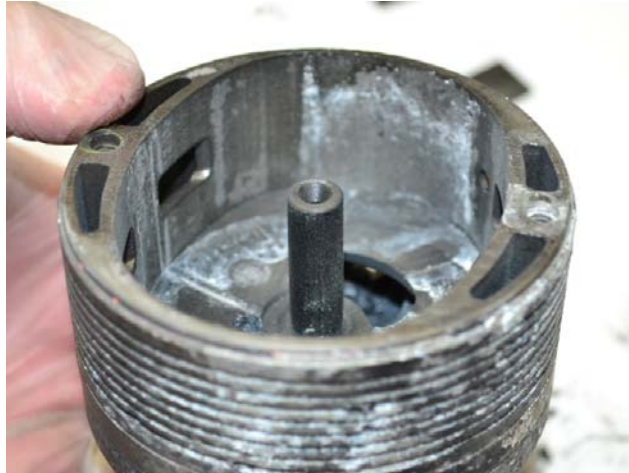
- Height of rotor 1.307
- Visual inspection of cavity shows damage to coating resulting from excessive heat.
- No apparent scratches or gouges were detected on the internal cavity wall.

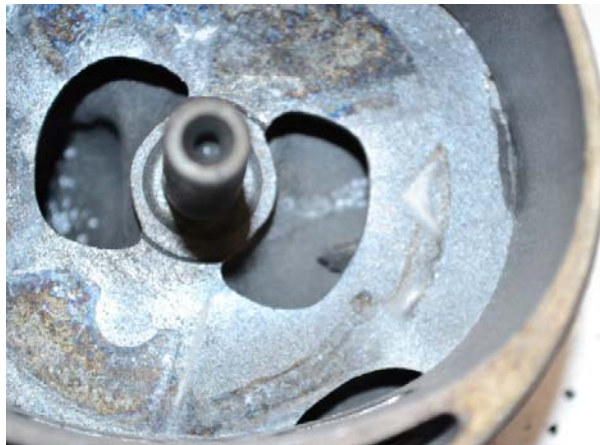
- Visual inspection of rear end showed debris lodged in outlet port of rear end.
- Debris appears to be the missing part of the chipped vane (Vane 5).

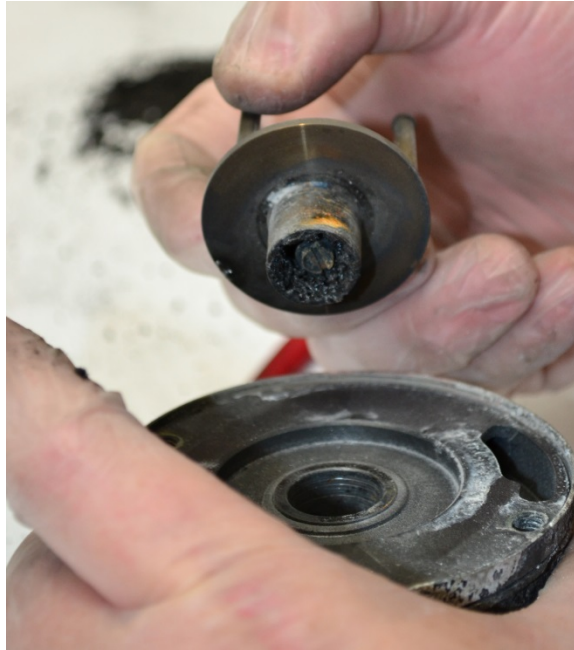
- Visual inspection of the front end after disassembly showed no signs of the sponge as a result of heat damage.
- Internal gear was damaged beyond recognition as a result of heat.
- Measured small O.D of 3 finger drive and found it measured at 0.722".

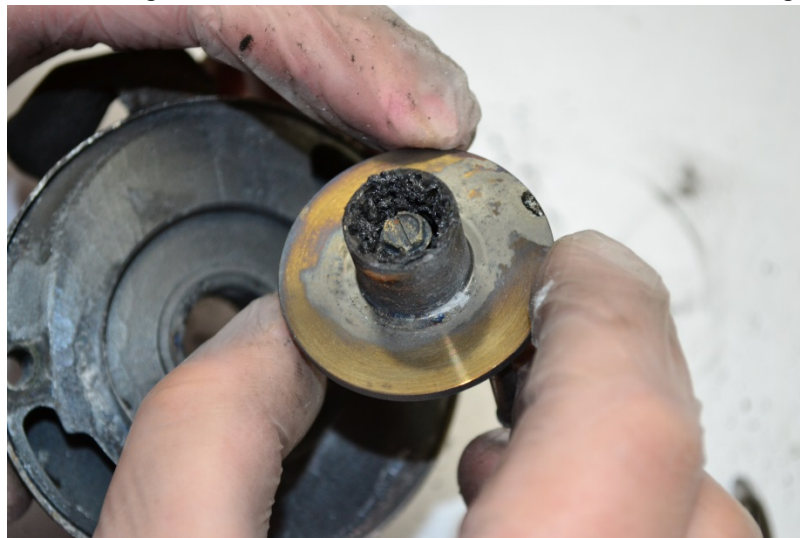
- Additional inspection of 3 finger drive indicates some corrosion and galling.
- Galling features on 3 finger drive mate with rotational scratches in bearing.

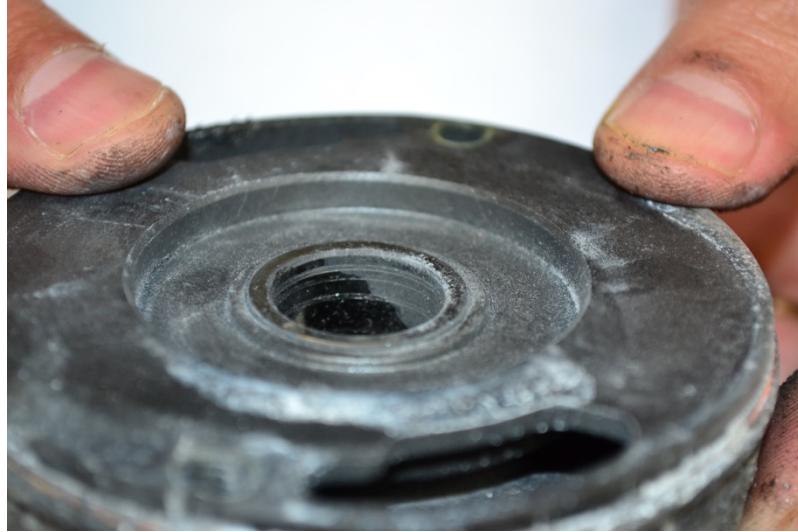
- Visual inspection of bearing showed some deep rotational scratches.
- Measured I.D of drive bearing. I.D of drive bearing measured at 0.723 – 0.726”.
