Air Safety Investigations

LEFT ENGINE FIELD RUN REPORT

ENGINE MODEL: TSIO-520-VB (10)

REGISTRATION: N2615G

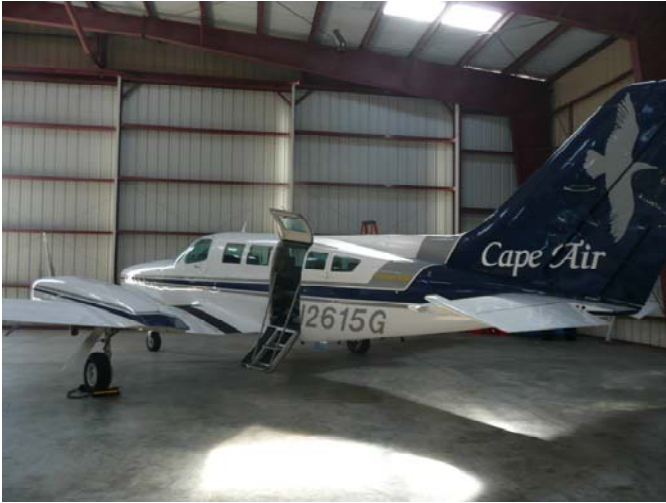
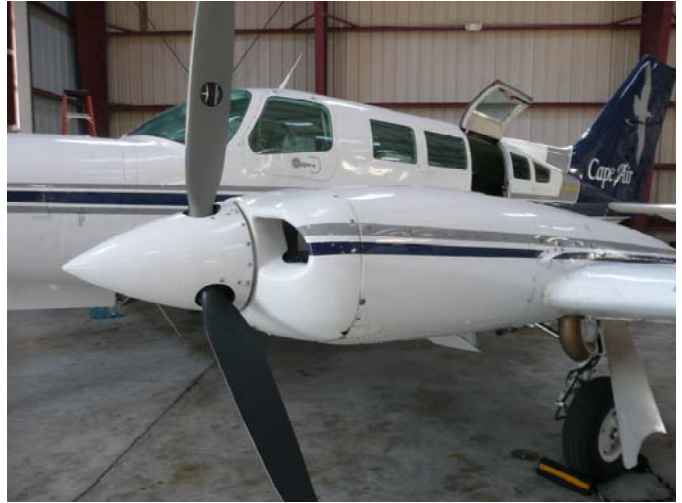
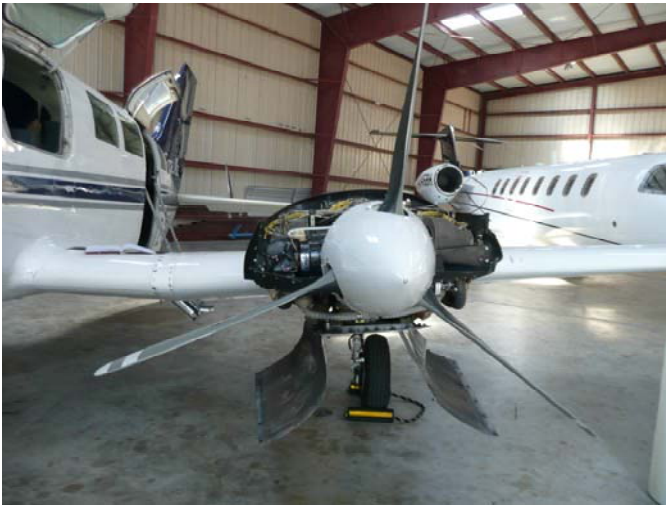
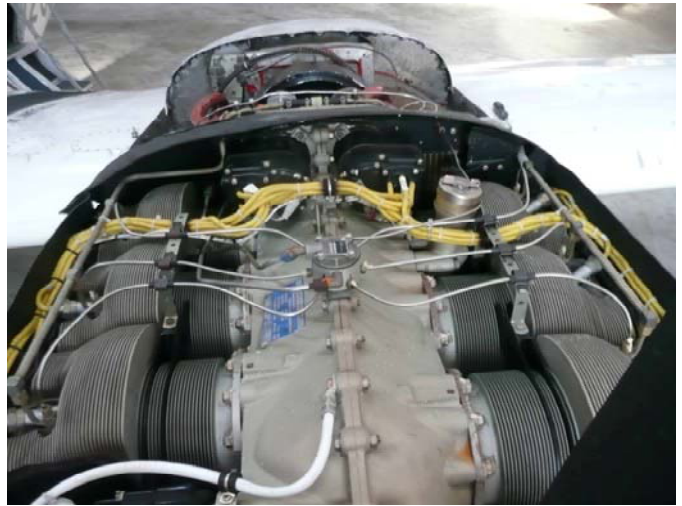
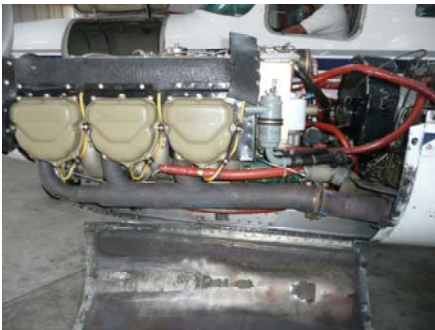
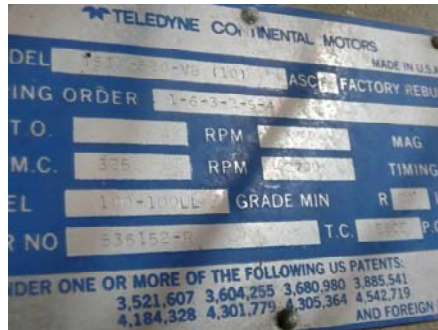
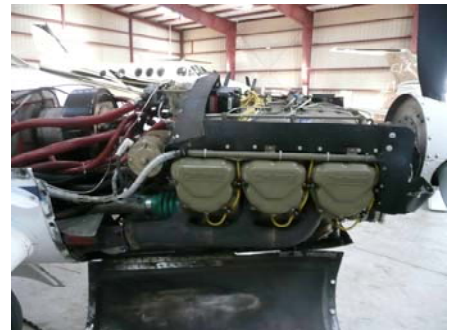
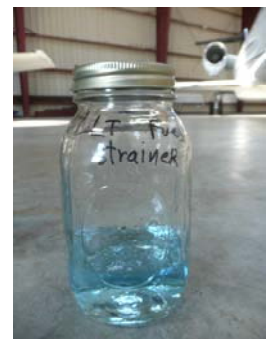
The left engine was intact and undamaged with no anomalies noted. The propeller was found in the feathered position. Twenty-four hours after the incident, the NTSB IIC energized the airplane and read the fuel quantity indicators to be 275 lbs in the left tank and 45 lbs in the right tank. The NTSB also emptied all fuel sumps and confirmed the fuel to be 100 LL with no contaminants.

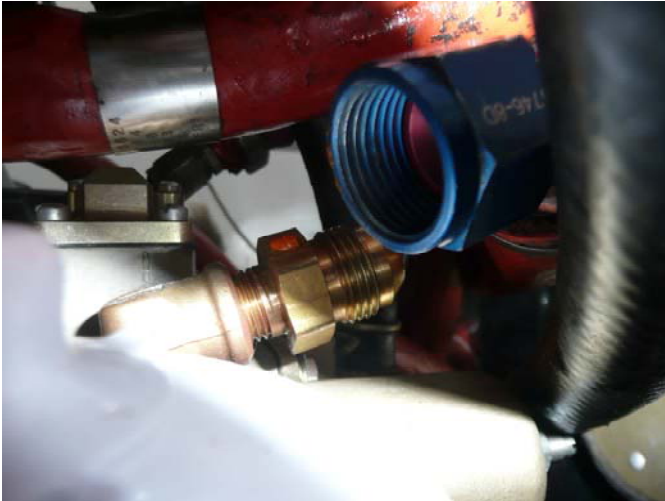
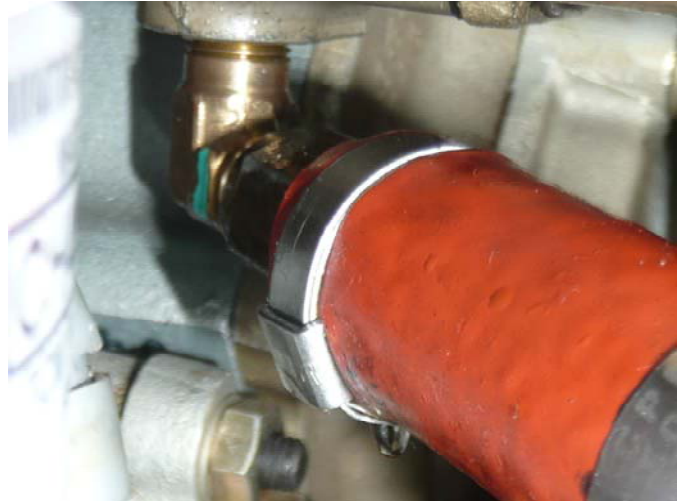
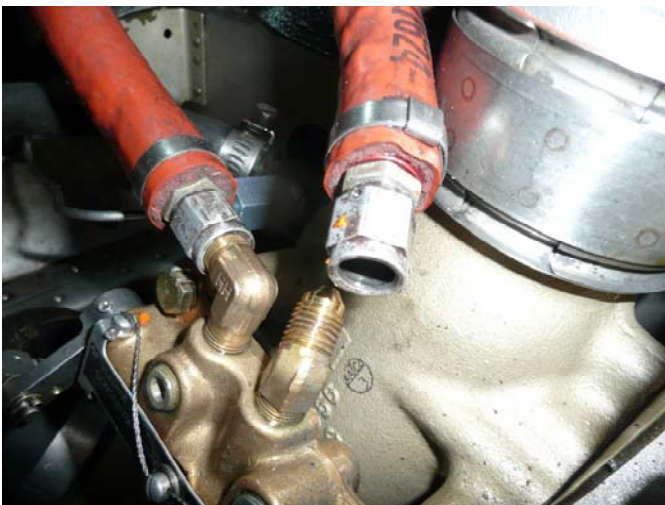
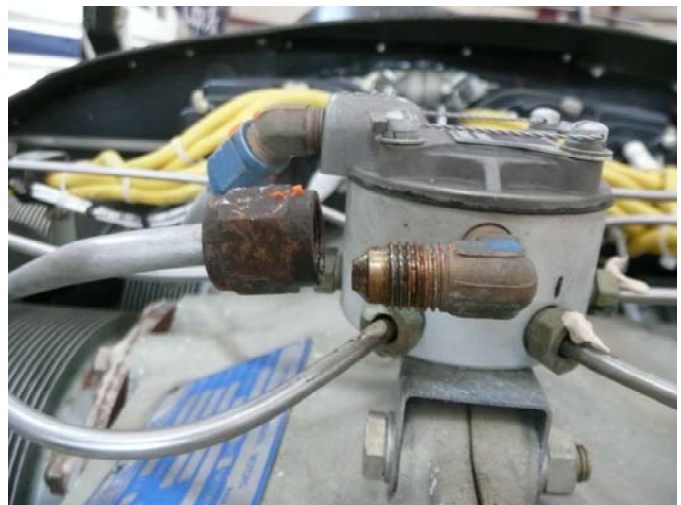
The fuel system hoses were inspected and found to be tight. The hoses were disconnected and only residual fuel was in the lines. The fuel hoses were reconnected in preparation for the engine run.

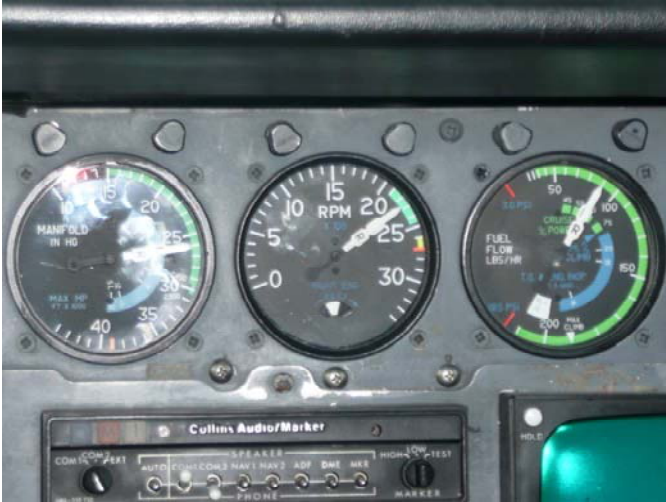
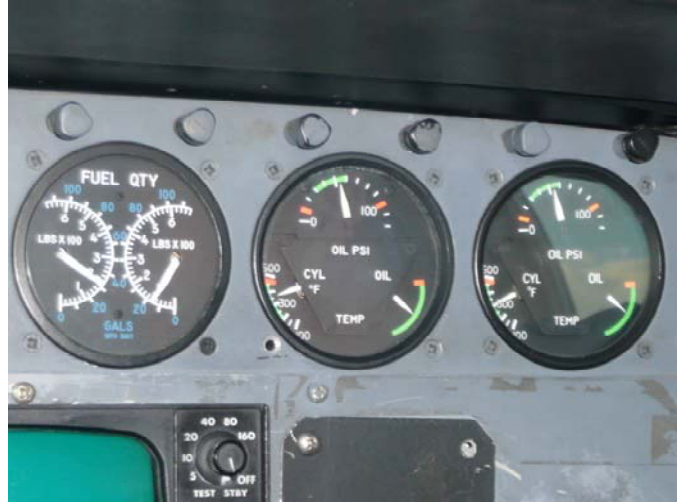
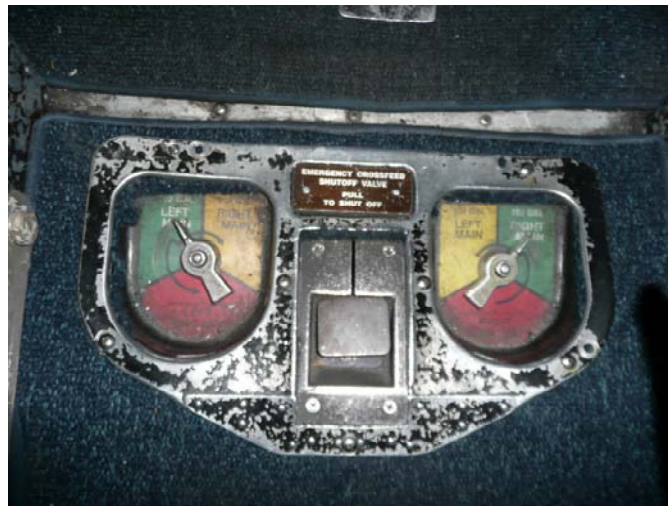
The engine run did not reveal any anomalies that would have prevented normal operation and production of rated horsepower. See the engine run video for additional information.

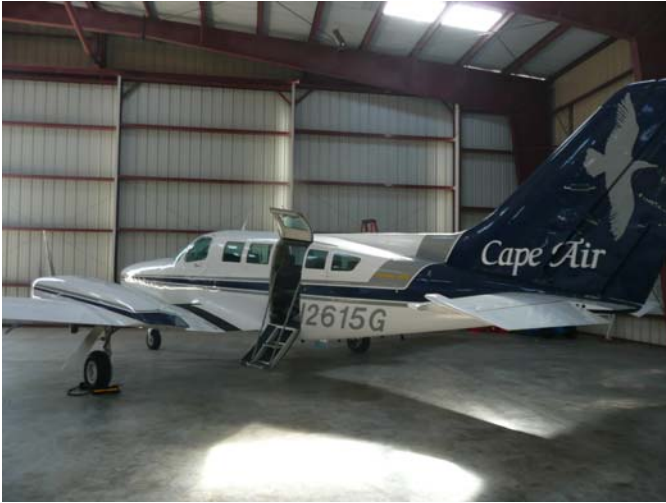
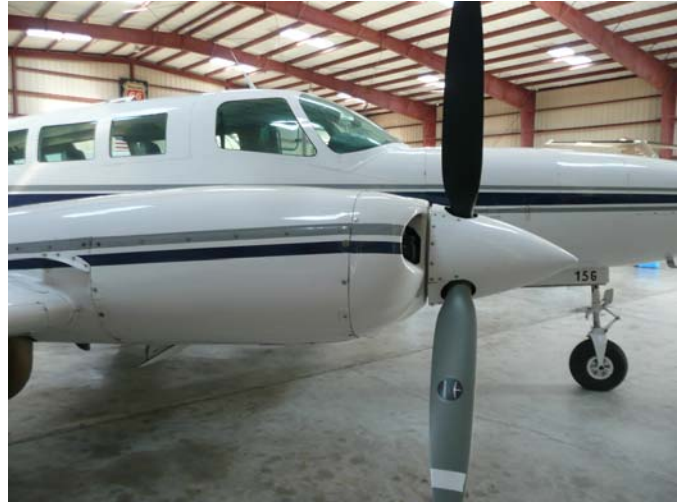
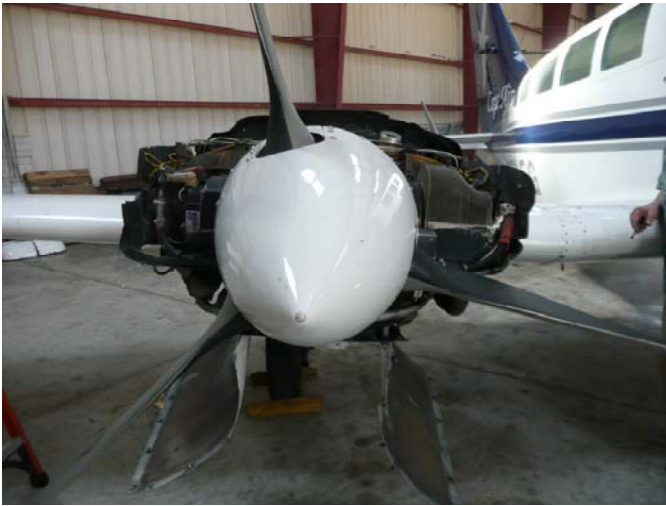
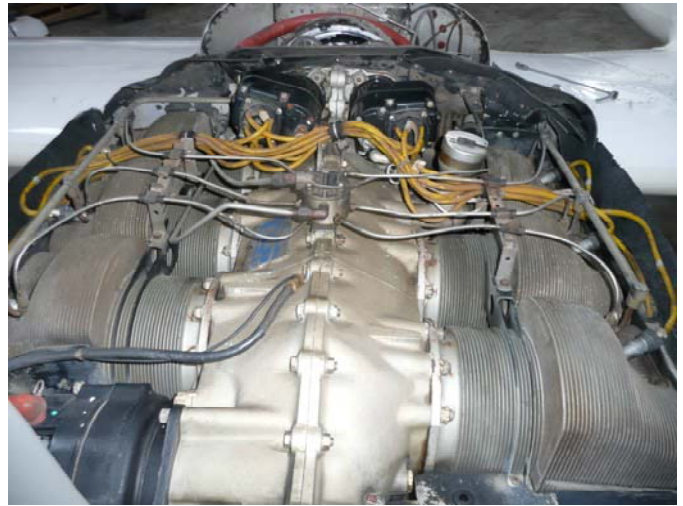
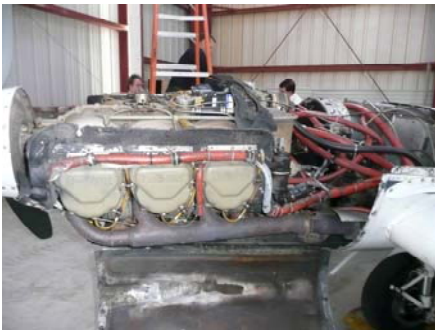
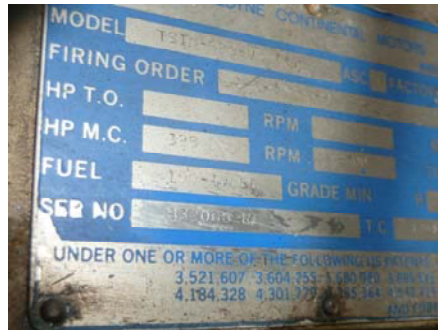
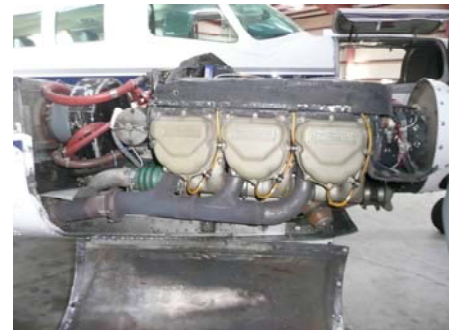
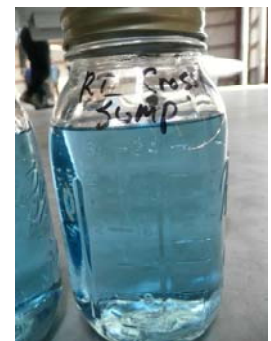
The right engine was intact and undamaged with no anomalies noted. The propeller was found in the feathered position. Twenty-four hours after the incident, the NTSB IIC energized the airplane and read the fuel quantity indicators to be 275 lbs in the left tank and 45 lbs in the right tank. The NTSB also emptied all fuel sumps and confirmed the fuel to be 100 LL with no contaminates.

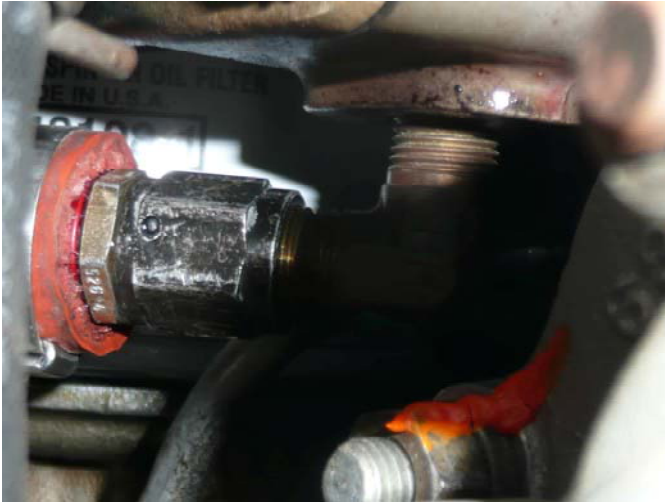
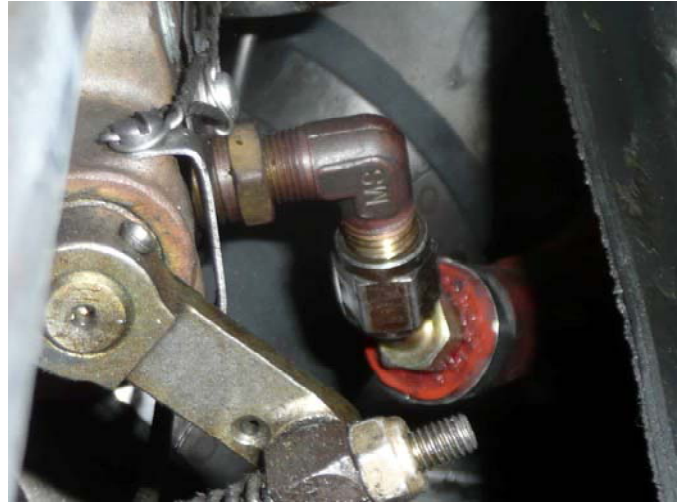
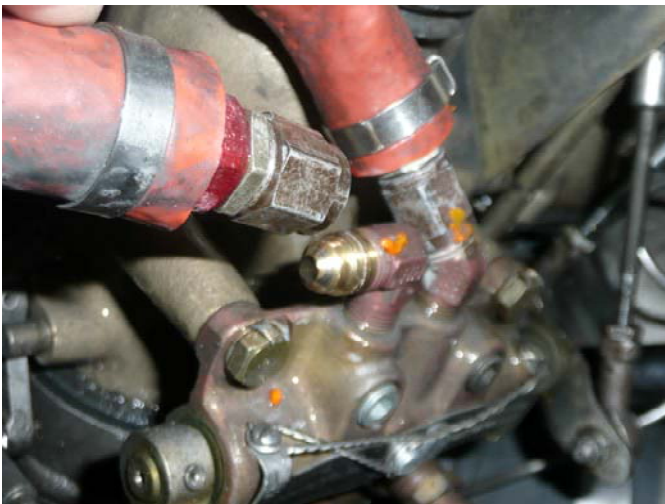
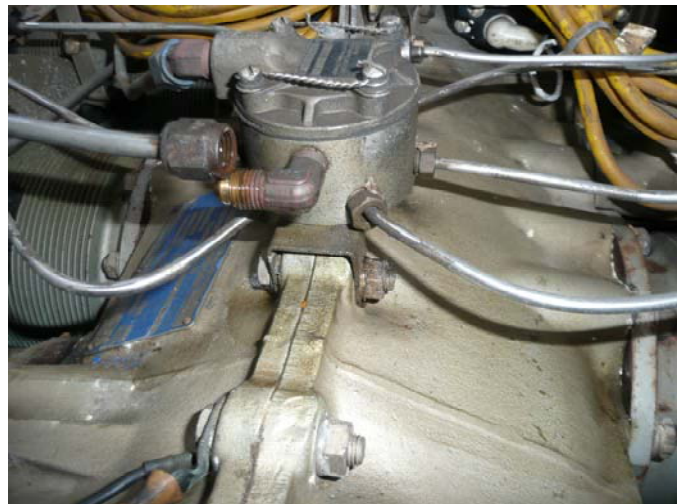
The fuel system hoses were inspected and found to be tight. The hoses were disconnected and only residual fuel was in the lines. The fuel hoses were reconnected in preparation for the engine run.

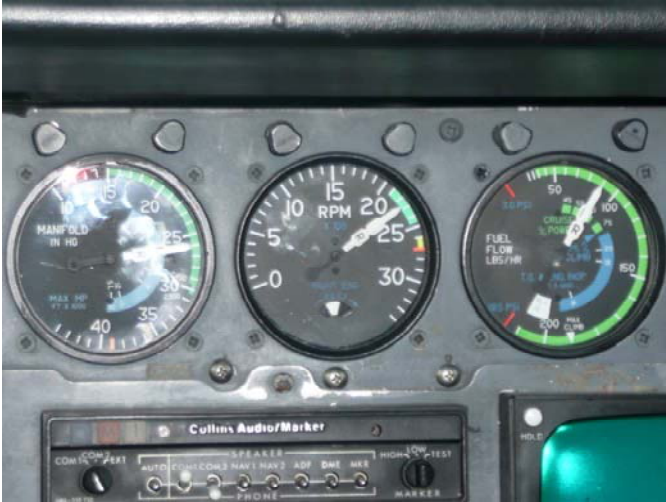
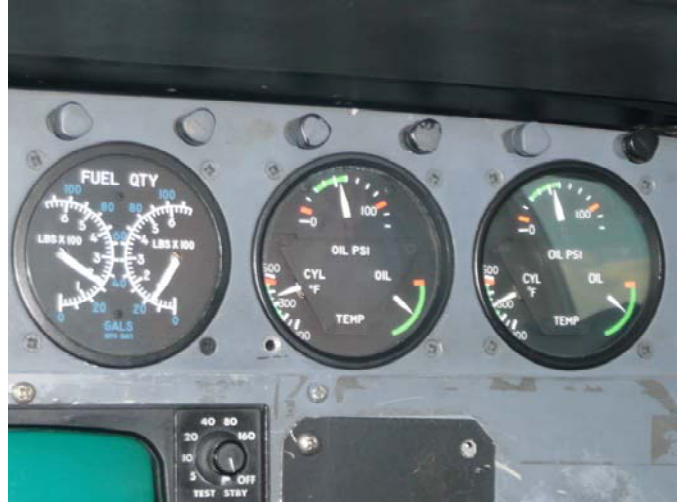
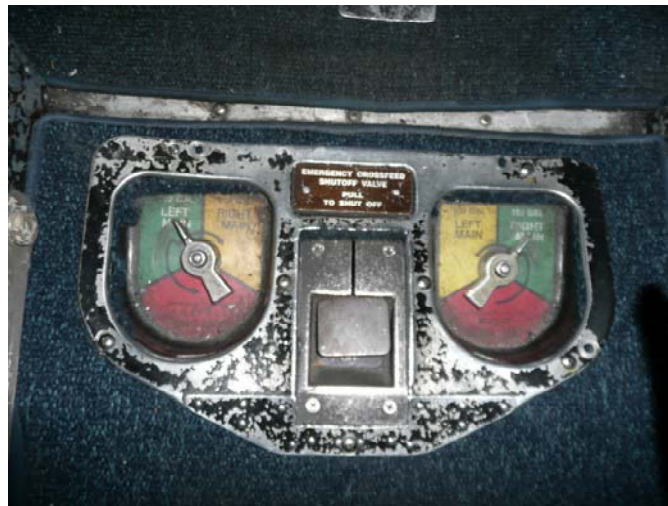
The engine run did not reveal any anomalies that would have prevented normal operation and production of rated horsepower. See the engine run video for additional information.
