1. ELT manufacturer, model number, and TSO Number

**Manufacturer: ACR Electronics**  
**Vendor p/n: 455-6608**  
**Cirrus p/n: 17190-007**  
**TSO-C126**

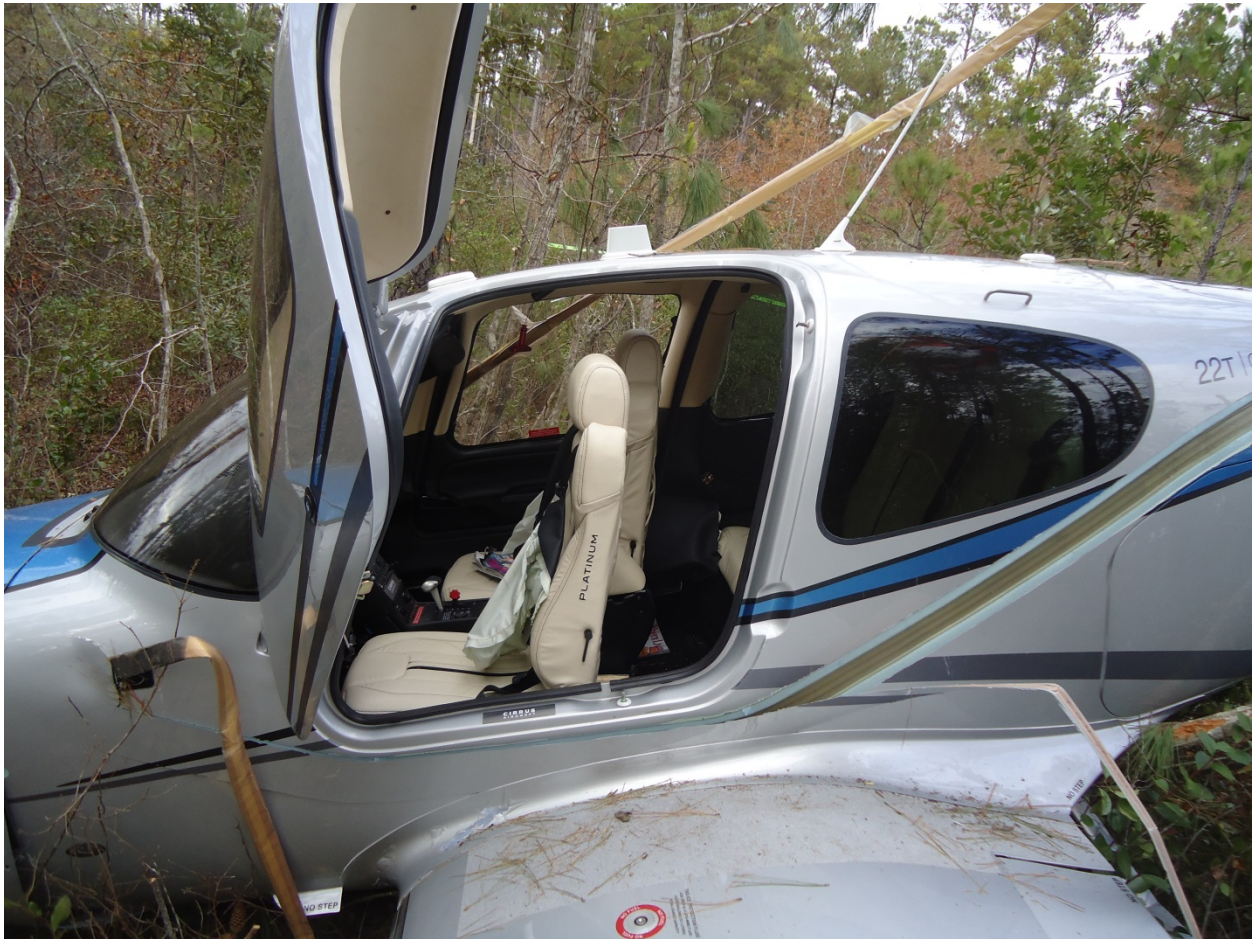
**Recovery company photos show that both front crew seat airbags had deployed.**

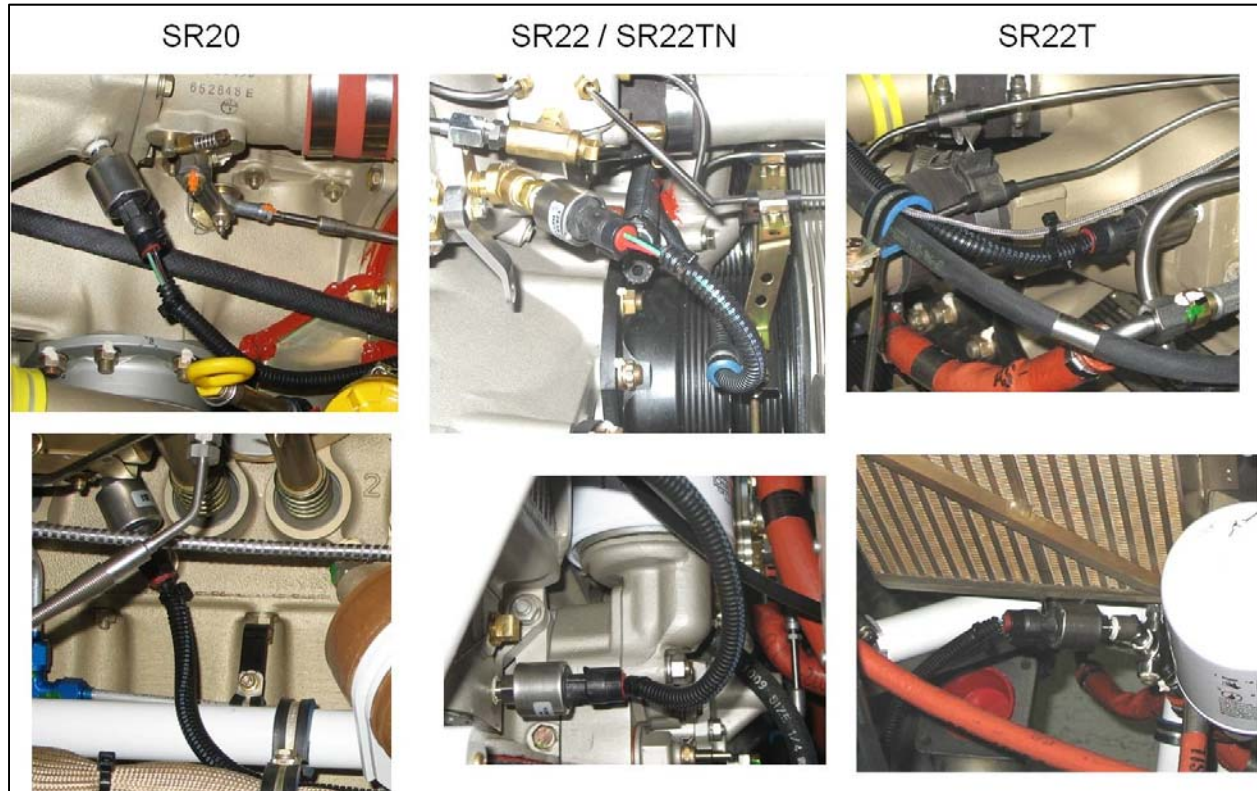
**Starting back in 2010, Cirrus Aircraft noticed an increase in warranty claims and customer satisfaction survey results that showed a high replacement rate for oil and manifold pressure sensors. These are identical parts and are installed and wired similarly.**

In November 2012, Service Bulletin SB2X-77-04 was released which described the replacement of the oil and manifold pressure sensors, the addition of strain relief parts at the sensor connector and removal of the baffle connector. This same system was installed on the production line in the months leading up to this service bulletin release.

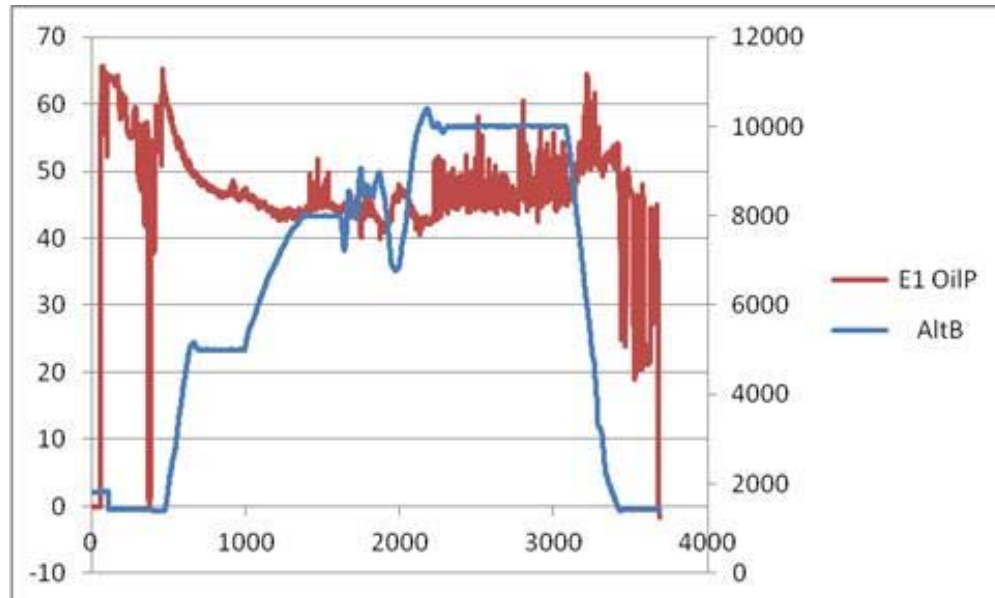
The reason for replacement was erratic indications of oil or manifold pressure as shown on the MFD. A typical example is shown below.

Several potential causes were explored for this issue and in the end, two causes were identified as contributing to the erratic behavior. Both of those causes were due to connectors. The first was baffle connector and the second was the connector at the sensor.
