The Egyptian Civil Aviation Authority requests and authorizes you to place the Response of EgyptAir to October 31, 2000 Submission of The Boeing Company regarding the EgyptAir Flight 990 investigation into the public docket for the EgyptAir Flight 990 investigation.

Response of EgyptAir  
to  
October 31, 2000 Submission of  
The Boeing Company  
Regarding  
The EgyptAir Flight 990 Investigation

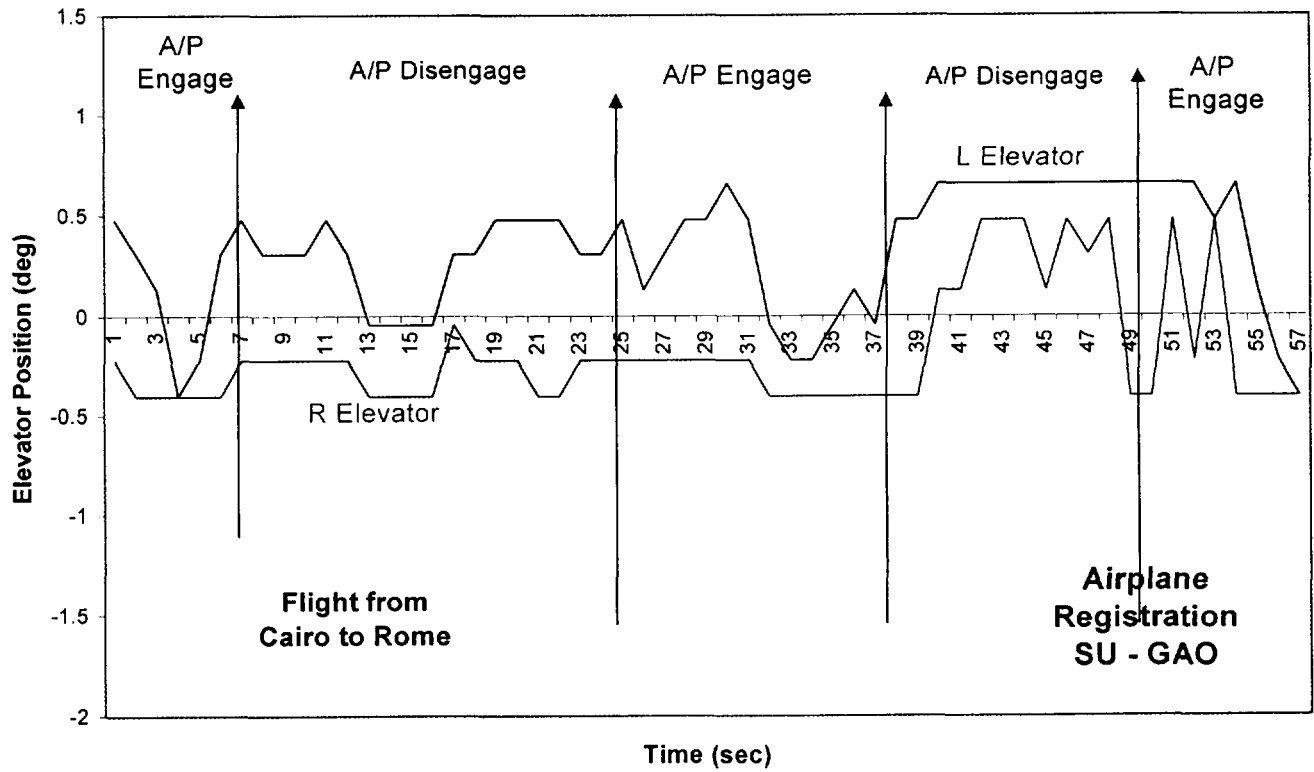
Figure 1. Elevator Response to Autopilot Disconnect on an Airworthy B-767

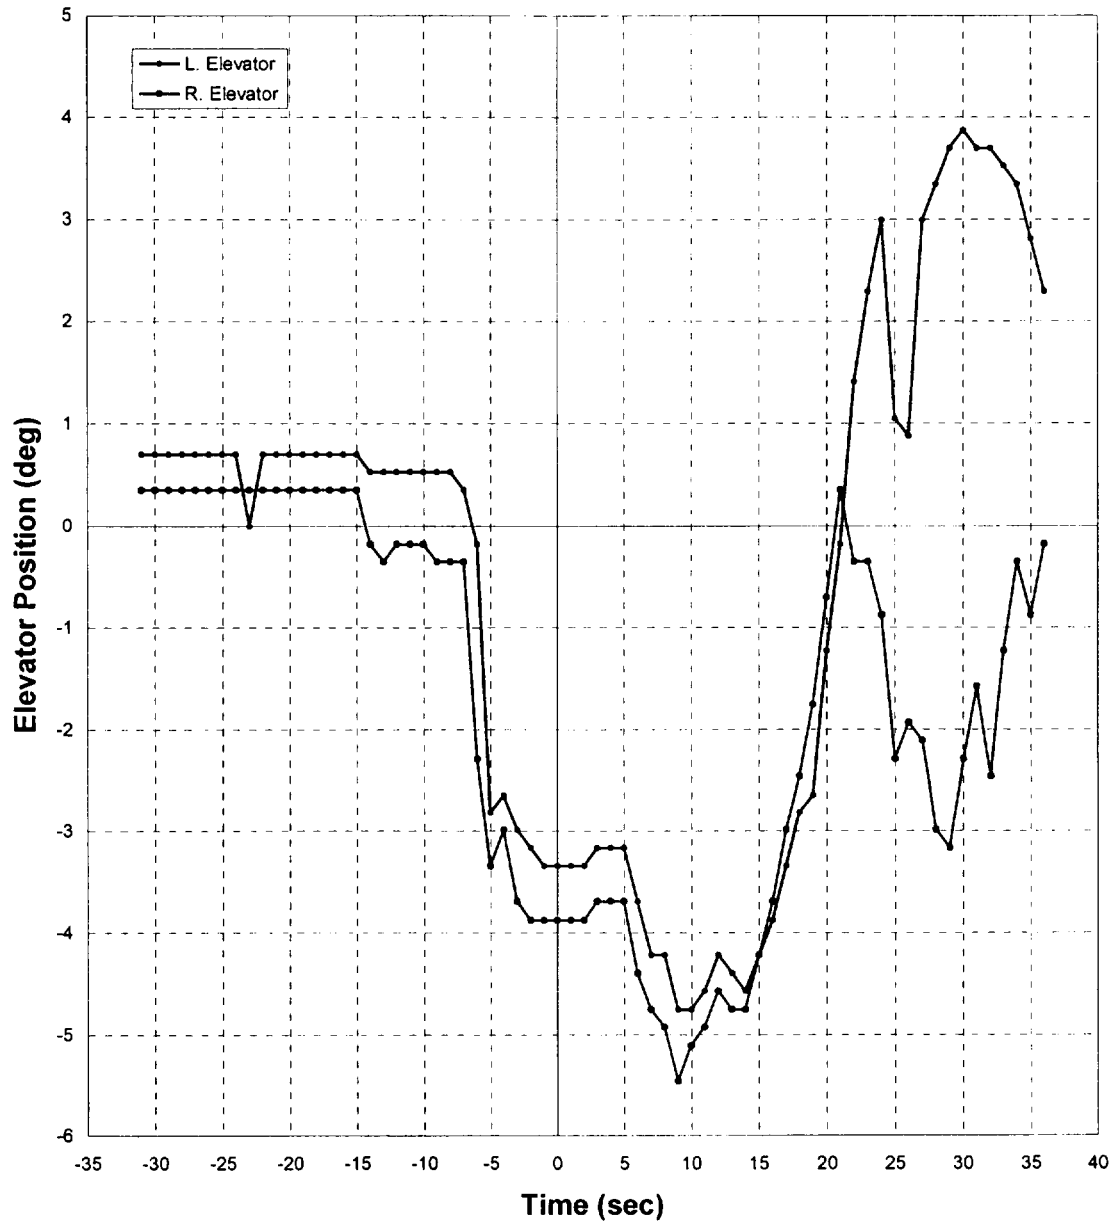
Figure 2. FDR Elevator Deflection

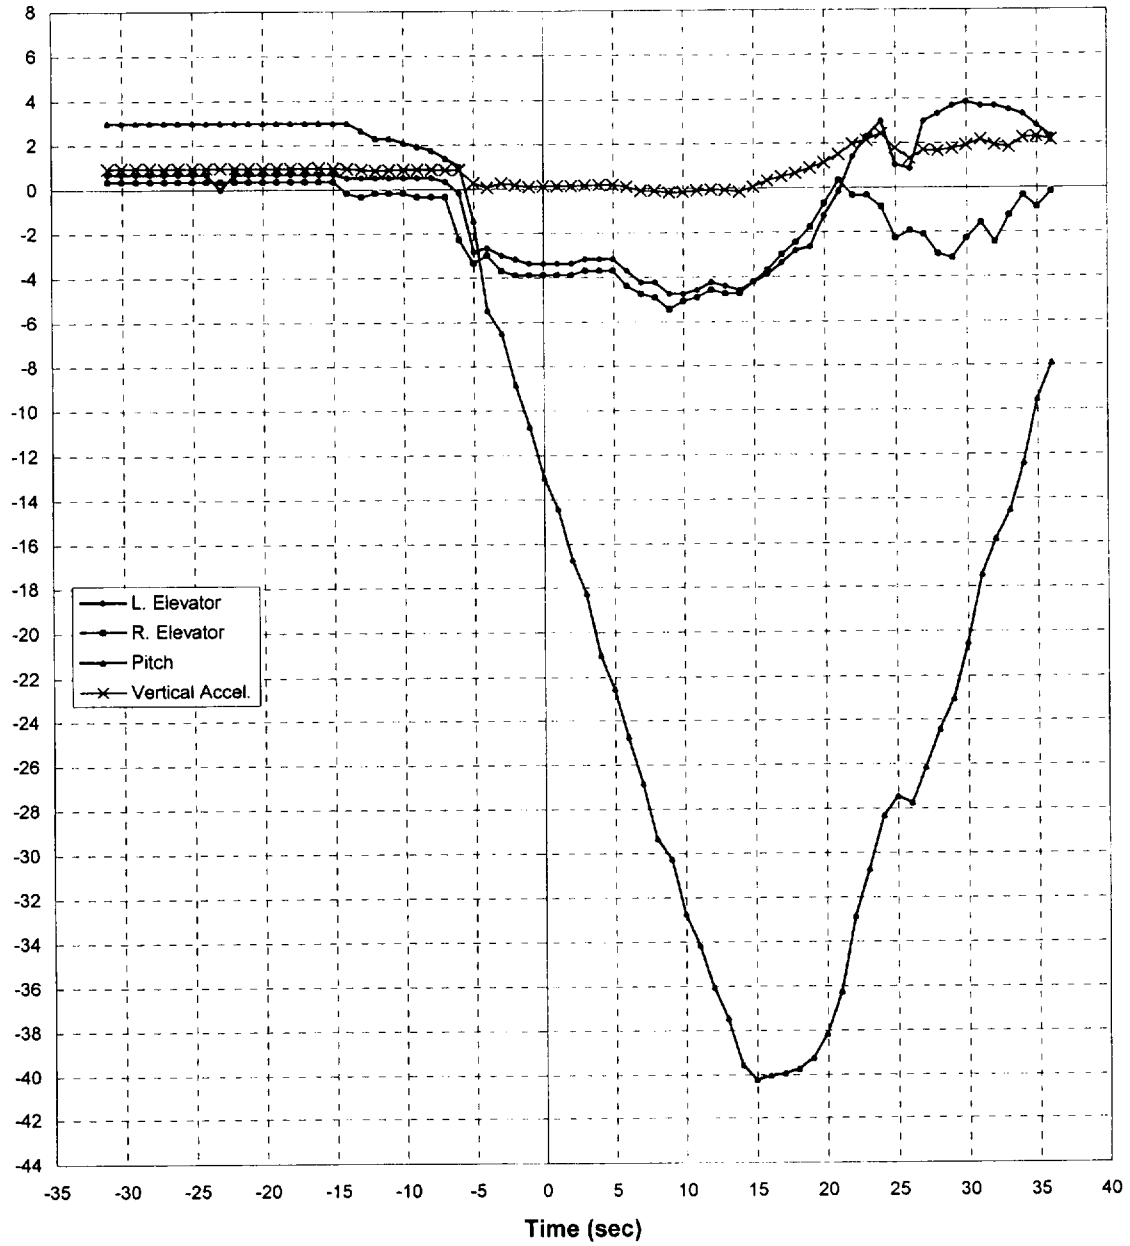
Figure 3. FDR Elevator Deflection, Pitch, and Vertical Acceleration

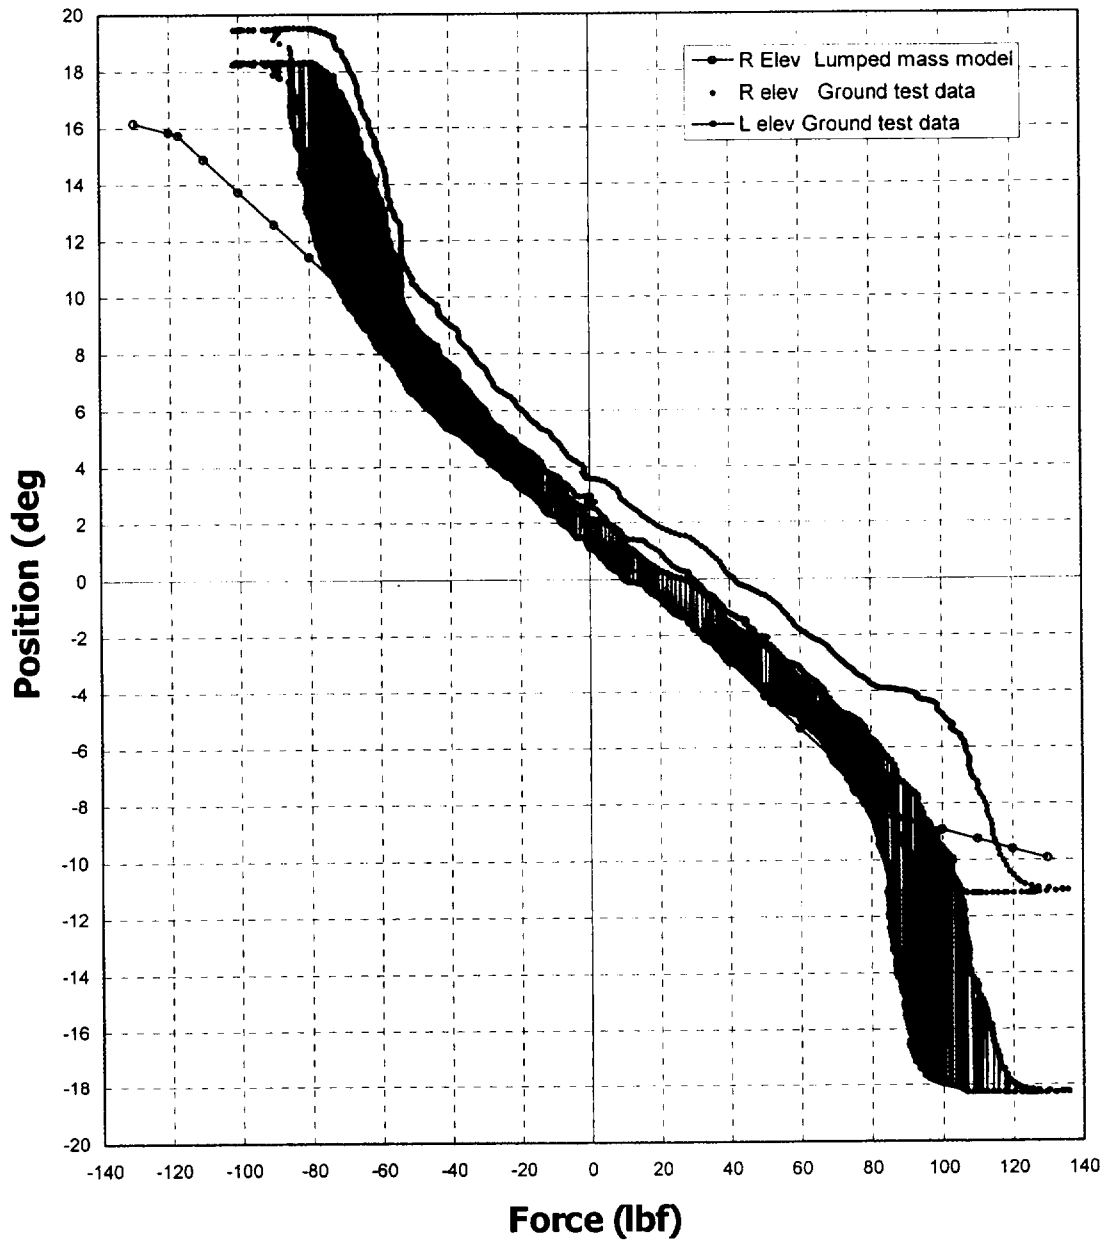
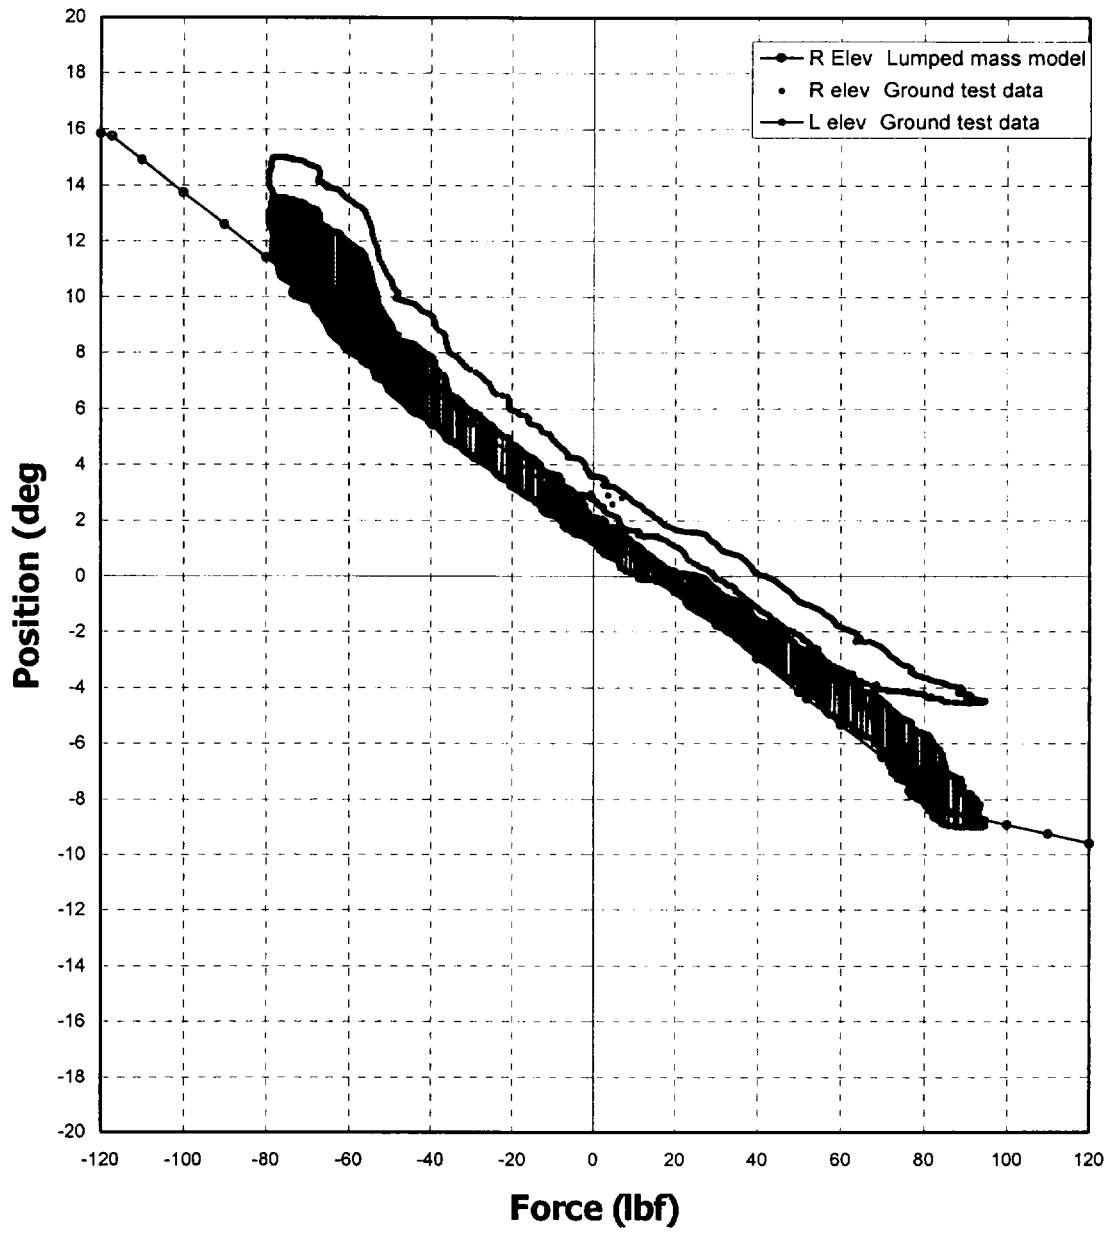
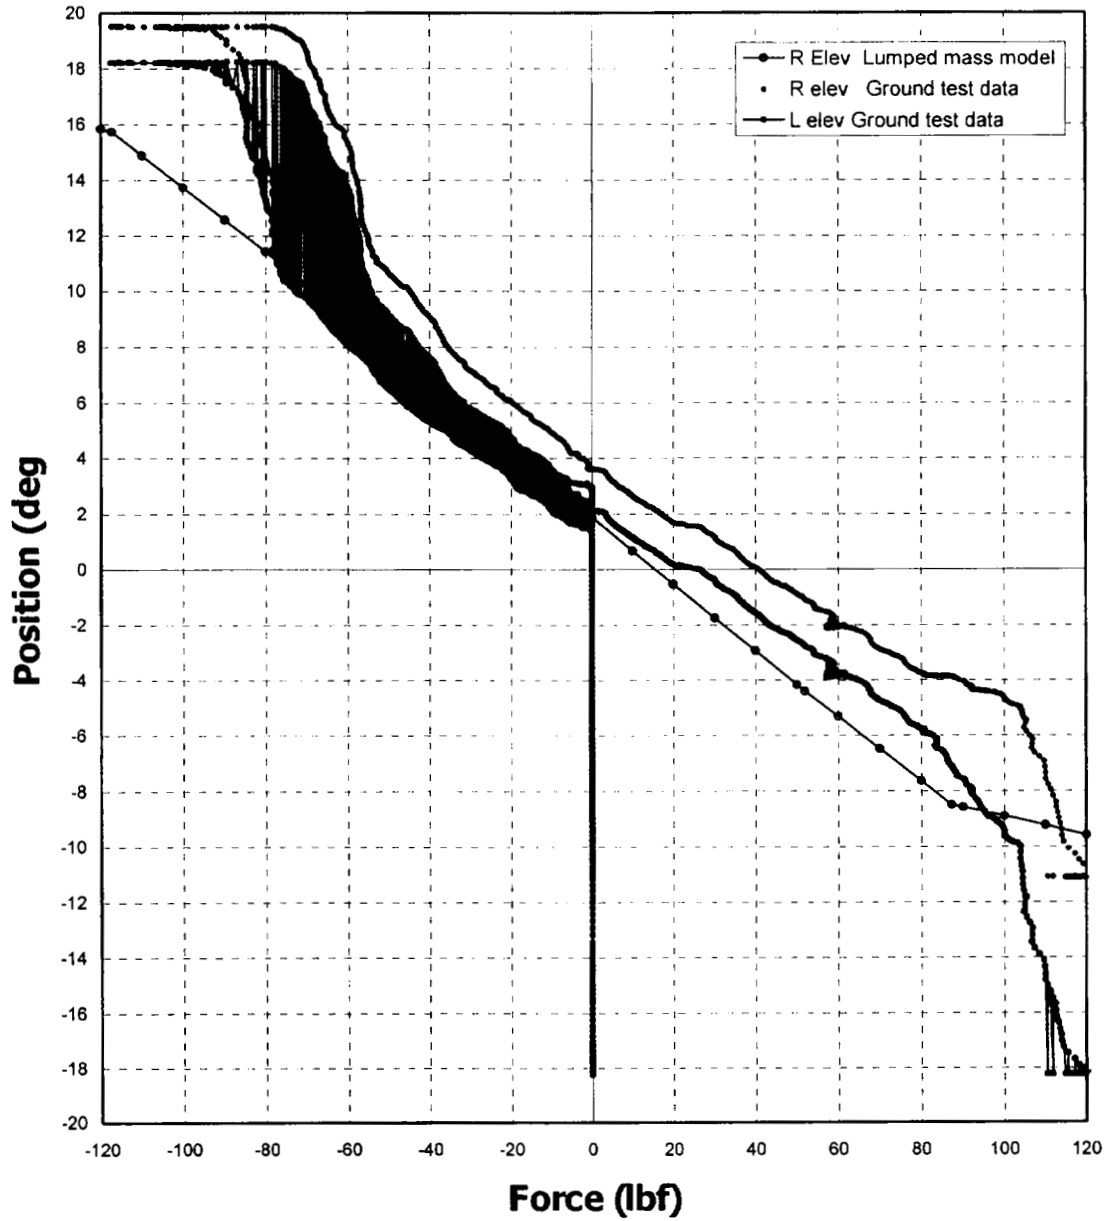
Figures 4, 5, and 6, which are extracted from the ground test data, indicate the elevator movement at a no-load condition as a result of a single PCA valve jam in the TED direction.<sup>2</sup> These figures show the results of three separate tests under the same test conditions –single PCA jam, 770 psi feel pressure, and pilot column sweep. They indicate that the right elevator is always leading the left elevator and are not consistent with the mathematical model included in Boeing report B-H200-17068-ASI-R2 -Split Elevator Failure Scenario, dated September 29, 2000 and Boeing report B-H200-17026-ASI, -767 Elevator System Operation with Regard to Column Splits, Aft Quadrant Splits, and Column Jams, dated August 2, 2000.

Figure 4. Elevator Deflection from Ground Test A and Analytical Model  
 Single PCA Control Valve Jam on the Right Elevator, 770 psi Feel Pressure, Pilot  
 Control Sweep

Figure 5. Elevator Deflection from Ground Test B and Analytical Model  
 Single PCA Control Valve Jam on the Right Elevator, 770 psi Feel Pressure, Pilot  
 Control Sweep

Figure 6. Elevator Deflection from Ground Test C and Analytical Model  
 Single PCA Control Valve Jam on the Right Elevator, 770 psi Feel Pressure, Pilot  
 Control Sweep

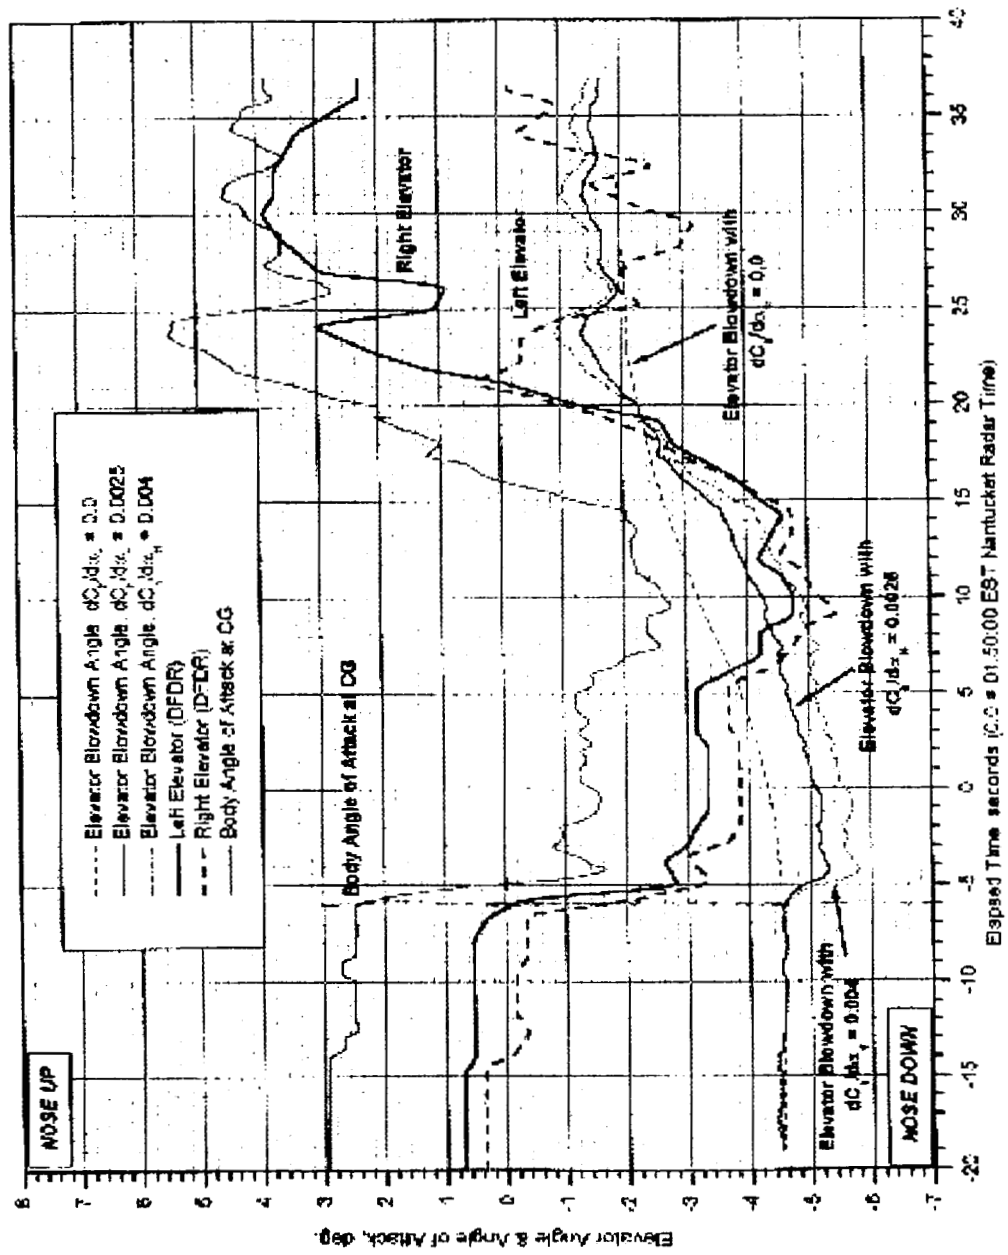
Figure 7 shows the expected elevator deflection as a result of a dual PCA control valve jam using the Boeing hinge moment data with and without considering the effect of airplane body angle variation and the FDR elevator data. These expected deflections were derived by the NTSB performance group chairman and validated by the Egyptian Delegation. From elapsed time of 7 seconds, the calculated right elevator position is within 1 degree of the FDR.<sup>3</sup>

<sup>3</sup> Figure 7 is from the NTSB and does not account for any differences caused by the rate at which the failure occurred. In addition, the labels for right and left elevator are reversed.

Figure 7. Expected Elevator Deflection as a Result of Dual PCA Valve Jam Failure (Produced by the NTSB Performance Group Chairman)

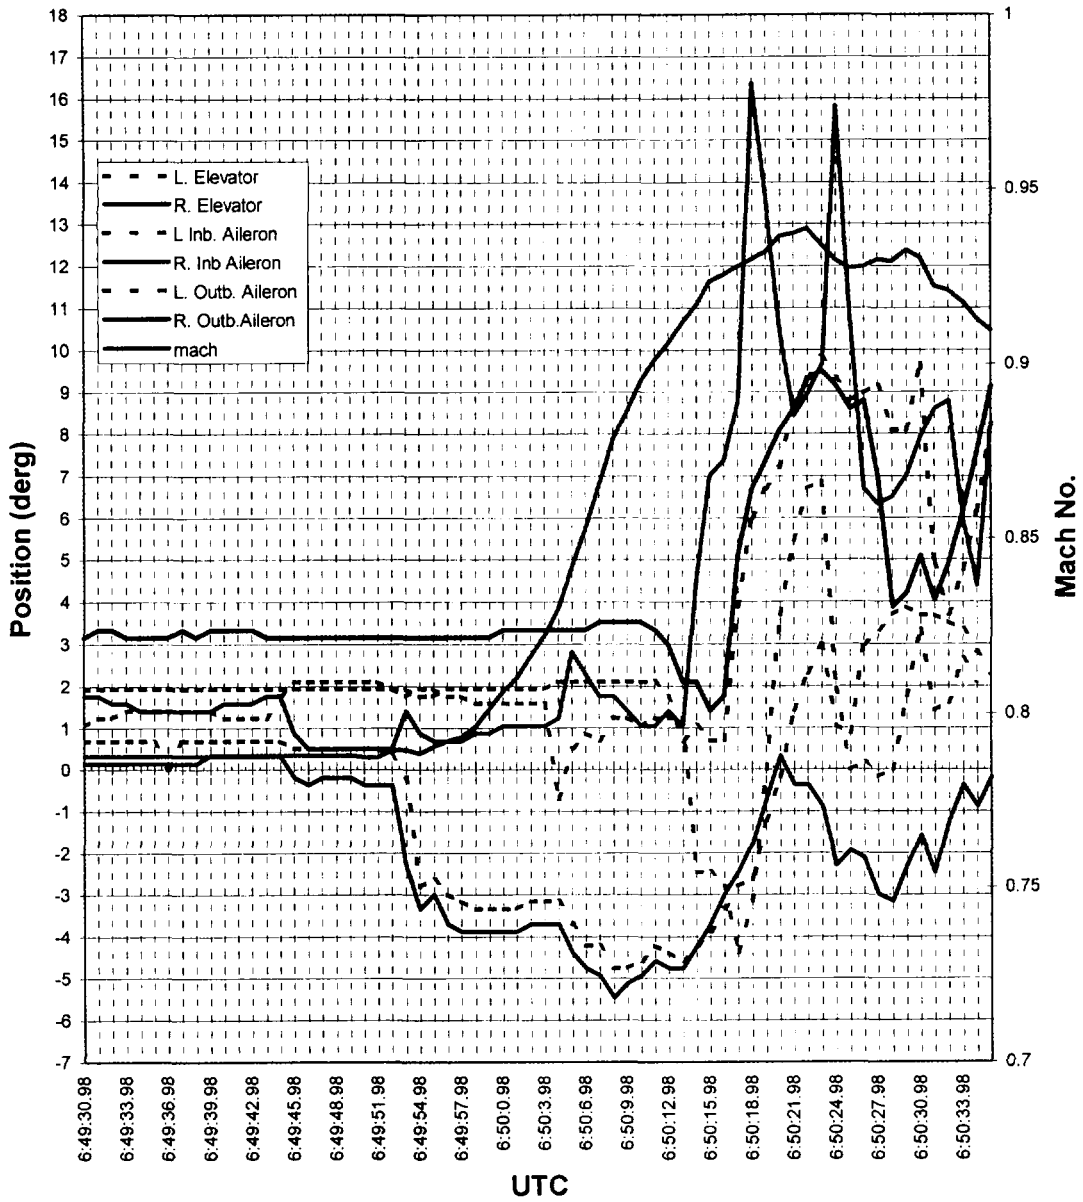
Figure 8. FDR Elevator and Aileron Deflection and Derive Mach Number

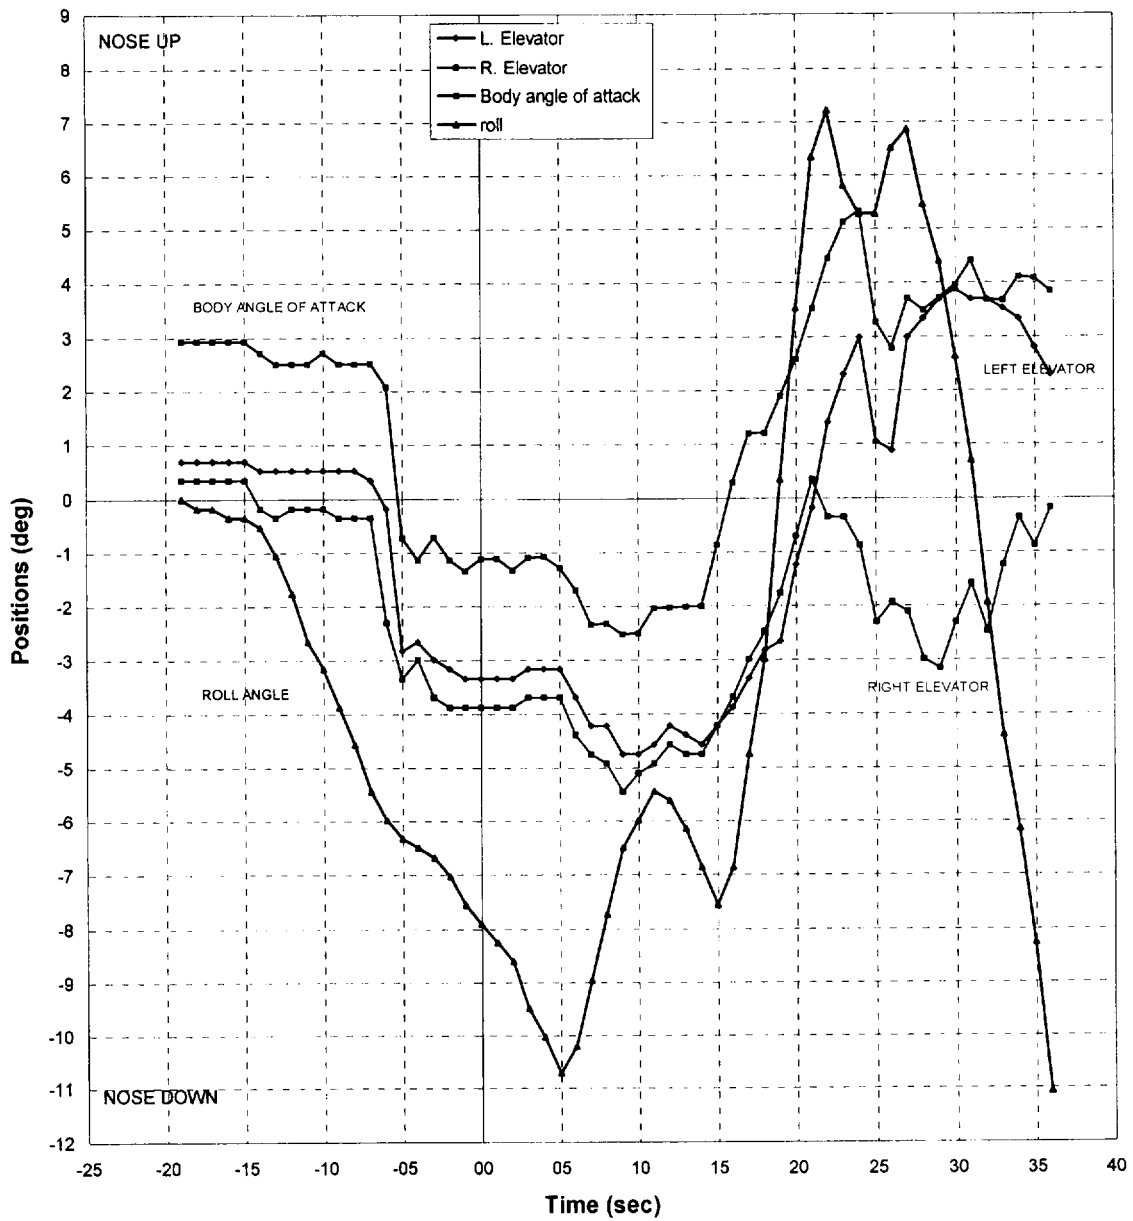
Figure 9. FDR Roll Angle and Derived Body Angle of Attack

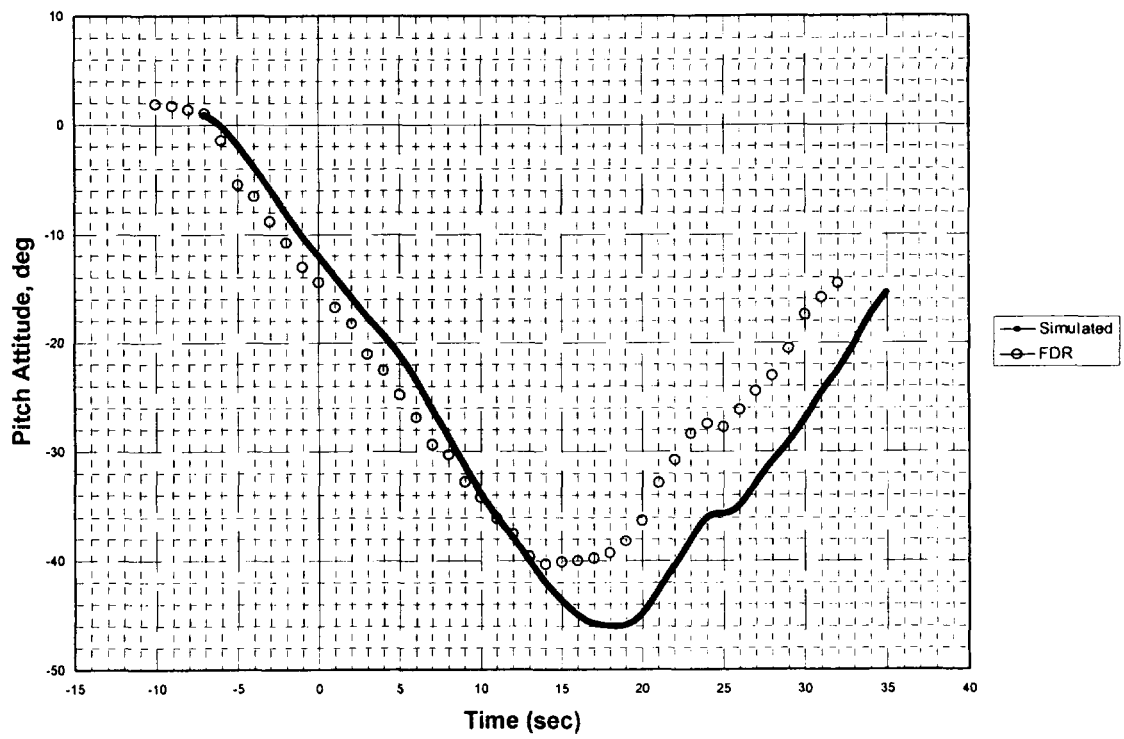
Figure 10. Pitchover Simulation, Right Elevator as Recorded on the FDR

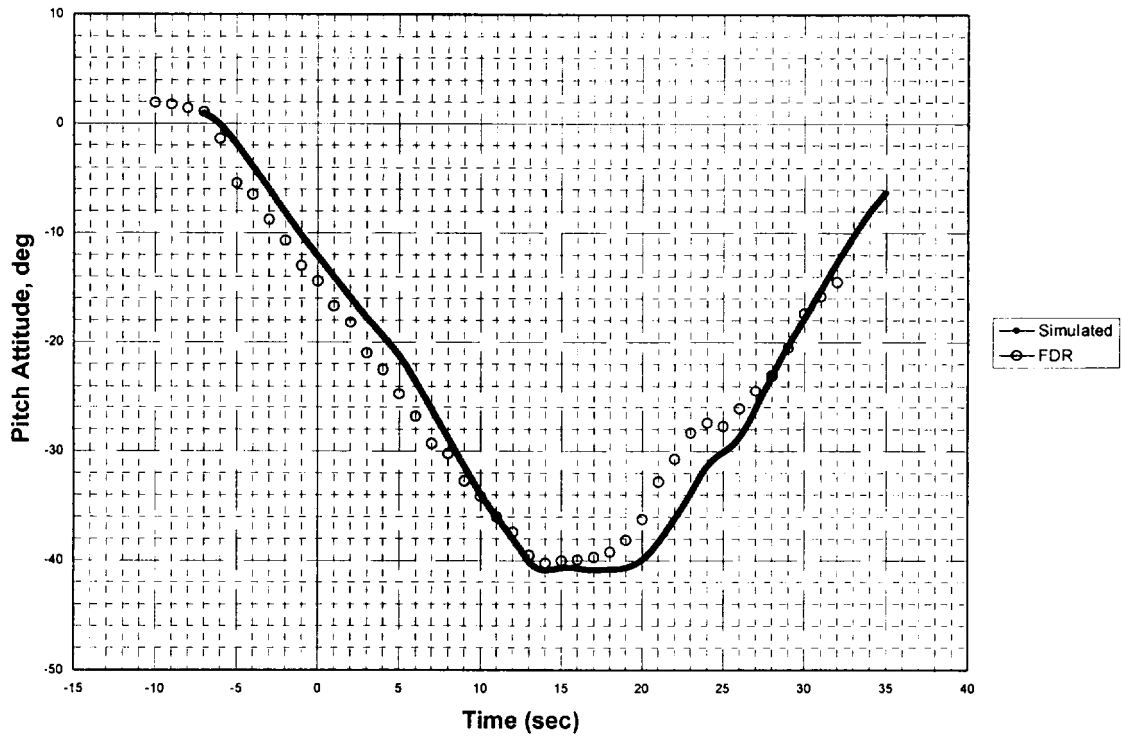
Figure 11. Pitchover Simulation, Right Elevator Missing

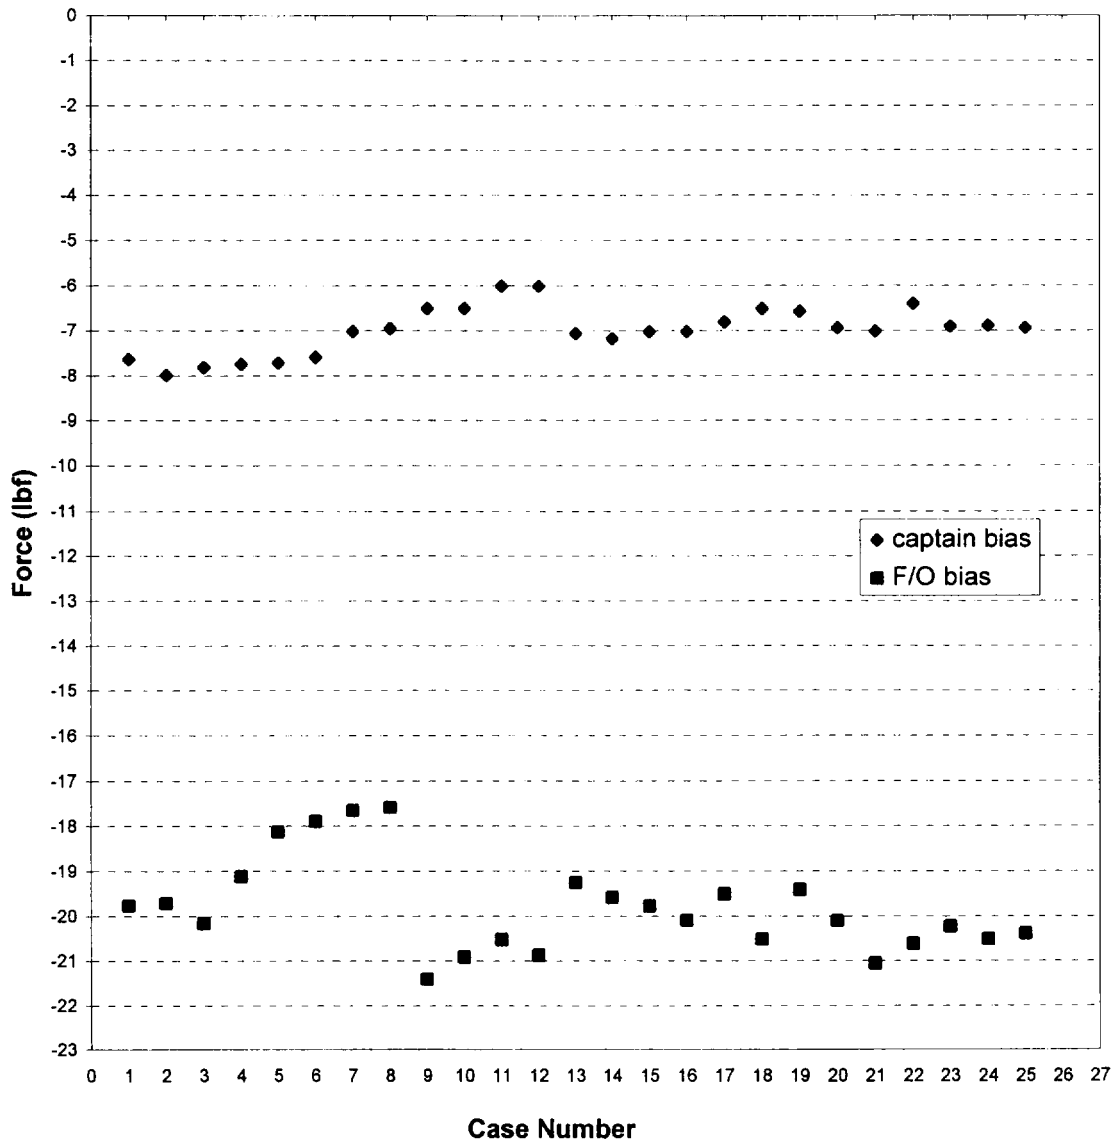
Further, Boeing's explanation of force bias due to temperature effects is not supported by the data. Figure 24 shows the bias on the Captain's column force measurement increasing with time, with the suggestion that changes in temperature caused this change in bias. If temperature were the cause of the change in bias, the bias in the First Officer's force measurement would have increased as well, but it decreased. In addition, the bias on the First Officer's force measurement does not change in the nearly linear manner that the bias on the Captain's force measurement does. If both force transducers have the same specifications, they should react to temperature in a very similar manner; there should not be an opposite reaction to changes in temperature.

Figure 24. March Ground Test Data, Bias Changes for Captain and First Officer Column Force Measurements

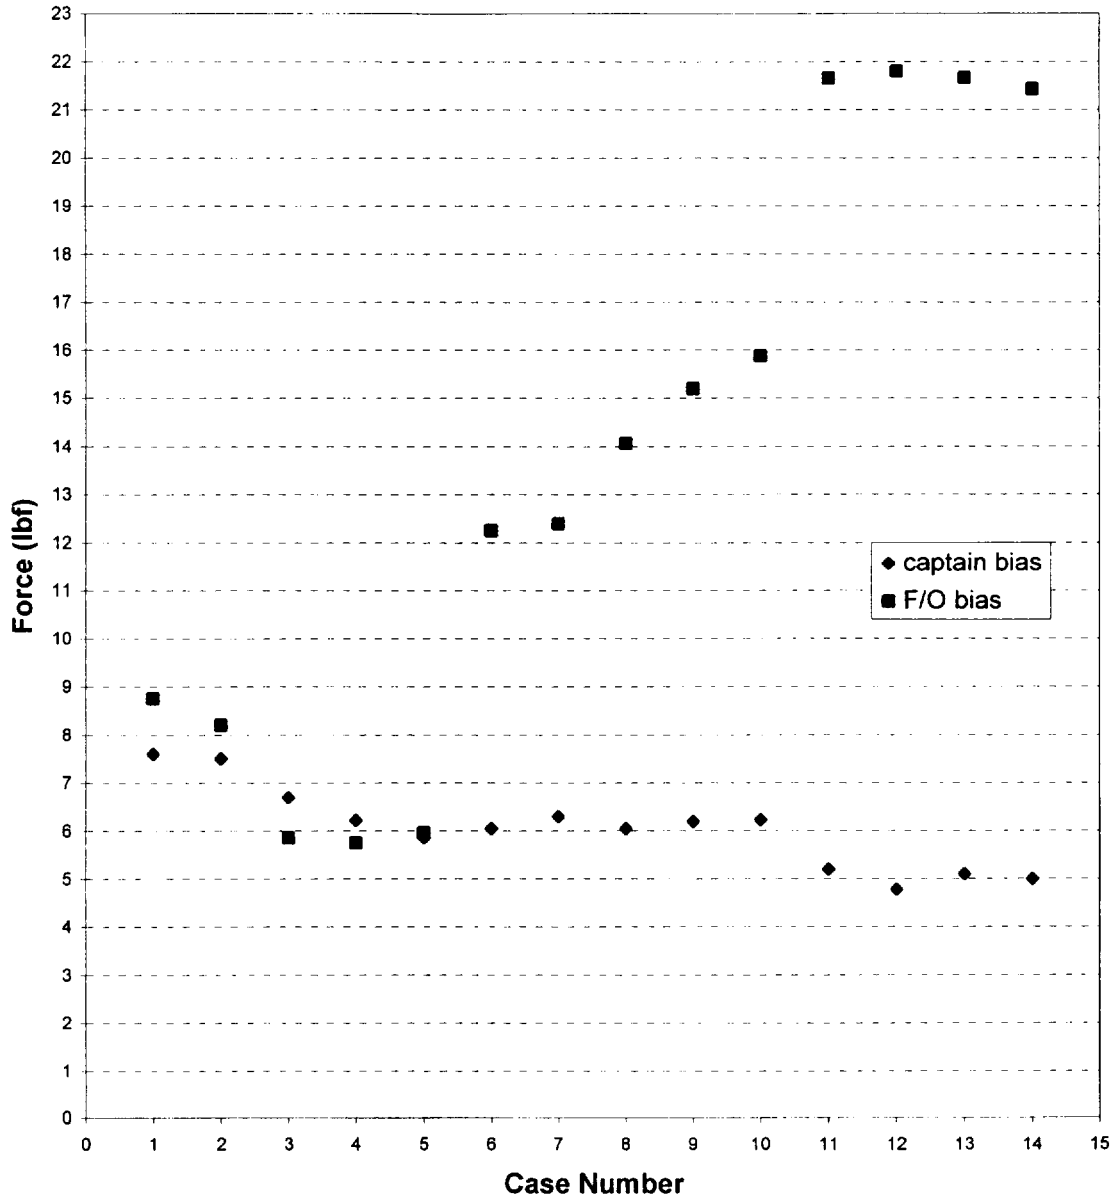
Figure 25. April Ground Test Data, Bias Changes for Captain and First Officer Column Force Measurements
